**NATIONAL ADVISORY COMMITTEE  
FOR AERONAUTICS**

**TECHNICAL NOTE 3925**

**PRELIMINARY METALLOGRAPHIC STUDIES OF BALL FATIGUE  
UNDER ROLLING-CONTACT CONDITIONS**

**By H. Robert Bear and Robert H. Butler**

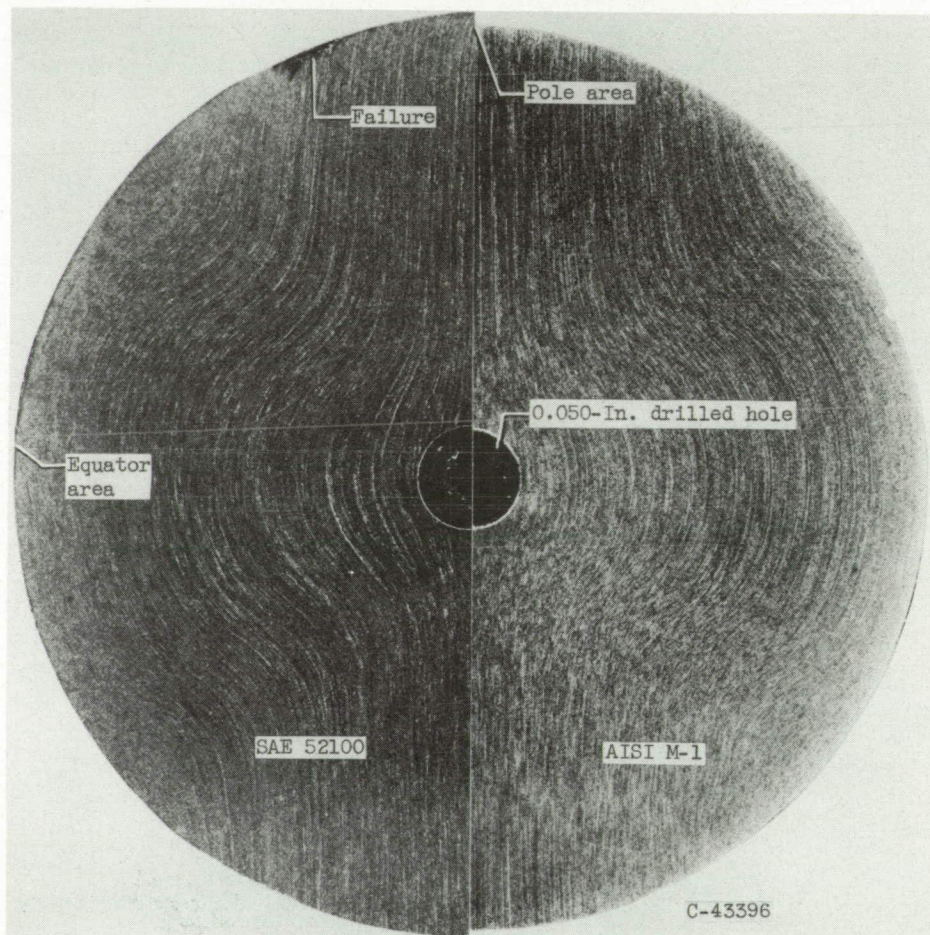
In figure 2(b), the macrostructures of SAE 52100 and AISI M-1 show the inherent structure nonhomogeneity resulting from chemical segregation and fabrication procedures.

A fatigue failure in the ball pole is included in figure 2(b). Since the fiber direction at the poles was parallel to the high compressive stresses, failure could originate from secondary tensile stresses. Origin and progression of fatigue failures are shown and discussed in the section Metallographic Results.

(b) Cross sections of SAE 52100 and AISI M-1 balls. X12.

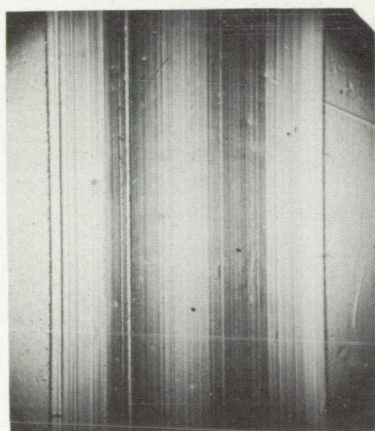
Track colorations varied from a pale straw color for the SAE 52100 balls tested at room temperature to a blue-purple on the 200° F AISI M-1 test balls. A characteristic stain pattern is shown in figure 3(a). This coloration is a very thin varnish-like layer and appears to be due to lubricant stain and oxidation within the pressure areas. Abrasive wear was absent, but metal furrowing occurred on some of the SAE 52100 specimens. Most balls showed a varying amount of pitting similar to the type often observed on gear teeth. More pitting occurred at 200° F than at room temperature. SAE 52100 specimens showed random pitting while in AISI M-1 pitting plus erosion was often shown.

(a) Ball track.

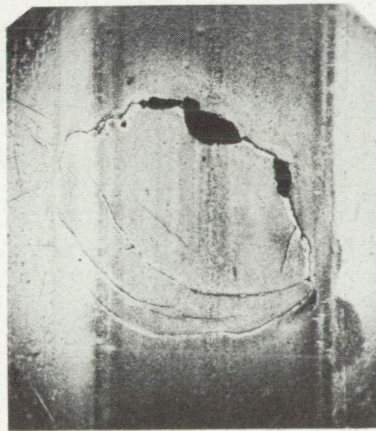
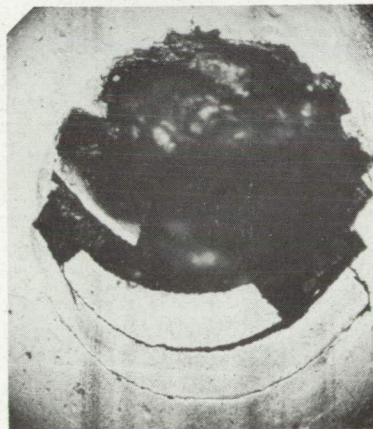
The appearance of fatigue failures obtained was similar, differing primarily in the degree of spalling. They are typical of the failures encountered in service and other bearing testing methods. Figures 3(b) and (c) show failures before and after spalling. Failures were shallow, spalling to a depth of 0.004 to 0.007 inch.

(b) Ball track fatigue failure, before spalling.

(c) Ball track fatigue failure, after spalling.

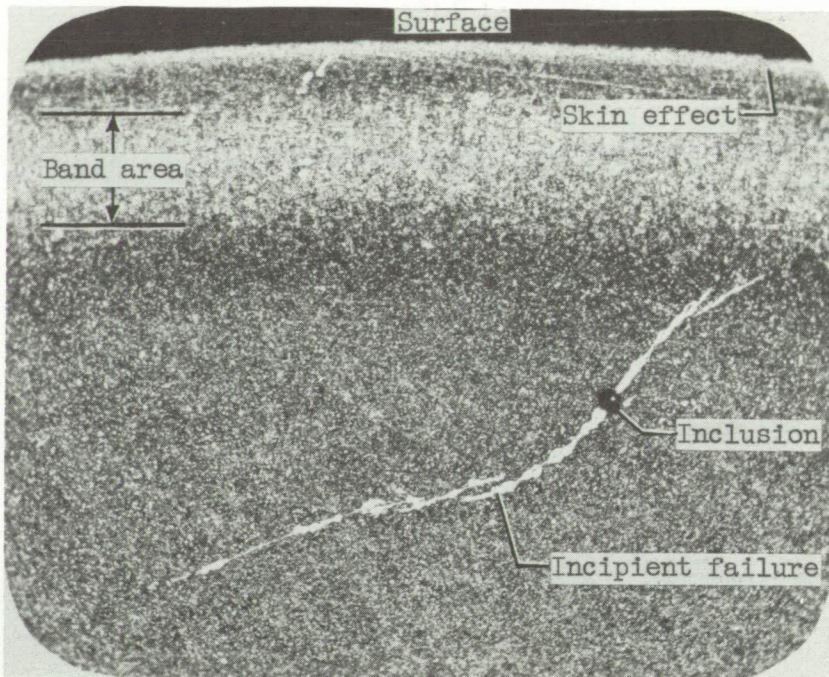
Skin effects. - Frequently, metallurgical changes occur immediately under the ball wear track. Since the depth of this condition never exceeded 0.001 inch (fig. 4), the term skin effect is considered appropriate.

Incipency. - Incipience as encountered in the discussions on inclusions and failures includes, in addition to crack initiation, some limited crack propagation. For example, the cracking around the inclusion in figure 4 shows progression yet is considered an incipient condition in relation to a fatigue failure.

Figure 4. - Nomenclature for defects in balls after test. X75.  
Figure has been printed at original magnification.

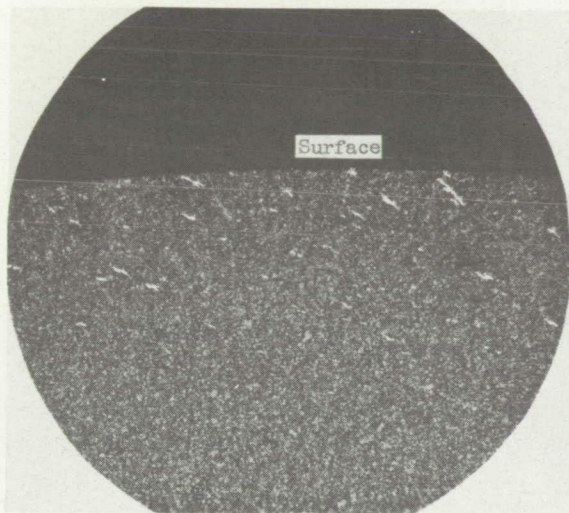
Figure 5(a) shows representative inclusion damage about which the following observations can be made:

- (1) These cracking conditions are the rule rather than the exception.
- (2) The angles of cracking generally are approximately  $45^{\circ}$  to normal, that is, they are in the maximum-shear plane.
- (3) When inclusions are segregated, there is a tendency toward crack alinement.

The ball of figure 5(a) had been tested for  $41 \times 10^7$  cycles without failure, so these defects are not too serious. However, figure 5(b) shows the damage that a single, medium-sized (0.0015-in. diam) inclusion can do in approximately  $8 \times 10^7$  cycles, even though it is located appreciably deeper than the maximum-shear-stress area.

(a) Small matrix cracks caused by inclusions in AISI M-1. X75.

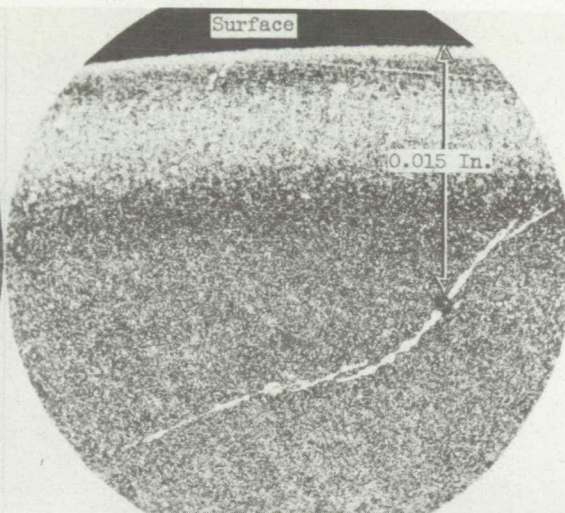
There were also variations in the effect of inclusions between SAE 52100 and AISI M-1 materials. Inclusions were more numerous in SAE 52100 steel; however, the majority were of the less harmful sulphide type. Although oxides initiated severe local matrix cracking in SAE 52100, crack propagation was less than for AISI M-1 steel. No instances of crack propagation such as shown in figure 5(b) were encountered in SAE 52100 steel.

(b) Crack propagation from large inclusion in AISI M-1. X75.

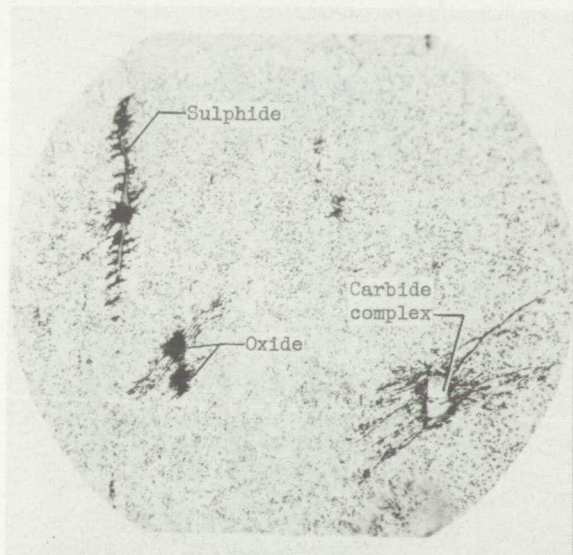
(1) Inclusion hardness affected the amount of matrix cracking. The softer sulphides produced less matrix cracking than the harder oxides. Occasionally very hard angular yellow colored inclusions, probably a nitrogen-rich solid solution of titanium nitride and titanium carbide, caused the most severe cracking conditions. All of these inclusion types are shown in figure 5(c).

(c) Relative matrix cracking incurred by carbide, oxide, and sulphide inclusions in SAE 52100. X500.

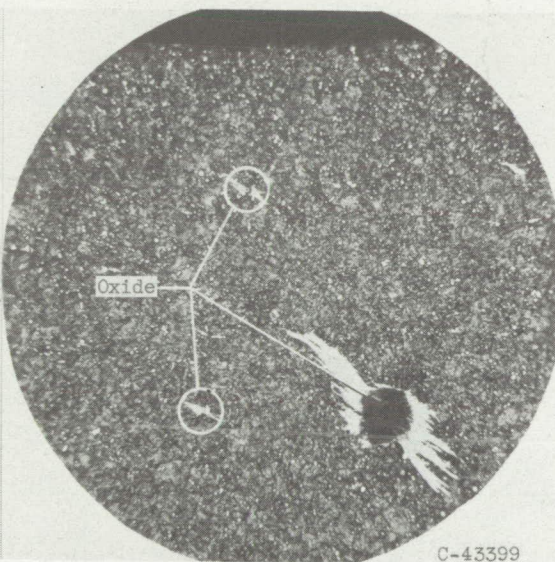
(3) Effects of variation in inclusion size are depicted in figure 5(d). Small laminations found only in AISI M-1 steel can be serious hazards (see fig. 5(e)).

(d) Inclusion size effects and cracking in AISI M-1. X250.

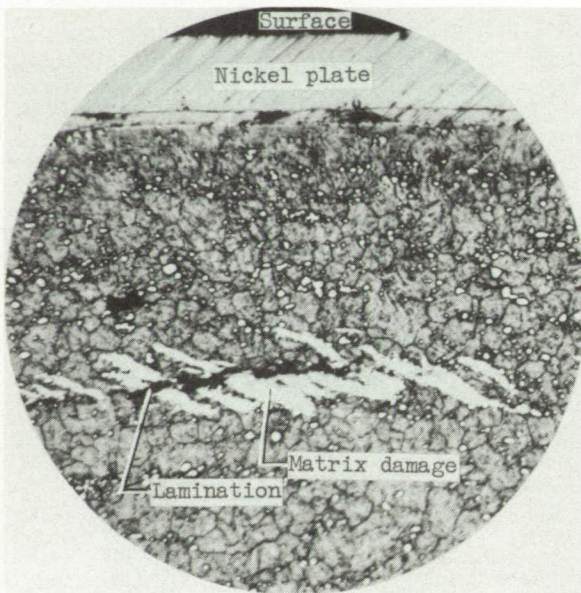
The oxides in AISI M-1 were more numerous than in SAE 52100 and frequently were segregated to cause small laminations (fig. 5(e)). The incidence of incipient cracking around all inclusions showed a slight decrease at the 200° F testing temperature. However, crack propagation, which showed a decided decrease at 200° F for SAE 52100 balls, was appreciably increased in AISI M-1 balls.

(e) Matrix damage (white) caused by lamination (black) in AISI M-1. X500.

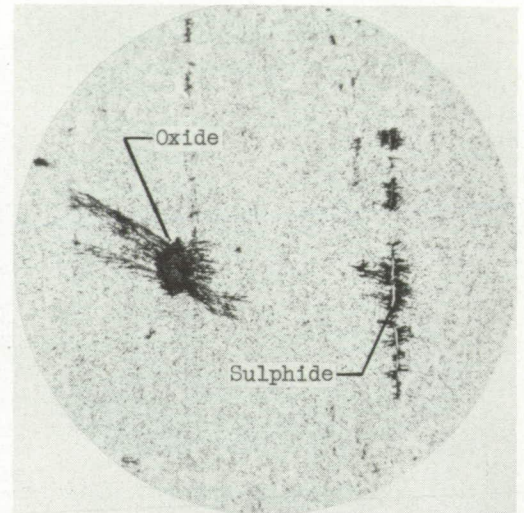
Figure 5(f) shows comparative matrix cracking produced by an oxide and by a sulphide inclusion in an SAE 52100 ball tested at room temperature. Also shown is that, although the matrix is severely cracked, crack propagation was limited, since this ball had a longer than average life of  $45 \times 10^7$  cycles.

(f) Brittle type of matrix cracking in SAE 52100. X250.

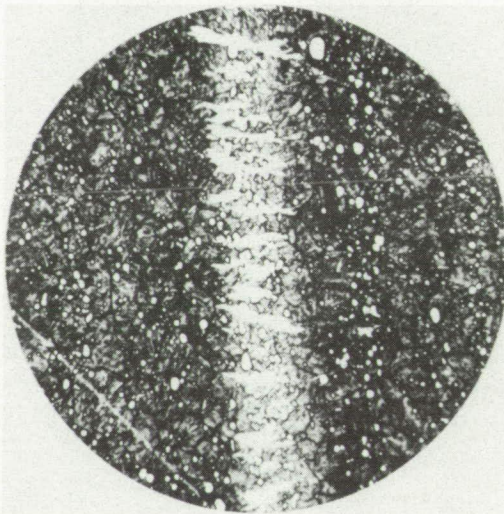
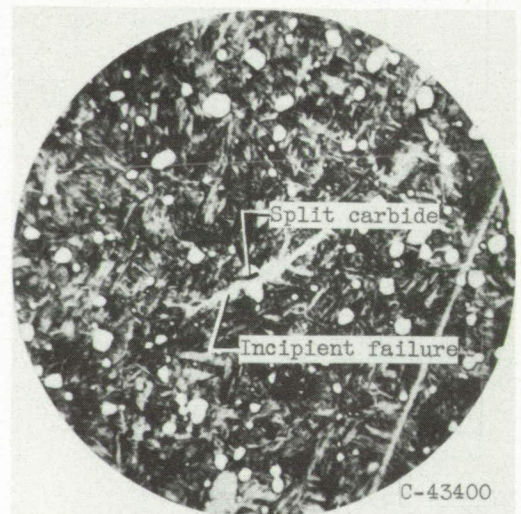
In AISI M-1 steel the carbides are larger and also cause incipient failure similar to inclusions. This is shown in figures 5(g) and (h). Figure 5(g) is a segregated carbide streak in a ball pole area, and in figure 5(h) the large carbide has been split in half by the concentrated high stresses. Note also that with normal etching the incipient failure progressing from the split carbide shows no cracking and remains unetched. Likewise the damaged matrix caused by the heavy scratch to the lower right remains unetched. This indicates a similar severe straining condition and is in contrast to the brittle matrix cracking observed in SAE 52100 balls (fig. 5(f)).

(g) Segregated carbide streak and matrix damage in AISI M-1. X500.

(h) Incipient failure progressing from a carbide (split) inclusion in AISI M-1. X1500.

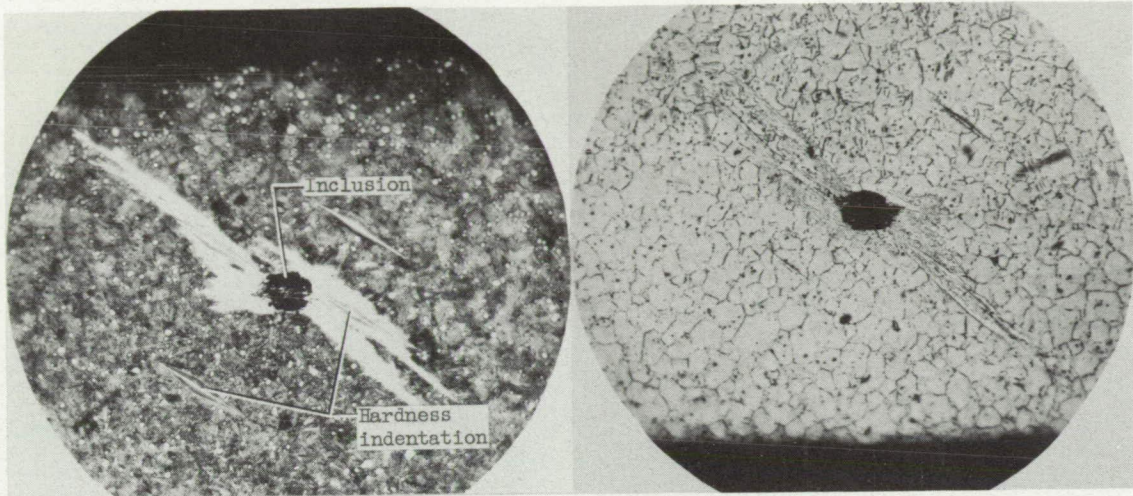
Some of the incipient failure regions, as in figure 5(i), were large enough for hardness measurements and showed hardnesses approximately 3 Rockwell C points higher than the surrounding matrix. This again indicates severe straining. In order to further establish the nature of such areas, this specimen was etched with electrolytic chromic acid (fig. 5(j)). This showed that these failure areas are a combination of very fine cracks and amorphous metal.

(i) AISI M-1 damaged matrix (white) showing no cracking with picral-HCL etch. X500.

(j) Same as (i) after additional etching with chromic acid (electrolytically); shows small cracks and amorphous structure.

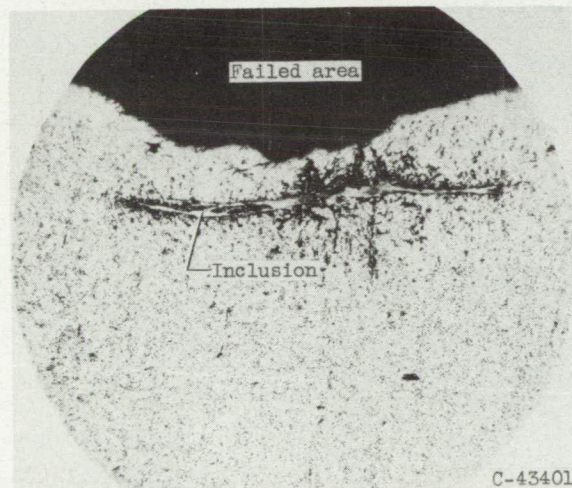
In summation, inclusions in this study were shown to cause stress concentrations resulting in incipient failures of varying degree. Although the majority of matrix cracking observed did not terminate in a ball fatigue failure, inclusions are responsible for some failures. Figure 5(k) shows a ball failure attributed to the inclusion marked by an arrow.

(k) Fatigue failure caused by inclusions in SAE 52100. X250.

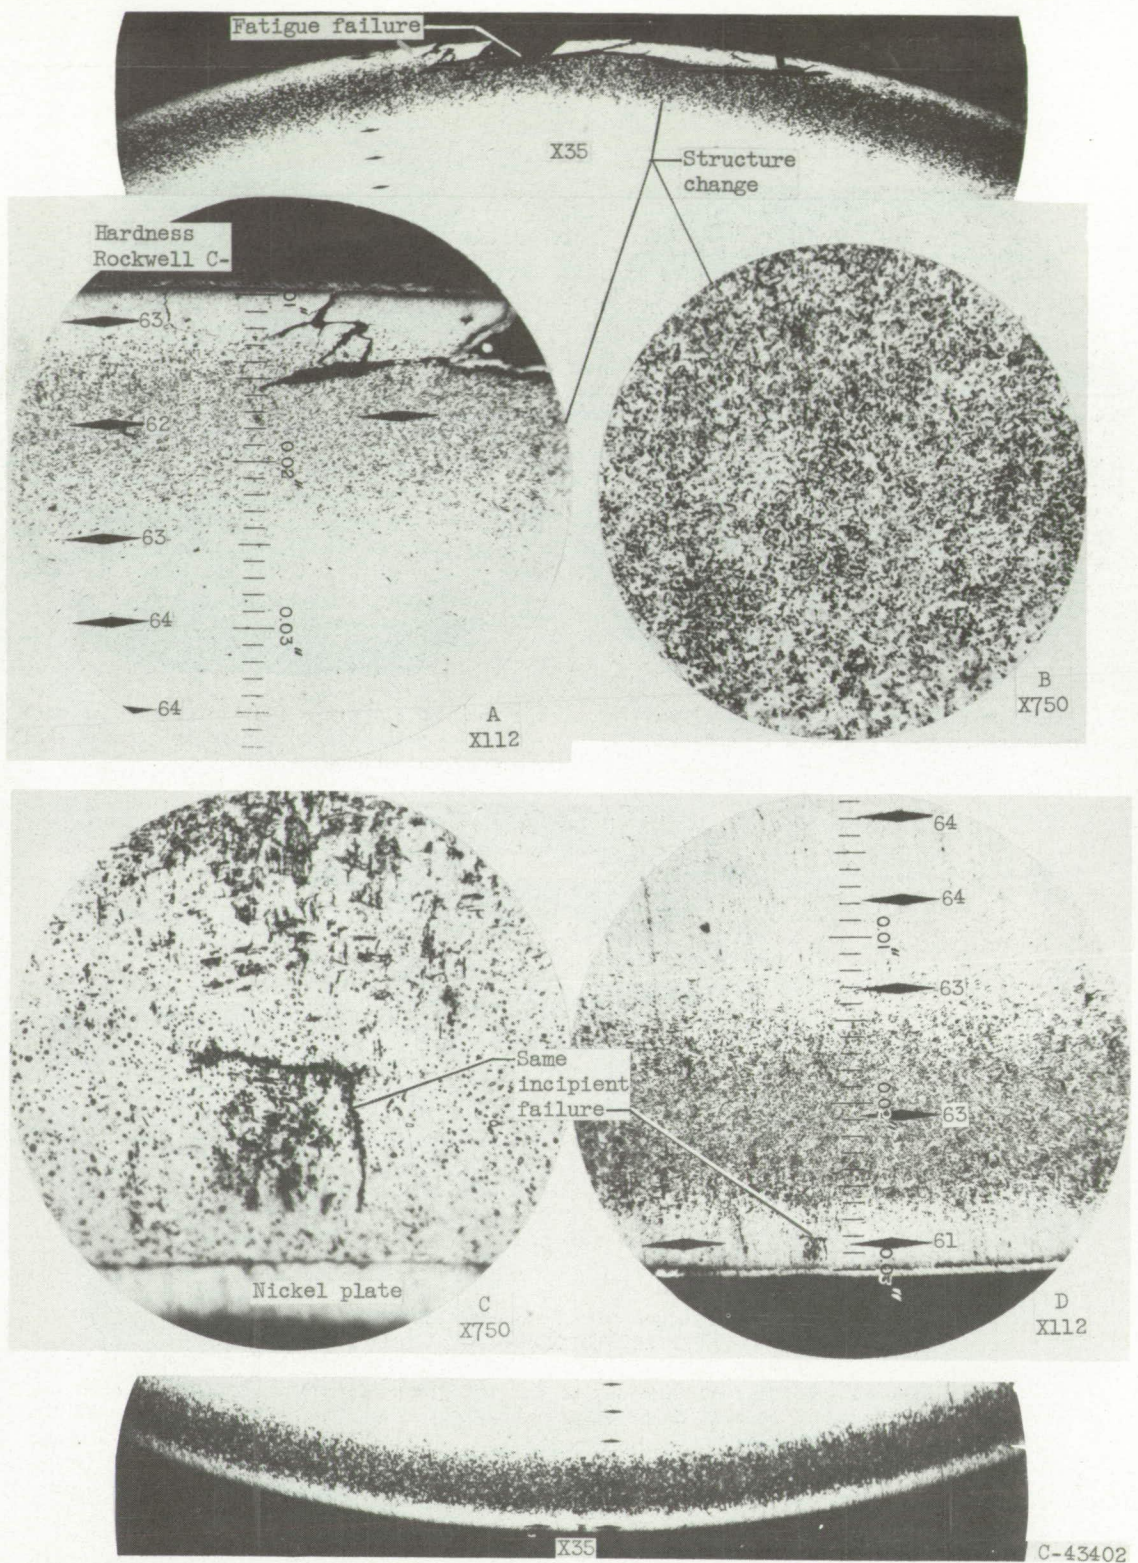
Tests at 250° F. - The occurrence of a change of structure in the high-shear-stress region of a bearing race was first reported in reference 5. Such changes of structure formed a dark etching band under the stressed track of SAE 52100 balls tested at 250° F. This condition is shown in figures 6, 7, and 8. The specimens were nickel plated to preserve ball track conditions and to reduce edge bevel. Figures 6 and 8 are longitudinal views midway through the 0.040-inch-wide track after  $3 \times 10^7$  and  $31 \times 10^7$  cycle tests. Figure 7 is a transverse section after a  $10 \times 10^7$  cycle run.

(2) The edges of these bands are acicular, occasionally with directional tendencies as shown in inset C of figure 6. This is believed to be an intermediate condition of tempering because it is more prominent in balls with short testing times. Inset C of figure 6 also includes an incipient failure with an entrapped area of dark etching matrix, which raises a speculative question: What was the source of the temperature rise which caused a structure change in this area?

(7) The ball failures included in figures 6 and 7 are typical of those encountered at  $250^\circ$  F. They are shallow, showing a tendency not to penetrate into the troostitic band, but rather to skim along its edge. This tendency may be caused by collapse of the harder layer resulting from insufficient support from the softer underlying troostite band. Ball failures are discussed again in the section Origin and Progression of Ball Failures.

Figure 6. - Structure change in SAE 52100 tested  $3 \times 10^7$  cycles at  $250^\circ \text{F}$ . Longitudinal view. Figure has been decreased 20 percent in printing.

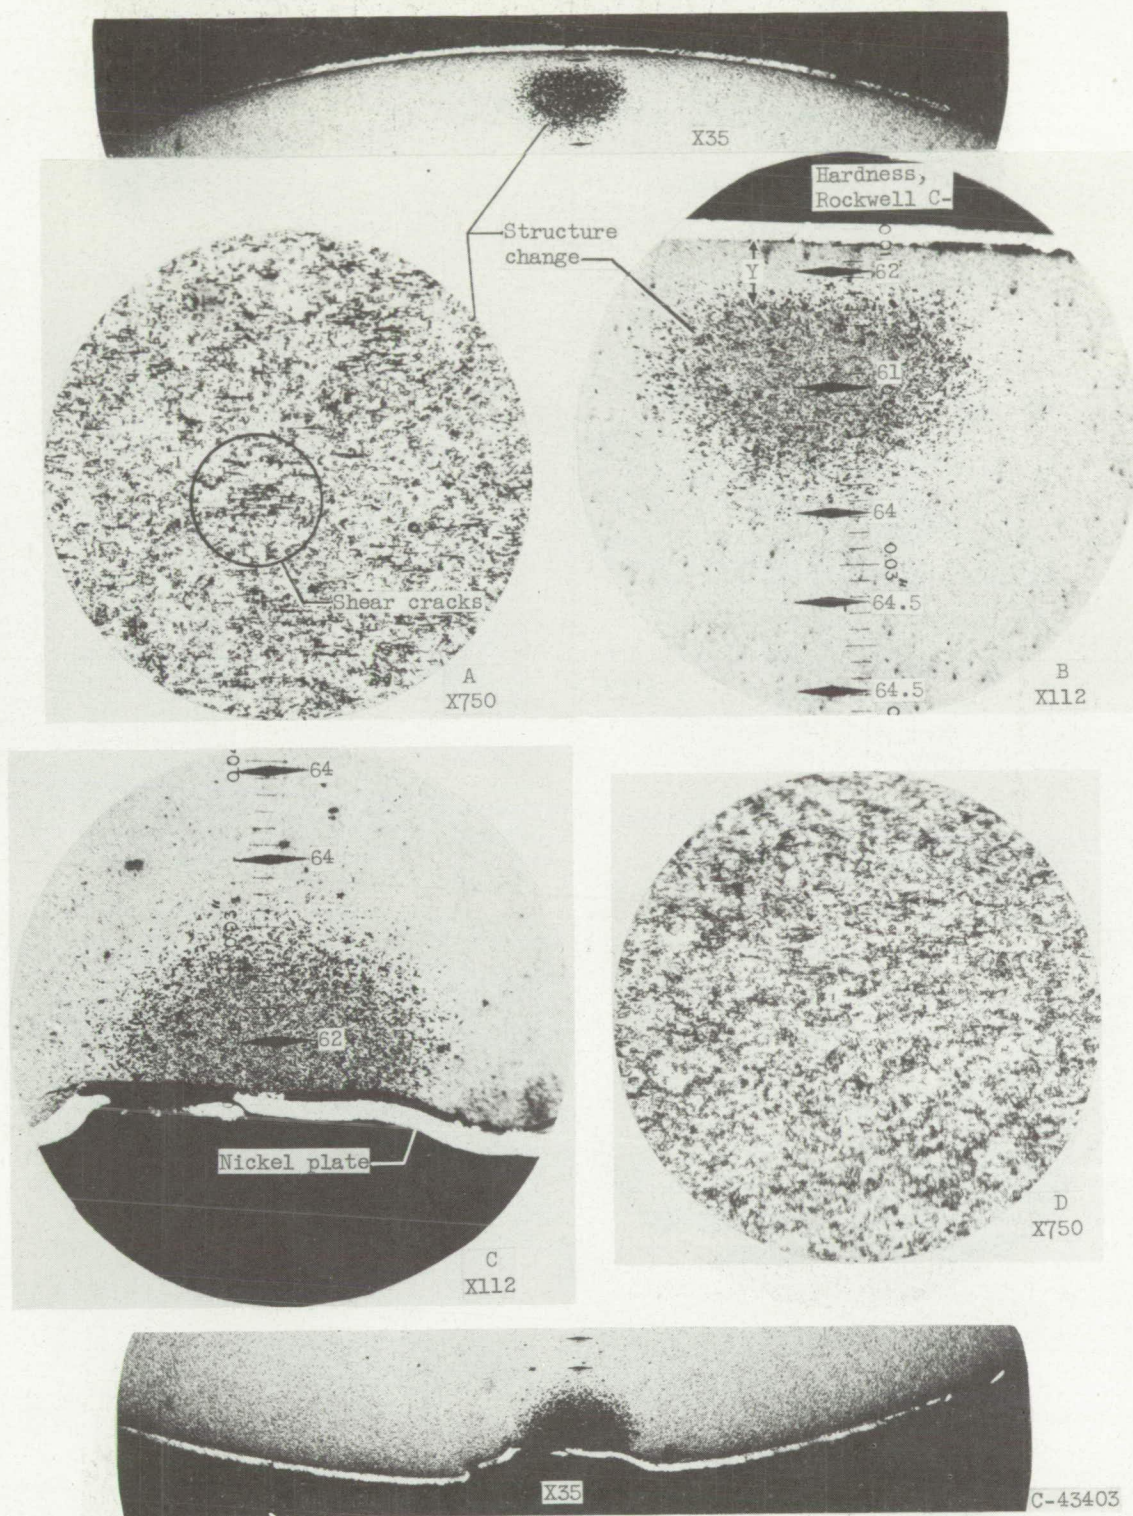
(5) In about  $10 \times 10^7$  cycles many very fine cracks develop in the troostite areas. Insets A and D of figure 7 show such cracks; they are partially obscured by the dark matrix etching, however. In this transverse view, the cracks are parallel to the track, being more numerous in the center of the elliptical band. With longer running times, these shear cracks enlarge and elongate as in inset A of figure 8. Inset B of figure 8 is a higher magnification of these shear cracks. In this longitudinal view the shear cracks are at an angle of  $45^\circ$  to the ball track and presumably result from the reduced strength caused by the structure change.

Figure 7. - Structure change in SAE 52100 tested  $10 \times 10^7$  cycles at  $250^\circ \text{F}$ . Transverse views. Figure has been decreased 20 percent in printing.

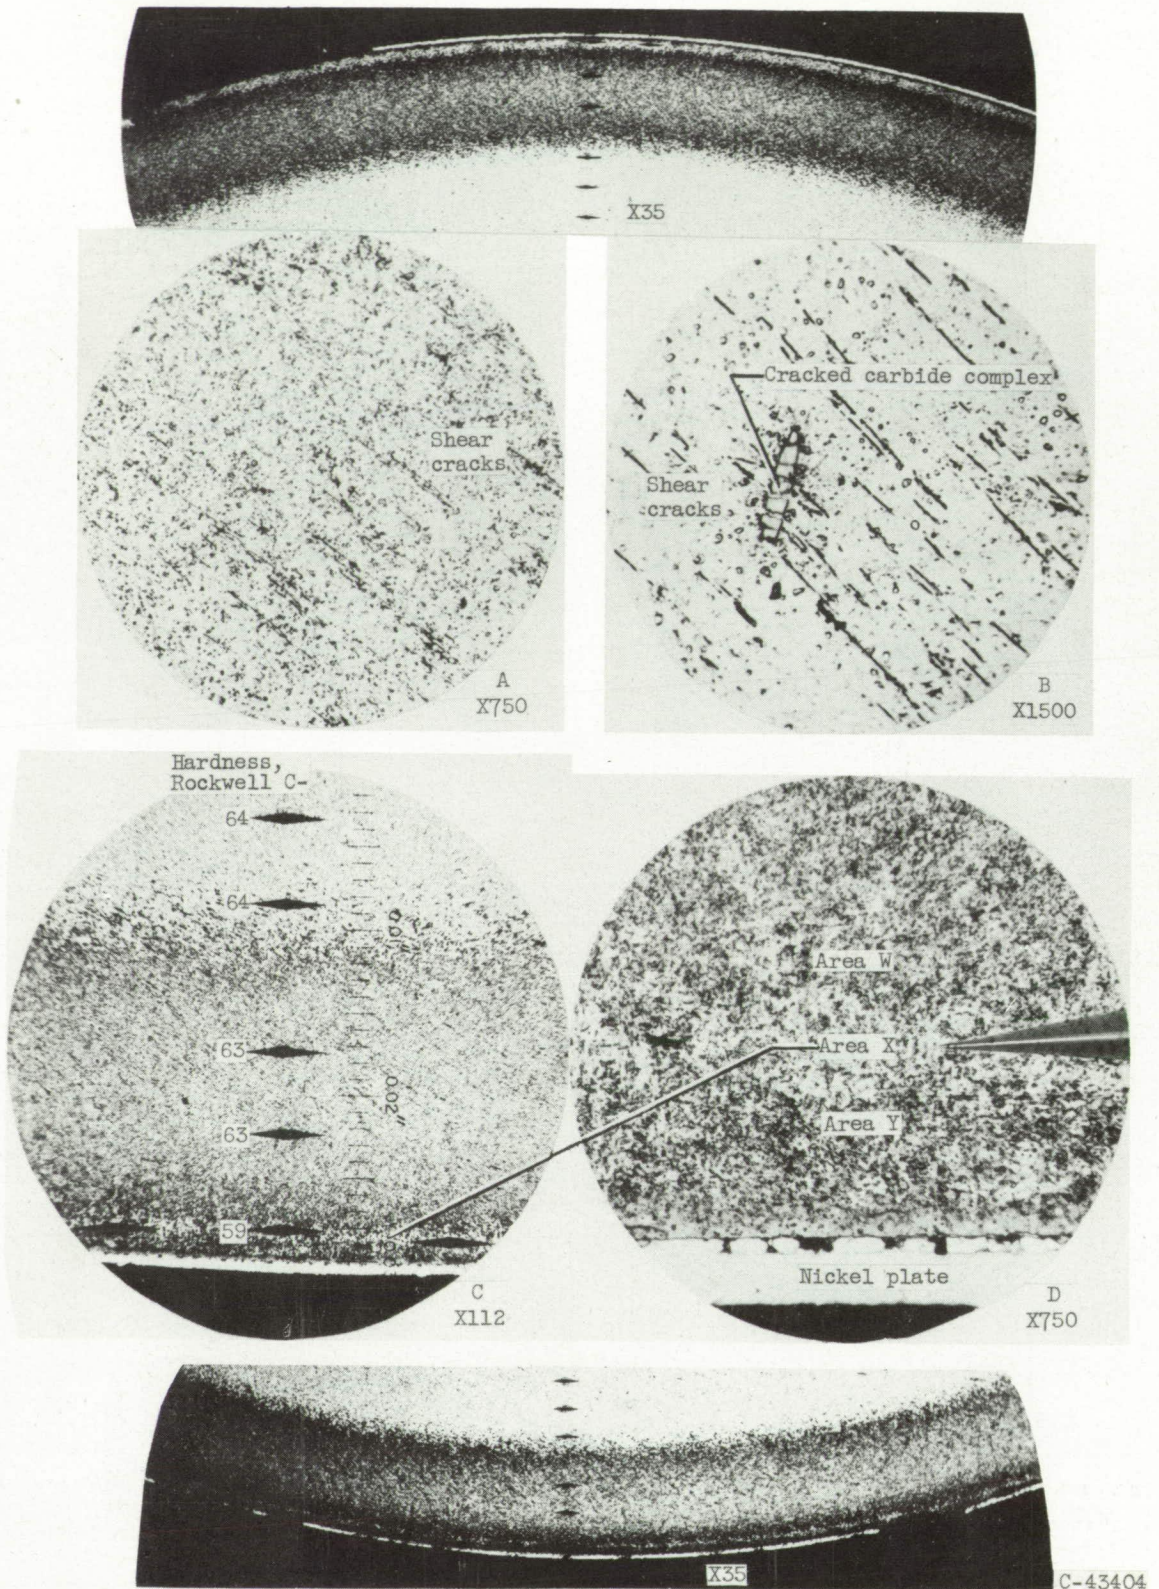
Figure 8. - Structure change in SAE 52100 tested  $31 \times 10^7$  cycles at  $250^\circ \text{F}$ . Longitudinal views. Figure has been decreased 20 percent in printing.

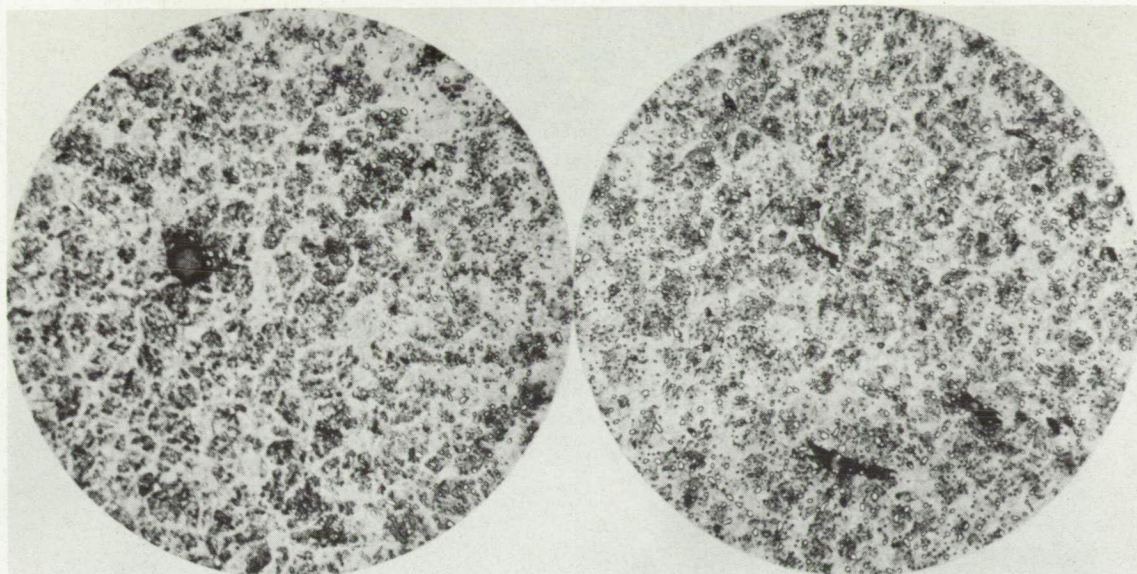
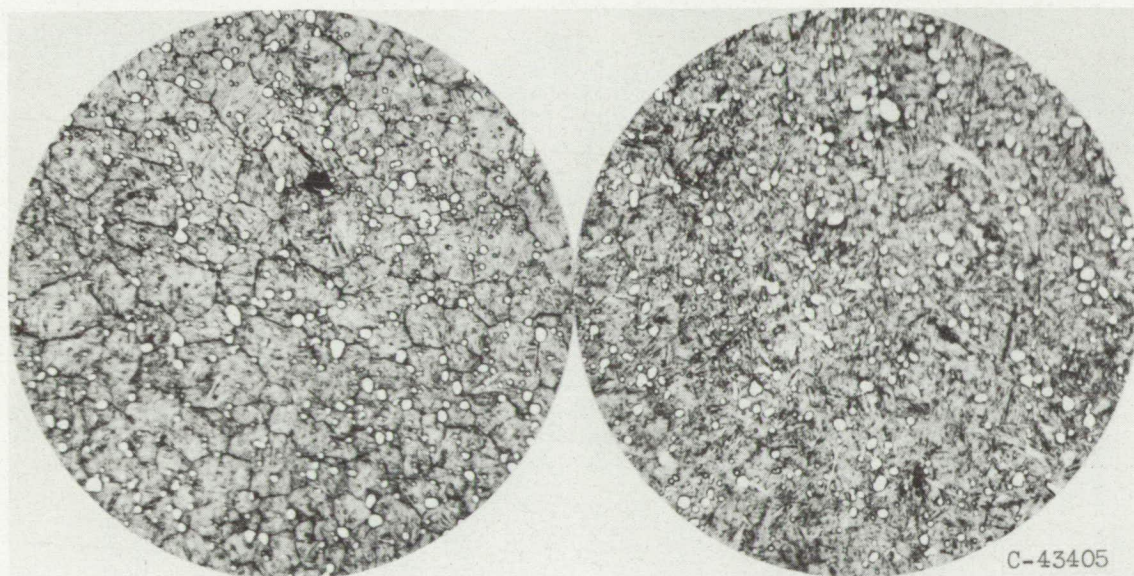
Tests at room temperature ( $80^\circ$  F). - Aside from the inclusion damage already discussed, the balls at room temperature showed no structural change. Figures 9(a) and (b) are comparison photomicrographs of one untested ball with another that ran for  $200 \times 10^7$  cycles without a failure.

Figure 9. - Typical microstructures before and after testing at room temperature X750. Figure has been decreased 8 percent in printing.

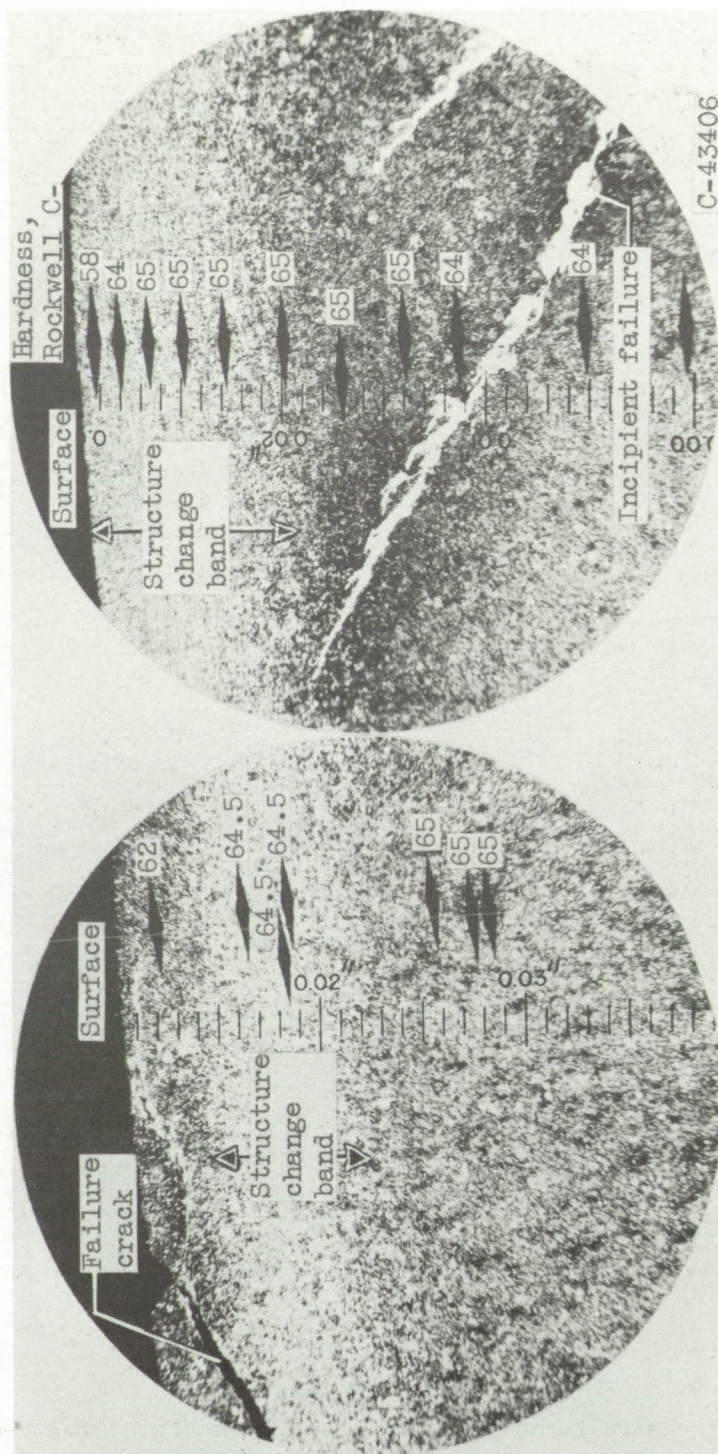
Such subtrack changes are shown in figure 10(a). The changed structure etches as a light rather than a dark band. Although etching characteristics are reversed, the bands are similar to SAE 52100 in size and area of origin and become more prominent with increased running time. Bands expand out to the surface as in the long running ball ( $111 \times 10^7$  cycles) in figure 10(b). However, they do not progress into the ball beyond a depth of 0.011 to 0.013 inch. The two white jagged lines approaching the ball surface (fig. 10(b)) are fatigue failure progressions originating from a small lamination beyond this photomicrograph.

Figure 10. - Structure changes in AISI M-1 tested at  $200^\circ \text{F}$ . Longitudinal views. X110. Figure has been printed at the original magnification.

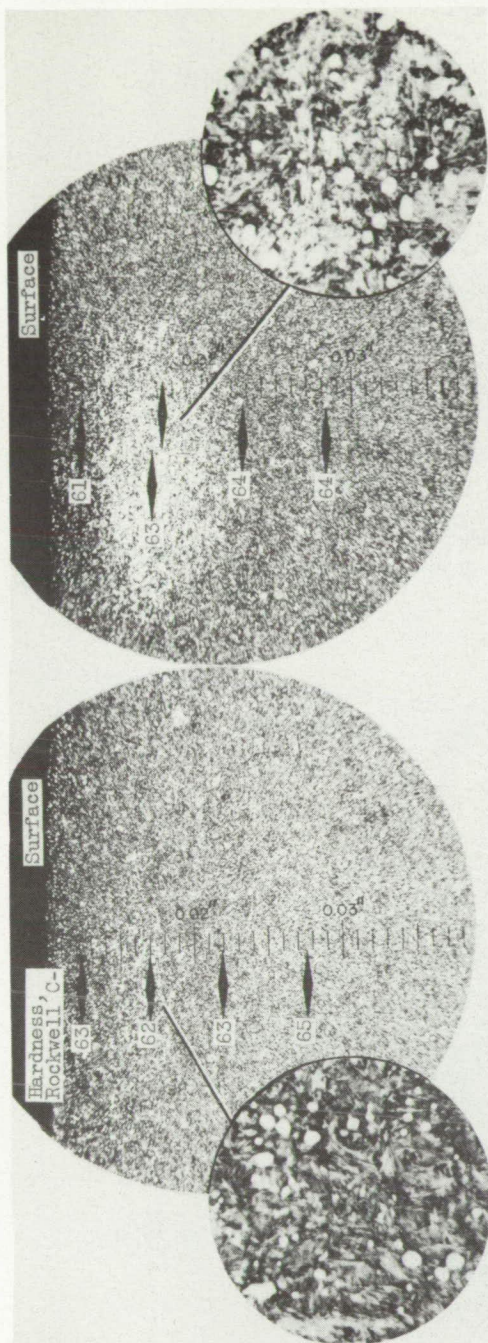
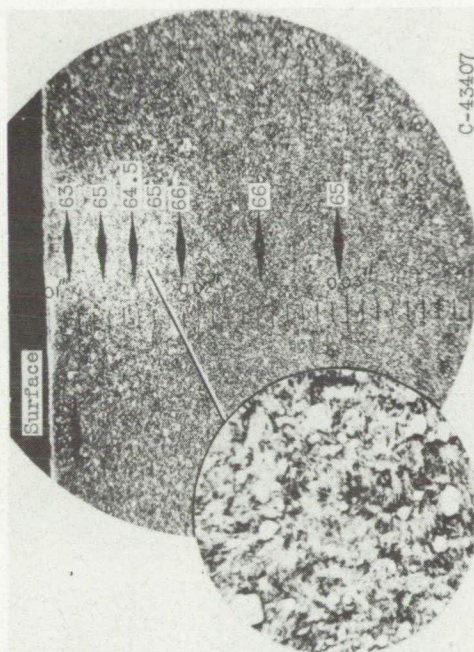
The time-life relation of the structure change is shown in figure 11. These are transverse views of representative  $4 \times 10^7$ ,  $20 \times 10^7$ , and  $111 \times 10^7$  cycle runs and include high-magnification views of the microstructures from the band centers. In short-run balls, structure changes

Figure 11. - Structure changes in AISI M-1 after various testing times. Test temperature,  $200^\circ\text{F}$ ; transverse views.  $\times 10$  and  $\times 1500$ . Figure has been decreased 25 percent in printing.

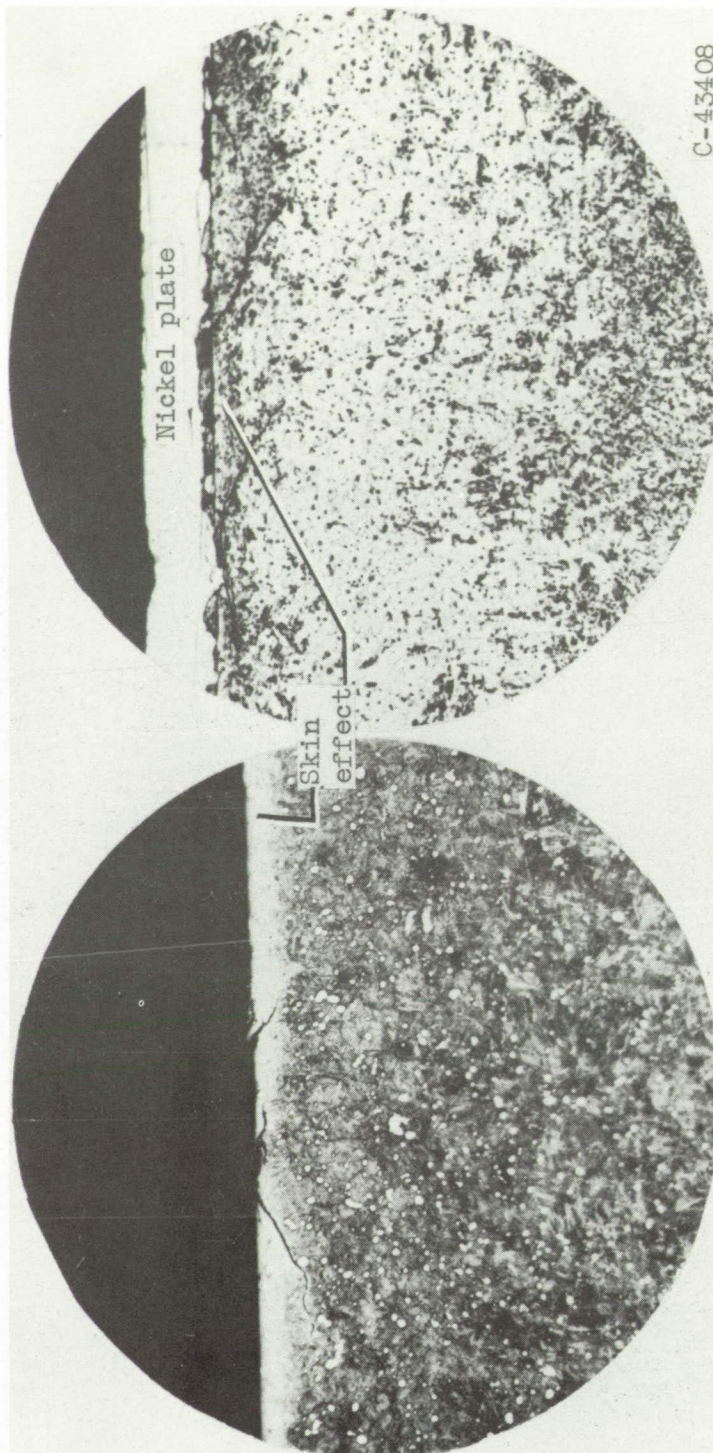
Skin effects, which were observed only on the longer running SAE 52100 balls tested at 250° F, occurred more frequently in AISI M-1 steel. This structure change was less than 0.001 inch deep, and its occurrence was erratic. Figure 12(a) is an above average case of such skin effects for AISI M-1 balls. The exact nature of this condition has not yet been determined. When pitting and wear occurred on the track, cracking developed as shown. Figure 12(b) shows similar cracking in an SAE 52100 ball.

Figure 12. - Cross section showing ball skin effect. Figure has been printed at original magnification.

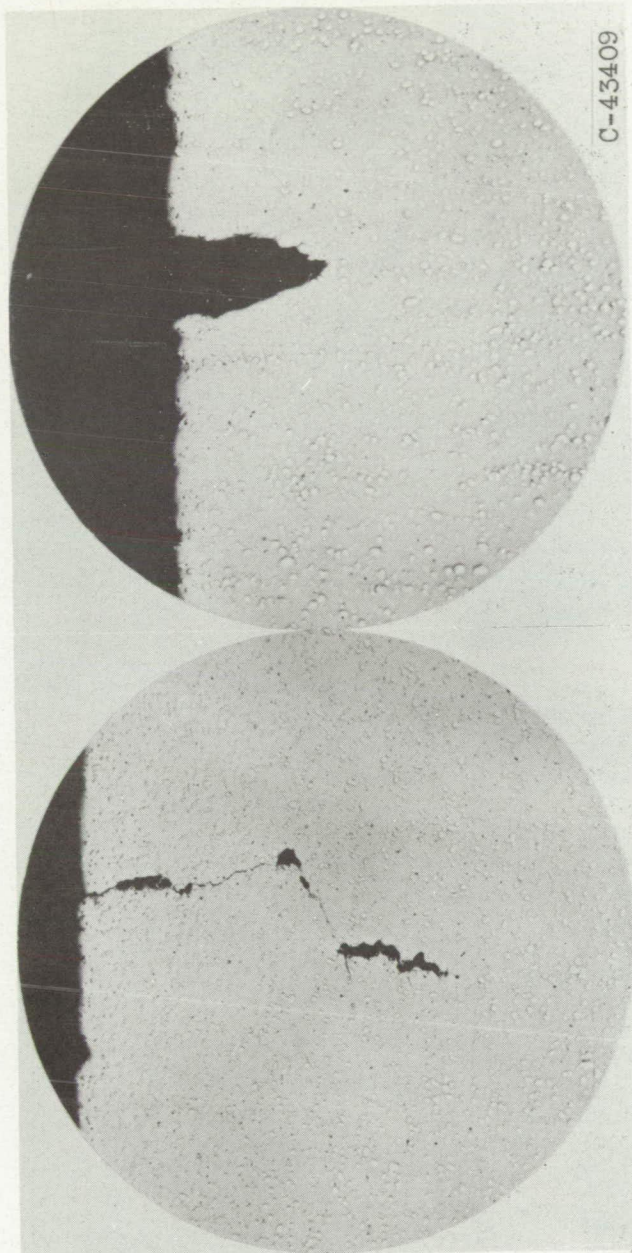
Very early failures (in less than  $5 \times 10^6$  cycles) are believed due to defective material not discernible by stringent preinspection. Several groups of balls were sectioned and examined in the as-received condition. Occasional defects, generally in the pole areas, were found such as shown in figure 13.

Figure 13. - Defects on as-received AISI M-1 balls. Unetched. X250.  
Figure has been printed at the original magnification.

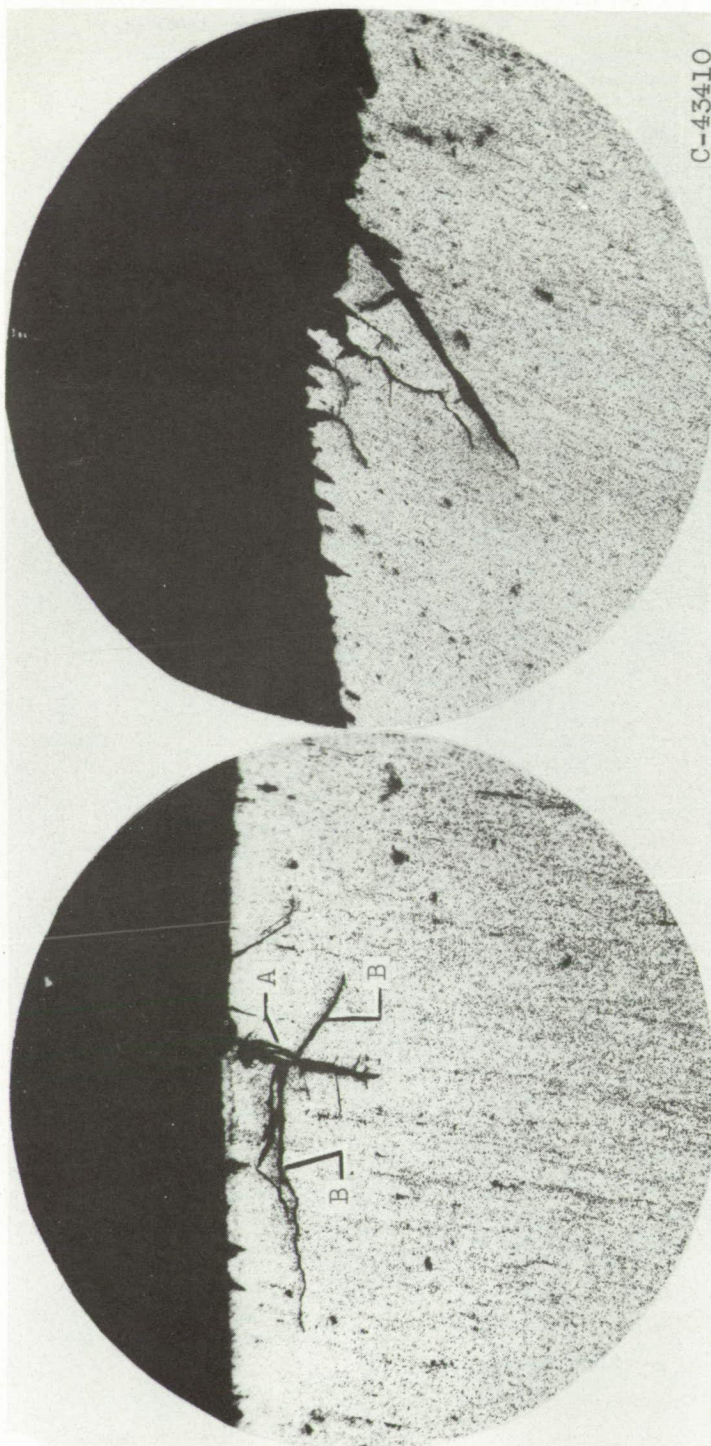
Figure 14(a) is an SAE 52100, room-temperature, pole-area failure showing failure origin and progression. Chemical segregation is parallel

to the high compressive stresses. Such structure inhomogeneity can result in changes in elastic modulus, or act as a metallurgical stress raiser. It is believed that secondary tensile stresses normal to the chemical segregation were too high, causing the fatigue crack indicated by arrow A in figure 14(a). Arrows B show shear cracks progressing from the original fatigue crack. A completed failure of such origin is shown in figure 14(b). A slight variation, whereby failures initiate and progress in shear cracks, is shown in figure 15(a), which shows the first spalling and the progressive spalling that follows.

Figure 14. - SAE 52100 fatigue failure. Room-temperature tests. Figure has been printed at original magnification.

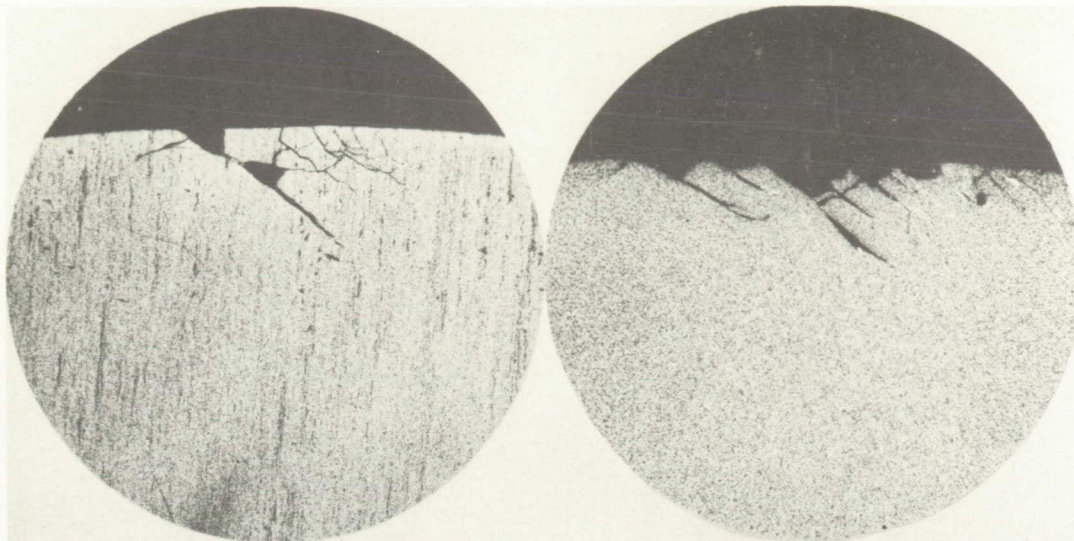
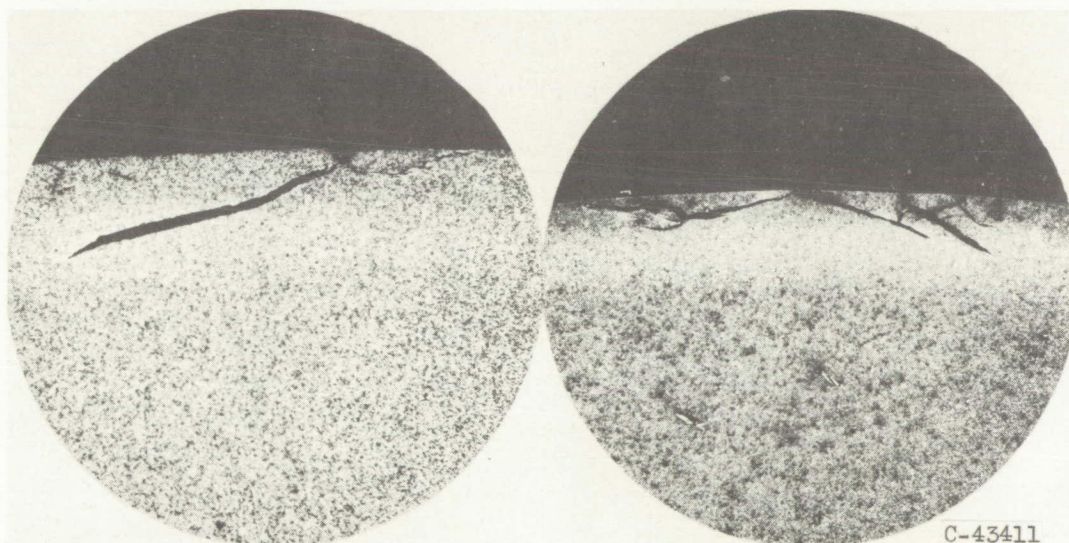
Figure 15. - Incompleted fatigue failures showing origin and progression in shear.  
Figure has been decreased 14 percent in printing.
