NATIONAL ADVISORY COMMITTEE FOR AERONAUTICS

TECHNICAL NOTE 4030

EXPERIMENTAL INVESTIGATION OF CERMET TURBINE BLADES
IN AN AXIAL-FLOW TURBOJET ENGINE

By William C. Morgan and George C. Deutsch

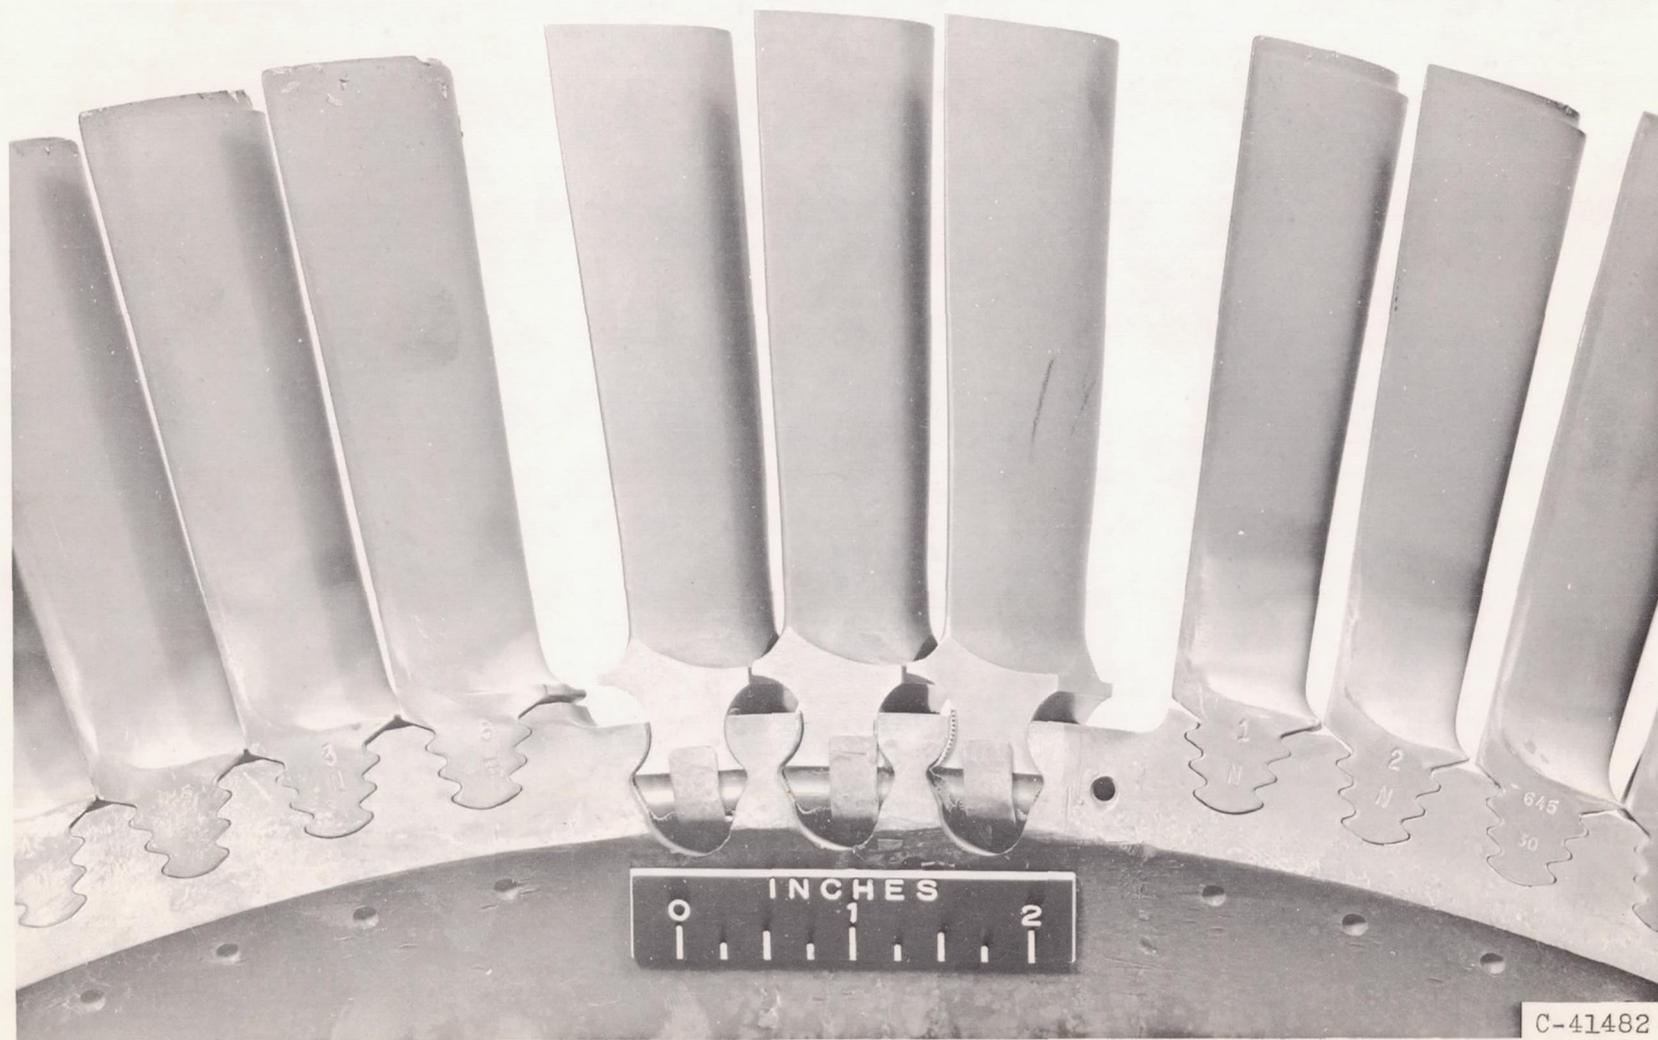
(c) Vibration may have been more serious in the six-blade tests. The spacing between the outer blades of a cluster of three and the adjacent metal blades was not a normal condition (fig. 2). In the course of a concurrent program on light-weight metal blades one test blade was placed in the space normally occupied by two blades. This metal test blade failed because of fatigue in the tip after a short time; blade life was less than 2 percent of the time for similar test blades in standard spacing.

Figure 2. - Three cermet turbine blades mounted in space normally provided for four standard metal blades.

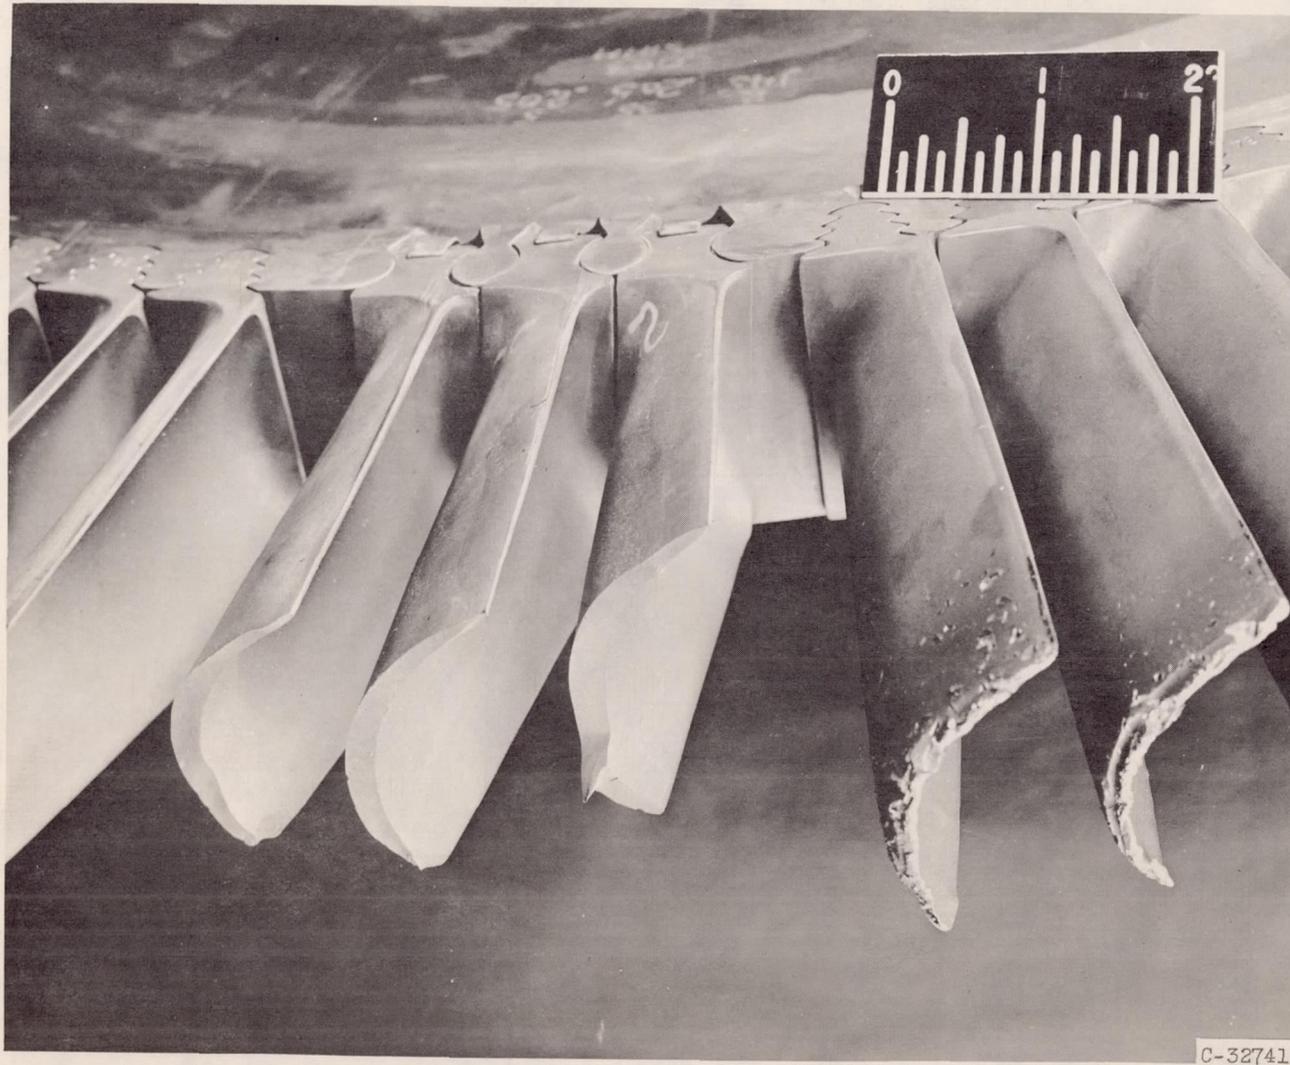
Table I gives operating time, number of starts, test conditions, and brief description of failure. In most of the early tests the blades were damaged in the tip region (tests 1 to 4 and 7). Figure 5 shows a typical failure. There are two possible causes for these failures, impact and fatigue.

Damage may have been caused by the impact of carbon fragments passing through the turbine. For example, hard carbon deposits were found in the combustion chambers in amounts considered excessive. This was a condition peculiar to the individual test engine. Figure 6 shows a piece of carbon removed during inspection. The deposits were not homogeneous, varying from a soft and amorphous material to a silver-gray substance comparable to industrial limestone slag. Spectroscopic analysis did not indicate the presence of material other than carbon.

Fatigue was considered as the other possible cause of blade failure. Damage occurred principally as tip failure. Metal turbine blades fail in this area as a result of excessive vibration, and this lends credence to the possibility of fatigue damage to cermet blades.

Figure 5. - Blade failures in test 1 after 1 hour and 25 minutes at maximum turbine speed, typical of runs 1 to 4 and 7.

The substitution of gasoline for standard fuel made some improvement in maximum blade life. It was used in tests 5, 6, 9, 9a, 12, 13, and 14. Test operation of 43 hours and 57 minutes was obtained in test 14 before occurrence of failure. Periodic inspection showed that carbon formation was low. In tests where standard fuel was used, with the exception of tests 15 and 16 where test conditions were radically different, the maximum blade life was 19 hours and 27 minutes (test 8).

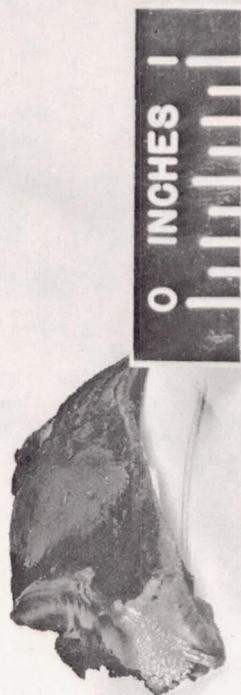
Figure 6. - Carbon deposit removed from combustion chamber.

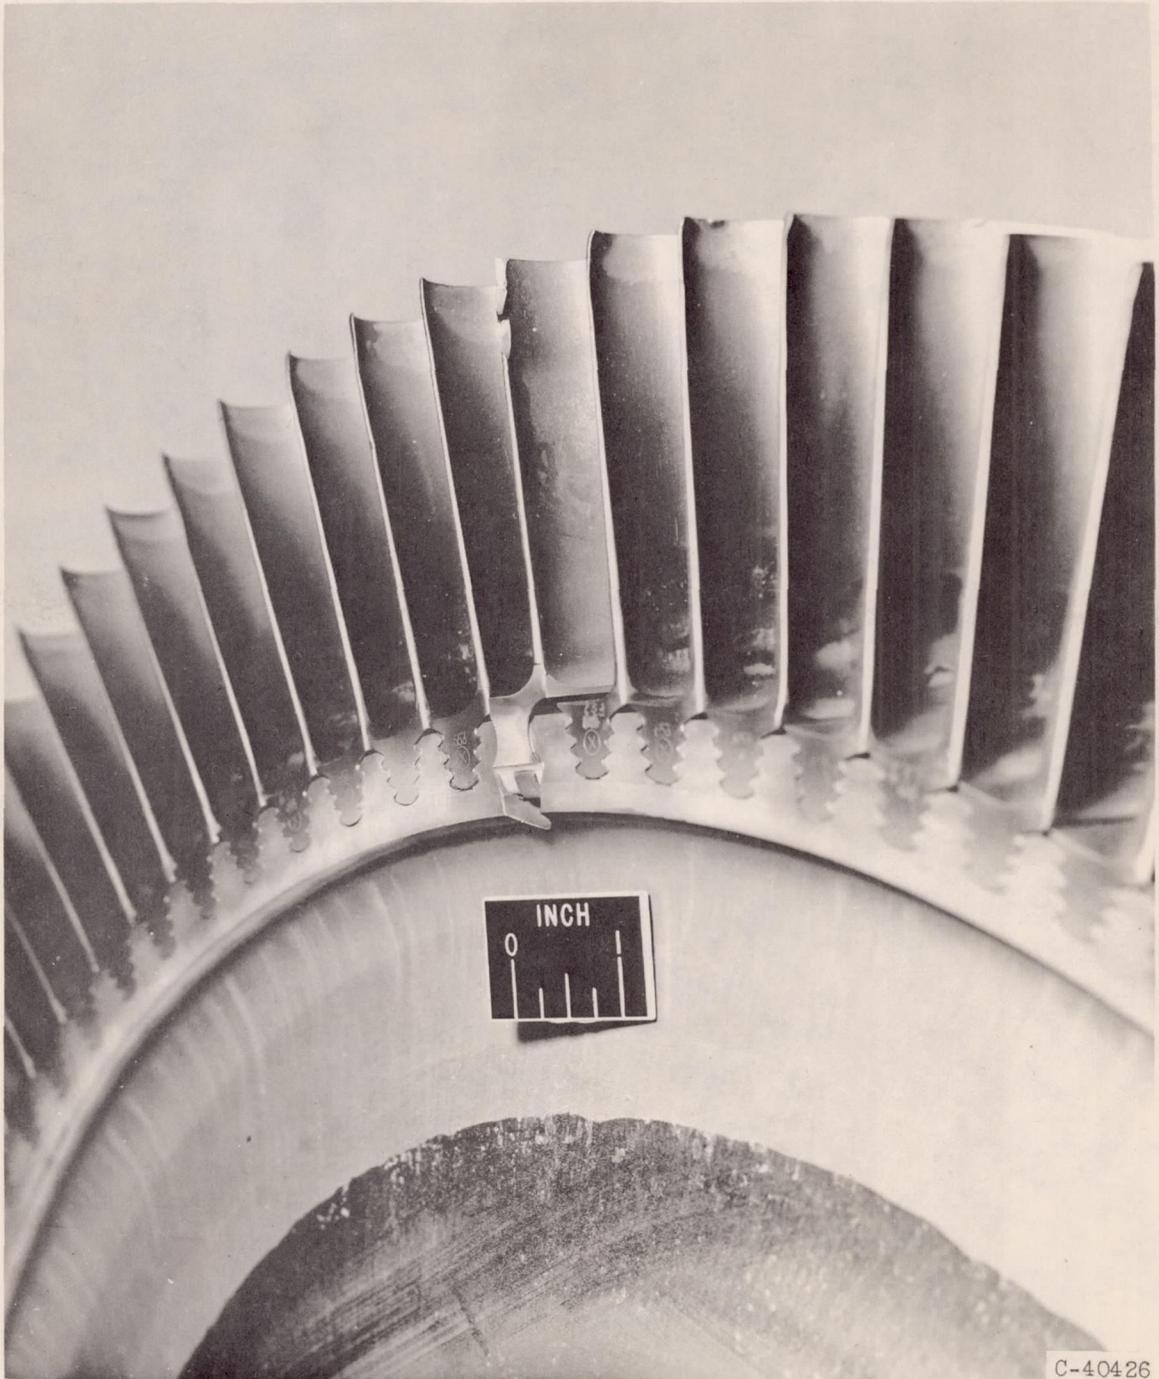
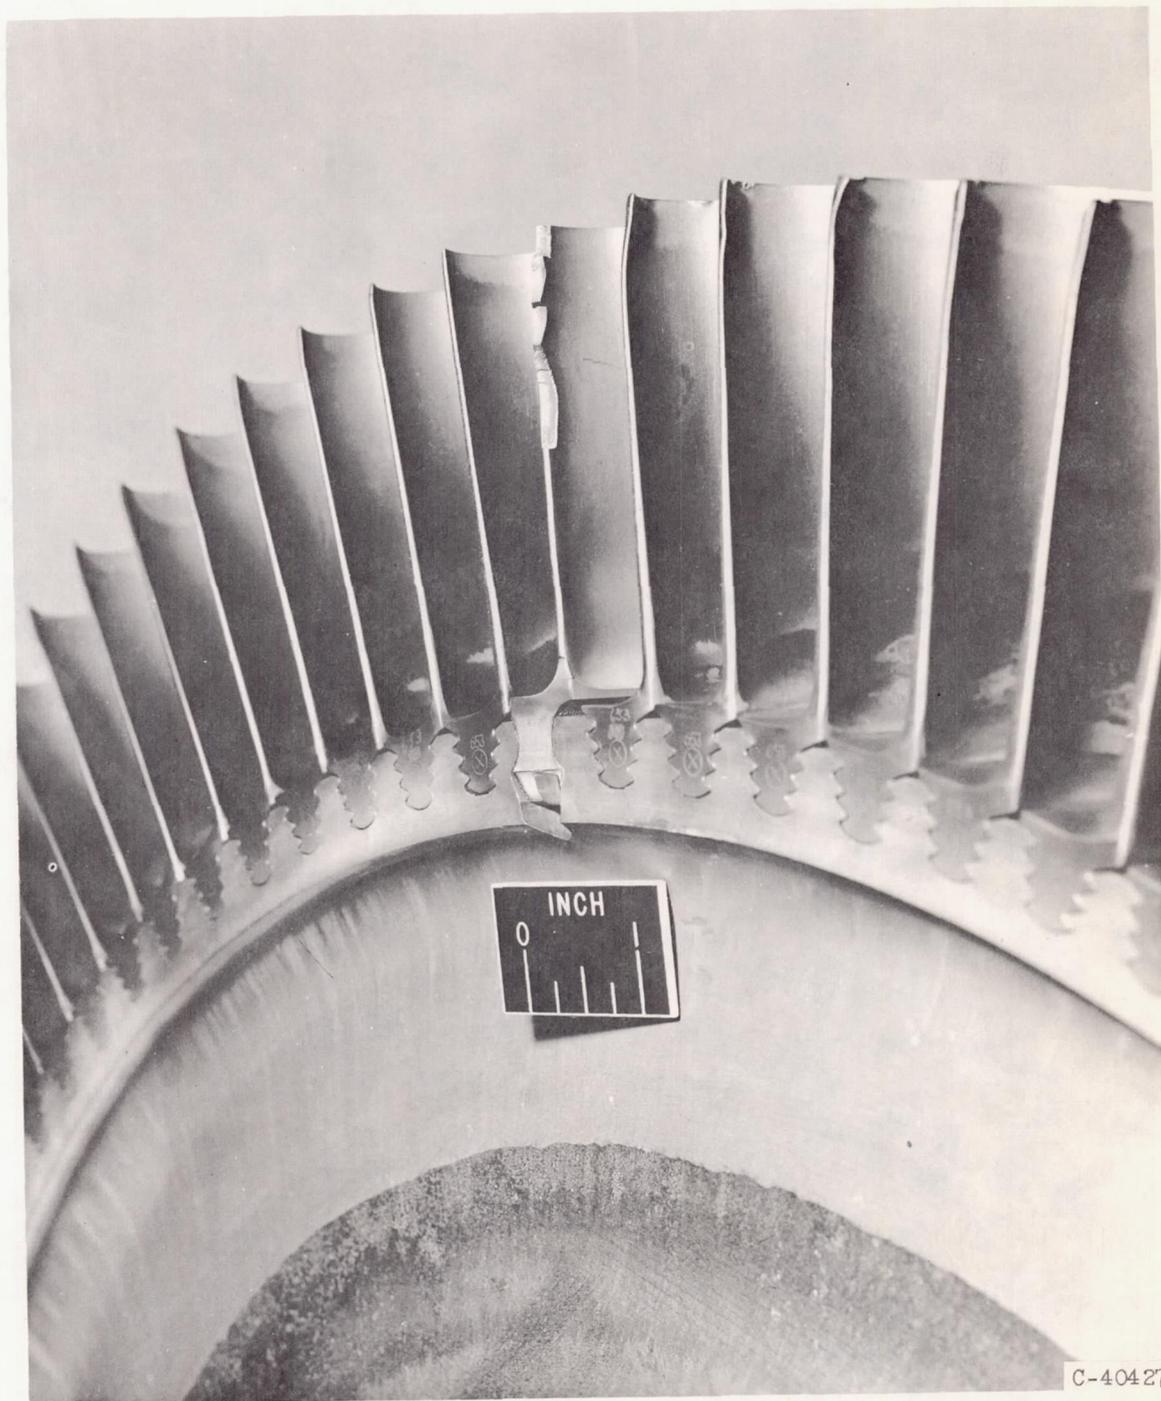
The best performances of cermet blades were obtained in tests 15 and 16, using the rotor modified for two test blades in standard spacing. The blades in test 15 had 1/4-inch radii at the tips. This test was discontinued after 150 hours at a turbine speed of 7950 rpm and exhaust temperature of 1260° F. One blade from test 15 lost a small chip from the tip (leading edge) after 84 hours and 34 minutes; the other blade was chipped in the same location after 97 hours and 38 minutes. Chipping continued during the remainder of the test. The extent of damage at the end of 150 hours is shown in figure 7,

Figure 7. - Cermet blades from test 15 after 150 hours at maximum turbine speed.

Figure 7. - Concluded. Cermet blades from test 15 after 150 hours at maximum turbine speed.

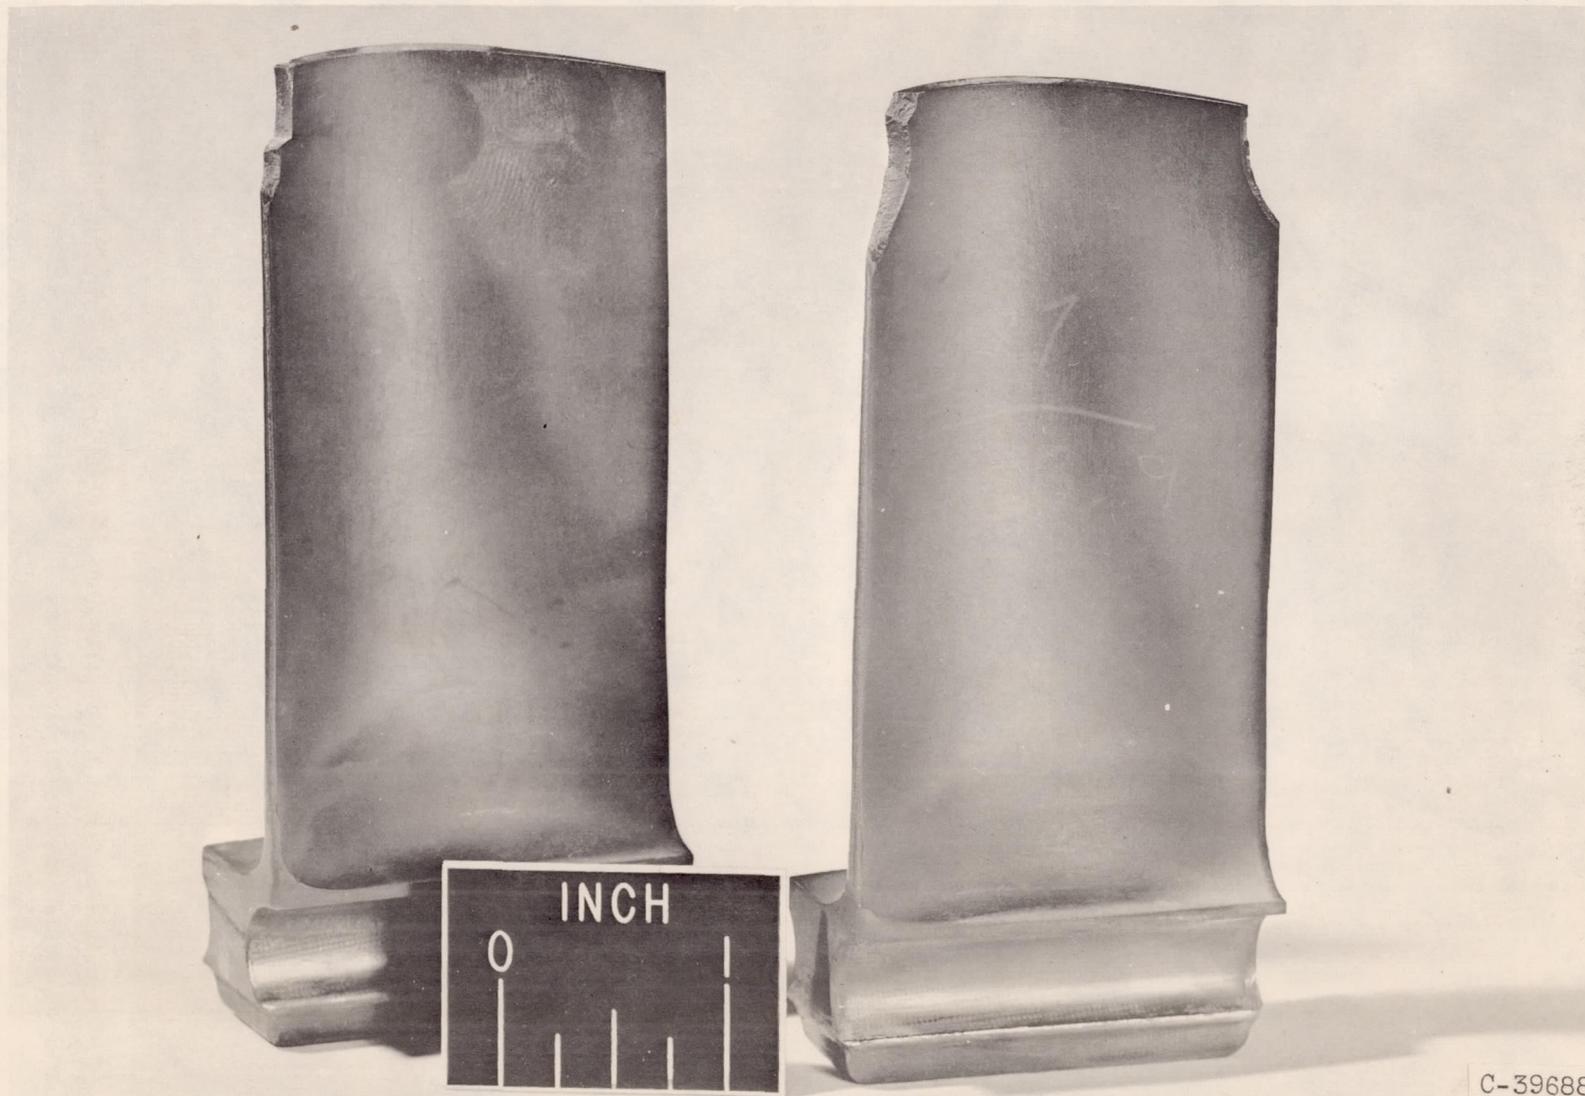
The two blades of test 16 were not modified. The test was ended after 150 hours and 30 minutes at the maximum conditions of operation. Initial chipping was observed in the leading edges of both blades and the trailing edge of one after 41 hours and 50 minutes. Damage was confined to the tip region. Figure 8 shows the total extent of damage at the end of the test.

Figure 8. - Cermet blades from test 16 after 150 hours 30 minutes at maximum turbine speed.

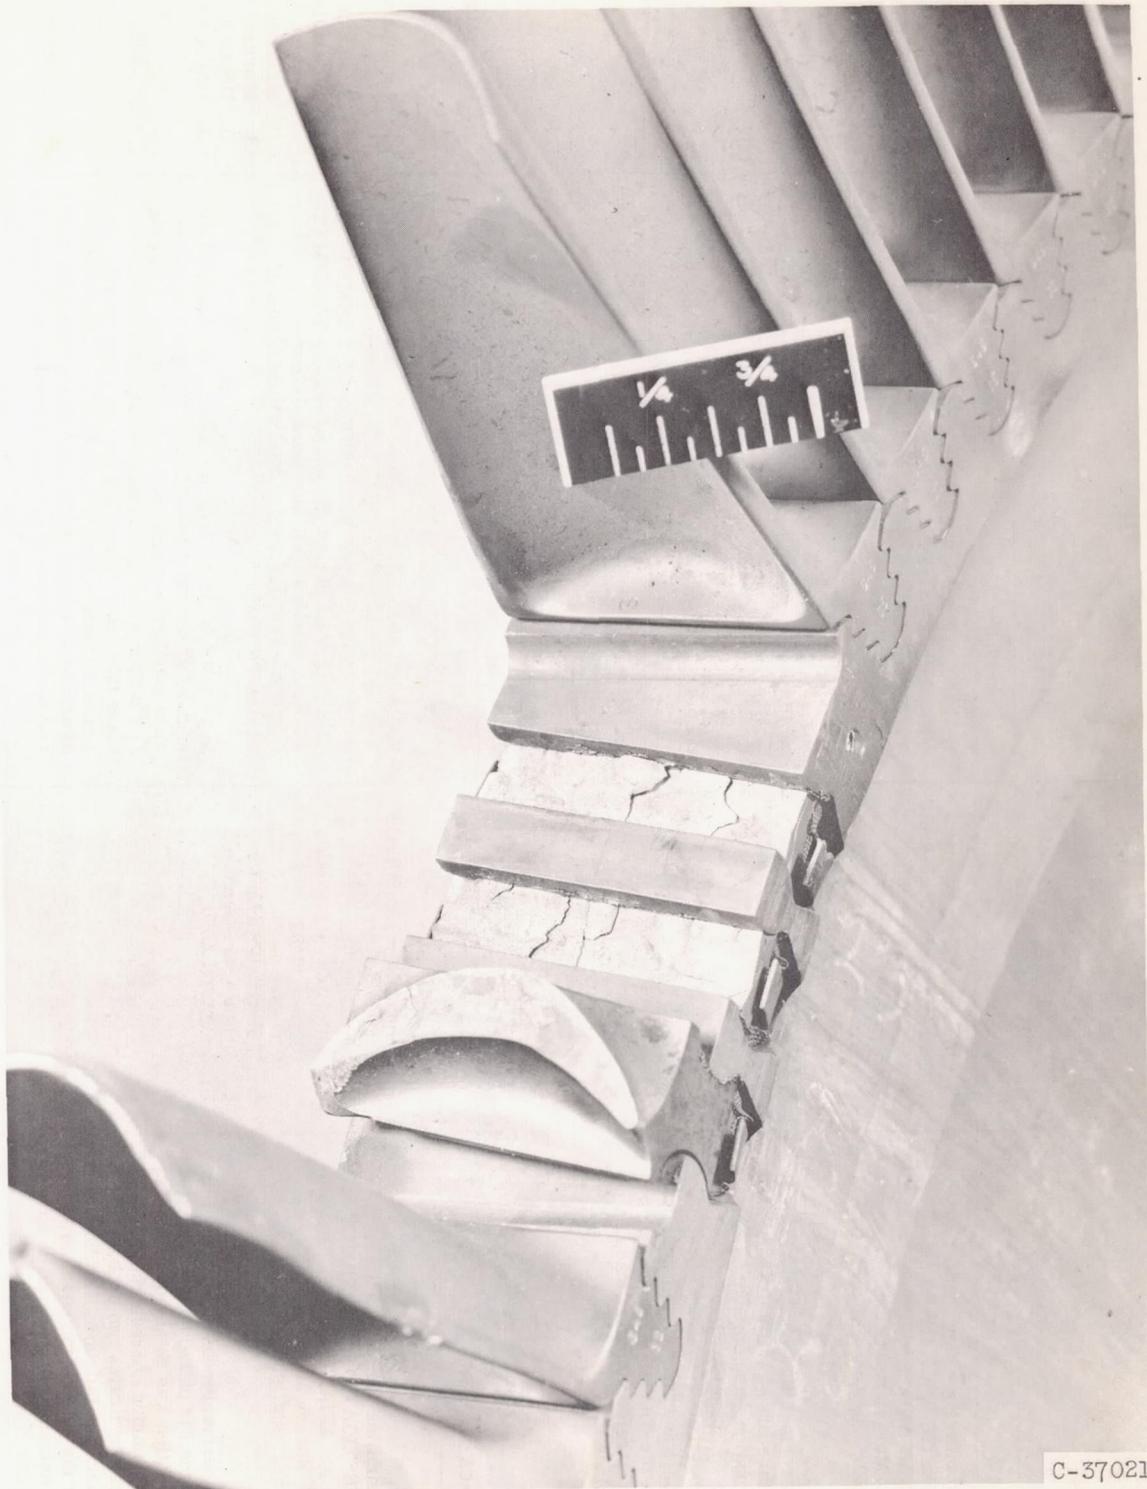
9	6	None	0.03-In. short	Standard	Gasoline	13	28	22	23	7	1	Tip region	The failure apparently was caused by impact with a foreign object. This test was made with a standard nozzle guide vane assembly. The blade was replaced and operation resumed (test no. 9a).
9a	6	None	0.03-In. short	Standard	Gasoline	6	6	29	5	19	4	Midspan and tip region	Five of the blades had total maximum speed operation of 28 hr 26 min.
10	6	Thick trailing edge	0.03-In. short	Phased	JP-4	3	6	39	4	49	All	Midspan and tip region	The trailing edges were increased from 0.30 to 0.60 in. in thickness.
11	6	Thick trailing edge	0.03-In. short	Phased	JP-4	1	1	45	1	36	All	Midspan and tip region	This test was made under the same condition as test 10.
12	6	Thick trailing edge; $\frac{1}{4}$ - in. radii tips; honed finish	0.03-In. short	Phased	Gasoline	7	12	49	7	35	All	Midspan or tip region	This test combined all blade modifications.
13	6	Thick trailing edge; $\frac{1}{4}$ - in. radii tips; honed finish	0.03-In. short	Standard	Gasoline	6	24	18	21	48	All	Midspan tip, or root	Three blades sustained damage in center or tip region. One blade failed near the base. Two blades failed in the root, with a lamellar type of fracture.

Figure 9. - Lamellar fracture in blade root observed in test 13 after 21 hours and 48 minutes at maximum turbine speed.
