# RESEARCH MEMORANDUM

OBSERVATIONS ON AN AILERON-FLUTTER INSTABILITY ENCOUNTERED  
ON A 45° SWEPT-BACK WING IN TRANSONIC AND SUPERSONIC FLIGHT

Marvin Pitkin, William N. Gardner  
and Howard J. Curfman, Jr.

April 11, 1947

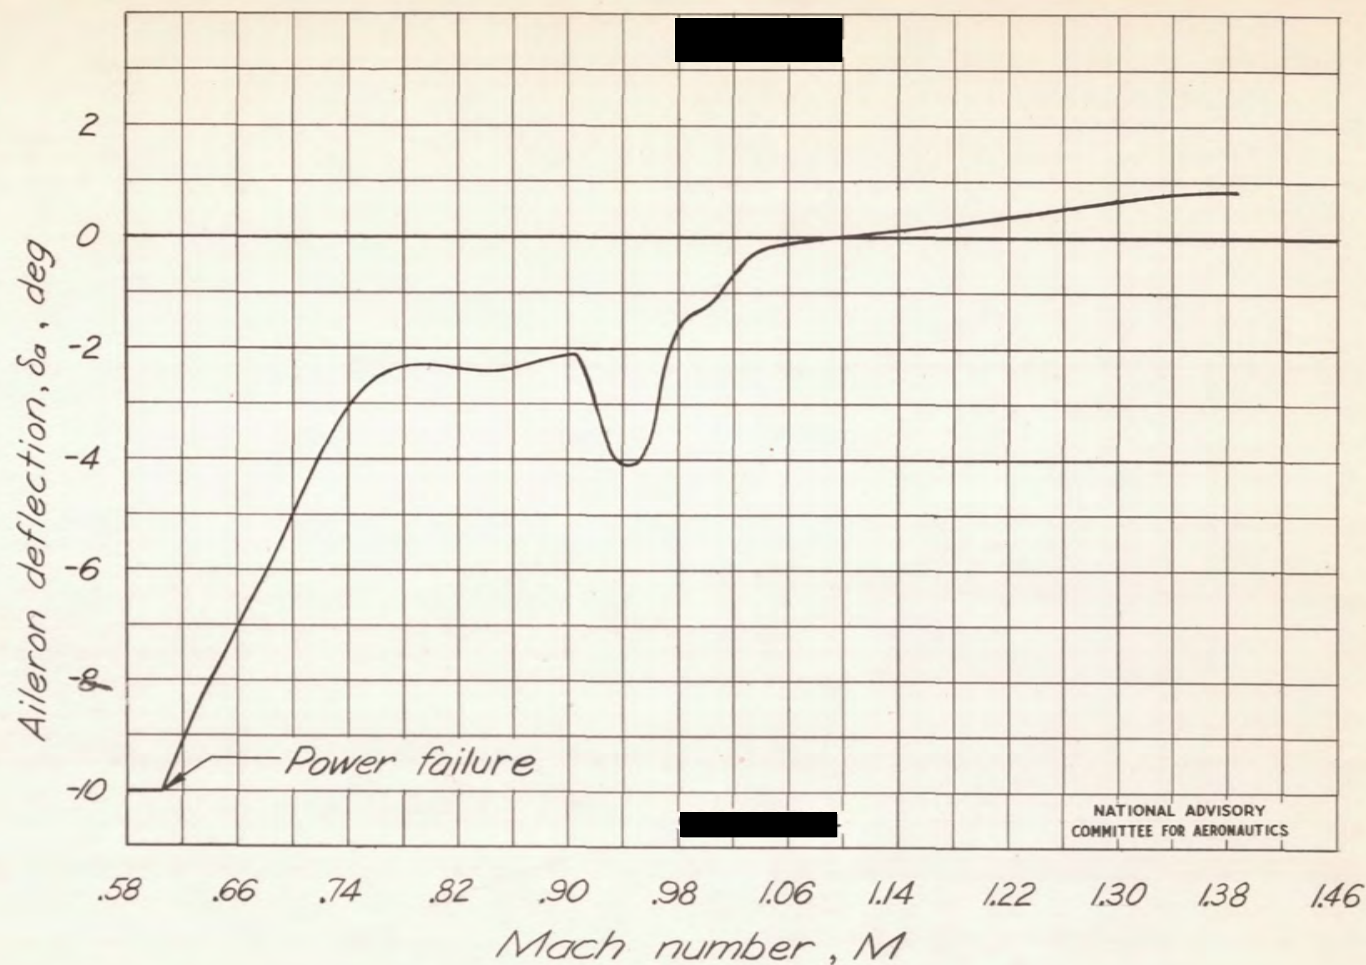
The data presented in figure 8(b) show that when power failed ( $M = 0.6$  approx.) the control was at full deflection and was slightly underbalanced in this deflection range as shown by its drift back toward neutral position. At higher subsonic velocities ( $M = 0.8$  to  $0.9$ ) the control trimmed at a constant deflection of approximately  $-2.3^\circ$  indicating thereby that the control was overbalanced at smaller deflections. The possibility that the  $-2.3^\circ$  deflection is the result of out-of-trim moments has been considered; however information to be presented later herein discounts this possibility. The tendency of the control to overbalance at small deflections is characteristic of beveled-edged controls

At Mach numbers between 0.90 and 0.95 the floating angle of the aileron increased abruptly indicating overbalance over a larger deflection range. A further increase in velocity reversed this effect and the control quickly returned to its neutral position remaining there until the peak Mach number of 1.395 was reached.

(b) Aileron deflection - Mach number.  
Figure 8.- Concluded.

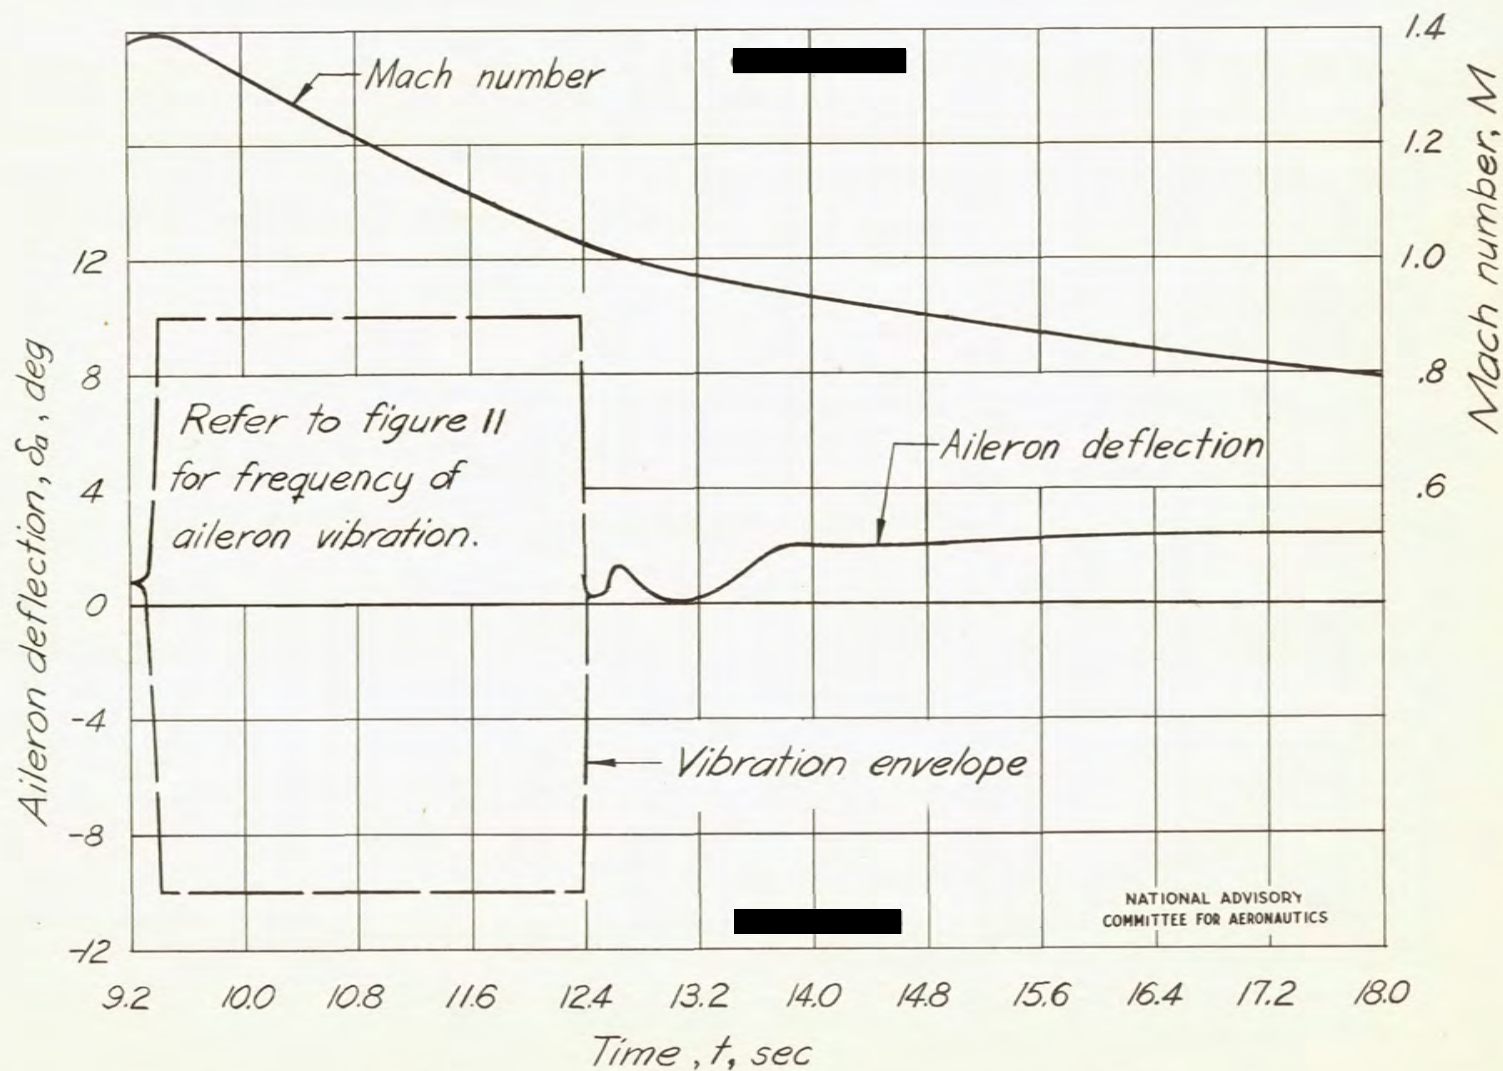
After the sustaining rocket ceased firing and precisely at the time the forward acceleration passed through zero, a violent high-frequency oscillation occurred on the aileron and wing. The failure of the ailerons to vibrate during the accelerated portion of the flight probably can be attributed to the restraining forces in the servomechanisms which were mounted in such a manner that the large forward accelerations of 6g to 8g could increase their friction considerably. Once the oscillation occurred, however, the friction forces caused by the small decelerations in coasting flight apparently had little influence upon the aileron behavior.

Figure 9(a) shows a time history of the aileron behavior in coasting flight, and in figure 9(b) these data are rearranged to show the variation of aileron deflection with Mach number.

(a) Aileron deflection and Mach number against time.  
 Figure 9. - Aileron characteristics in coasting flight.

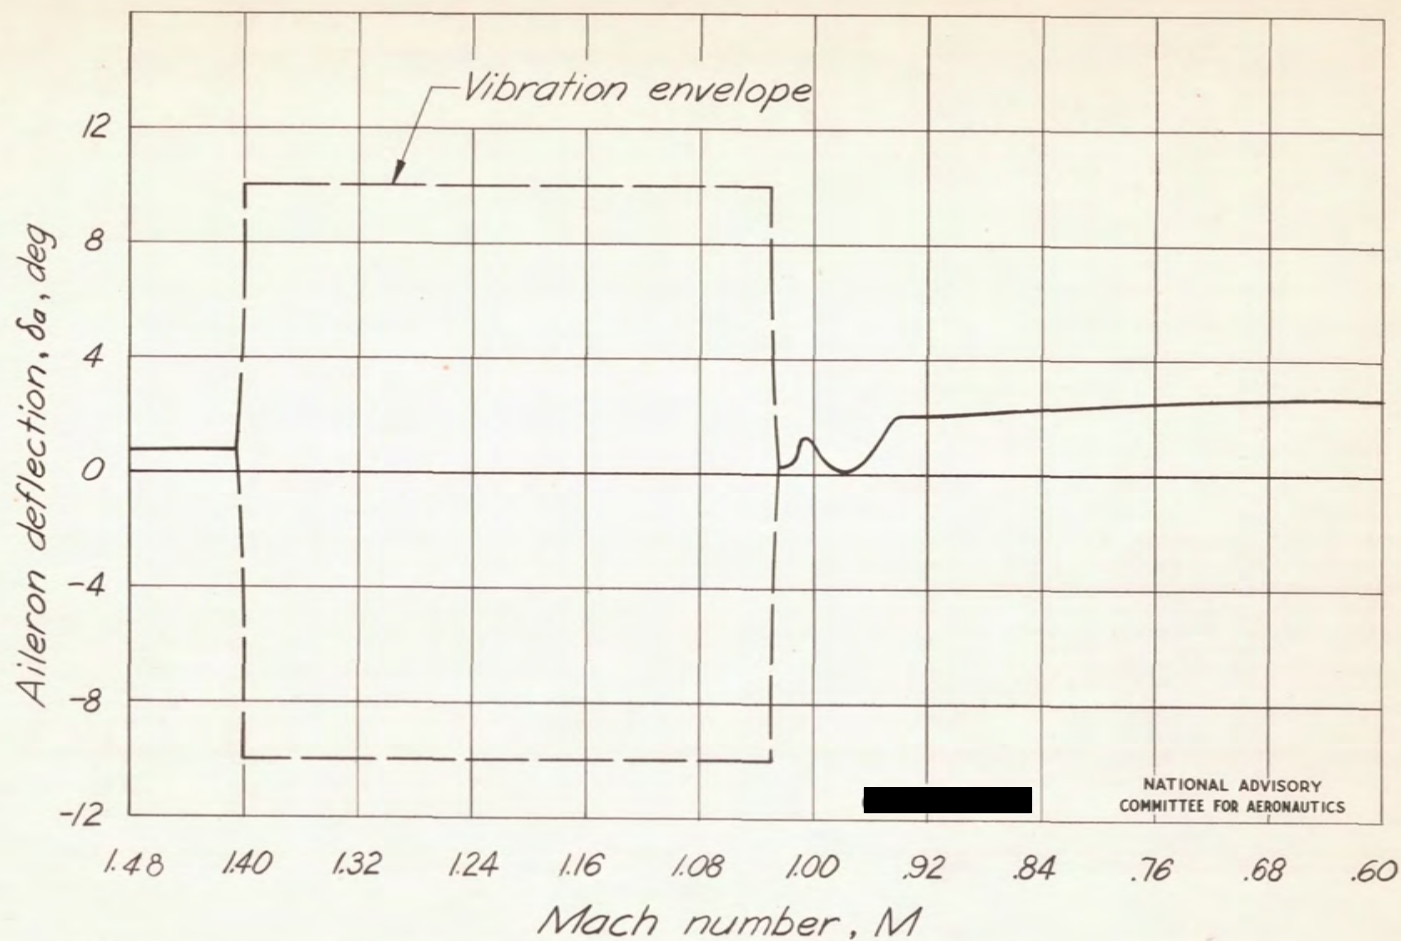
The data presented in figure 9(b) show that the aileron oscillated with an amplitude of full  $\pm 10^\circ$  deflection over the entire supersonic range of velocities. As the velocity fell below a value corresponding to a Mach number of 1.03, erratic aileron behavior was observed in the transonic region, and at subsonic speeds the aileron again floated at a small deflection of  $2.4^\circ$ . This deflection is approximately equal to the trim deflection noted at subsonic speeds in accelerated flight; however the deflection is now positive rather than negative and therefore substantiates the idea that the deflection indicates overbalance of the control and not merely an out-of-trim position.

(b) Aileron deflection - Mach number.  
Figure 9.- Concluded.

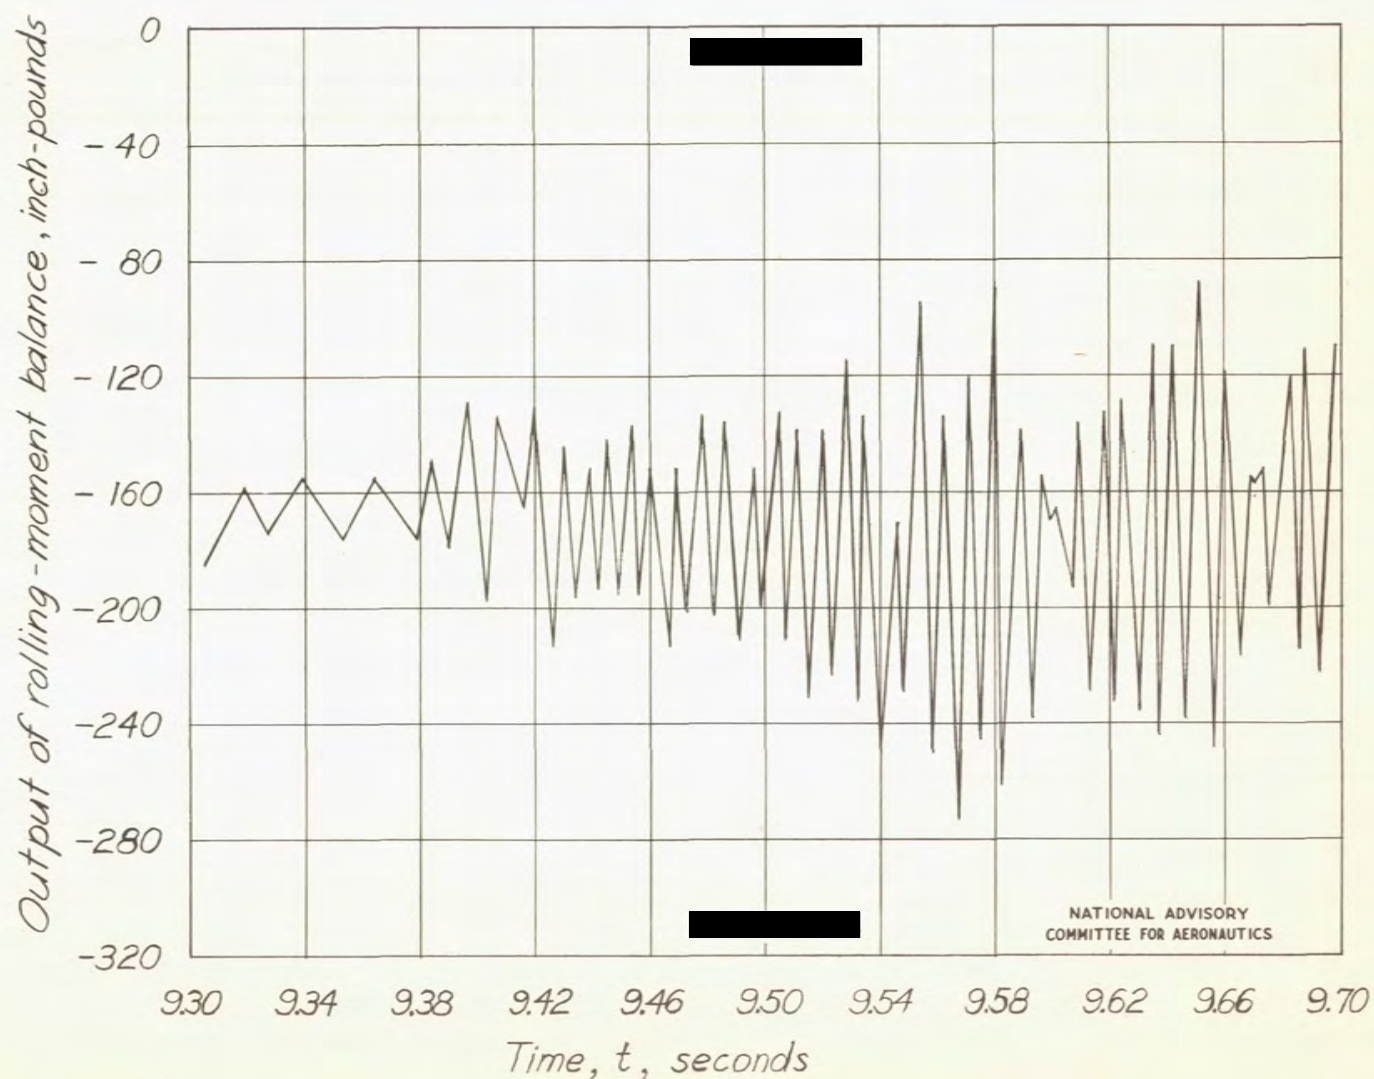
Fig. 10a

A high-frequency wing oscillation accompanied the aileron oscillation at all times. The characteristics of this wing oscillation as evidenced by rolling-moment data at the start and at the end of the vibration period are presented in figures 10(a) and 10(b), respectively. It is believed that the amplitude of the wing vibration as shown by these data represents approximately 50 percent of the actual magnitude. The exact percentage is not definitely known however because a frequency response test of the recording instrument was not made at the time of the flight but at some time afterwards, and the instrument characteristics may be subject to change over a period of time. The modulation of the rolling-moment record, prevalent except for the last half second of the vibration period, is believed to be due to deficiencies in the recording equipment when operating at frequencies outside of its design range.

(a) Start of vibration period.

Figure 10. - Time history of rolling-moment balance vibration.

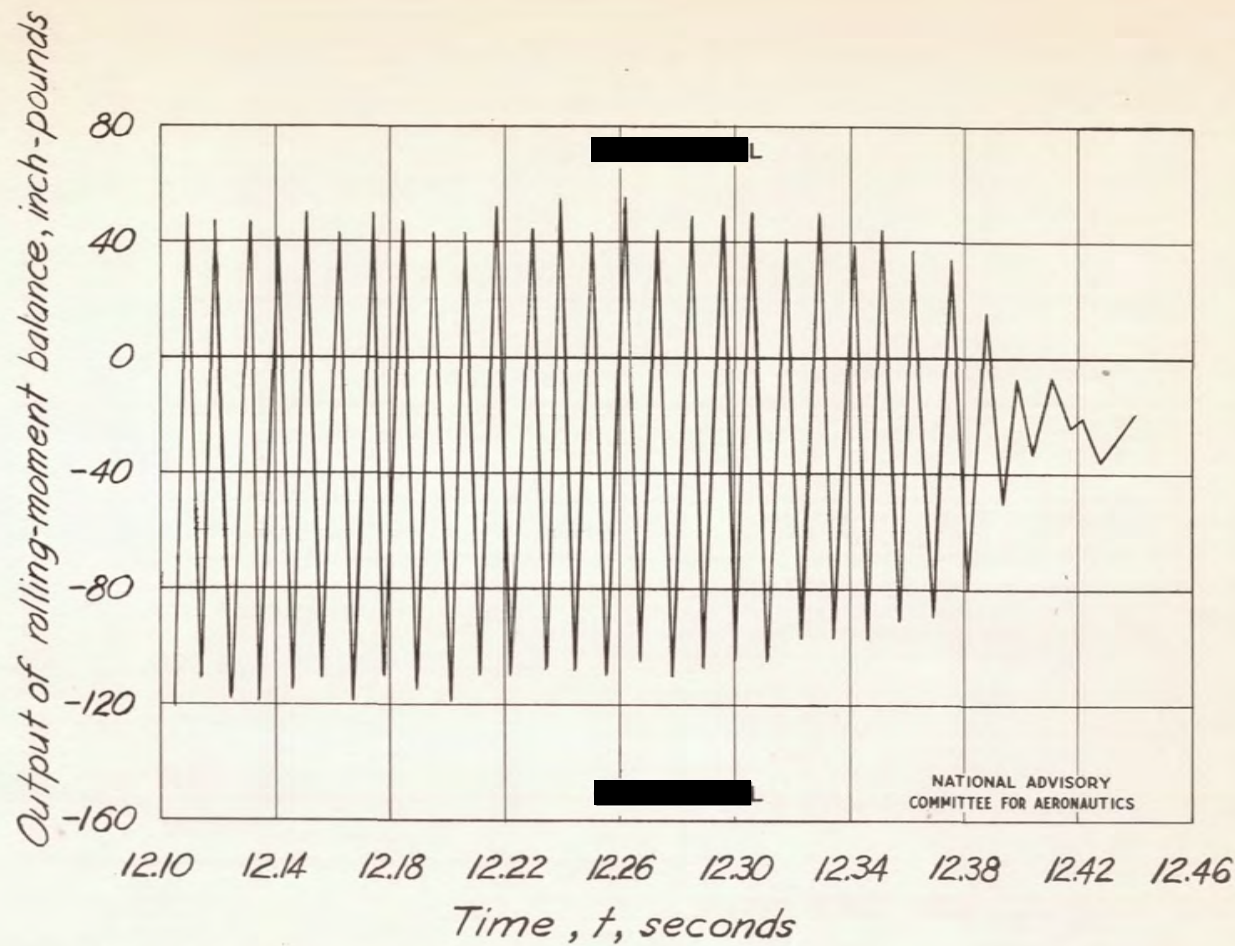
The data in figure 10(b) show that both the wing and aileron oscillations stop at approximately the same Mach number (1.03) at which the ailerons regained control on the RM-1 flight reported in reference 1. As the velocity was reduced past the velocity corresponding to this value, the aileron did not show the large degree of overbalance noted at near-critical speeds in accelerated flight but instead appeared to regain its subsonic characteristics without appreciable transition. It is possible that the violent aileron oscillation in the supersonic region may have damaged the control-position indicator causing faulty readings. Another more likely explanation may be that shock conditions on the wing do not disappear in the same manner in which they are formed. It may be that the wing shock waves vanish abruptly as the velocity is decreased through the critical speed rather than by a gradual process of weakening intensity. Such procedure would explain the aileron behavior of the RM-1 model at transonic and subsonic velocities in coasting flight.

(b) End of vibration period.

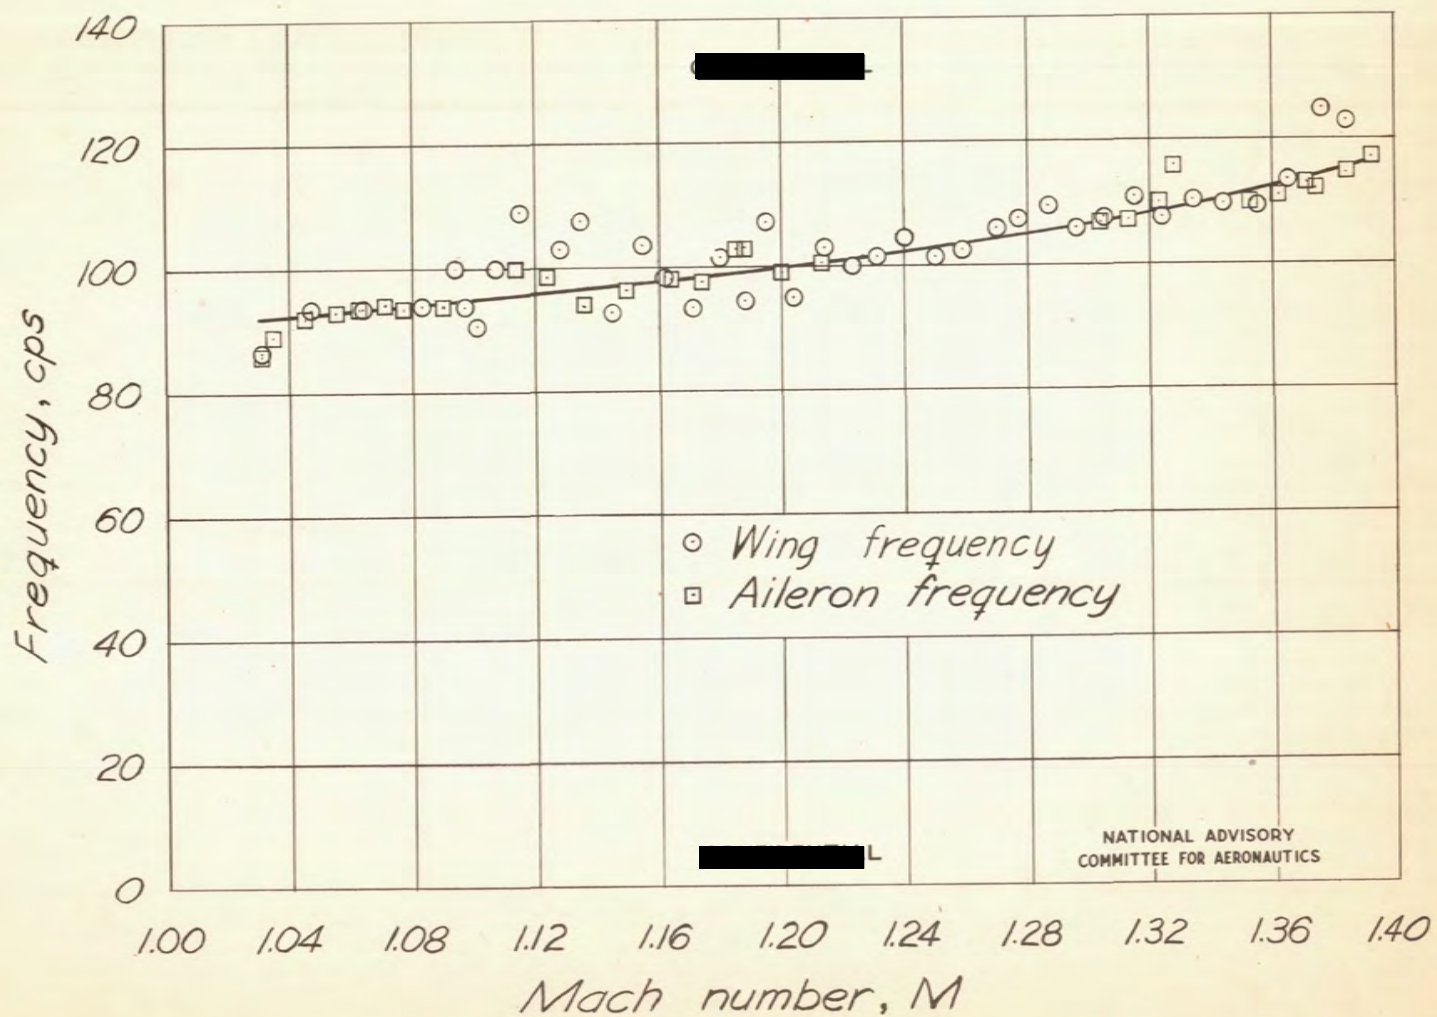
The frequency characteristics of the wing and aileron vibration are shown plotted against Mach number in figure 11. These data show the wing and ailerons vibrated at the same frequency for any given Mach number and that the frequency of the wing and aileron oscillations increased with increase of Mach number.

The flutter speed of swept-back wings of the type used on the RM-1 cannot be calculated at present. Vibration tests were therefore made on a wing rolling-moment balance setup identical to that used on the model reported herein. These tests showed that the first symmetrical bending frequency was 21 cycles per second with the node at the root chord and that the symmetrical torsion frequency was 75 cycles per second with the node line approximately parallel to the leading edge and at a distance of 48 percent of the wing chord behind it. In the simplest type of classical wing flutter, the flutter frequency would be expected to lie between those of first bending and first torsion frequencies. However, the frequencies of the vibrations recorded in the flight tests (90 to 120 cycles per second) were considerably higher than

the wing structure frequencies measured. It is probable therefore that the flight oscillations did not represent a classical flutter condition but rather were associated with the phenomenon known as "aileron buzz" or aileron compressibility flutter hitherto encountered only on straight wing-aileron combinations of nonsymmetrical airfoil section, at supercritical speeds. Flight tests of a Bell P-63A-6 airplane reported in reference 4 and wind-tunnel tests of a modern high-speed-airplane wing made in the Ames 16-foot high-speed tunnel show aileron and wing oscillations at high speed similar to those observed in the subject test. It is believed that aileron compressibility flutter is associated with a coupling of the variations of the relative intensities of the upper-surface and lower-surface shock waves with aileron motion. The condition might be considered to be a flutter condition requiring only one degree of freedom, that is, aileron rotation about its hinge line. The wing oscillation is believed to be the result of flow and load changes induced by the aileron and in the case of the RM-1 model was probably amplified in intensity by the flexibility of the wing and rolling-moment balance system.

Figure 11.-Variation of wing and aileron vibration frequencies with Mach number.
