NACA RM E50C15

EFFECTS OF INLET ICING ON PERFORMANCE OF AXIAL-FLOW
TURBOJET ENGINE IN NATURAL ICING CONDITIONS

By Loren W. Acker and Kenneth S. Kleinknecht

May 25, 1950

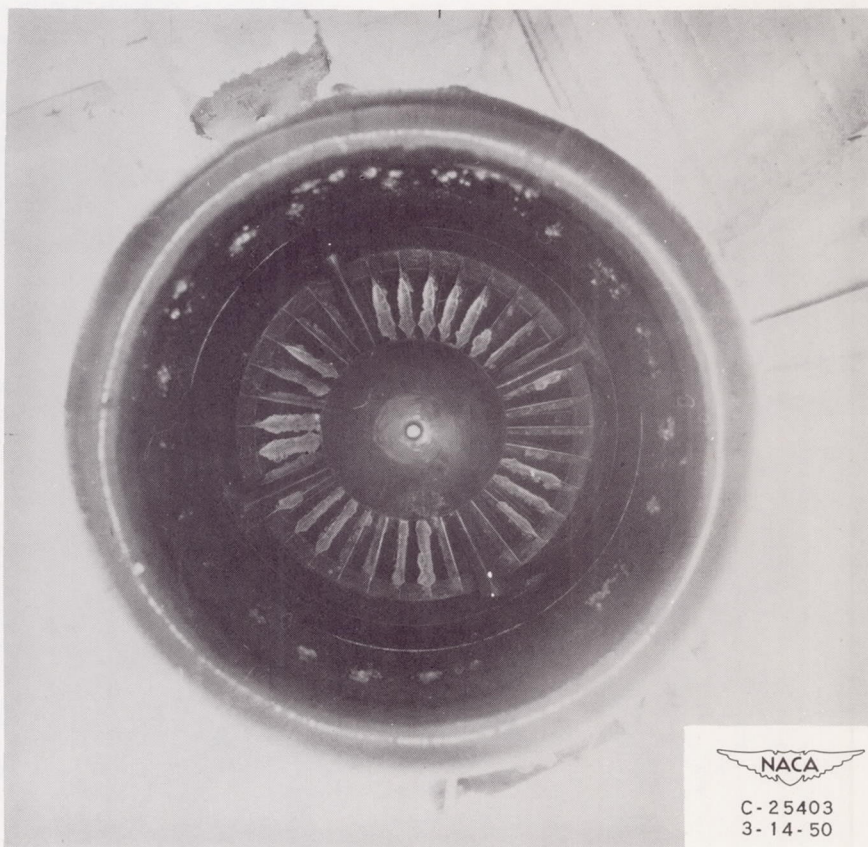
(b) Elapsed time in icing conditions, 17 minutes.

Figure 7. - Continued. Ice formation on compressor-inlet guide vanes during flight 2, with anti-icing. Liquid-water content, 0.3 to 0.5 gram per cubic meter; droplet size, 11 to 17 microns; ambient-air temperature, 22° to 25° F; thrust loss, 8 percent.

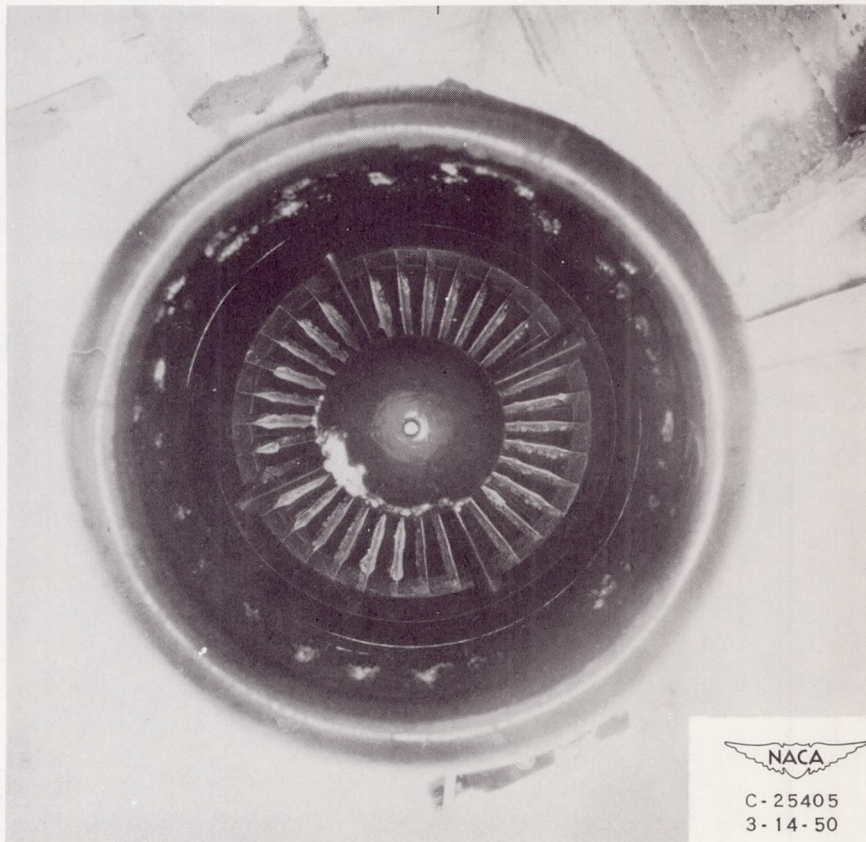
(d) Elapsed time in icing conditions, 35 minutes.

Figure 7. - Concluded. Ice formation on compressor-inlet guide vanes during flight 2, with anti-icing. Liquid-water content, 0.3 to 0.5 gram per cubic meter; droplet size, 11 to 17 microns; ambient-air temperature, 22° to 25° F; thrust loss, 8 percent.

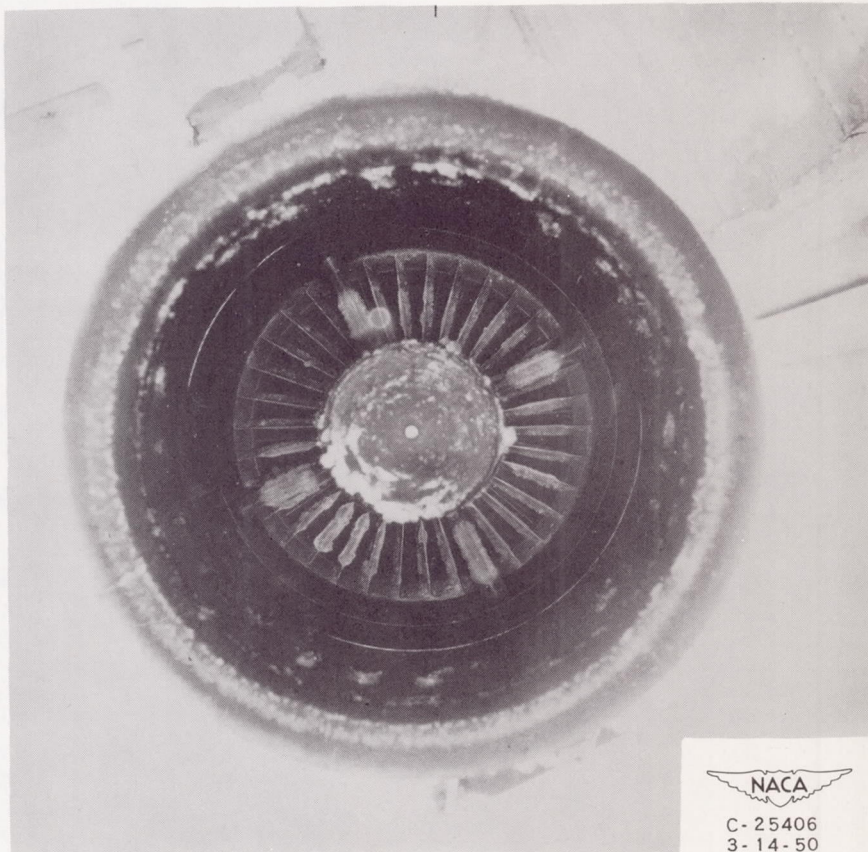
(a) Elapsed time in icing conditions, 5 minutes.

Photographs taken during the second part of the flight (fig. 8) show the progress of the ice formations on the entire engine inlet, when no heating was applied to any of the components. The guide-vane ice formations were similar to those of the first part of the flight. These formations, which appeared to be clear ice built-up, became unstable and broke off in a continuing cycle. This cycle of forming and shedding occurred several times during both parts of flight 2, and was characteristic of all flights in the investigation. After 15 minutes of the second part of the flight had elapsed, however, the formations on the inlet lip and the starter dome became large and the guide-vane formations appeared to stabilize. A large quantity of the water droplets was probably separated out of the air stream by the large crater-like formations on the inlet lip and the starter dome and collected on these formations ahead of the guide vanes.

Figure 8. - Ice formation on turbojet-engine inlet during flight 2, without anti-icing. Liquid-water content, 0.1 to 0.5 gram per cubic meter; droplet size, 11 to 20 microns; ambient-air temperature, 22° to 26° F; thrust loss, 13 to 16 percent.

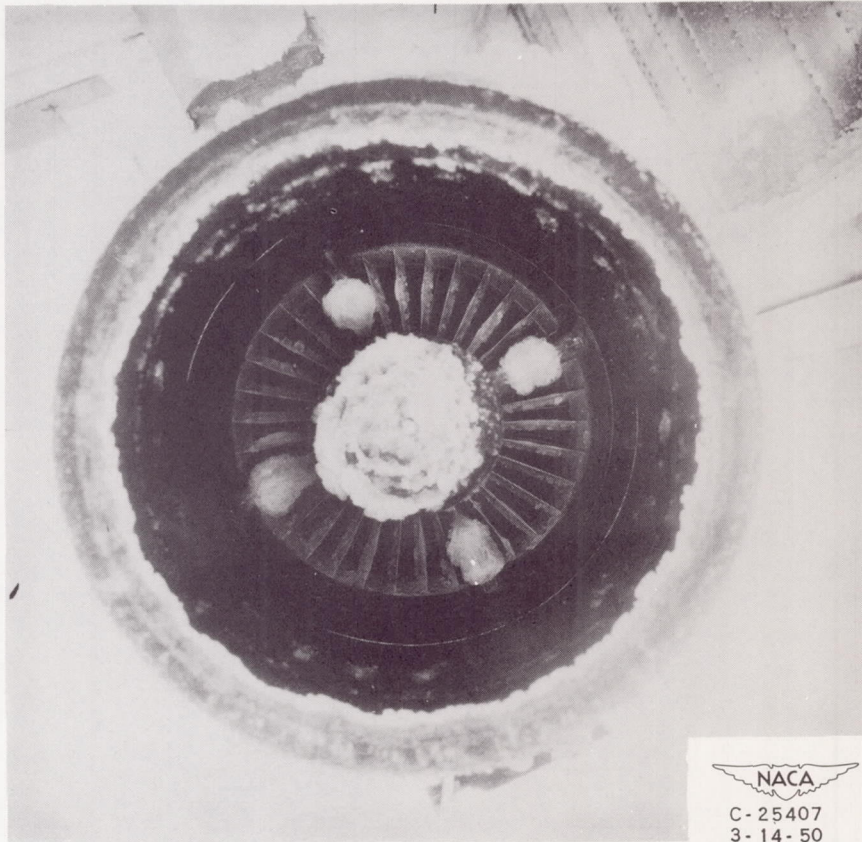
(b) Elapsed time in icing conditions, 9 minutes.

Figure 8. - Continued. Ice formation on turbojet-engine inlet during flight 2, without anti-icing. Liquid-water content, 0.1 to 0.5 gram per cubic meter; droplet size, 11 to 20 microns; ambient-air temperature, 22° to 26° F; thrust loss, 13 to 16 percent.

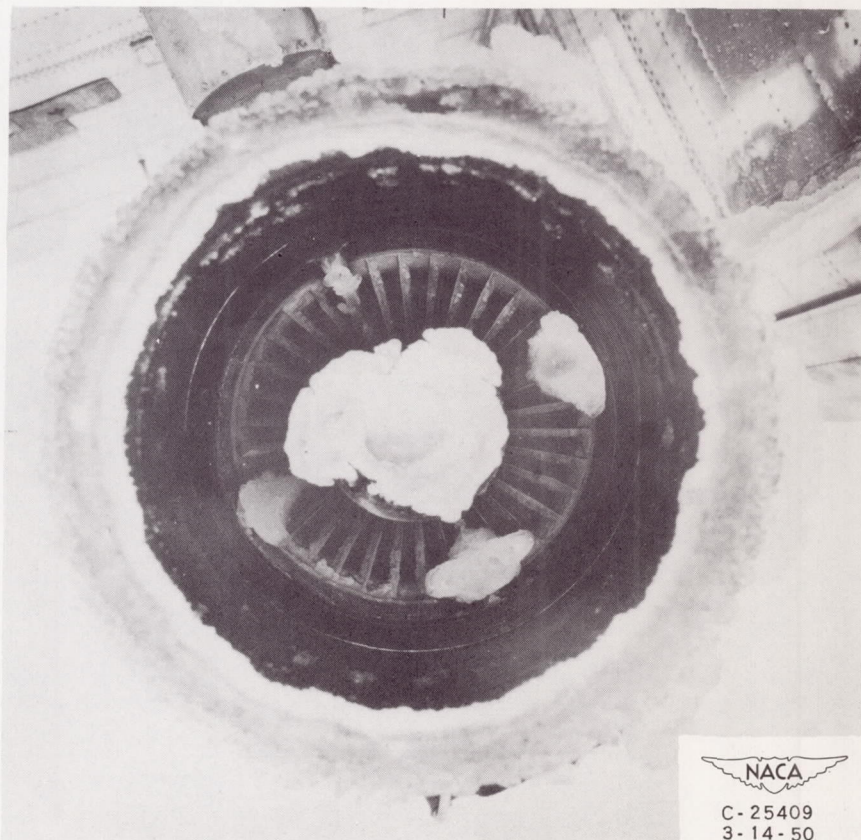
(d) Elapsed time in icing conditions, 28 minutes.

Figure 8. - Continued. Ice formation on turbojet-engine inlet during flight 2, without anti-icing. Liquid-water content, 0.1 to 0.5 gram per cubic meter; droplet size, 11 to 20 microns; ambient-air temperature, 22° to 26° F; thrust loss, 13 to 16 percent.

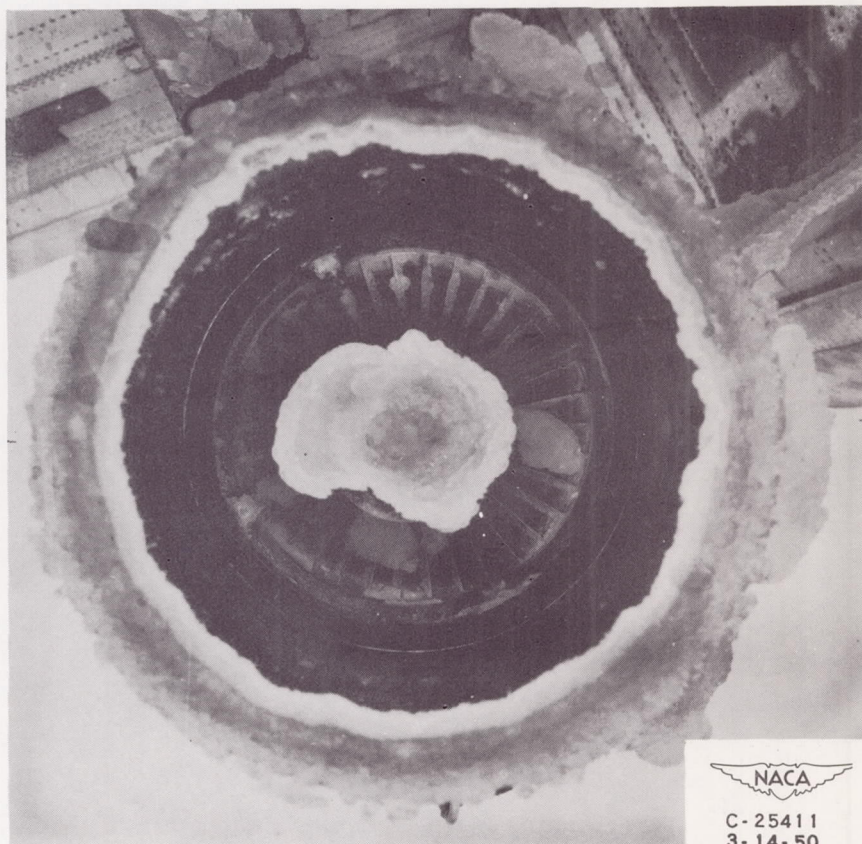
(f) Elapsed time in icing conditions, 47 minutes.

Figure 8. - Concluded. Ice formation on turbojet-engine inlet during flight 2, without anti-icing. Liquid-water content, 0.1 to 0.5 gram per cubic meter; droplet size, 11 to 20 microns; ambient-air temperature, 22° to 26° F; thrust loss, 13 to 16 percent.

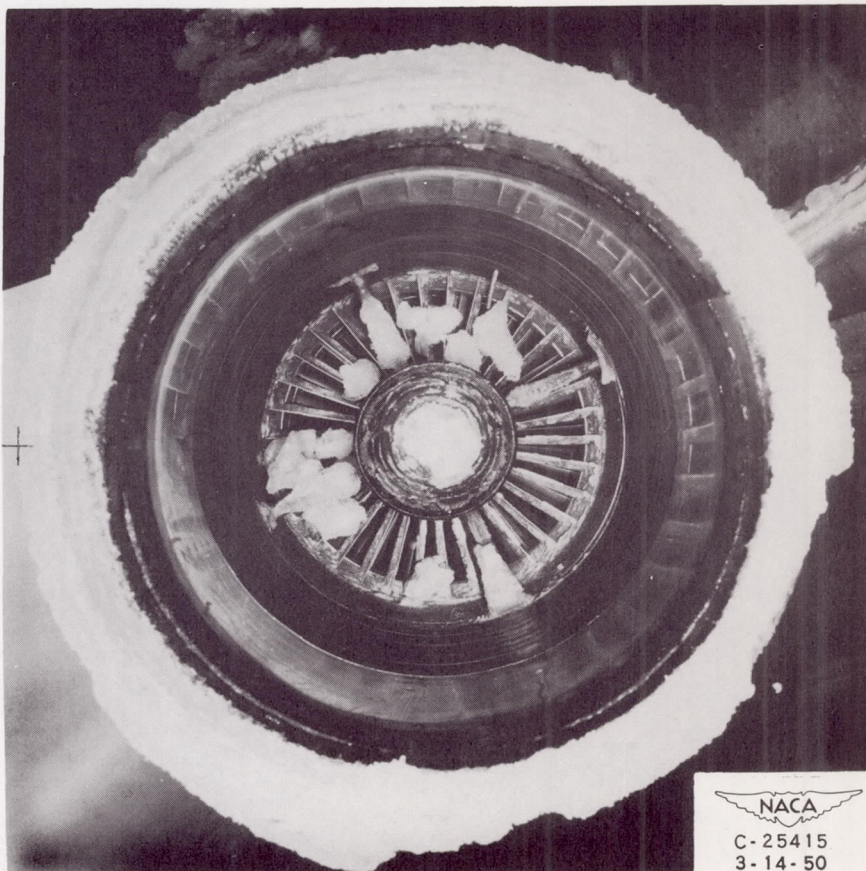
(b) Elapsed time in icing conditions, 76 minutes.

Figure 10. - Concluded. Ice formation on turbojet-engine inlet during flight 3 at 92-percent rated engine speed. Liquid-water content, 0.4 to 0.9 gram per cubic meter; droplet size, 12 to 14 microns; ambient-air temperature, 17° to 22° F; thrust loss, 26 percent.

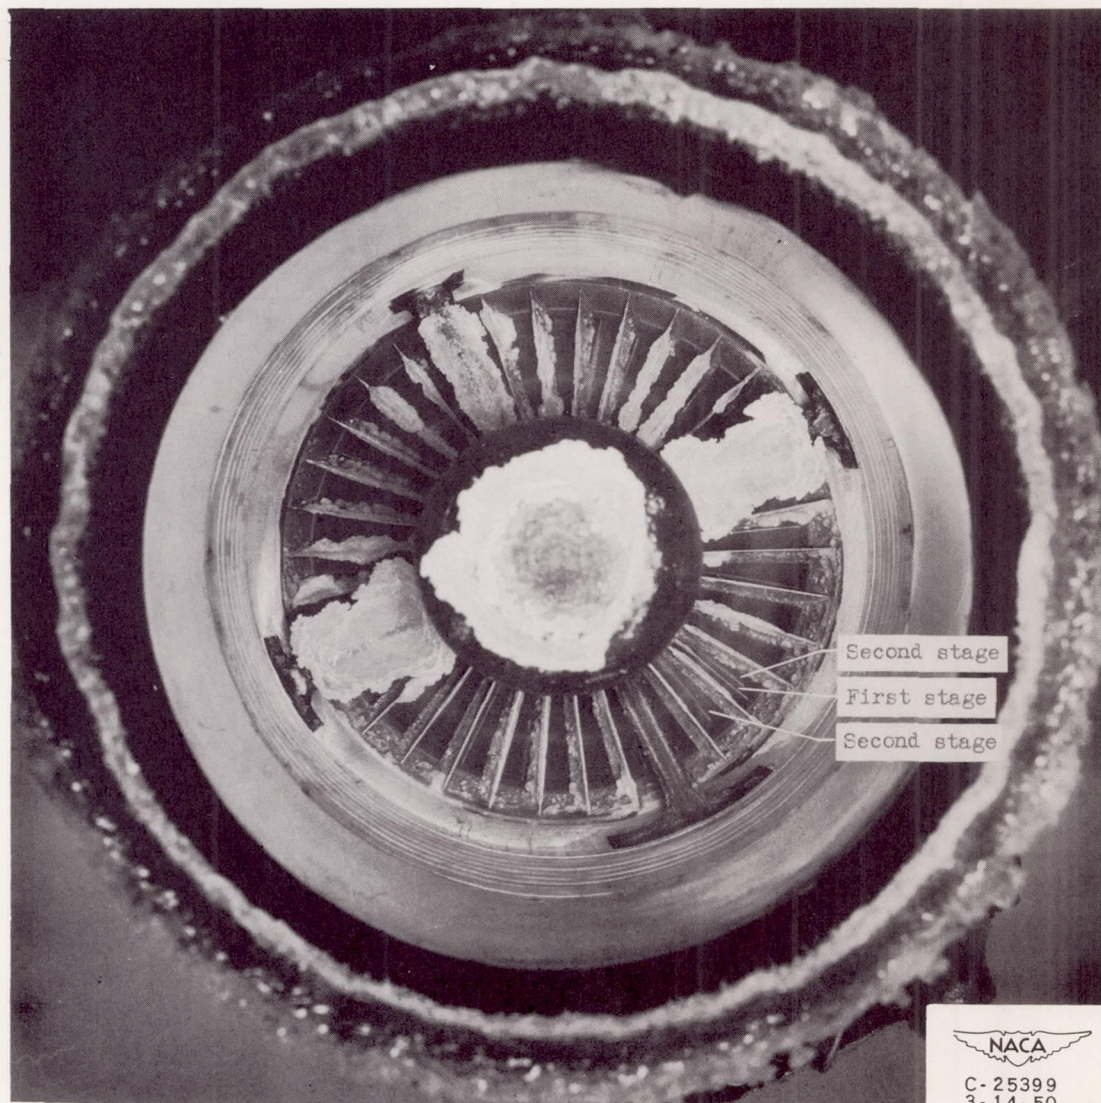
The ice formations on the engine inlet after 22 minutes of operation in the icing condition of flight 4 is shown in figure 12. The first-stage stator blades of the compressor had a light formation of ice and one second-stage stator blade evidently had an ice accretion at the blade root. Further penetration of ice formations into the compressor is not visible.

Figure 12. - Ice formations on turbojet-engine inlet at rated speed during flight 4. Time in icing, 22 minutes; liquid-water content, 0.4 to 0.6 gram per cubic meter; drop size, 11 to 16 microns; ambient-air temperature, 25° F; loss in thrust, 18 percent.

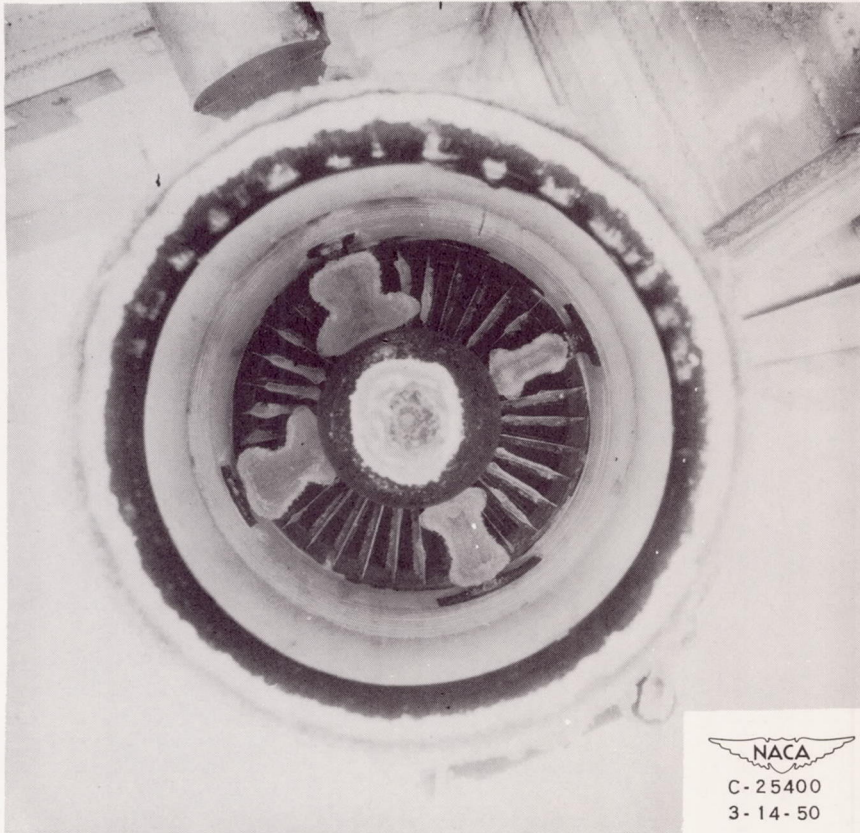
During flight 5, the engine was operated at 100- and 92-percent rated speed for 70 minutes in an icing condition in which the liquid-water content varied from 0.1 to 0.5 gram per cubic meter, with water-droplet sizes of 10 to 18 microns and an ambient-air temperature of 20° to 24° F. Operation in this icing condition resulted in a maximum reduction of 12 and 9 percent in engine thrust, 7 and 5 percent in air flow, 9 and 5 percent in compressor efficiency, and tail-pipe temperature was increased a maximum of 40° and 10° F at 100- and 92-percent rated speed, respectively, (fig. 13). Within the first minute in the icing encounter, the engine thrust at rated speed was reduced approximately 10 percent and the tail-pipe temperature increased 40° F. The initial losses were equivalent to the maximum losses reached during the entire 70-minute flight, thus illustrating again that the steady growth of the ice formation during the first few minutes of exposure to icing caused the greatest rate of reduction in engine performance. A photograph taken after approximately 23 minutes of operation in this icing condition (fig. 14) shows the typical ice formations obtained during the encounter.

Figure 14. - Ice formation on turbojet-engine inlet during flight 5. Time in icing, 23 minutes; liquid-water content, 0.1 to 0.5 gram per cubic meter; droplet size, 10 to 8 microns; ambient-air temperature, 20° to 24° F; thrust loss, 9 to 12 percent.
