# RESEARCH MEMORANDUM

INVESTIGATION OF MECHANISMS OF BLADE FAILURE OF  
FORGED HASTELLOY B AND CAST STELLITE 21  
TURBINE BLADES IN TURBOJET ENGINE

By C. Yaker, C. F. Robards, and F. B. Garrett

August 22, 1951  
Declassified September 10, 1954

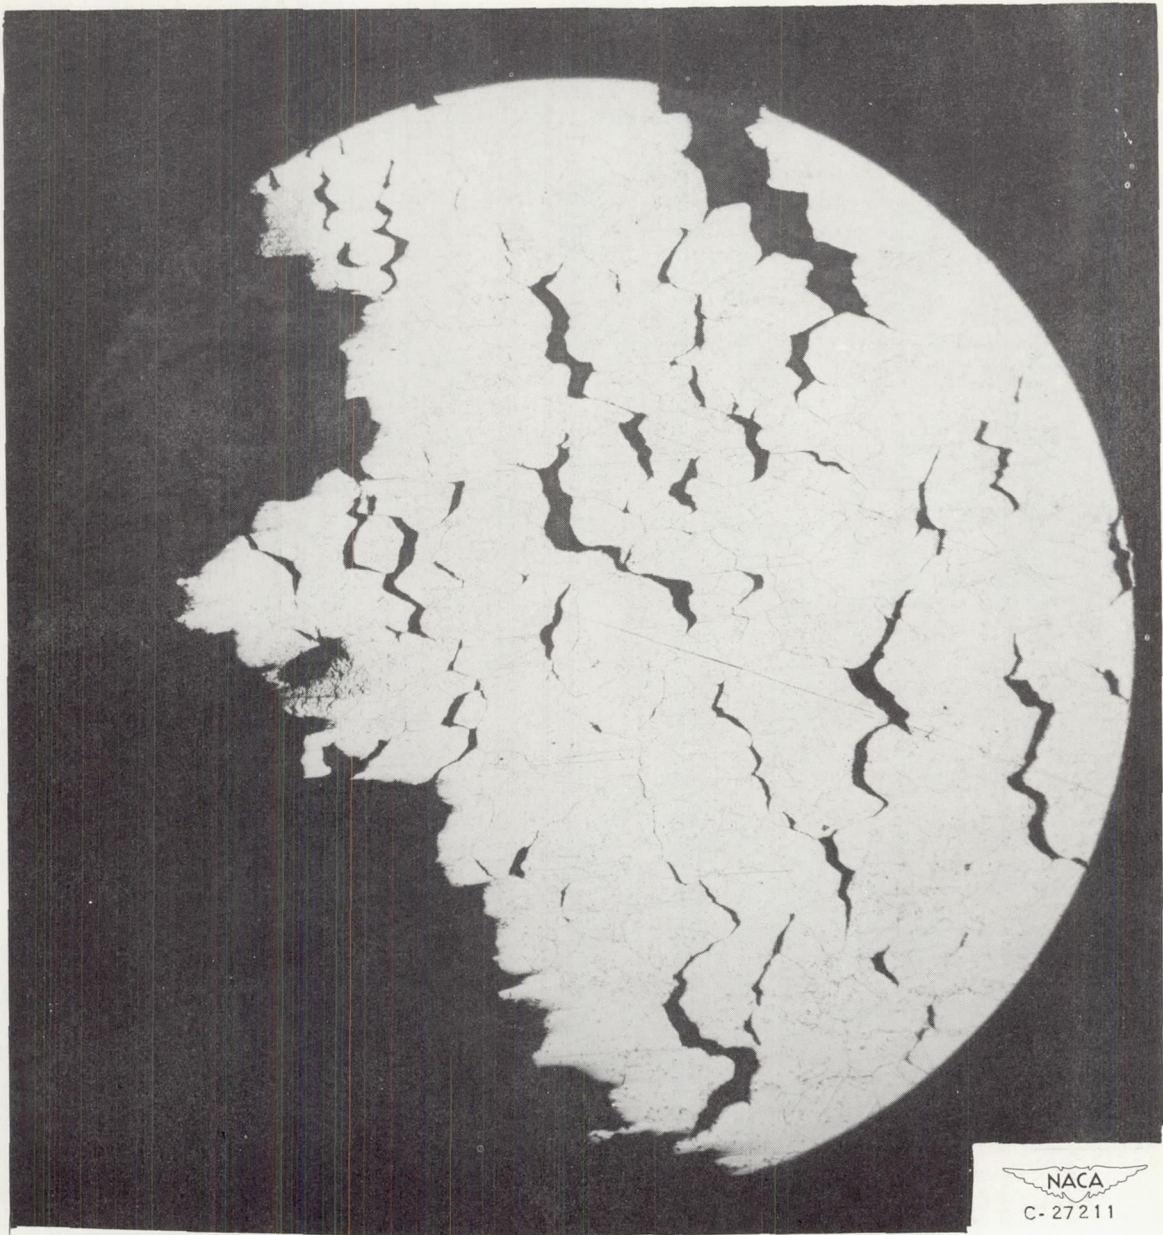
The results of the rupture tests on the individual Hastelloy B and Stellite 21 specimens cut from blades are listed in table I. Microscopic examination of broken stress-rupture specimens indicated that the stress-rupture fractures were intercrystalline in both alloys (figs. 5 and 6).

Figure 5. - Intercrystalline fracture in Hastelloy B stress-rupture specimen. Etched in solution of aqua regia in glycerine. X50.

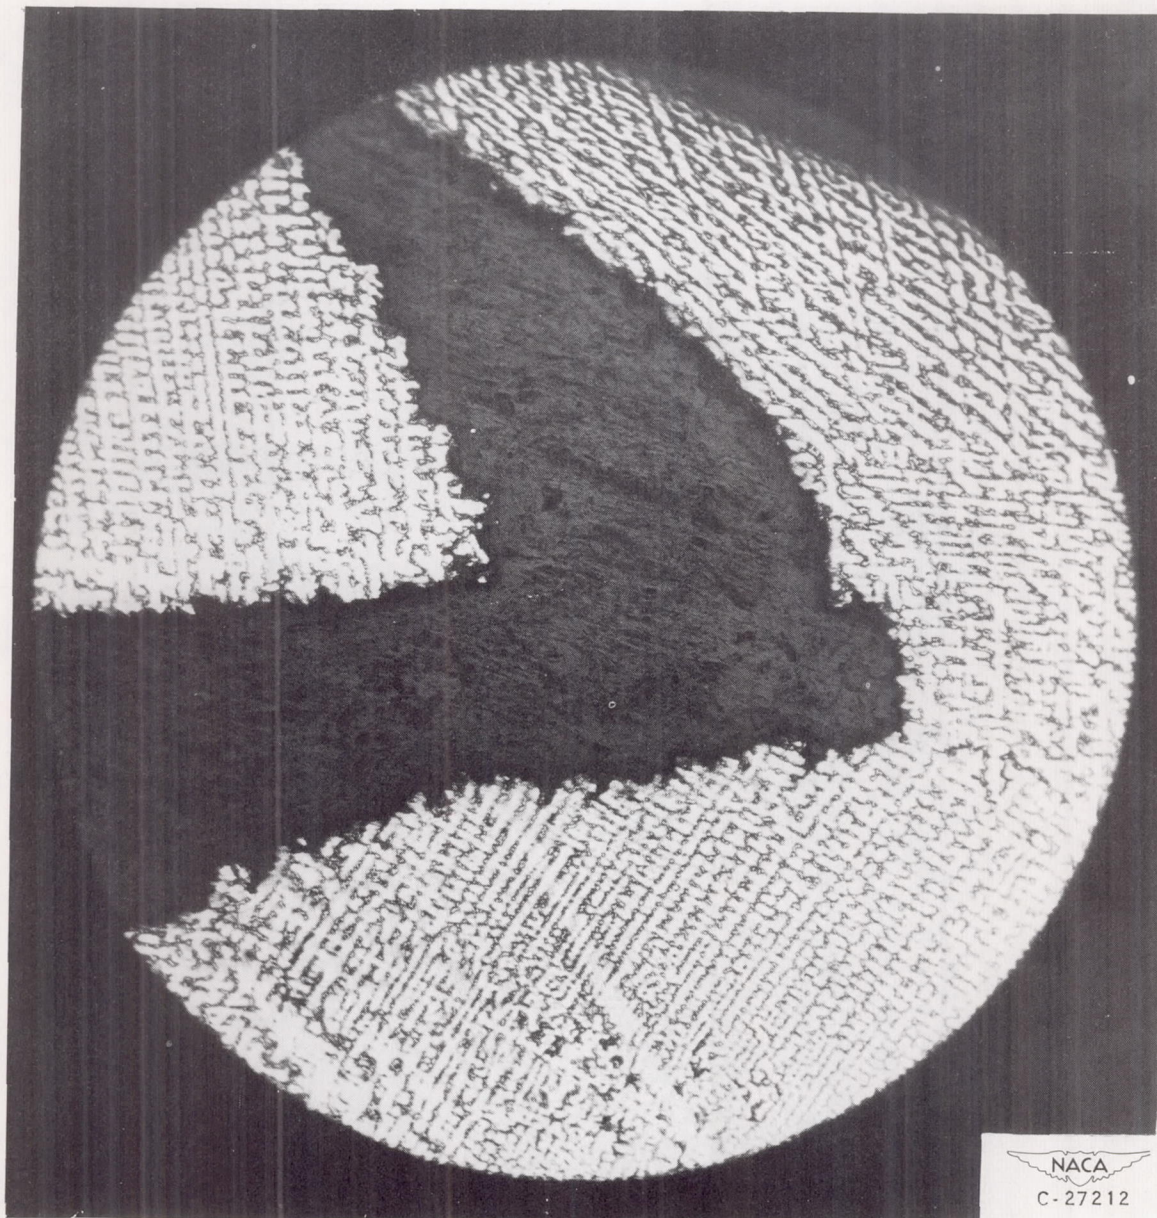
Figure 6. - Intercrystalline fracture in Stellite 21 stress-rupture specimen. Electrolytically etched in solution of 10-percent nitric acid and 10-percent ethylene glycol in ethyl alcohol. X50.

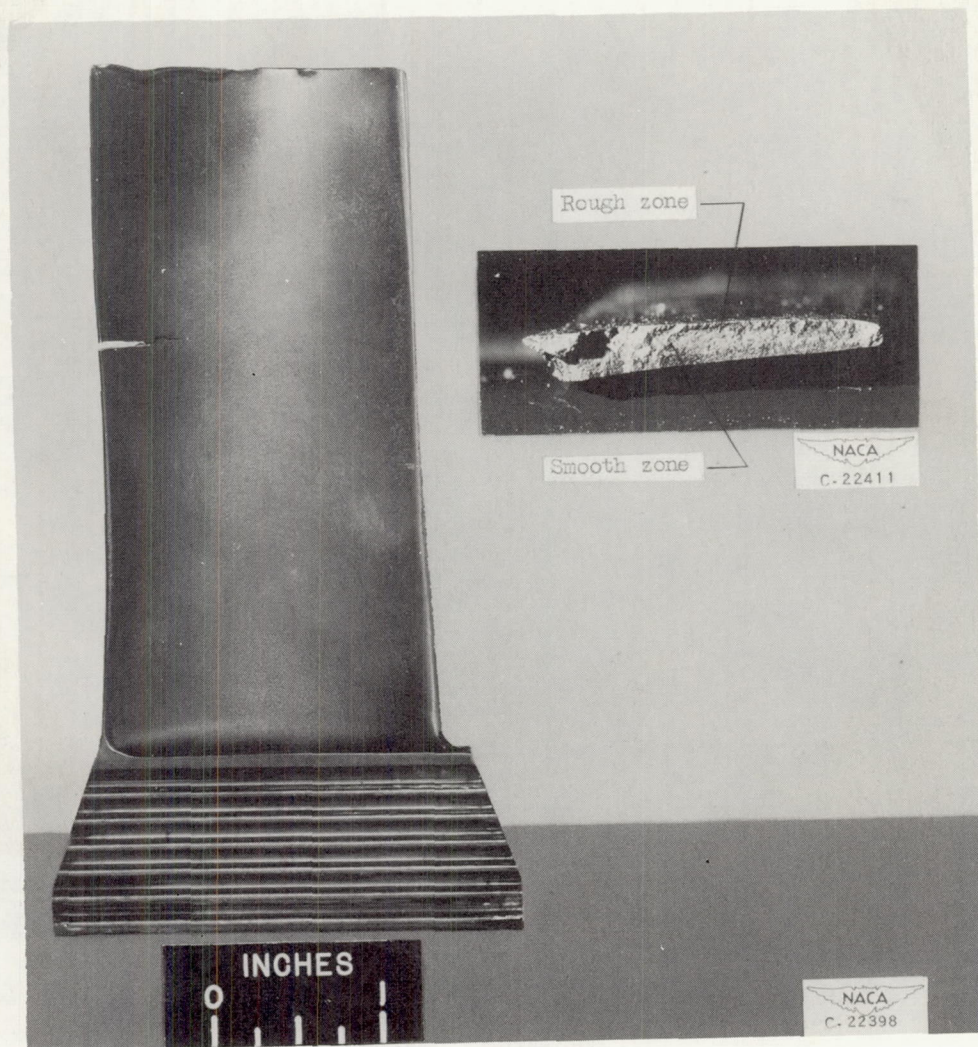
From the results of the engine operation, the first Hastelloy B blade failure occurred in the trailing edge of blade 14 after 14.25 hours of operation or within the range predicted by the stress-

rupture tests (fig. 20). This failure, however, could not be classed as a stress-rupture failure because unlike a rupture failure, it was transcrystalline in its propagation and had a smooth fracture surface. The failure started at a point on the blade above the zone of critical stress and maximum temperature (fig. 7). From the nature of the fracture, therefore, vibratory stresses were probably a principal cause of this first failure. After 16.75 hours of operation, the majority of the remaining Hastelloy B blades developed intercrystalline leading-edge cracks characteristic of the stress-rupture failures of the blade specimens. Inasmuch as this operating time was within the stress-rupture failure times expected from operating conditions, these cracks can be considered as evidence of the beginning of blade failure by stress rupture. The distribution of these cracks along the leading edge (fig. 11(a)) suggests that corrosion or localized hot zone along the leading edge may have been partly responsible for their formation. However, the correlation of the nature of the crack propagation and the time of the crack formation with the results of the stress-rupture tests on blade specimens indicates that other contributing causes such as corrosion are of less importance. As the engine operation continued, the remaining Hastelloy B blade fractures progressed from these leading-edge cracks. The failures progressed by two mechanisms, fatigue and stress rupture. Hastelloy B blades 4 and 34 (figs. 11(b) and 11(d)) fractured after 18.47 hours of (1.72 additional hr) operation as a result of a condition favorable for fatigue fracture having been set up by the leading-edge cracks. The vibratory stresses in the blades were therefore merely propagating a failure originated by stress rupture. In Hastelloy B blade 54 after 28.75 hours (12 additional hr) of operation, fracture occurred by the progression of the initial crack across the blade continued by a stress rupture following an intercrystalline path. Some of the original Hastelloy B blades were still in operation at times in excess of the predicted rupture life, which would be expected since a complete stress-rupture band for the alloy was unavailable, making the maximum blade life unknown. All but three of the original 27 Hastelloy B blades, however, had cracked or fractured at the conclusion of operation, indicating that failure had started in all but three blades.

| Alloy | Blade | Time at rated speed (hr) | Origin of failure <sup>a</sup> | Turbine blades | | Apparent cause of failure <sup>b</sup> |
|---|---|---|---|---|---|---|
| Hastelloy B | 14 <sup>c</sup> | 14.25 | Trailing-edge crack | Partly smooth and partly rough appearance (see fig. 7) | Transcrystalline (fig. 8) | Vibratory stresses superimposed on centrifugal stress (fatigue) |

Figure 7. - Trailing-edge crack in Hastelloy B blade 14 after 14.25 hours (57 cycles) of operation. (Fracture surface of crack at X5 shown in inset.)

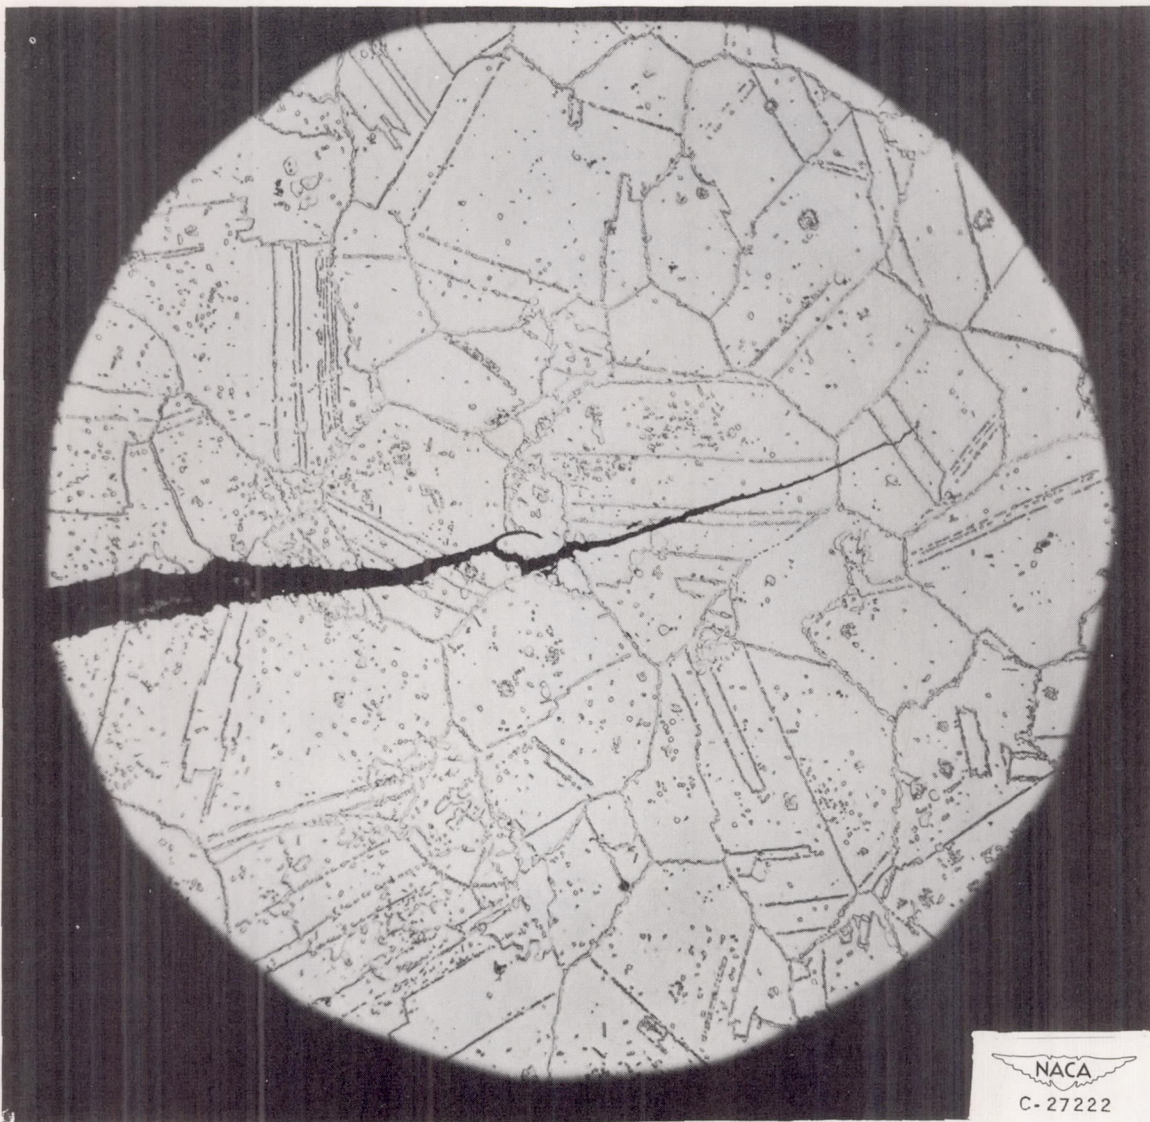
Figure 8. - Transcrystalline trailing-edge crack in Hastelloy B blade 14 after 14.25 hours (57 cycles) of operation. Etchant, aqua regia in glycerine. X250.

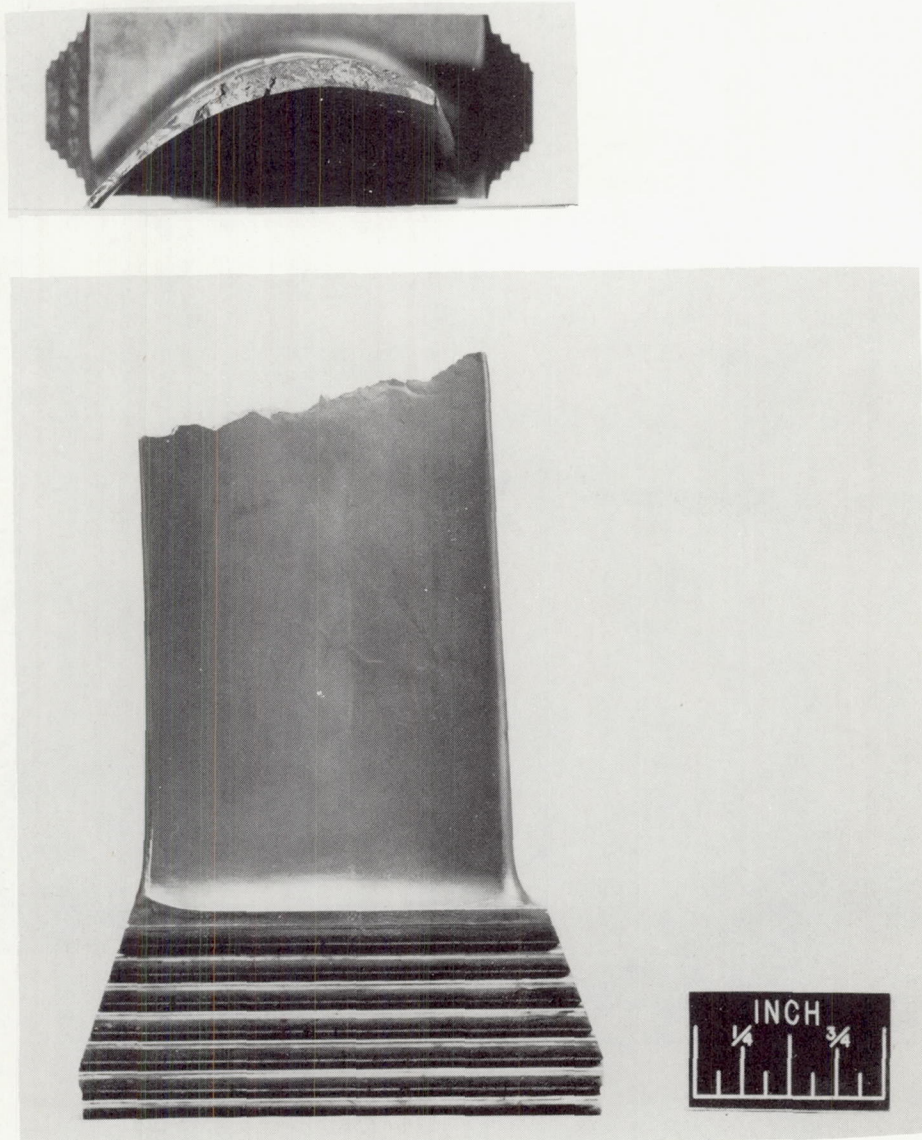
In the case of the Stellite 21 blades, the first blade failure (blade 25) occurred after 16.75 hours, which is below the predicted rupture life of 21 hours. Like the first Hastelloy B failure, the fracture started at the trailing edge and was not of the characteristic stress-rupture type inasmuch as it was transcrystalline in its propagation and had smooth fracture facets. Also like the first Hastelloy B failure, fracture started at a point above the zone of critical stress and maximum temperature. As in the case of the first Hastelloy B blade, therefore, vibratory stresses were largely responsible for this fracture. At this same time (16.75 hr), intercrystalline

| Alloy | Blade | Time at rated speed (hr) | Origin of failure <sup>a</sup> | Turbine blades | | Apparent cause of failure <sup>b</sup> |
|---|---|---|---|---|---|---|
| Stellite 21 | 25 <sup>c</sup> | 16.75 | Trailing-edge fracture | Fracture path at angle to horizontal. Fracture started with zone with smooth crystalline facets then changed to zone of rough surface (fig. 9(a)) | Transcrystalline (fig. 10) | Vibratory stresses superimposed on centrifugal stress (fatigue) |

(a) Blade 25 fractured after 16.75 hours (67 cycles) of operation.

Figure 9. - Fractured Stellite 21 blades.

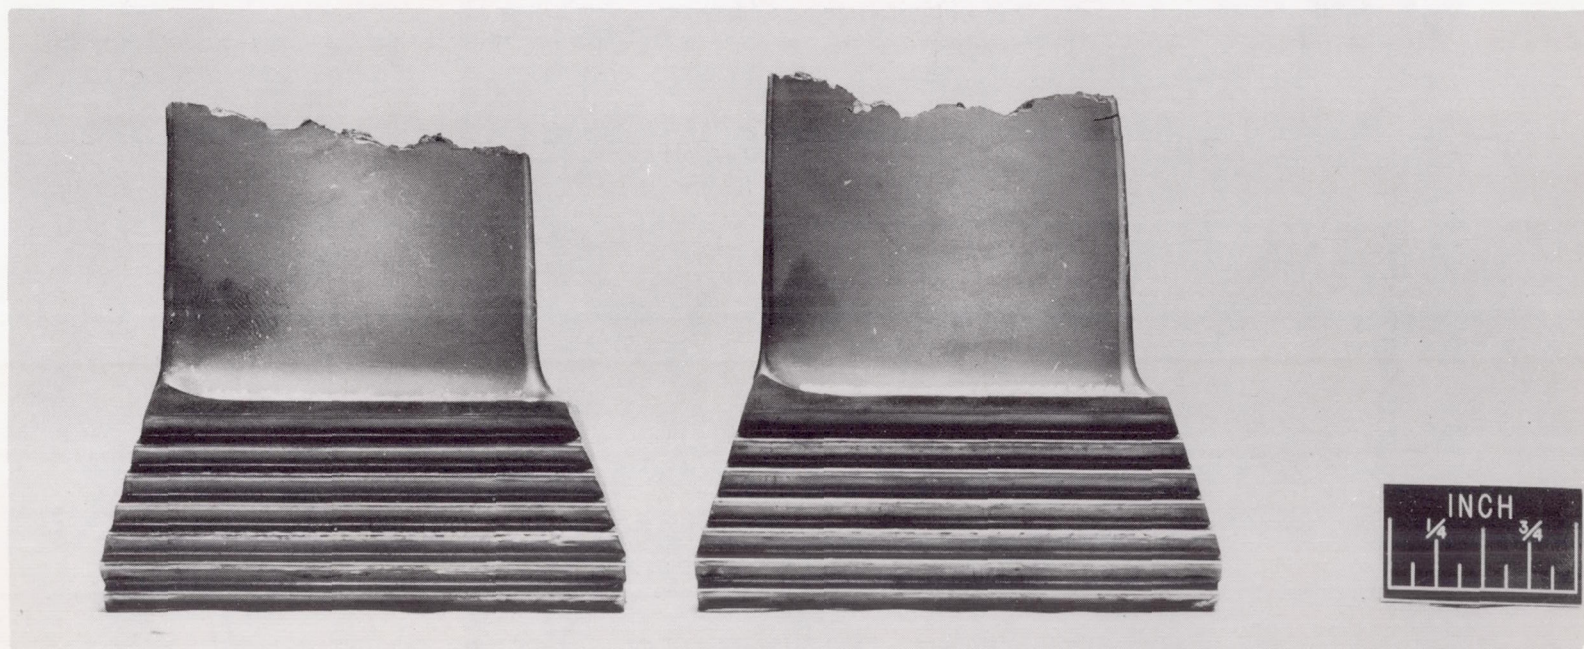
| Alloy | Blade | Time at rated speed (hr) | Origin of failure <sup>a</sup> | Turbine blades | | Apparent cause of failure <sup>b</sup> |
|---|---|---|---|---|---|---|
| Stellite 21 | 1<br>3 | 28.75 | Fracture origin not determinable | Irregular fracture surface having coarse appearance (figs. 9(b) and 9(c)) | Transcrystalline | Impact with failure fragments suggested by close proximity of failures as shown in fig. 14 |

(b) Blade 3 fractured after 28.75 hours (115 cycles)  
of operation.

(c) Blade 1 fractured after 28.75 hours (115 cycles)  
of operation.

Figure 9.-Concluded. Fractured Stellite 21 blades.

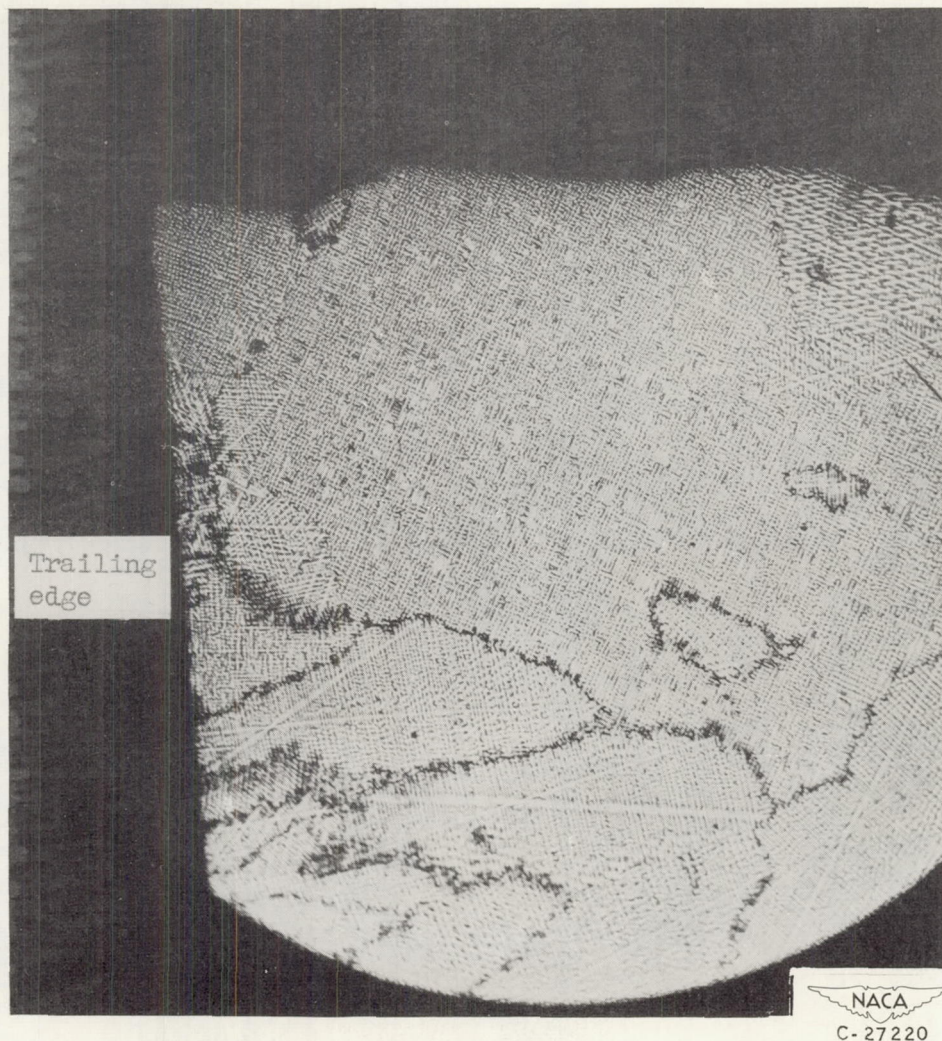
Figure 10. - Transcrystalline path in Stellite 21 fracture blade 25 after 16.75 hours (67 cycles) of operation. Electrolytically etched in 10 percent nitric acid and 10 percent ethylene glycol. X50.

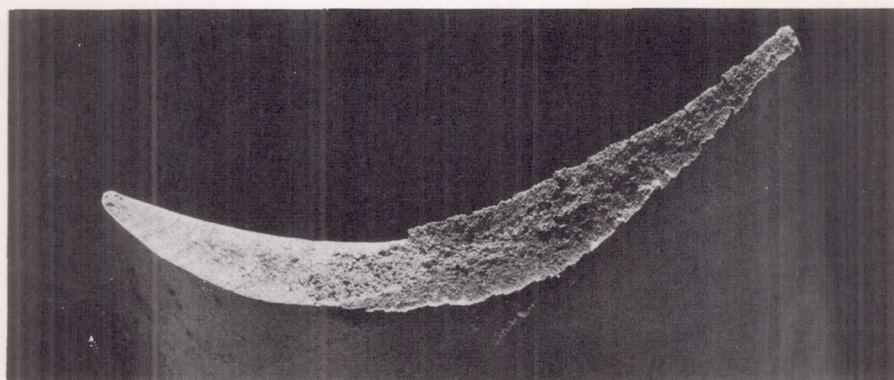
| Alloy | Blade | Time at rated speed (hr) | Origin of failure <sup>a</sup> | Turbine blades | | Apparent cause of failure <sup>b</sup> |
|---|---|---|---|---|---|---|
| Hastelloy B | 4 <sup>c</sup> | 18.47 | Leading-edge fractured | Fracture started normal to edge from point where crack was observed then changed direction and moved at angle with horizontal. The surface in flat portion of fracture has concentric-ring markings typical of fatigue failure. The remaining surface has coarse appearance (figs. 11(b) and 11(c)). | Intercrystalline changing to transcrystalline (fig. 13) | Centrifugal stress at origin, fracture then propagated to vibratory stresses (stress rupture to fatigue) |

(c) Fracture surface of blade 4 (fig. 11(b)). X2.

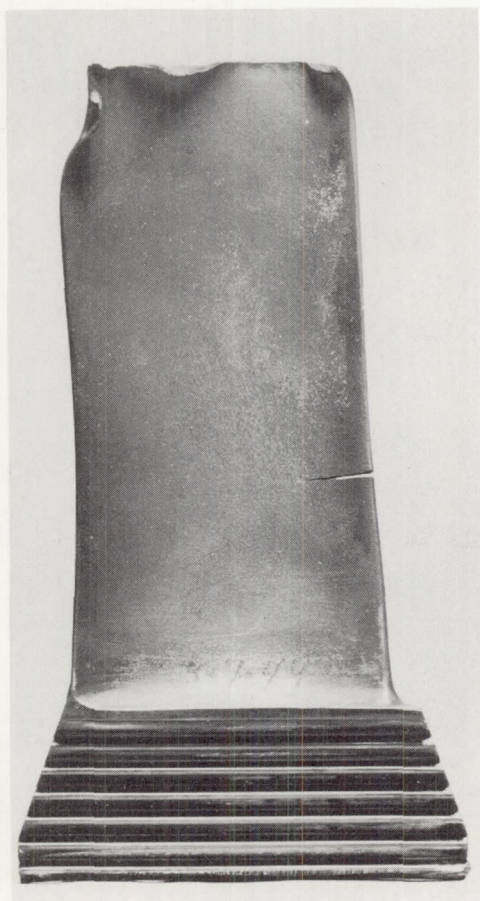
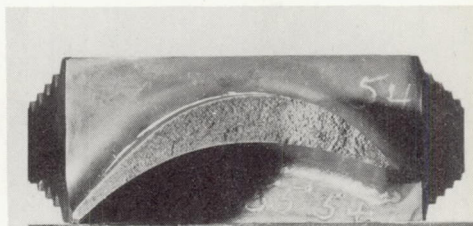
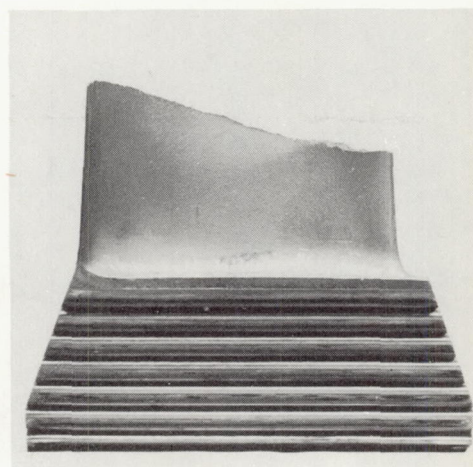
| Alloy | Blade | Time at rated speed (hr) | Origin of failure <sup>a</sup> | Turbine blades | | Apparent cause of failure <sup>b</sup> |
|---|---|---|---|---|---|---|
| Hastelloy B | 34 <sup>c</sup> | 18.47 | Extension of leading-edge crack (crack only) | Same as start of fracture in blade 4 (fig. 11(d)) | Intercrystalline changing to transcrystalline (fig. 13) | Same as preceding blade 4 |
| Hastelloy B | 54 <sup>c</sup> | 28.75 <sup>e</sup> | Leading-edge fracture <sup>d</sup> | Fracture path at angle to horizontal from point where crack was observed. Entire surface has coarse appearance (fig. 11(e)). | Intercrystalline | Centrifugal stress (stress rupture) |

(d) Blade 34 after 18.47 hours (74 cycles)  
of operation.

(e) Blade 54 fractured after 28.75 hours  
(115 cycles) of operation.

Figure 11. - Concluded. Fractured and cracked Hastelloy B blades.

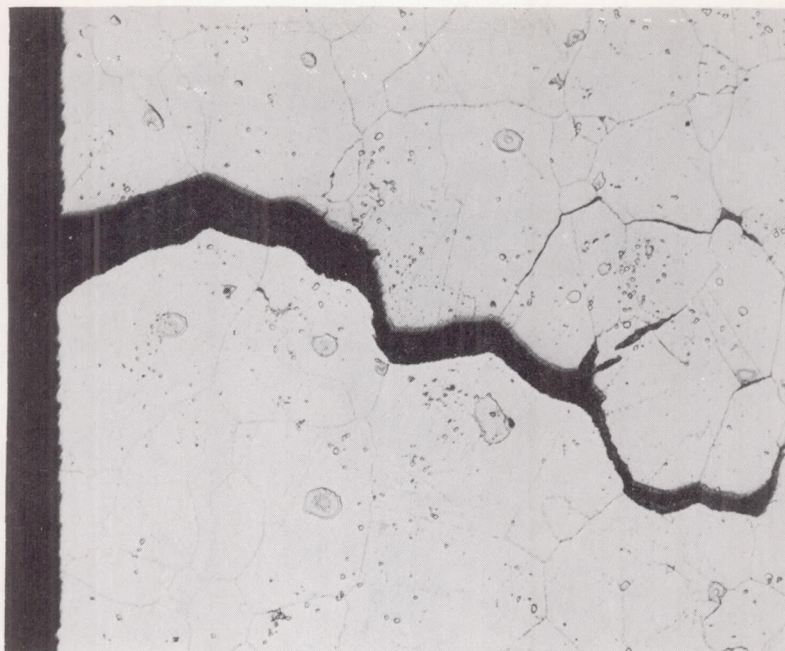
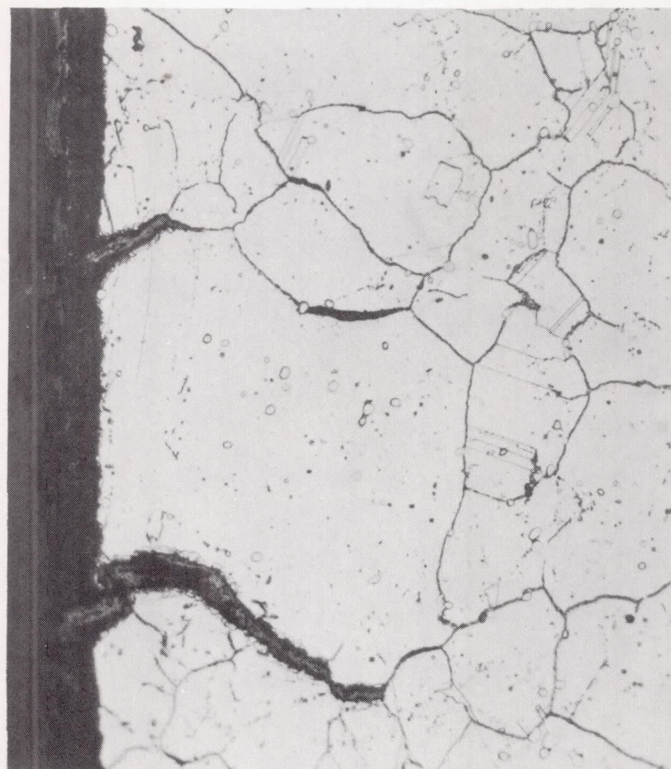
| Alloy | Blade | Time at rated speed (hr) | Origin of failure <sup>a</sup> | Turbine blades | | Apparent cause of failure <sup>b</sup> |
|---|---|---|---|---|---|---|
| Hastelloy B | 4<br>5<br>8<br>10 <sup>c</sup><br>12 <sup>c</sup><br>16<br>18<br>20 <sup>c</sup><br>22<br>30 <sup>c</sup><br>32 <sup>c</sup><br>34<br>36 <sup>c</sup><br>38 <sup>c</sup><br>46 <sup>c</sup><br>48<br>50 <sup>c</sup><br>52<br>54 | 16.75 | Leading-edge cracks (for example, fig. 11(a)) | | Intercrystalline (fig. 12) | Centrifugal stress (stress rupture) |
| Hastelloy B | 2<br>24<br>26<br>28 | 28.75 | Leading-edge cracks | | Intercrystalline (fig. 12) | Centrifugal stress (stress rupture) |

(a) X100.

(b) X250.

Figure 12. - Typical intercrystalline leading-edge cracks in Hastelloy B blades. Etchant, aqua regia in glycerine.

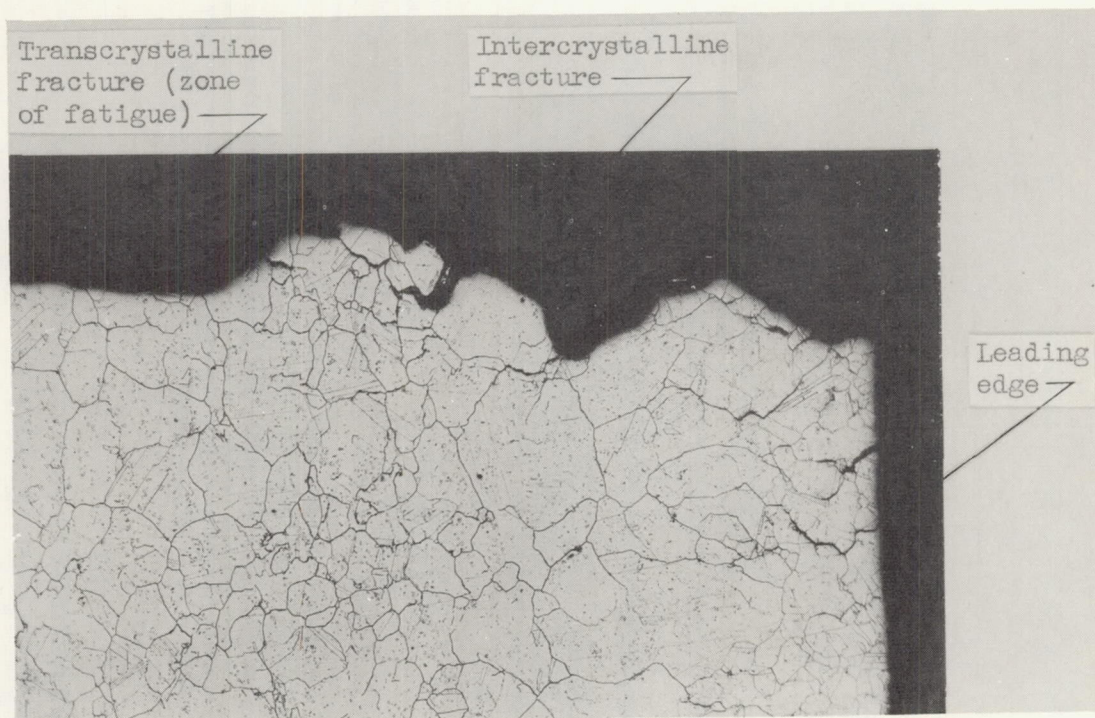
(a) Failure path from leading edge of fractured blade 4. X50.

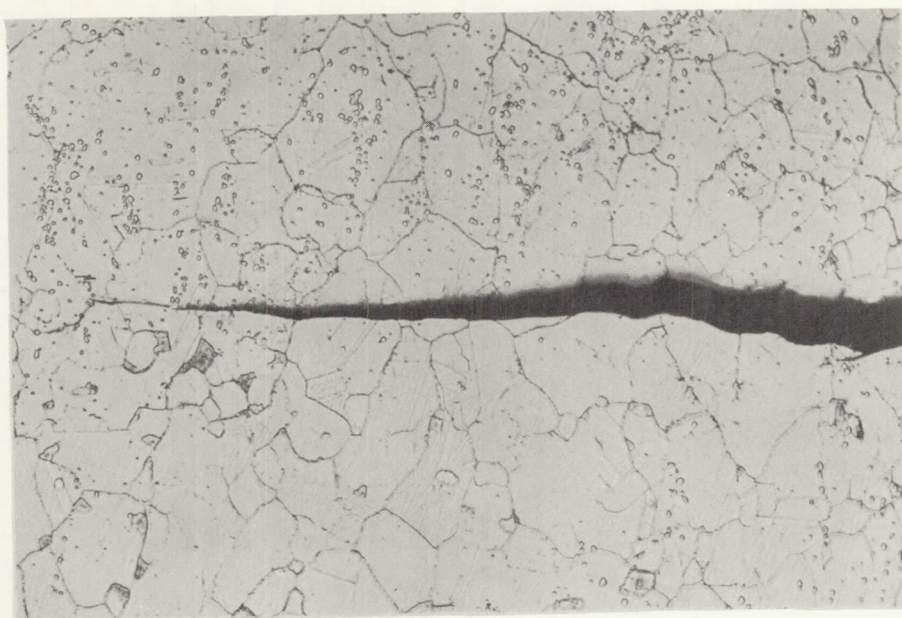
(b) Transcrystalline failure path in zone of fatigue of cracked blade 34. X100.

Figure 13.-Failure progression in Hastelloy B blades. Etchant, aqua regia in glycerine.

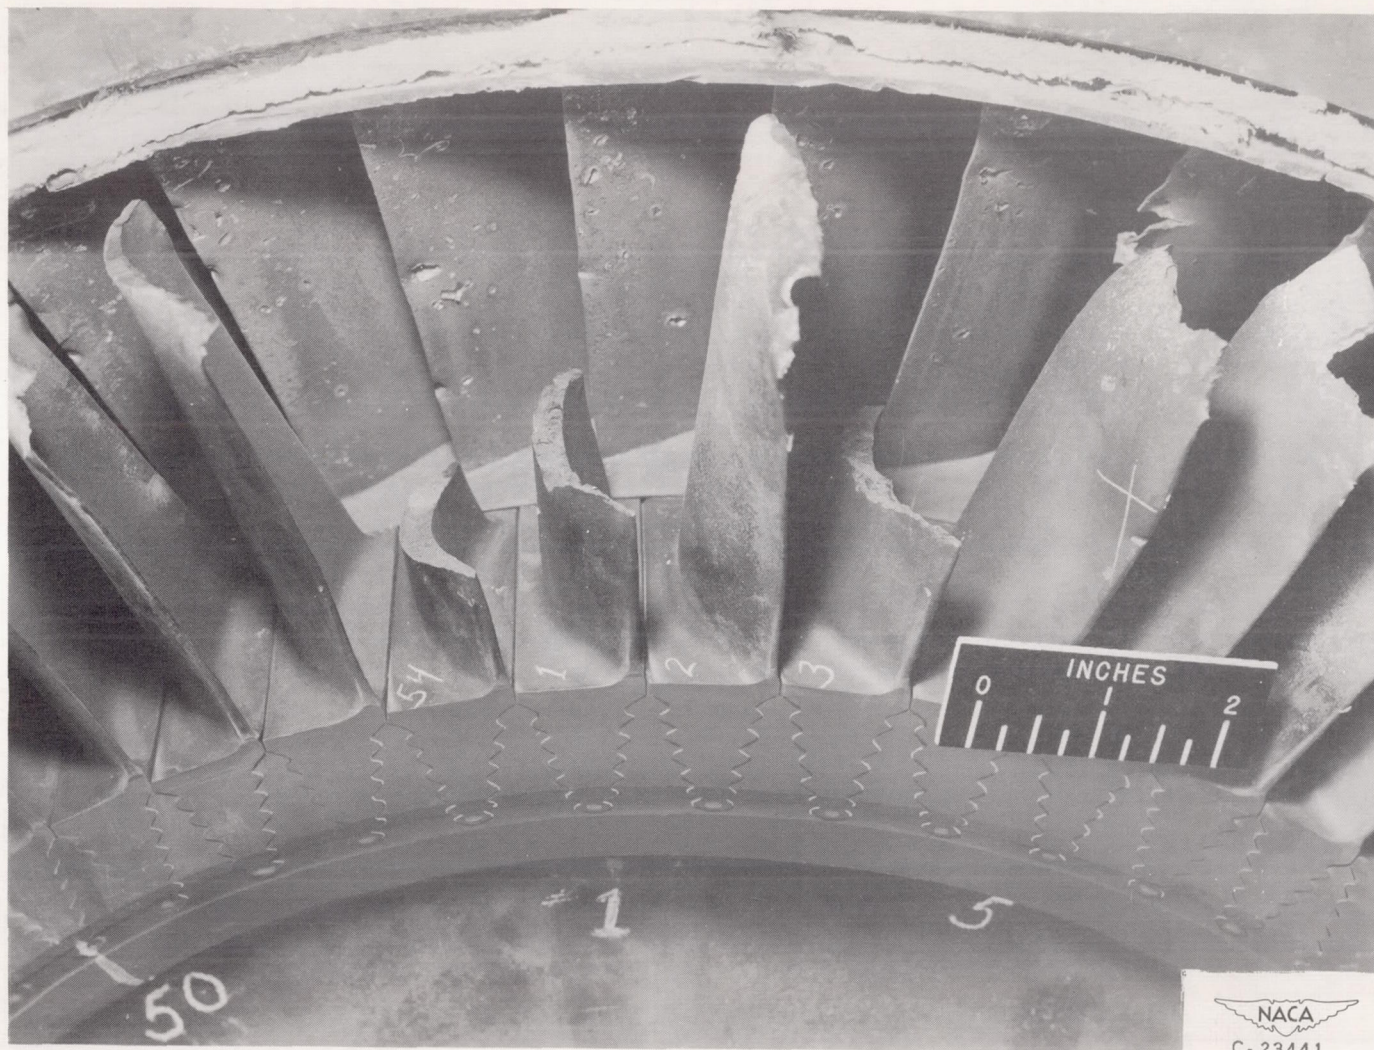
Figure 14. - Fractured blades at conclusion of operation.

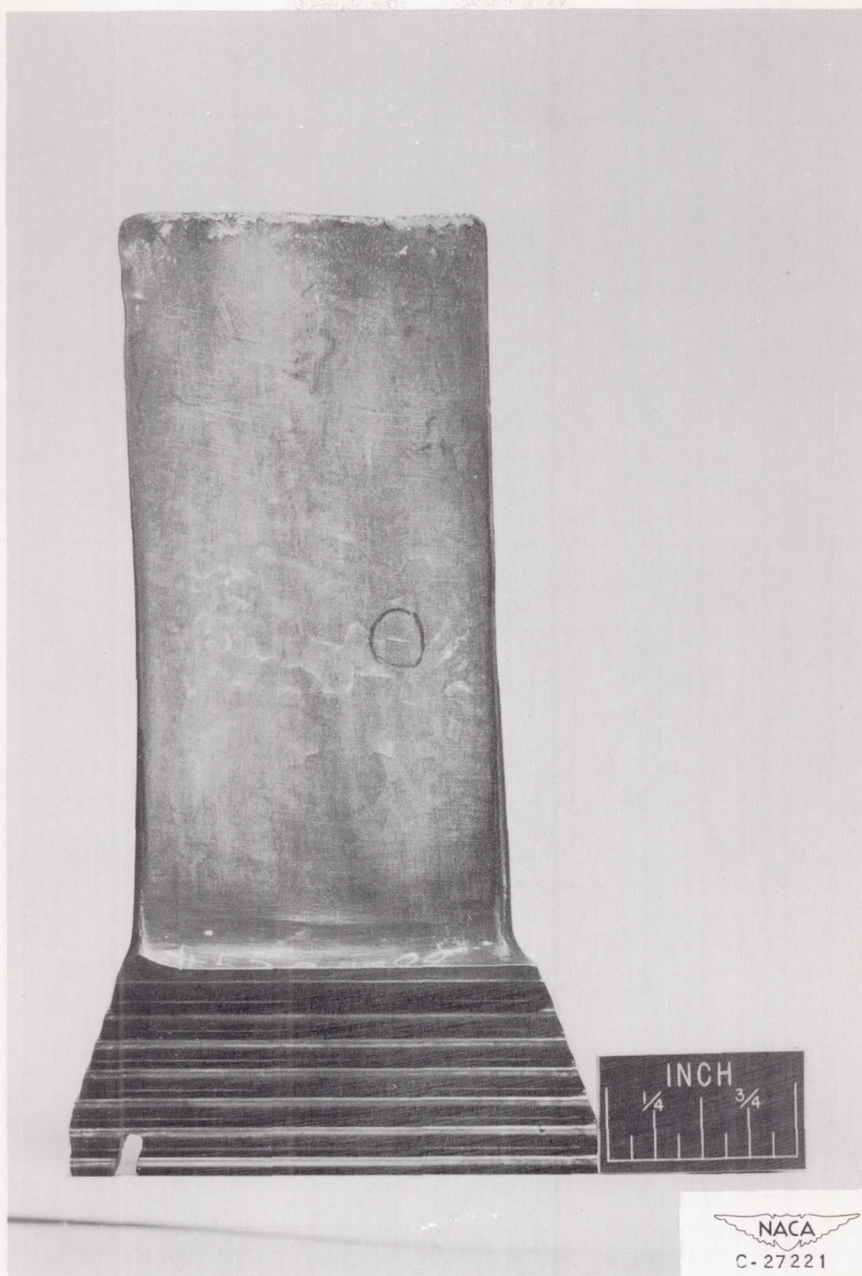
The Stellite 21 blade surfaces after 28.75 hours (115 cycles) of operation were coated with a thin dark-gray oxide and exhibited the "alligator skin" appearance characteristic of deformation in coarse-grained alloys, as described in reference 4. (See fig. 18.) The Hastelloy B blade surfaces were coated with a flaked dark-brown-to-purple oxide and exhibited a slight amount of oxide pitting. The fracture surfaces of all Hastelloy B blades were coated with a similar oxide pattern, a dark-gray oxide at the fracture origin that changed to a blue temper color as the fracture progressed across the blade. This same color pattern also existed on the fracture surface of Stellite 21 blade 25. The colorings of the fracture surfaces of Stellite 21 blades 1 and 3, however, were anomalous in that they were entirely a straw temper color.

Figure 18. - Surface condition of Stellite 21 blade after 28.75 hours (115 cycles) of operation.
