RESEARCH MEMORANDUM

RESULTS OF TURBOJET ENGINE OPERATION TESTS USING
A 50-50 MIXTURE OF JP-4 AND TRIBUTYL BORATE
AS THE FUEL

By Louis J. Schafer, Jr., and Francis S. Stepka

Lewis Flight Propulsion Laboratory
Cleveland, Ohio

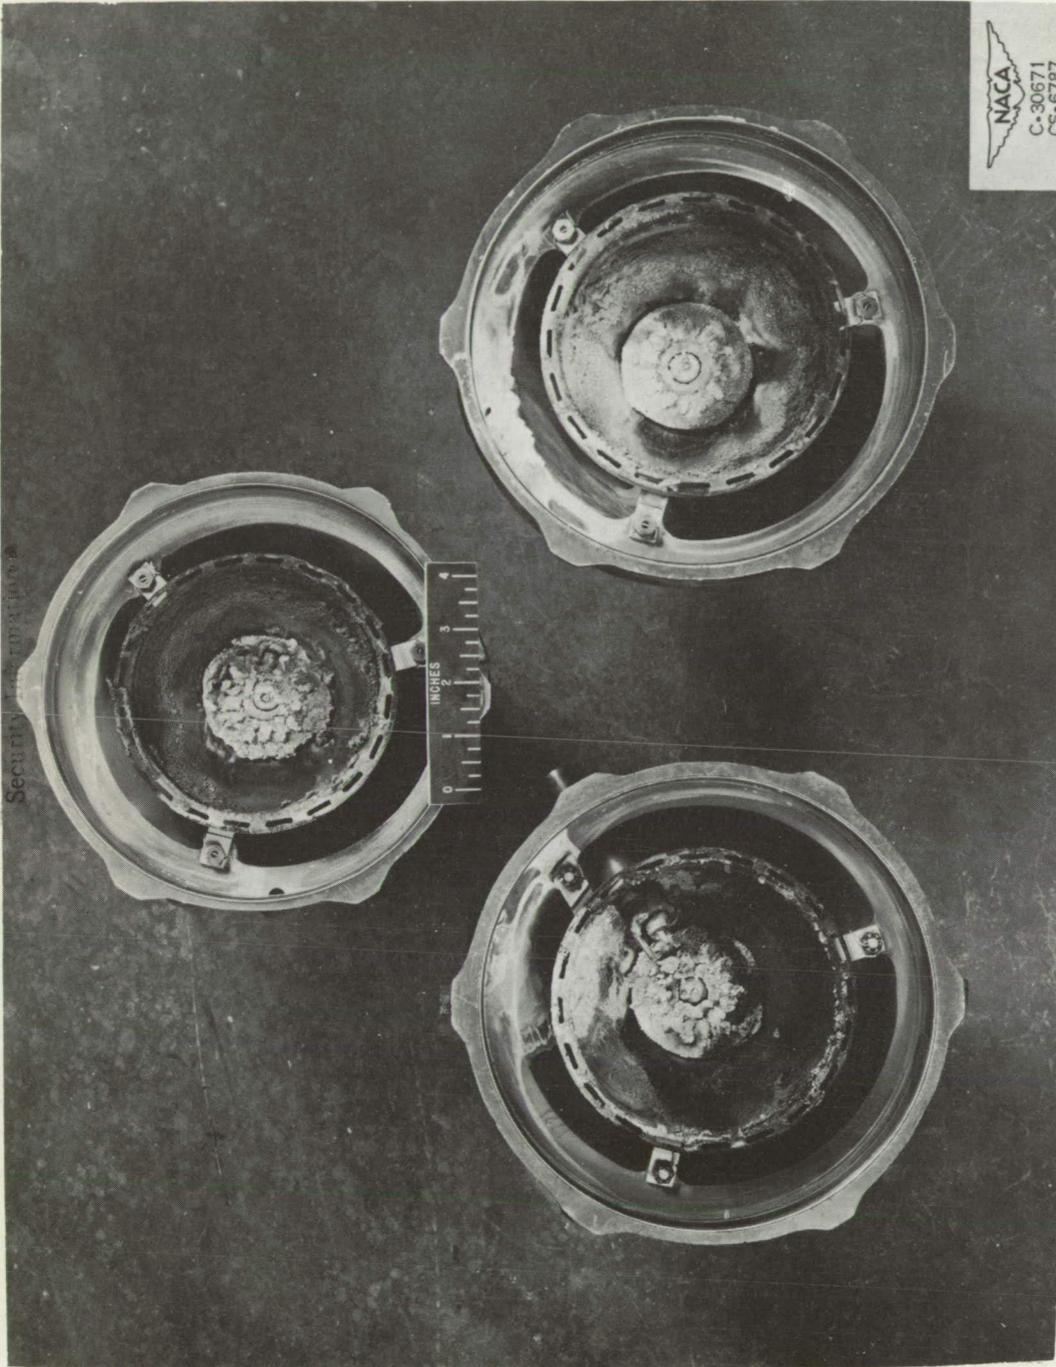
Three fuel nozzles assembled in their burner domes are shown in figure 1. The deposits in these parts were thicker than in any others. The deposits were heaviest on the fuel nozzles and on the air spinner disk which fits around the fuel nozzles. It is conceivable that the deposit on the fuel nozzles could build up to such a degree that it would alter the shape of the cone of the fuel spray and thus reduce the combustion efficiency. Besides having the boric oxide deposit on the outside, several of the fuel nozzles were completely plugged. This was probably a result of the fuel left in the nozzles hydrolyzing after the engine was shut down. This is a characteristic of the high-energy fuels also, and is a disadvantage that must be considered. The build-up of boric oxide on the air spinner disk was very heavy also. The vanes in the spinner were almost completely plugged. This condition did not seem to have any effect on the engine operation. The air adapter containing the spark plug is shown at the lower left corner of figure 1. Some evidence of the deposits was observed on the spark plug electrodes, but they did not close the gap. The spark plug still operated satisfactorily. The coating on the burner dome was not as thick as it was on the other parts shown in figure 1.

1. The greatest accumulation of boric oxide in the engine was found in the burner domes where the air spinners were almost completely plugged and the boric oxide deposits on the fuel nozzles was such as to possibly alter the shape of the fuel spray and decrease the combustion efficiency.

Figure 1. - Build-up of boric oxide deposits on fuel nozzles and burner dome.

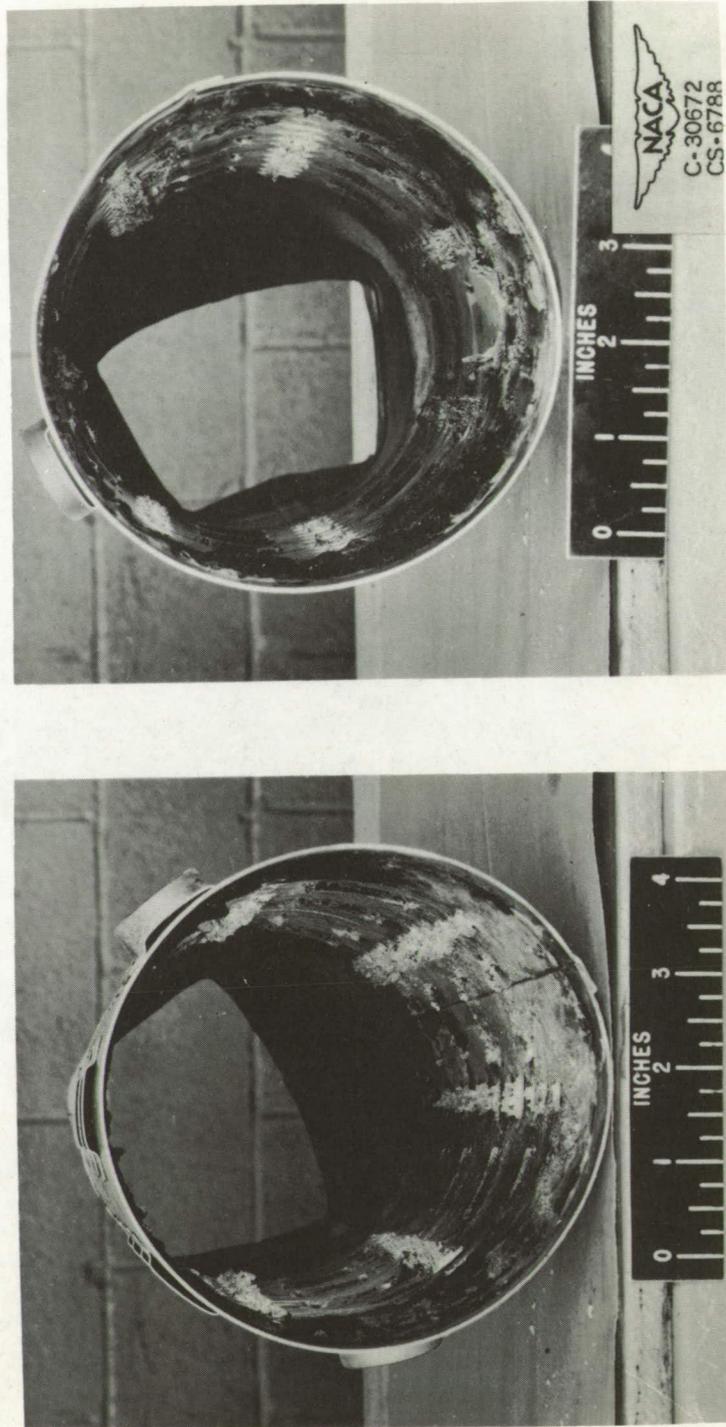
Two of the burner liners are shown in figure 2. These showed a buildup of deposits over small areas just downstream of the air holes in the liners. These deposits were the same type as those that were found in the burner domes and around the fuel nozzles. The rest of the surface of the burner liners had a thin rippled coating of boric oxide. The boric oxide was obviously molten on these surfaces of the liners and was flowing toward the nozzle diaphragm where it built up in clumps at the exit of the burner liners as is shown in figure 3. There was also evidence of molten boric oxide between the outer ring of the nozzle diaphragm and the engine casing shown in figure 3.

Figure 2. - Build-up of deposits on burner liners.

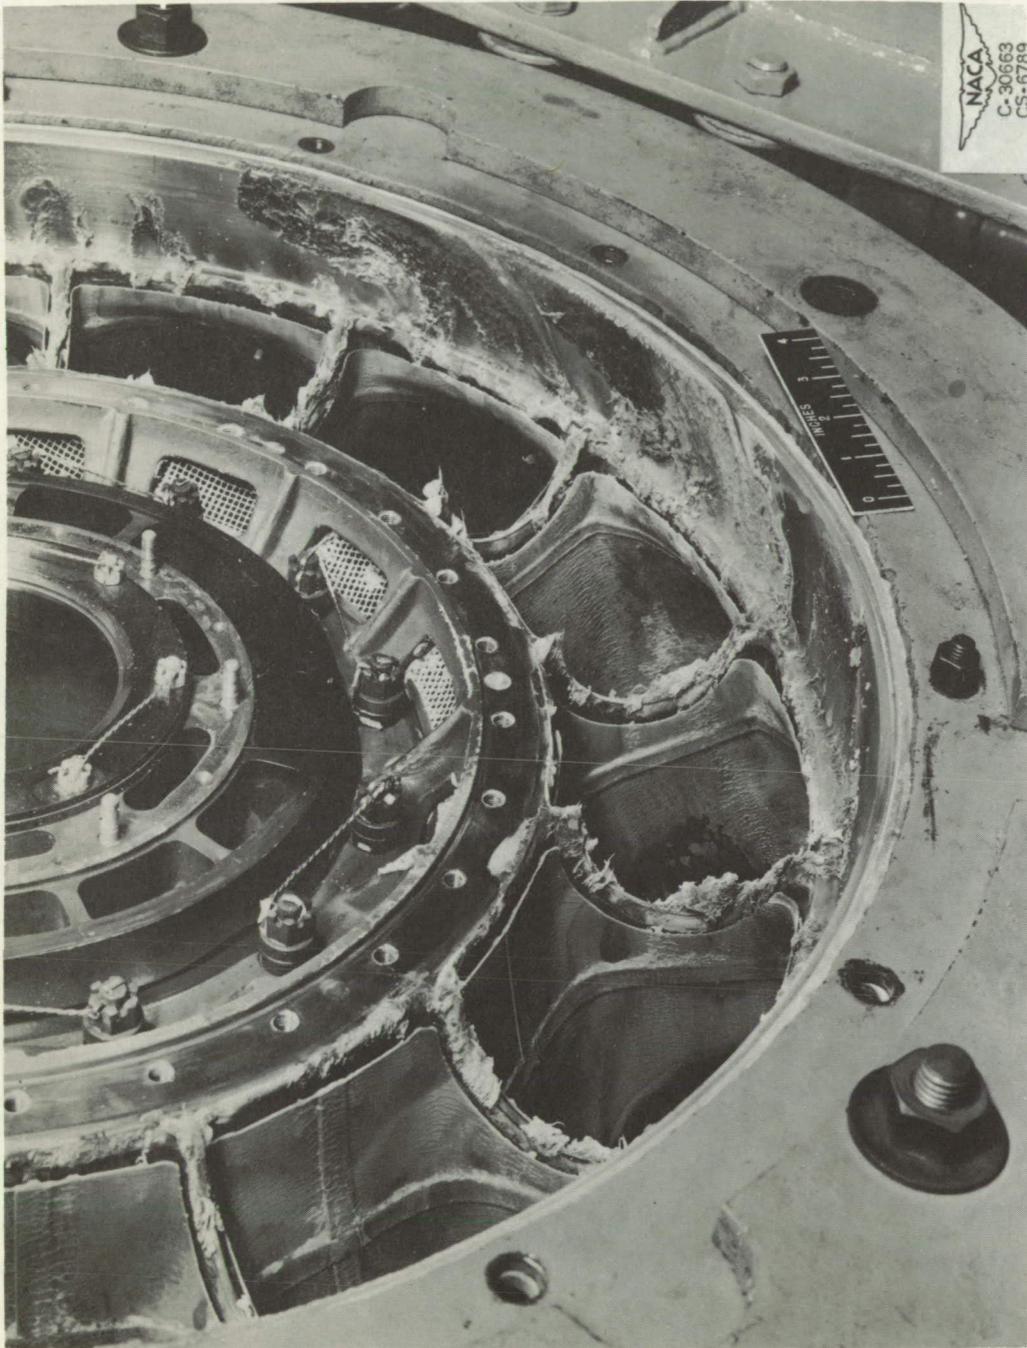
A more serious location of the deposit of a rather powdery formation of boric oxide was on the exit screens for the turbine-disk cooling air. This deposit is also shown in figure 3. There was a partial plugging of some of these screens. If these screens become plugged completely, the cooling air that is supplied to cool the rear engine bearing would be blocked off, and this would result in excessive temperatures of this bearing.

Figure 3. - Build-up of deposits at exit of burners.

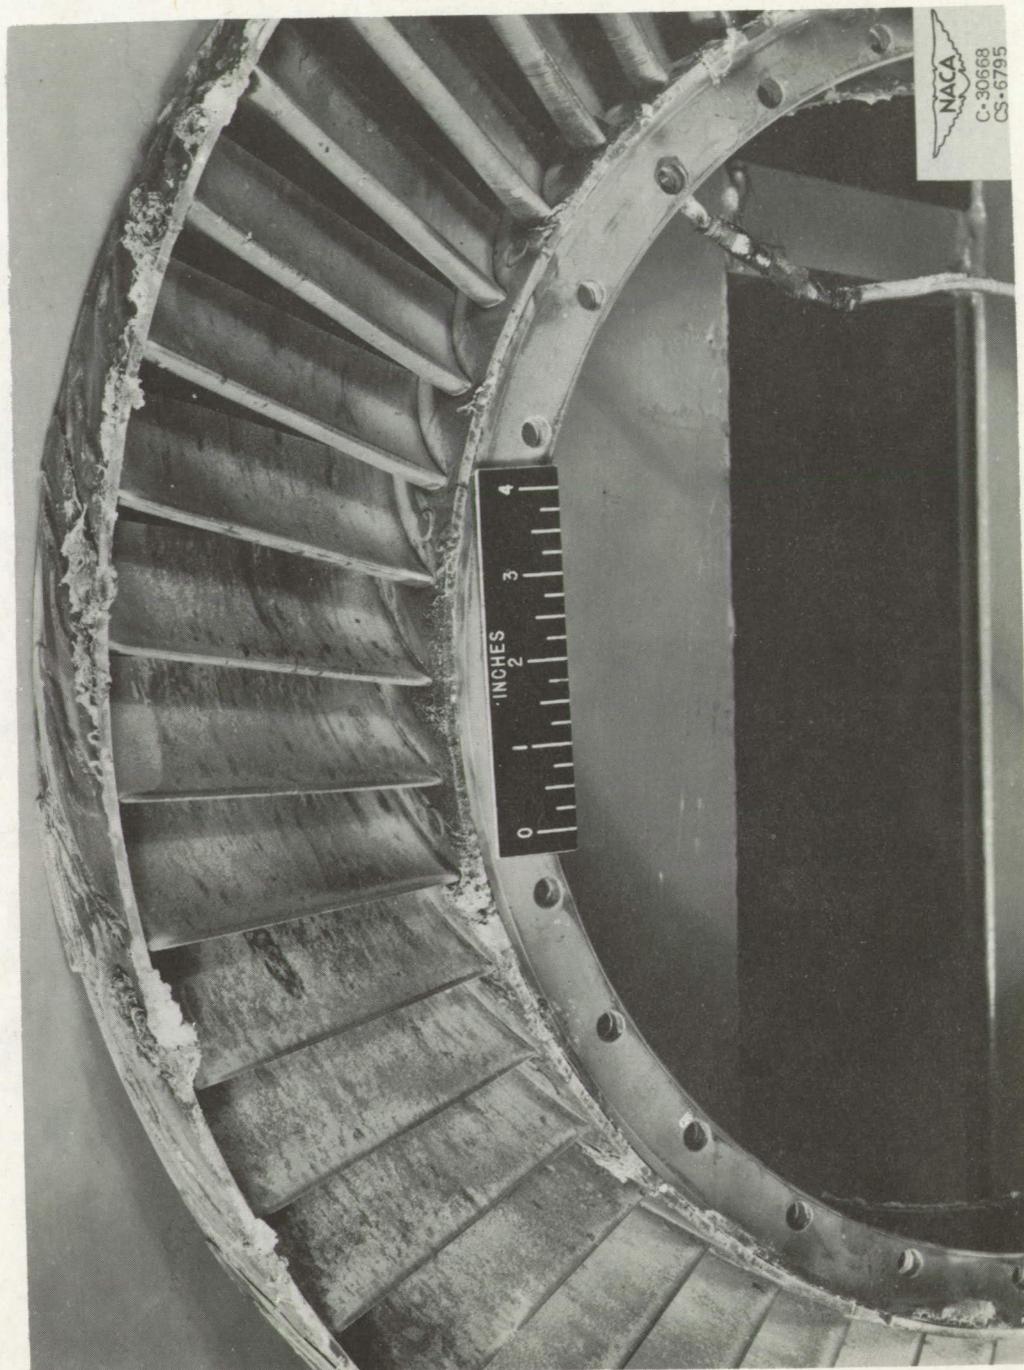
(a) Upstream side of diaphragm.

The deposit formations on the upstream and the downstream sides of the nozzle diaphragm are shown in figure 4. The deposits on this part are the molten type of deposit. The deposits on the nozzle blades were insignificant. Most of the deposit was found around the outside of the outer diaphragm ring where it would have no effect on the aerodynamic performance of the nozzles. There was also a coating of the deposit on the gas seal rings between the nozzle diaphragm and the turbine rotor.

Figure 4. - Build-up of deposits on nozzle diaphragm.

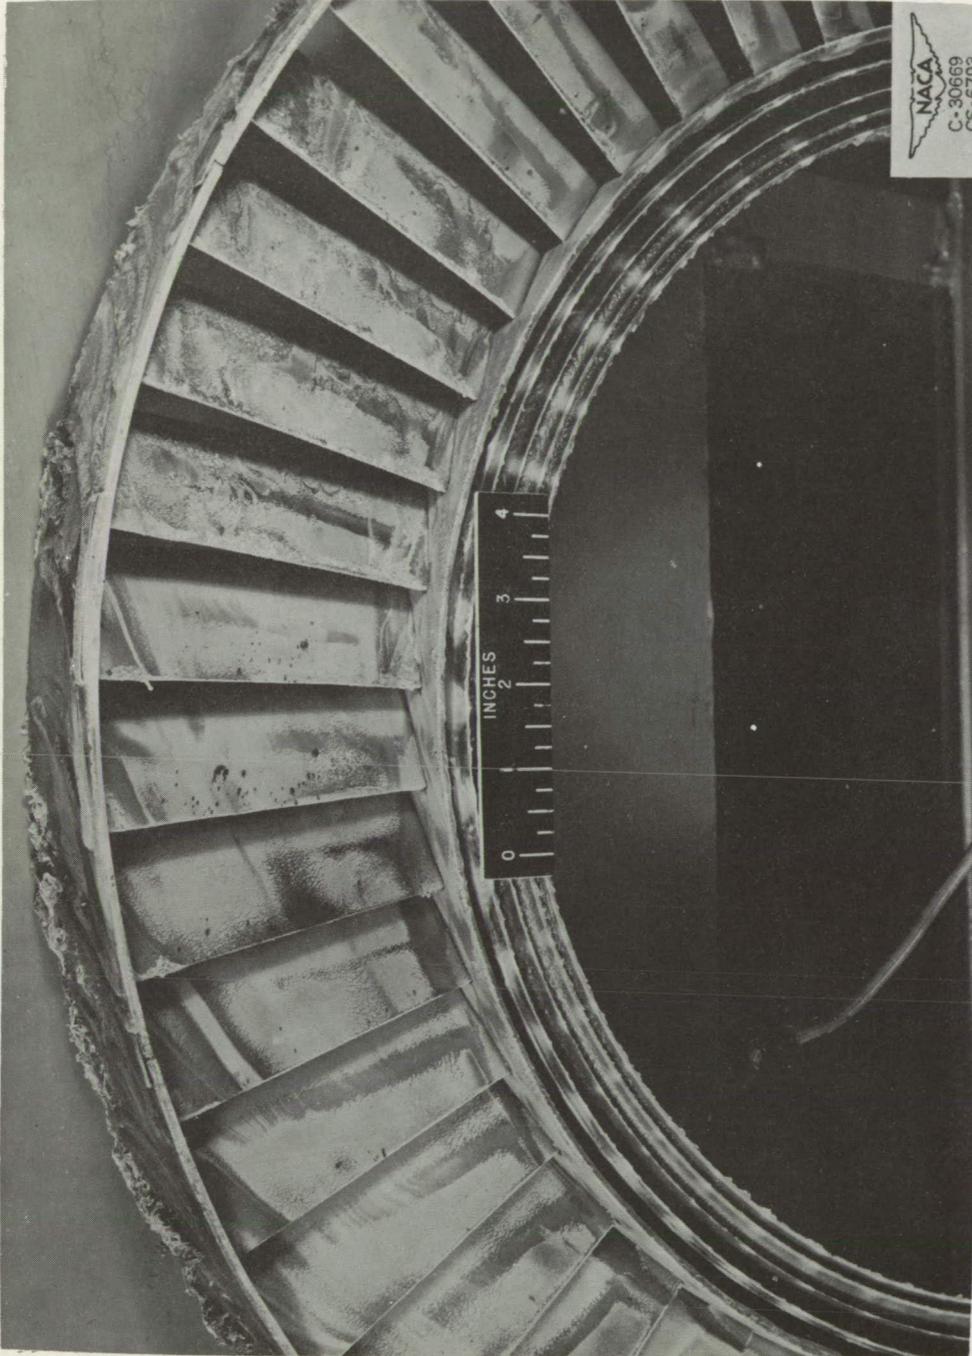
(b) Downstream side of diaphragm.

Figure 4. - Concluded. Build-up of deposits on nozzle diaphragm.

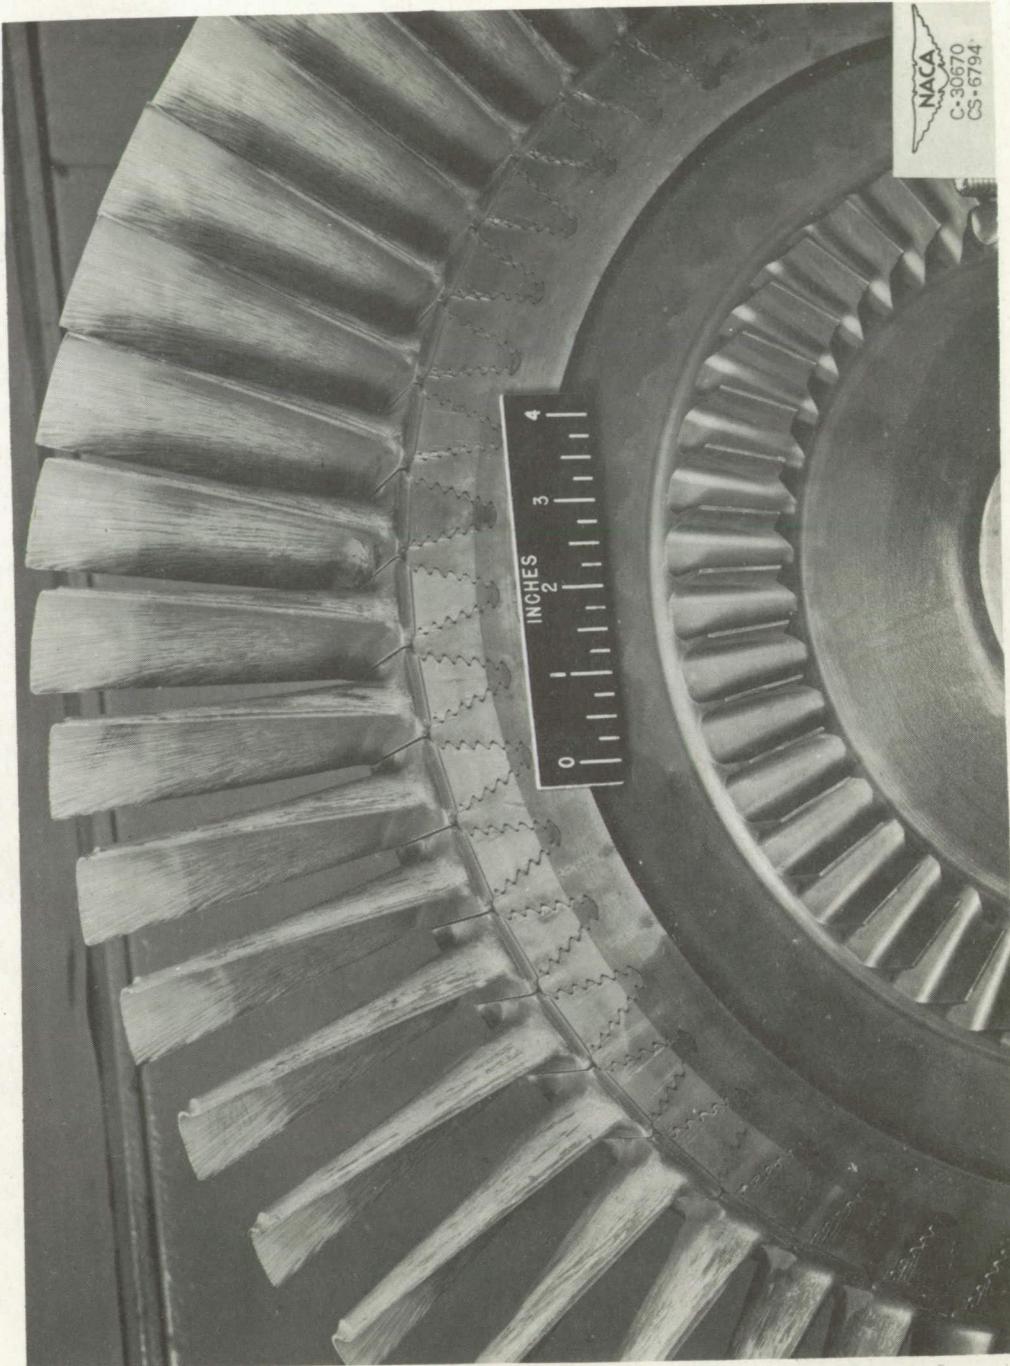
(a) Upstream side of rotor.

Photographs of the upstream and the downstream side of the turbine rotor are shown in figure 5. The deposits on this part were very thin.

The boric oxide that formed on the blades evidently was thrown off the blade tips. This flow of the deposits along the blade span is borne out by the nearly radial flow lines that can be seen on the blades in figure 5(a). The pressure surface of the rotor blades was covered with the deposits more completely than the suction surface. Only the tip half of the suction surface (fig. 5(b)) showed evidence of any coating. The turbine rotor disk had no coating of boric oxide on the upstream side but the downstream side showed a very thin, uniform coating.

Figure 5. - Build-up of deposits on turbine rotor.

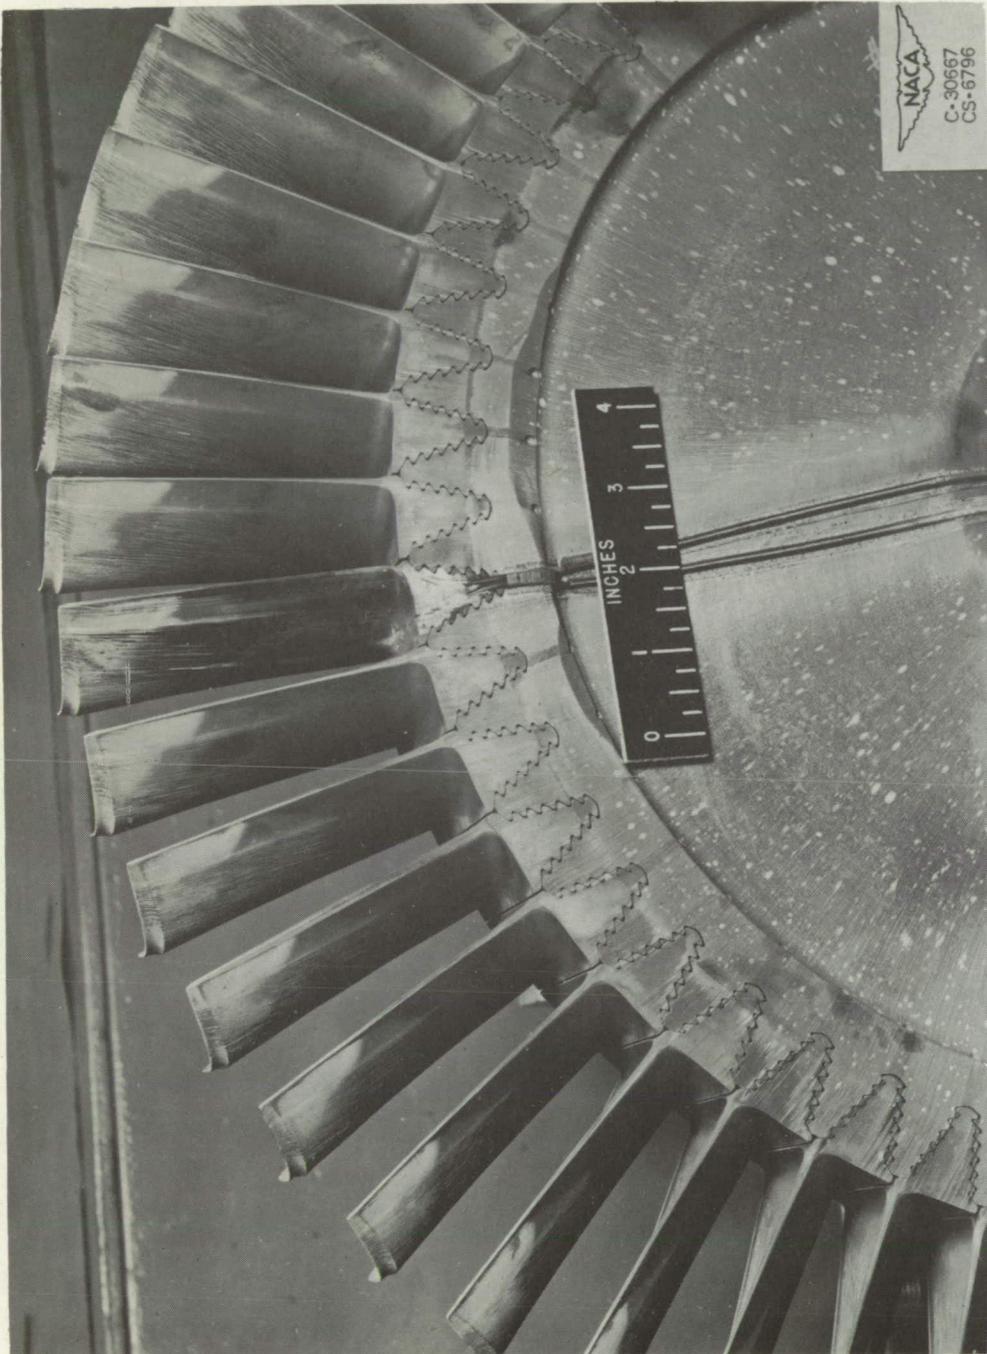
(b) Downstream side of rotor.

Figure 5. - Concluded. Build-up of deposits on turbine rotor.

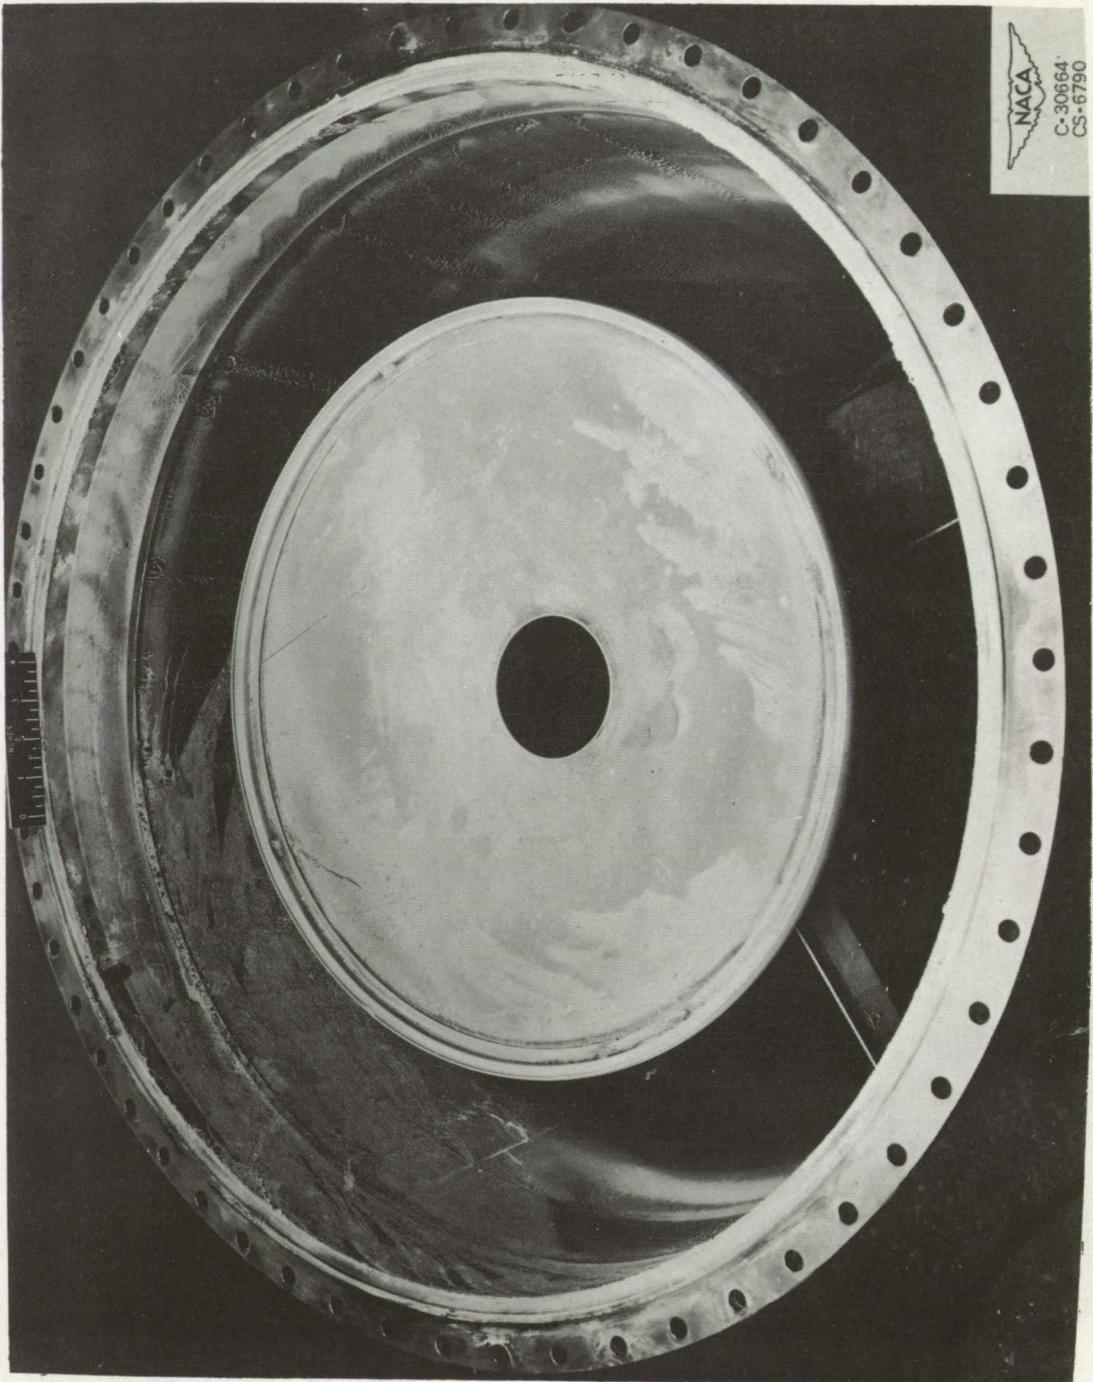
The tail cone (fig. 6) had a thin coating of boric oxide that had been thrown from the tips of the turbine rotor blades and flowed along the inside surface of the outer exhaust cone. Besides these streams of boric oxide there was a uniform thin coating over the entire inner surface of the tail cone.

Figure 6. - Build-up of deposits in exhaust tail cone.

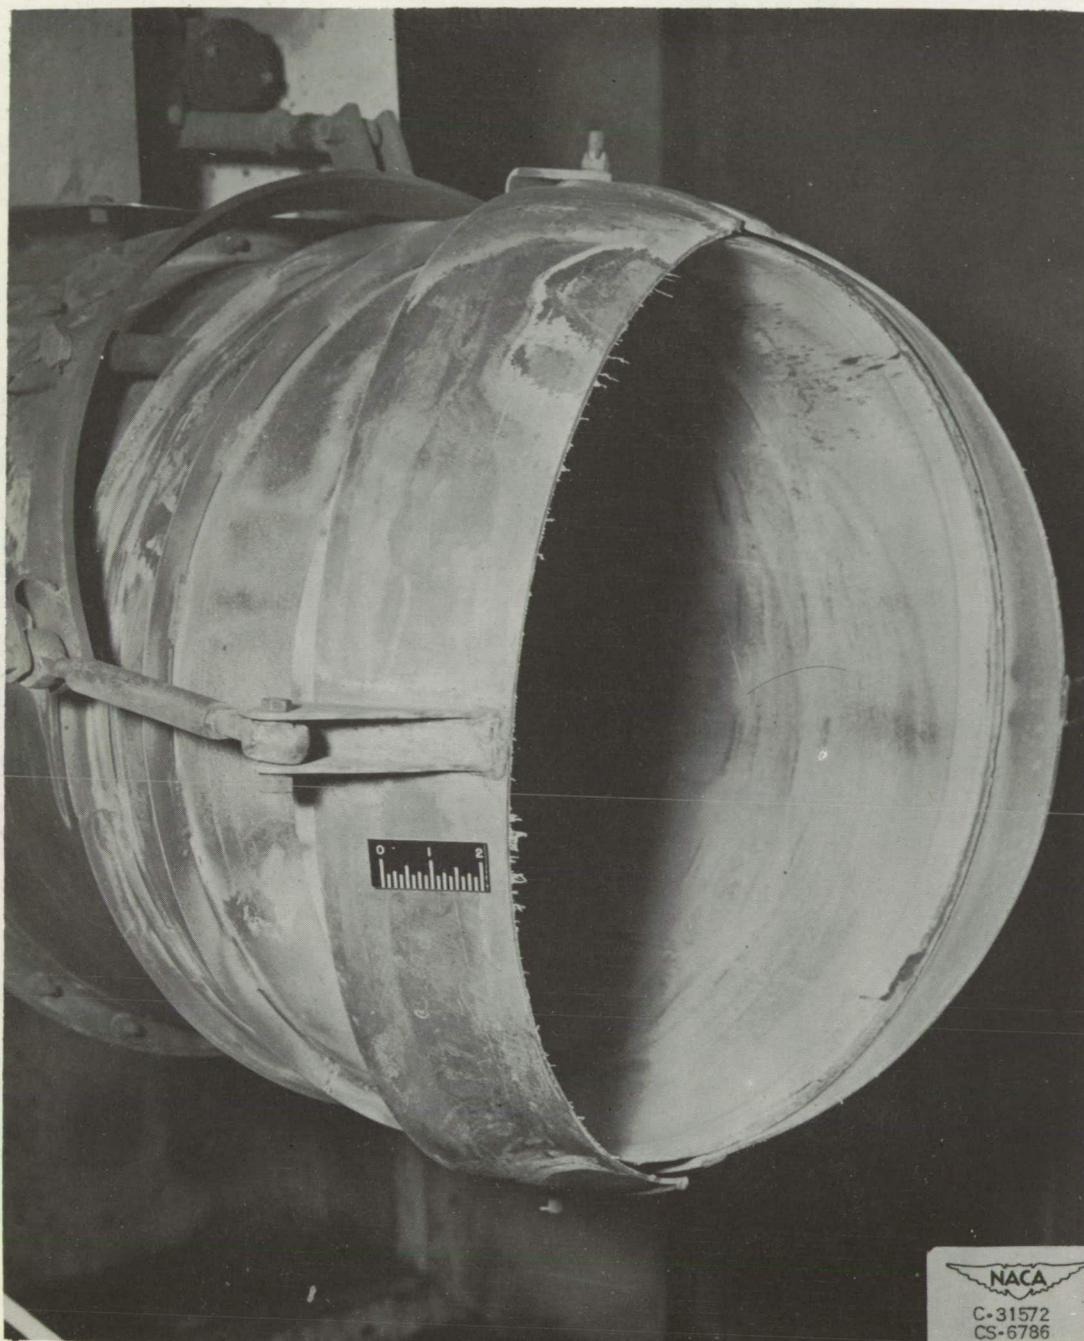
There was a thin coating over the inside surface of the tail pipe and a light fringe of the deposit at the exit of the tail pipe nozzle as shown in figure 7. The exhaust-gas thermocouples that were located in the tail pipe had a thick coating on their downstream side, but the coating did not affect the temperature measurements that were made with them.

Figure 7. - Build-up of deposits on exhaust tail pipe nozzle.
