RESEARCH MEMORANDUM

ADHESIVE AND PROTECTIVE CHARACTERISTICS OF CERAMIC
COATING A-417 AND ITS EFFECT ON ENGINE LIFE OF FORGED
REFRACTALOY-26 (AMS 5760) AND CAST STELLITE 21

(AMS 5385) TURBINE BLADES

NATIONAL ADVISORY COMMITTEE
FOR AERONAUTICS
WASHINGTON

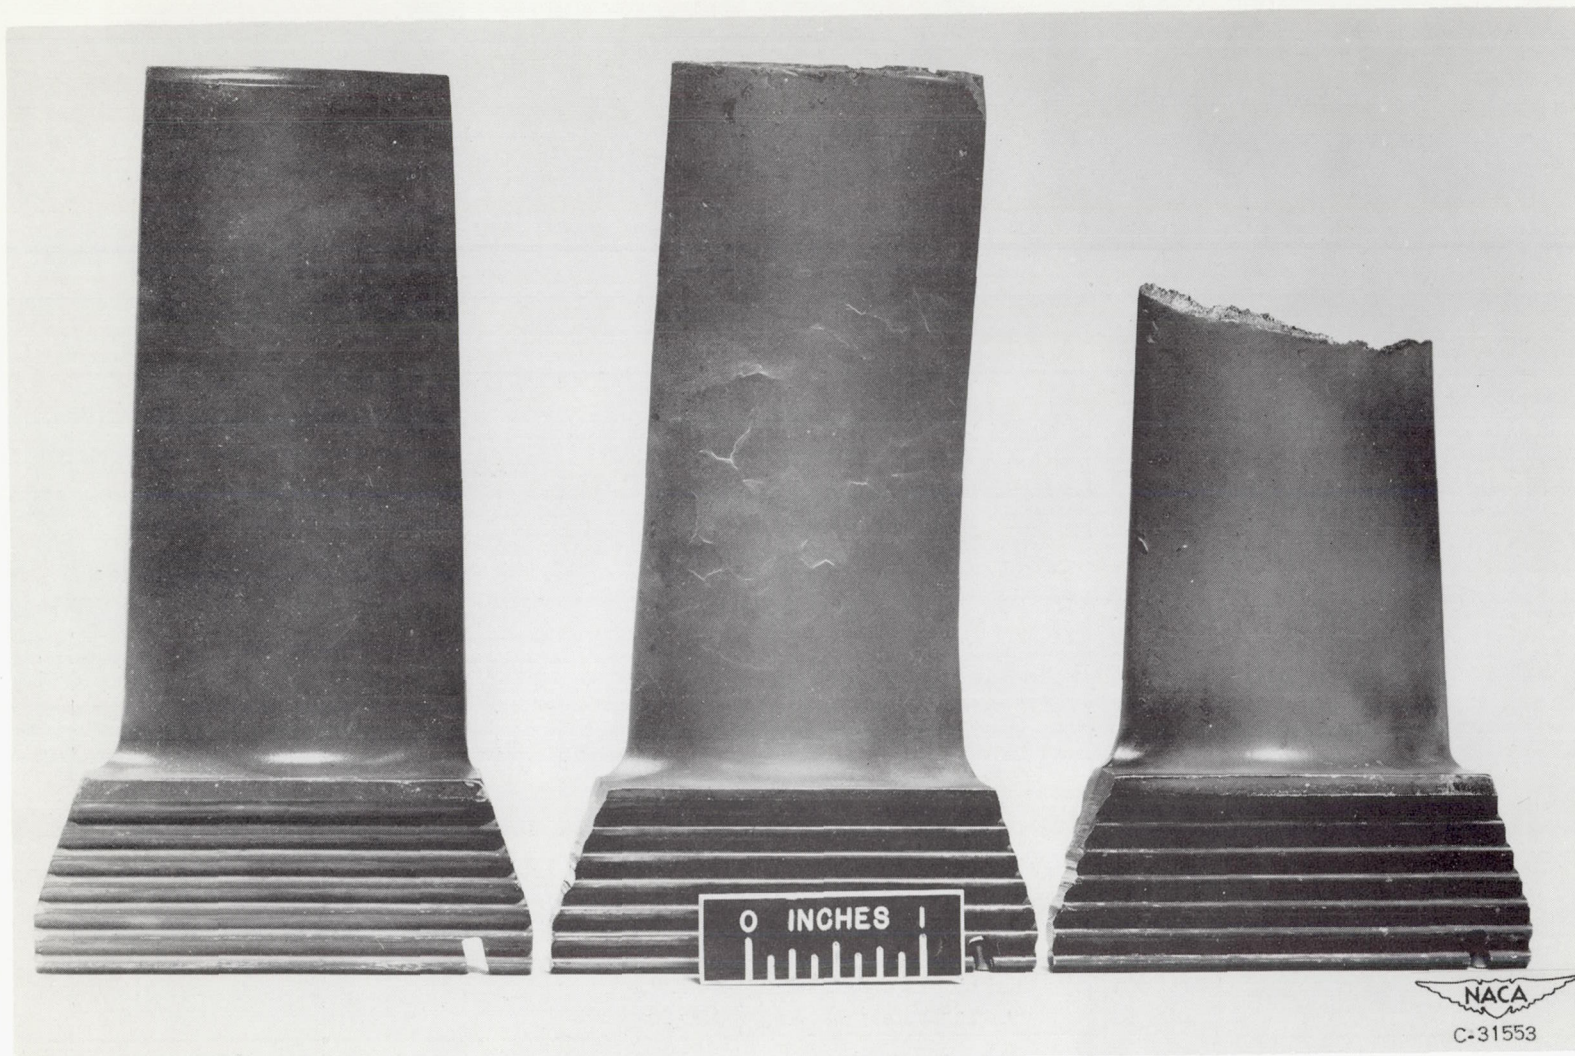
Figure 1. - Comparison of ceramic coated blades.

Appearance of blades. - Appearances of typical coated blades before and after operation are shown in figure 1. The blade in figure 1(a) is representative of as-coated blades. The coating is continuous over the airfoil surface and has a characteristic chromic oxide green color with a vitreous sheen. During operation, the sheen is removed and the color is lightened by the action of the hot gases. The blade of figure 1(b), Stellite 21, and the blade of figure 1(c), Refractaloy 26, are typical blade failures. Stress-rupture cracking of the Stellite 21 blades was not localized to the critical stress and temperature zone (2 in. above the root flat form) but became general over a wide area, giving an "orange peel" effect. Numerous grain boundaries were opened with a consequent shifting of some grains. This mass movement of metal broke the continuity of the coating, as would be expected, but the ceramic-to-metal bond remained intact. The Refractaloy 26 blade failed completely by stress rupture. The spalling of the ceramic coat noted in the center and right-hand blades was caused by fragments of prior failures impinging

on these blades. Macroscopic examination of the coated blades showed that the damage to the ceramic coating by impinging fragments was slight.

(a) As coated; unoperated.

(b) Coated Stellite 21; failed by
cracking after 99.7 hours.

(c) Coated Refractaloy 26; failed by
rupturing after 99.7 hours.

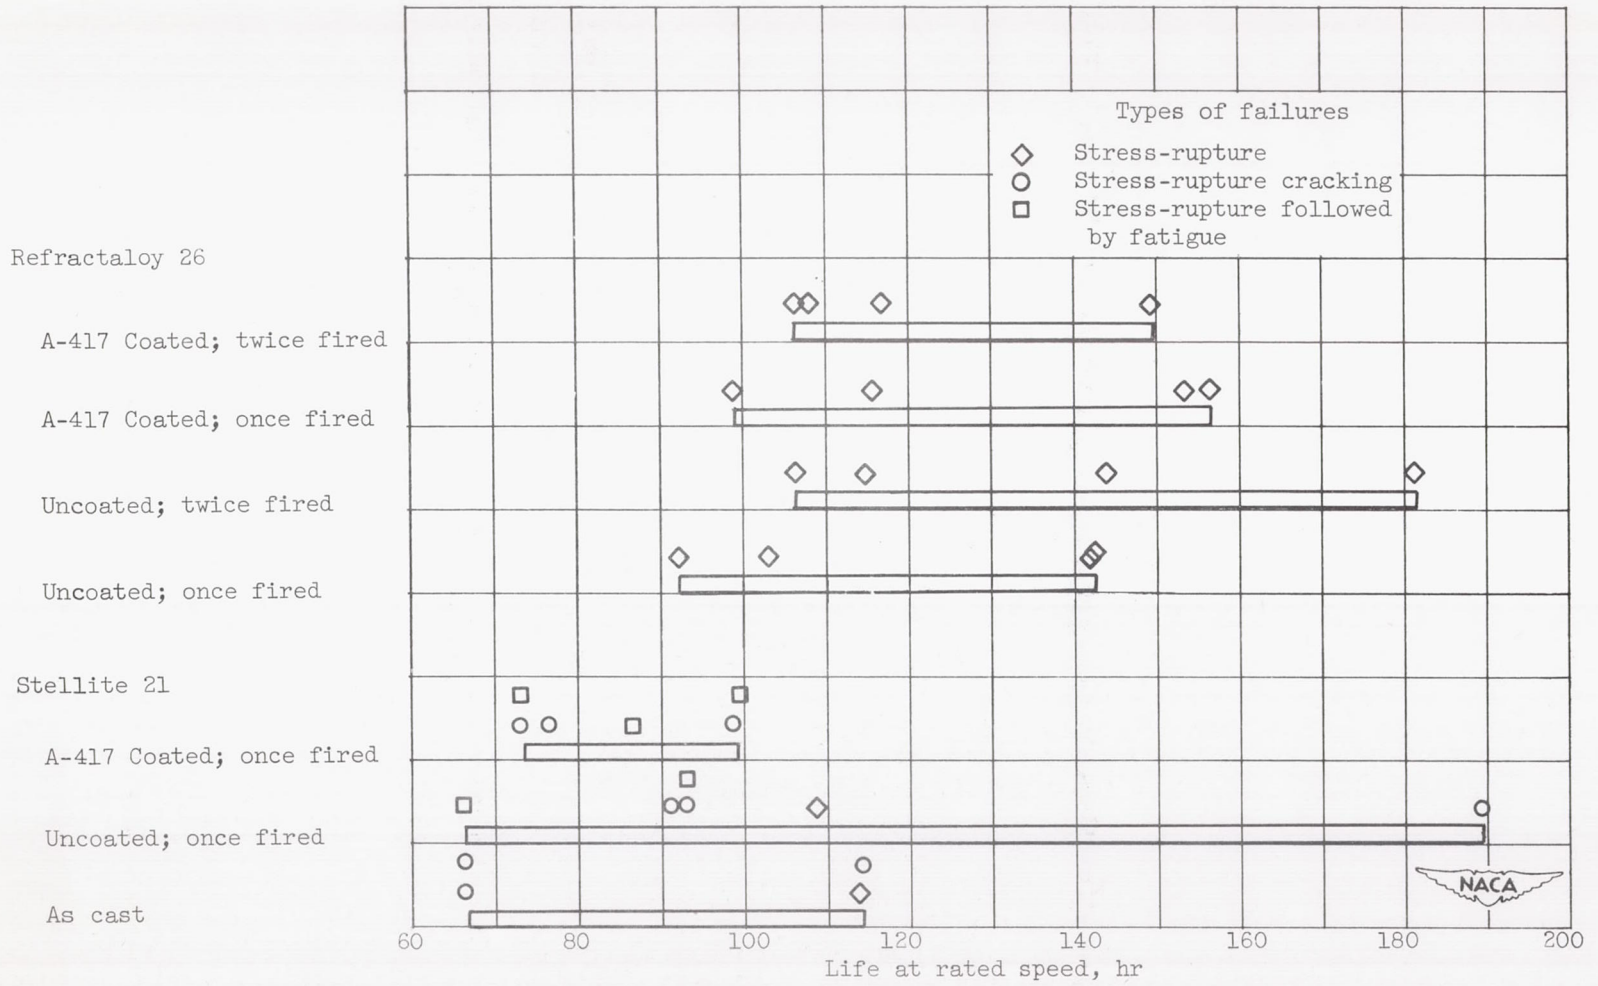
Figure 2. - Classification of A-417 coated and uncoated Refractaloy 26 and Stellite 21 blade failures.

Results of engine operation. - The results of the engine operation are plotted in figure 2, and the average life of the alloys is listed in table III. All the Refractaloy 26 blades and more than half of the Stellite 21 blades failed by stress rupture.

It is evident from these data that the ceramic coating did not noticeably improve blade performance; nor did the coated blades fail by mechanisms different from those of the uncoated blades, as the symbols of figure 2 indicate. It will subsequently be shown that the ceramic coating protected Refractaloy 26 and Stellite 21 blades from corrosion by the combustion products. In the case of Refractaloy 26, the alloy known to be susceptible to high-temperature corrosion, an improvement in performance would be expected; however, the results indicate that apparently the performance of these blades did not depend on their corrosion resistance.

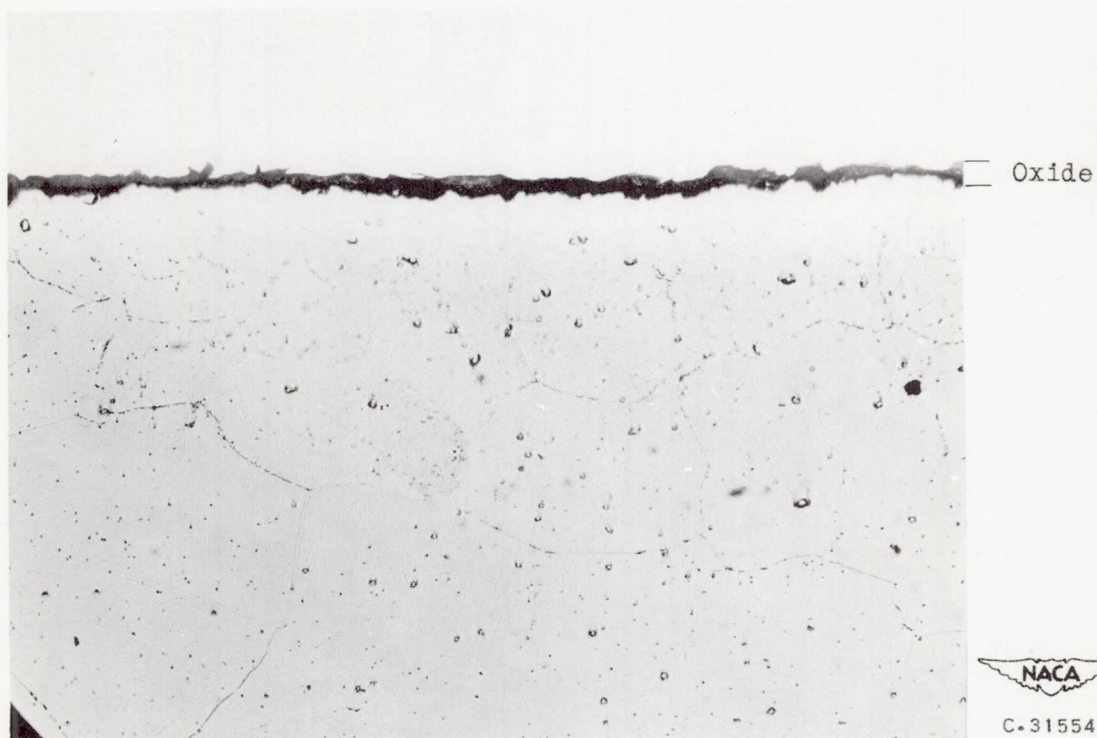
Examination of uncoated blades. - A typical oxide coating produced by solution treating and aging Refractaloy 26 is shown in the photomicrograph of figure 3. The oxide layer was approximately 0.00025 inch thick, and penetration of the grain boundaries of the recrystallized zone was observed although it is not apparent in the photomicrograph. Excessive grain-boundary corrosion of uncoated Refractaloy 26 blades operated for 106 and 143 hours is shown in figure 4. Severe corrosion of this type would be expected to lead to short operational life. However, as has been noted, failure times of coated and uncoated blades are practically the same.

Figure 3. - Oxidation of Refractaloy 26 during heat treatment. Electrolytically etched in 50-percent hydrochloric acid. X250.

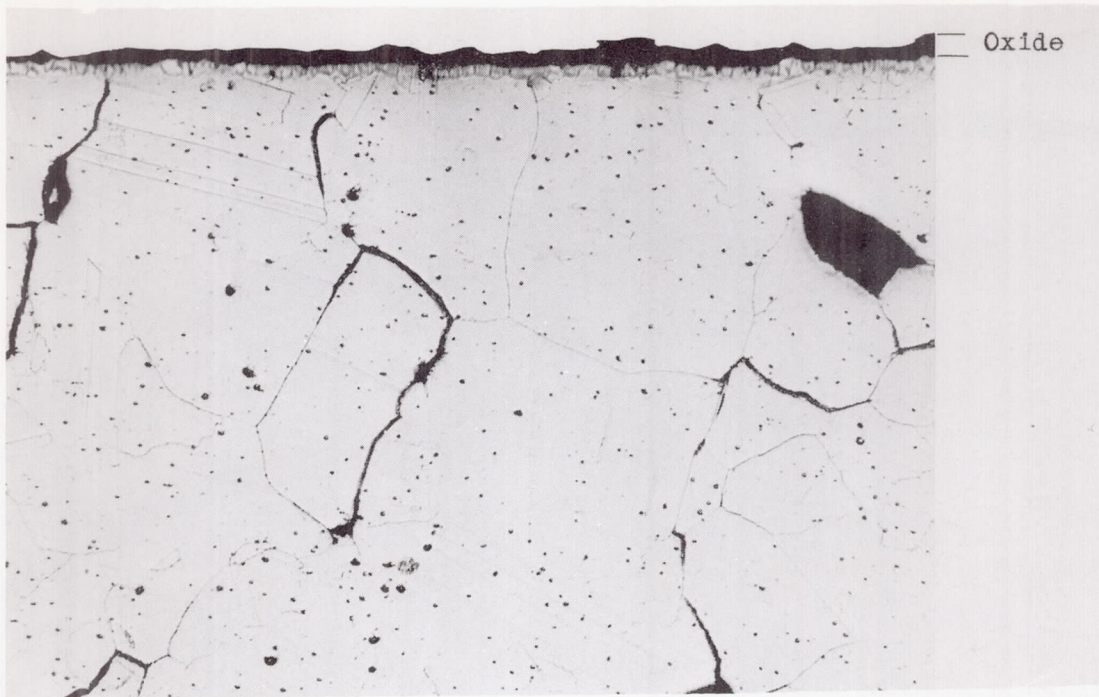
Figure 4. - Extensive grain boundary corrosion of uncoated Refractaloy 26 operated in a turbojet engine.

(a) Fired twice; operated 106.4 hours. Electrolytically etched in 50-percent hydrochloric acid. X100.

(b) Same specimen as in figure 4(a) at X250.

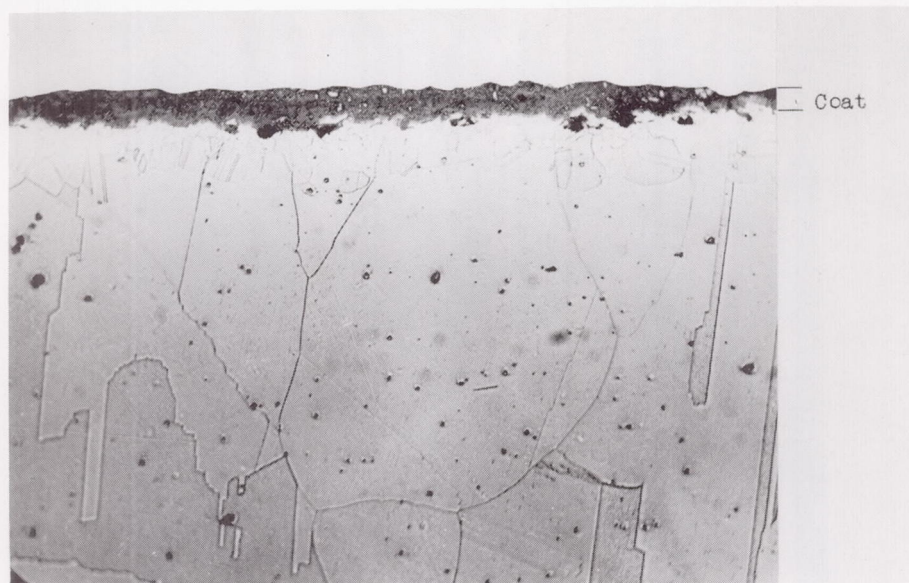
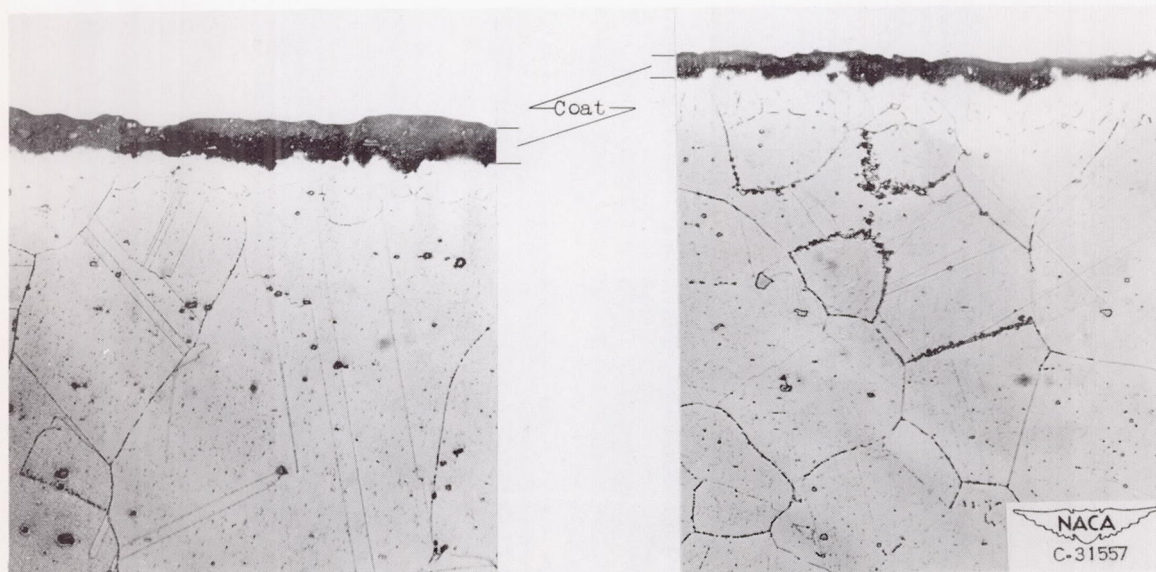
Figure 5. - Ceramic-metal interfaces of coated Refractaloy 26 before and after operation in a turbojet engine. Photographed at X250; reduced 23 percent in reproduction.

Examination of coated blades. - Metallographic examinations of specimens cut from portions of operated blades that did not elongate severely showed that the ceramic coating prevented corrosion and adhered well to the surfaces of the metal (fig. 5). Some of these sections, which were protected from corrosion, were obtained from the immediate vicinity of the fractures, in the hottest, most critically stressed zones of the blades. In other specimens, in areas near the fractures, corrosion was observed, but the fracturing of the ceramic that permitted this corrosion almost certainly occurred after the blade alloy entered third-stage creep.

(a) Fired once; unoperated. Electrolytically etched in 50-percent hydrochloric acid.

(b) Fired once; operated 99.2 hours. Electrolytically etched in 50 percent hydrochloric acid.

(c) Fired twice; operated 149.5 hours. Extensive precipitation in grain boundaries. Electrolytically etched in 50-percent hydrochloric acid.

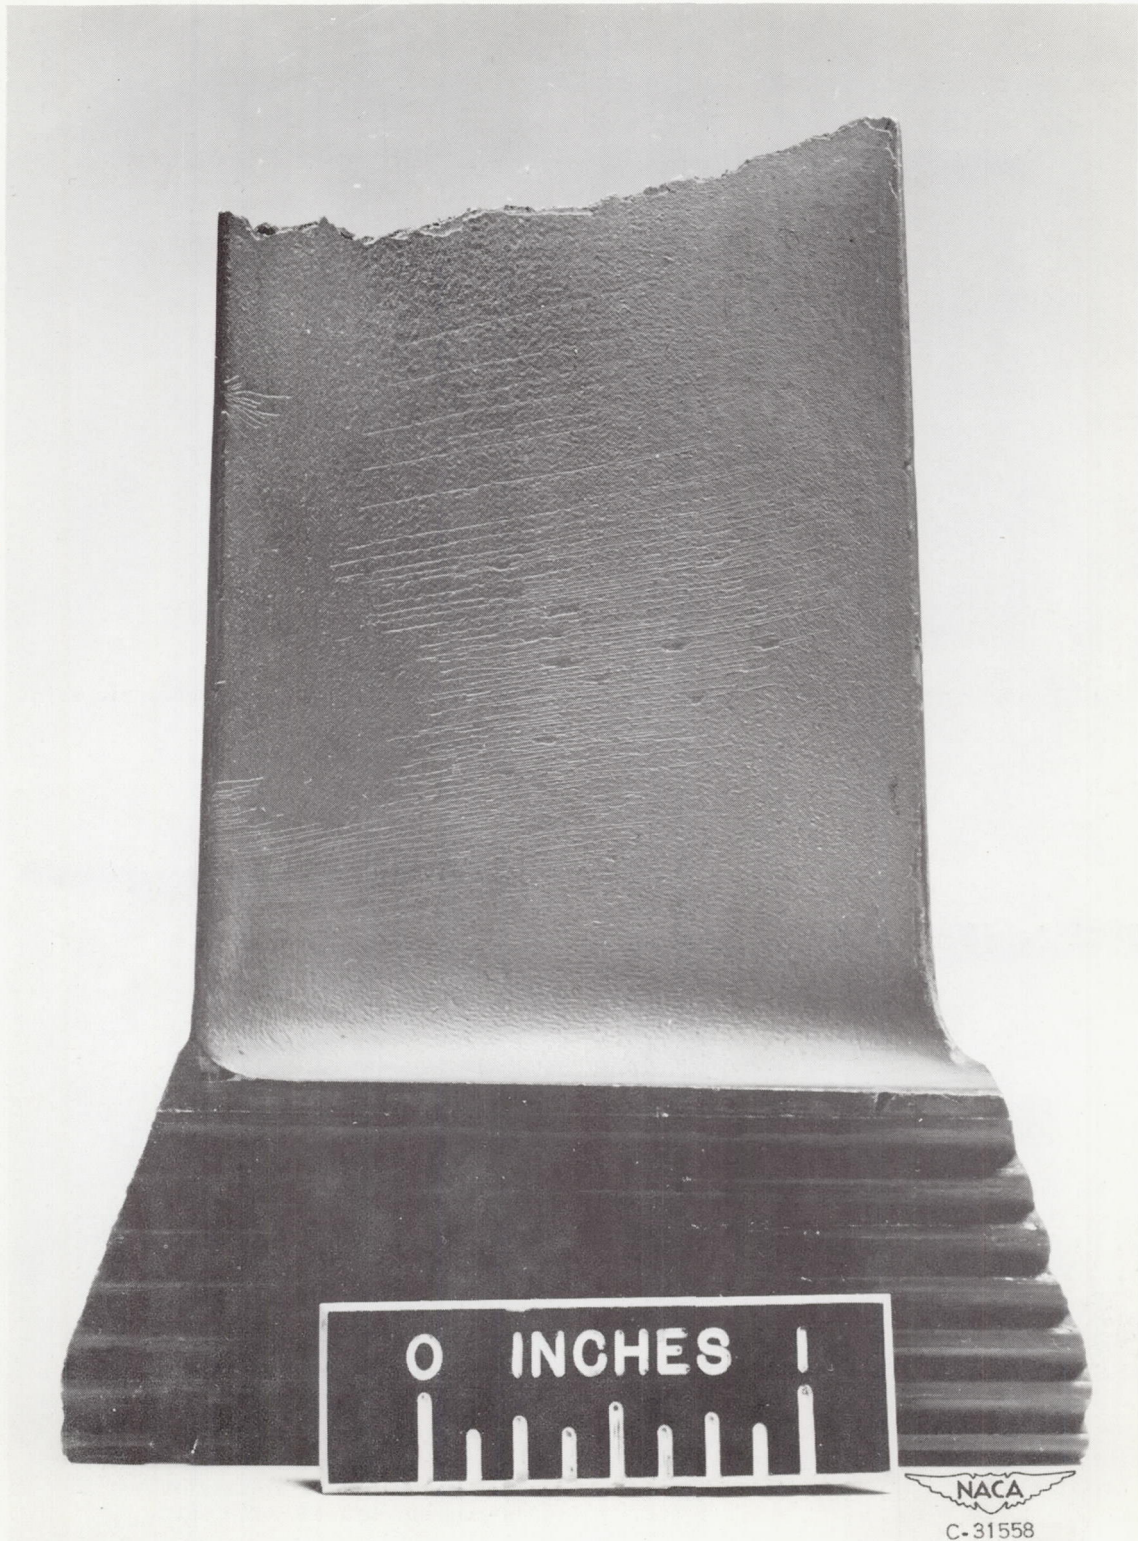
Three of the four blades which had a coat thickness of 1.0 to 2.0 mils developed striations on the concave face during operation (see fig. 6). The striae probably formed in these thick coatings during cooling at shut downs of the engine, which produced an elastic recovery of the base metal.

The ceramic is believed to have flowed plastically as the metal elongated both plastically and elastically during heating. On cooling, the metal recovers by a greater amount than the ceramic. To relieve the compressive stresses, ridges are built up on the outer surface by plastic movement of the coating. This analysis is substantiated by an examination of a cross section of the striae. Photomicrographs of this section (fig. 7) show a ridge and valley on the coat surface, but no visible change occurs to the ceramic-metal interface.

Figure 6. - Striations present in thick coating (1.0 to 2.0 mil) on Refractaloy 26 after 153.6 hours of engine operation.

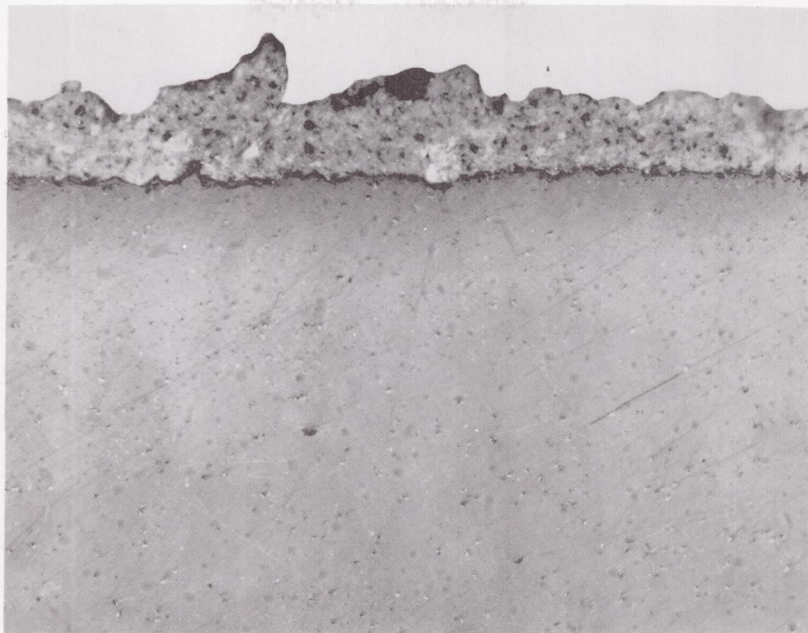
Figure 7. - Ridges produced in thick ceramic coating on Refractaloy 26 during engine operation.

(a) Unetched. X100. Polarized light.

(b) Same specimens above electrolytically etched in 50-percent hydrochloric acid. X250.
Recrystallization zone produced during heat treatments.

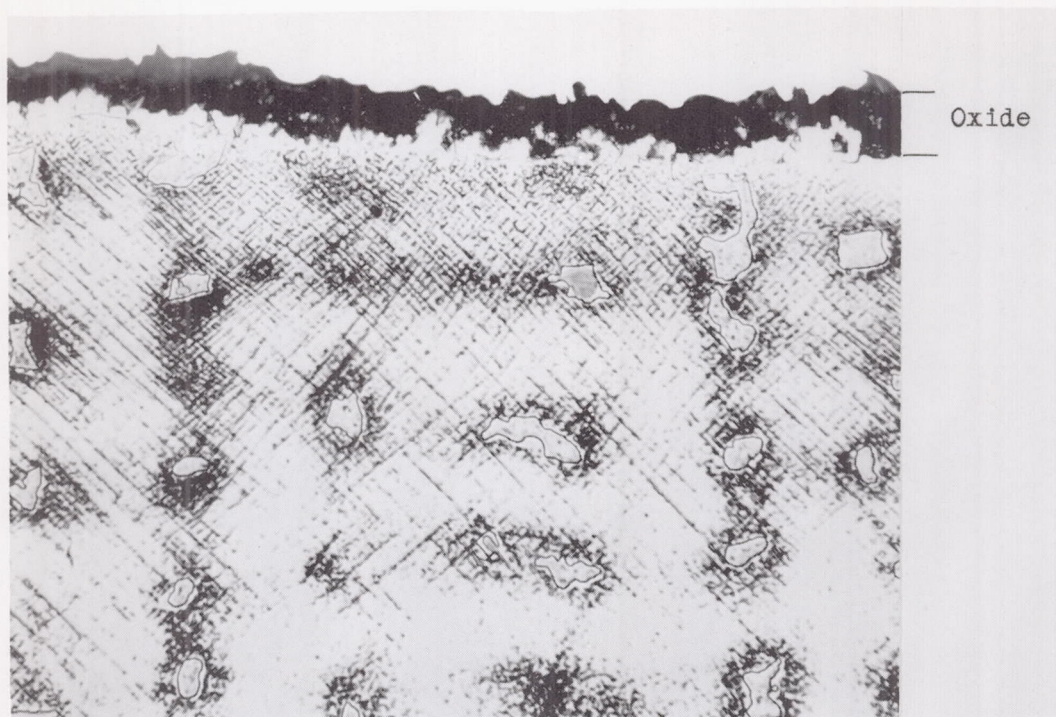
Examination of uncoated and as-cast Stellite 21 blades. - A thin oxide layer (approximately 0.0003 in.) was produced on all unprotected Stellite 21 blades by the hot gases (fig. 9(a)) and slight oxide penetration of the grain boundaries occurred (although infrequently) during engine operation.

(a) Uncoated; fired once; operated 66.5 hours. Electrolytically etched in 5-percent aqua regia. X750.

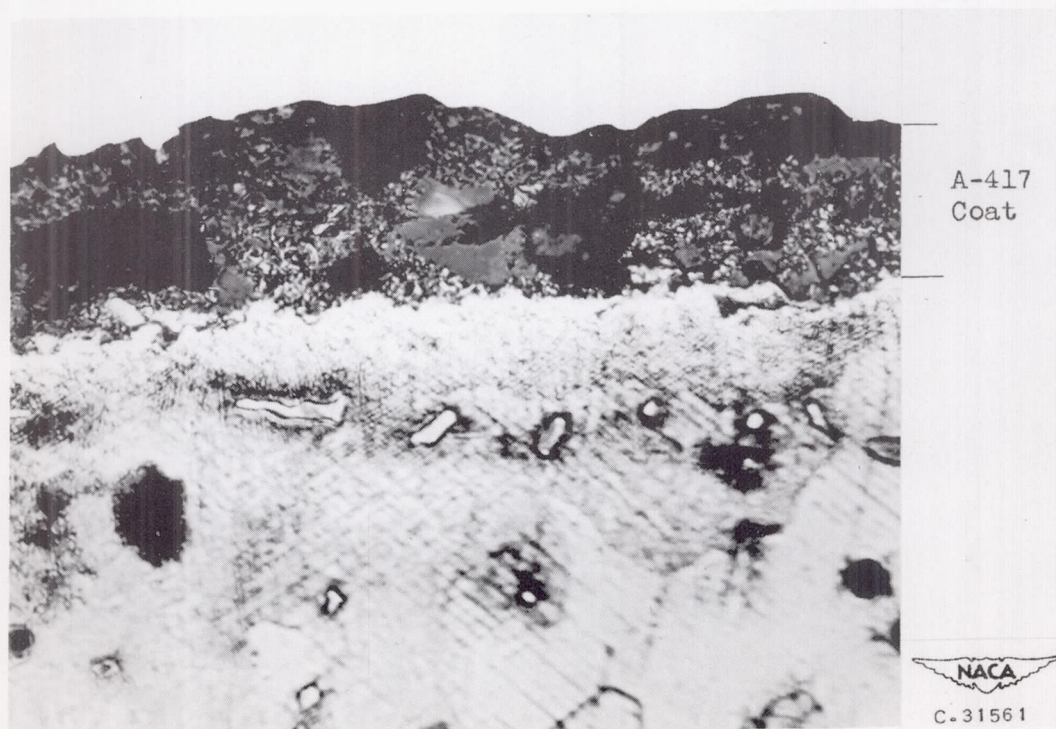
Examination of coated Stellite 21 blades. - Metallographic examinations of operated blades showed that the adherence of the A-417 coating to Stellite 21 was excellent. No oxide penetration of the coating was detected on any of the coated blades. A typical coating-to-metal interface is shown in figure 9(b).

(b) Coated; fired once; operated 73.6 hours. Electrolytically etched in 5-percent aqua regia. X750.
