RESEARCH MEMORANDUM

PRELIMINARY INVESTIGATION OF SEVERAL ROOT DESIGNS FOR
CERMET TURBINE BLADES IN TURBOJET ENGINE

II - ROOT DESIGN ALTERATIONS

NATIONAL ADVISORY COMMITTEE
FOR AERONAUTICS

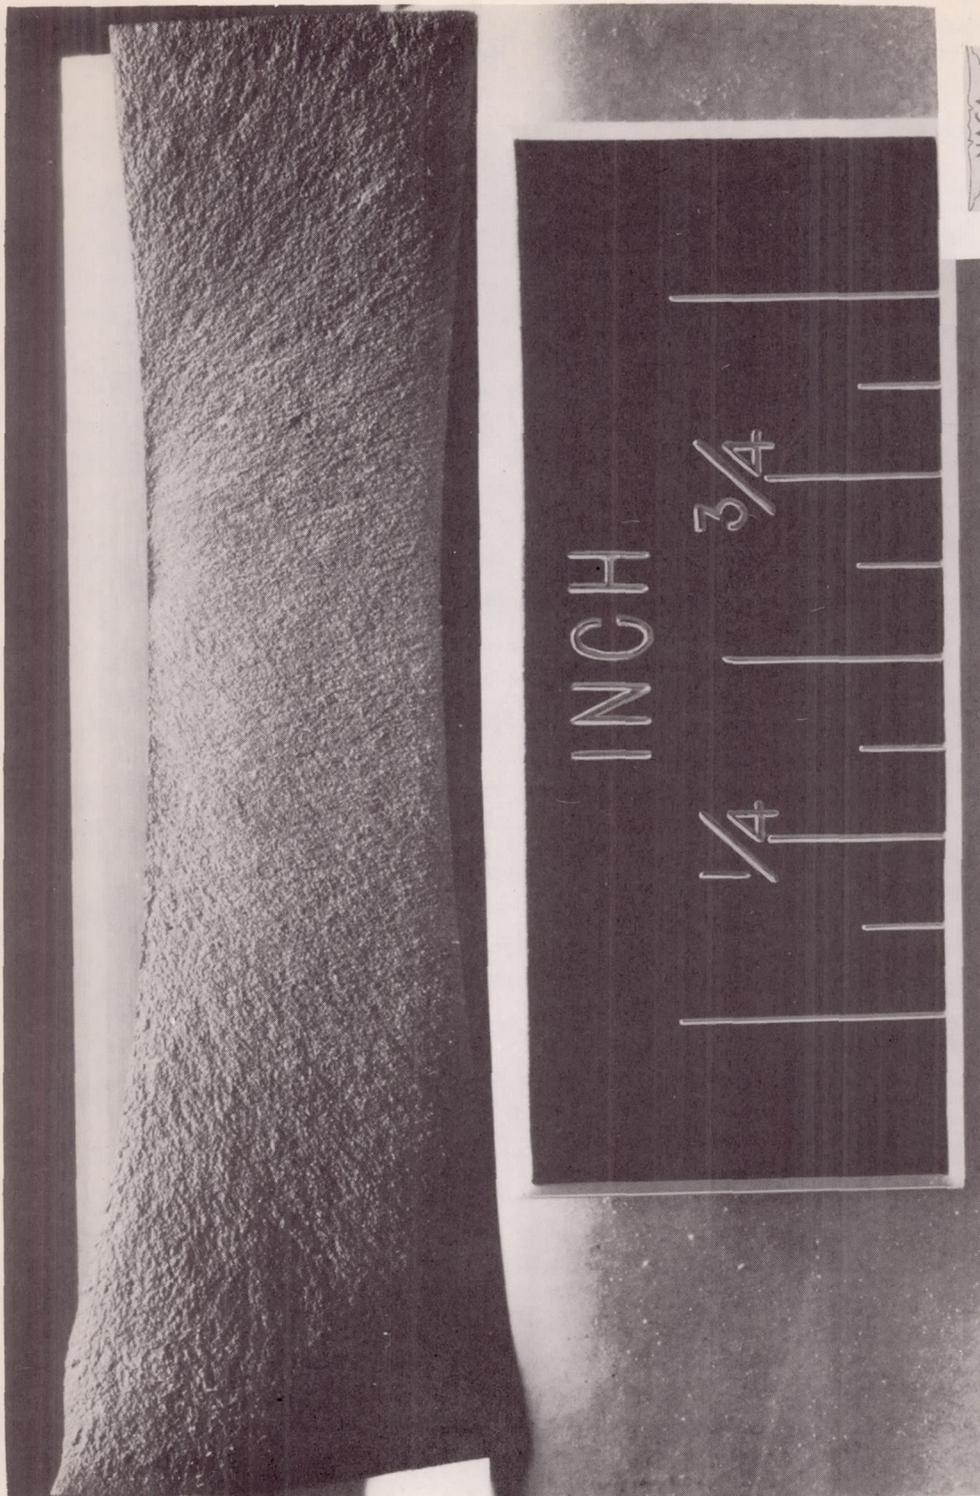
One root, however, failed after only 6 minutes at rated speed (11,750 rpm) and the fractured surface is shown in figure 1. Figure 2 shows the location of the failed blade with respect to the other cermet and the metal blades.

Figure 1. - Fracture surface of root failure in run 11.

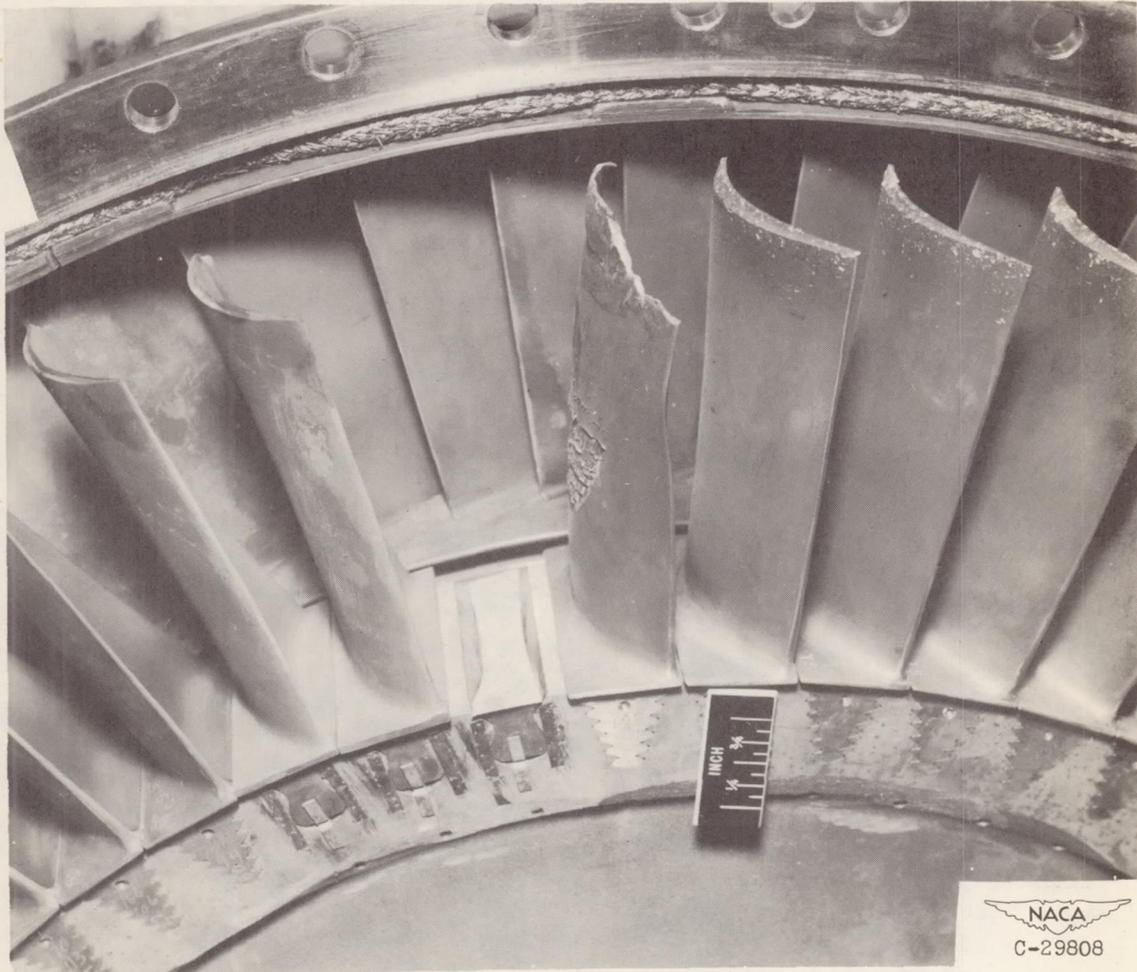
At this point in the program it became apparent that in all the runs using six cermet blades and involving root failures (runs 8 to 12) the failure was always adjacent to a metal blade (figs. 2 and 4). The center cermet blade in a group of three failed only in run 10 and, in this case, all three cermet blades on one side of the turbine wheel failed in the root making it impossible to determine where the failure originated. Looking from the rear of the turbine, the root failures occurred mostly in the blade which was farthest in the clockwise direction (opposite to the direction of rotation); the only exception was run 8 with the pin-type root design where the blade farthest in the counterclockwise direction failed first. The metal blades were 50 percent heavier than the cermet blades because of the differences in material densities. This factor undoubtedly imposed an unsymmetrical loading condition on the turbine wheel segment between the metal and the cermet blade and is considered to have had an effect on which blade failed first. Why the clockwise-most blade generally failed was not known.

Figure 2. - Root failure in run 11.

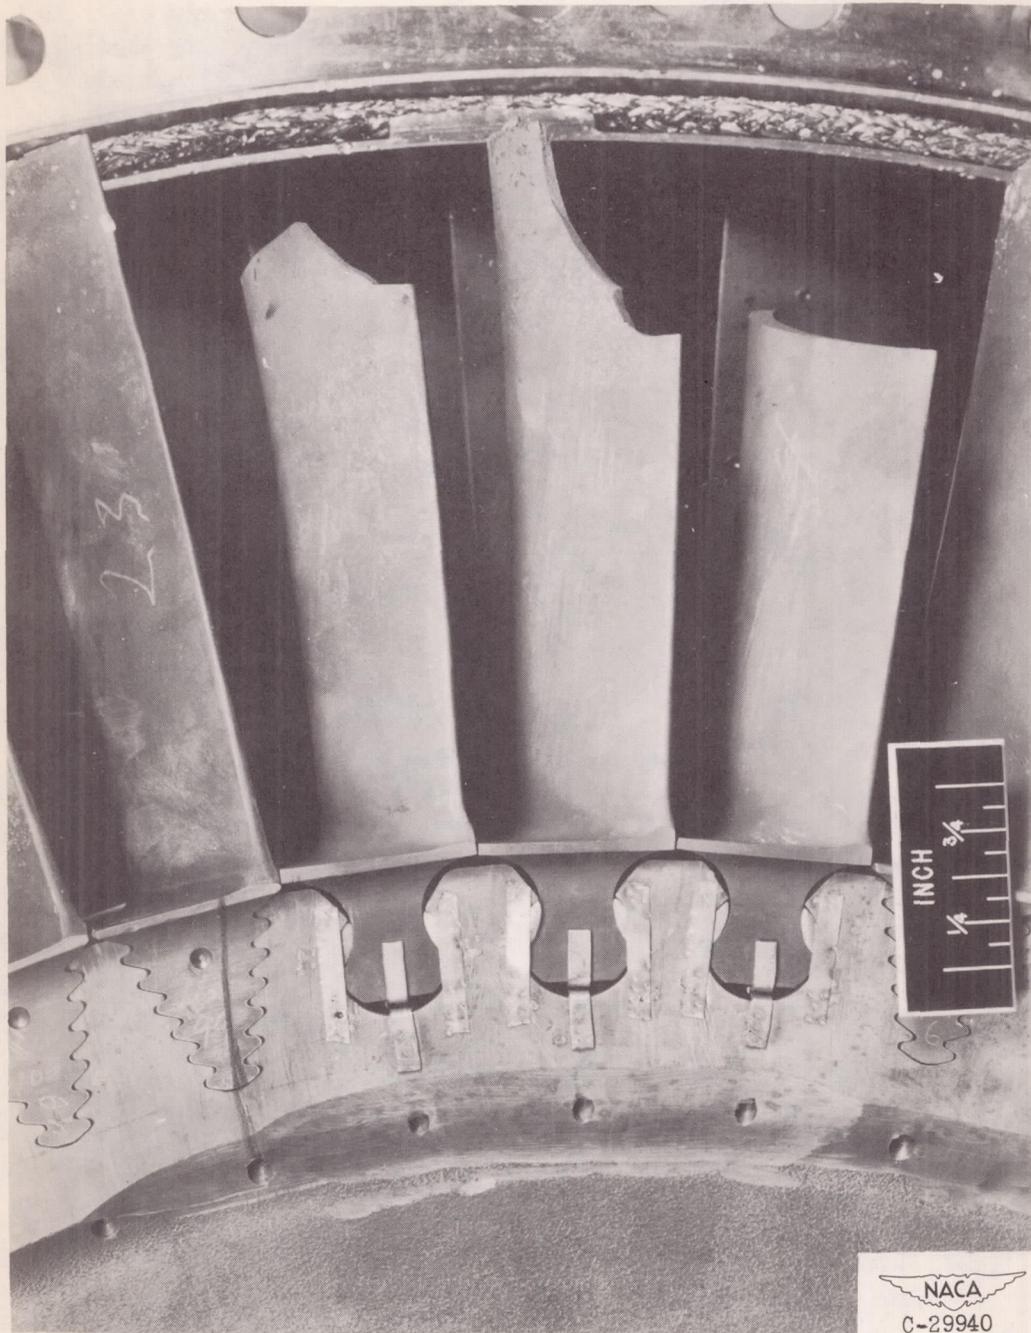
Run 11A. - Because the apparent damage to the other cermet blades in run 11 was very slight, and after penetrant-oil inspection indicated that these blades were still sound, the failed blade was replaced and the wheel was rebalanced. This assembly did not attain rated speed but failure occurred in the airfoil during acceleration at 50 rpm below rated speed. Possibly the failure resulted from a defect in the previously used blades which was not detected during inspection. The broken cermet airfoils are shown in figure 3.

Figure 3. - Airfoil failures in run 11A.

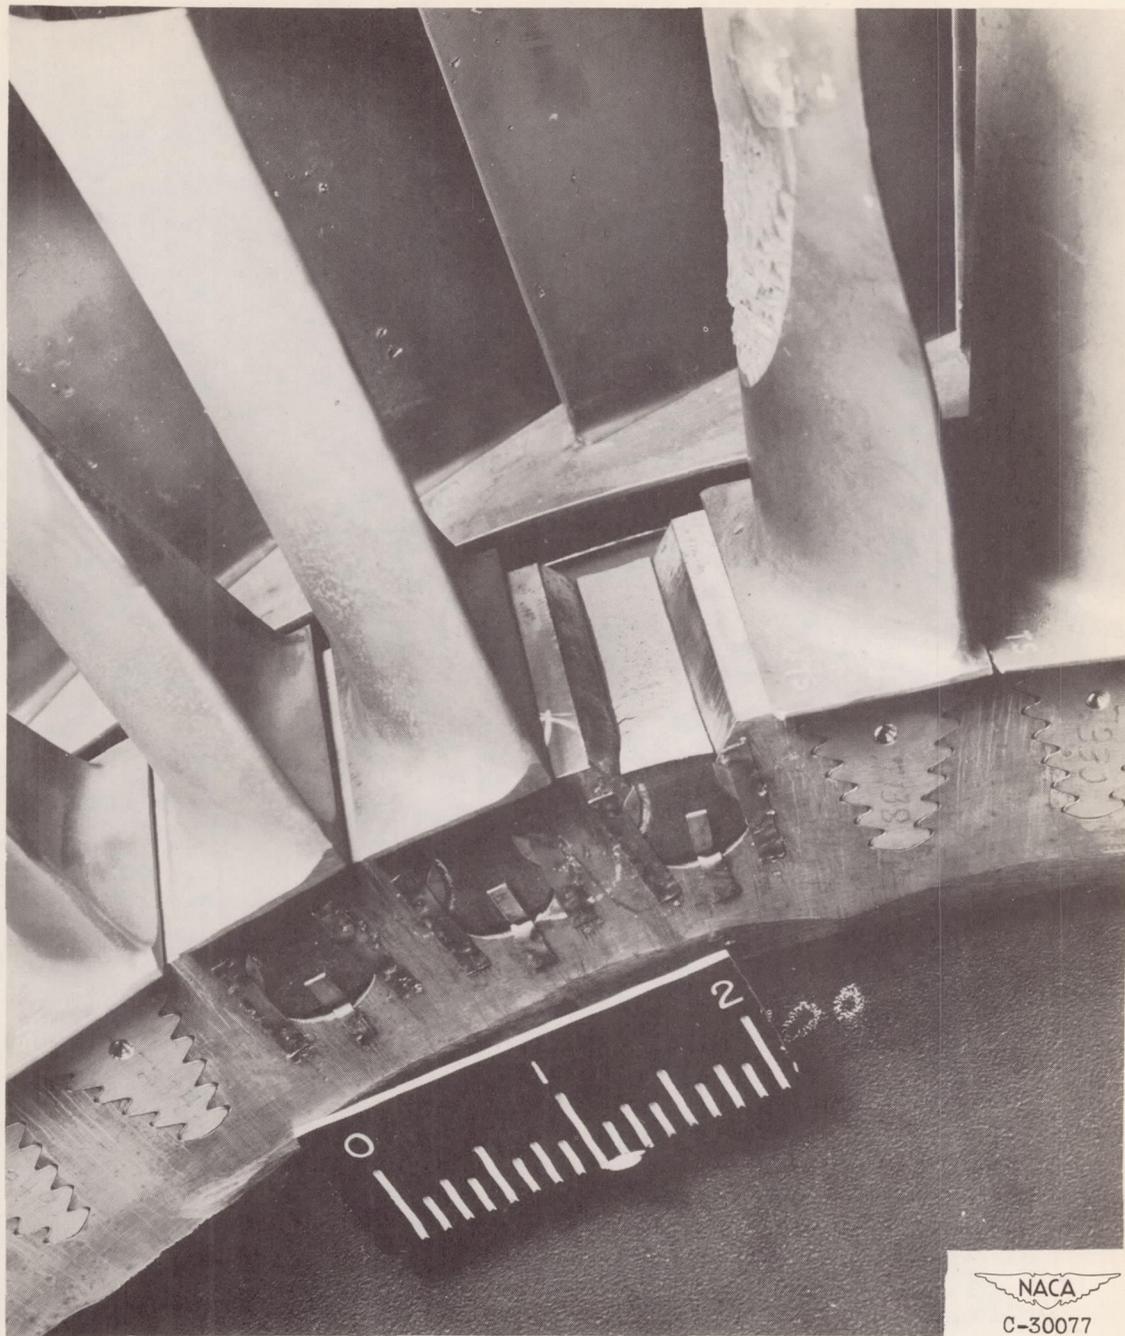
Run 12. - Run 12 was also conducted with six cermet interlock blades; however, the metal content in the root was increased from 30 percent to 50 percent by weight. The objective of the change was to increase the ductility and thus reduce the notch sensitivity and thereby provide increased life in the engine. The change however did not prove beneficial because a root failure occurred after 7 minutes at rated speed. The failure is shown in figure 4. Again the damage to the other cermet blades was very slight and therefore only two of the blades were replaced with cermet blades of uniform composition.

Figure 4. - Failure of blade with increased nickel content in root; run 12.

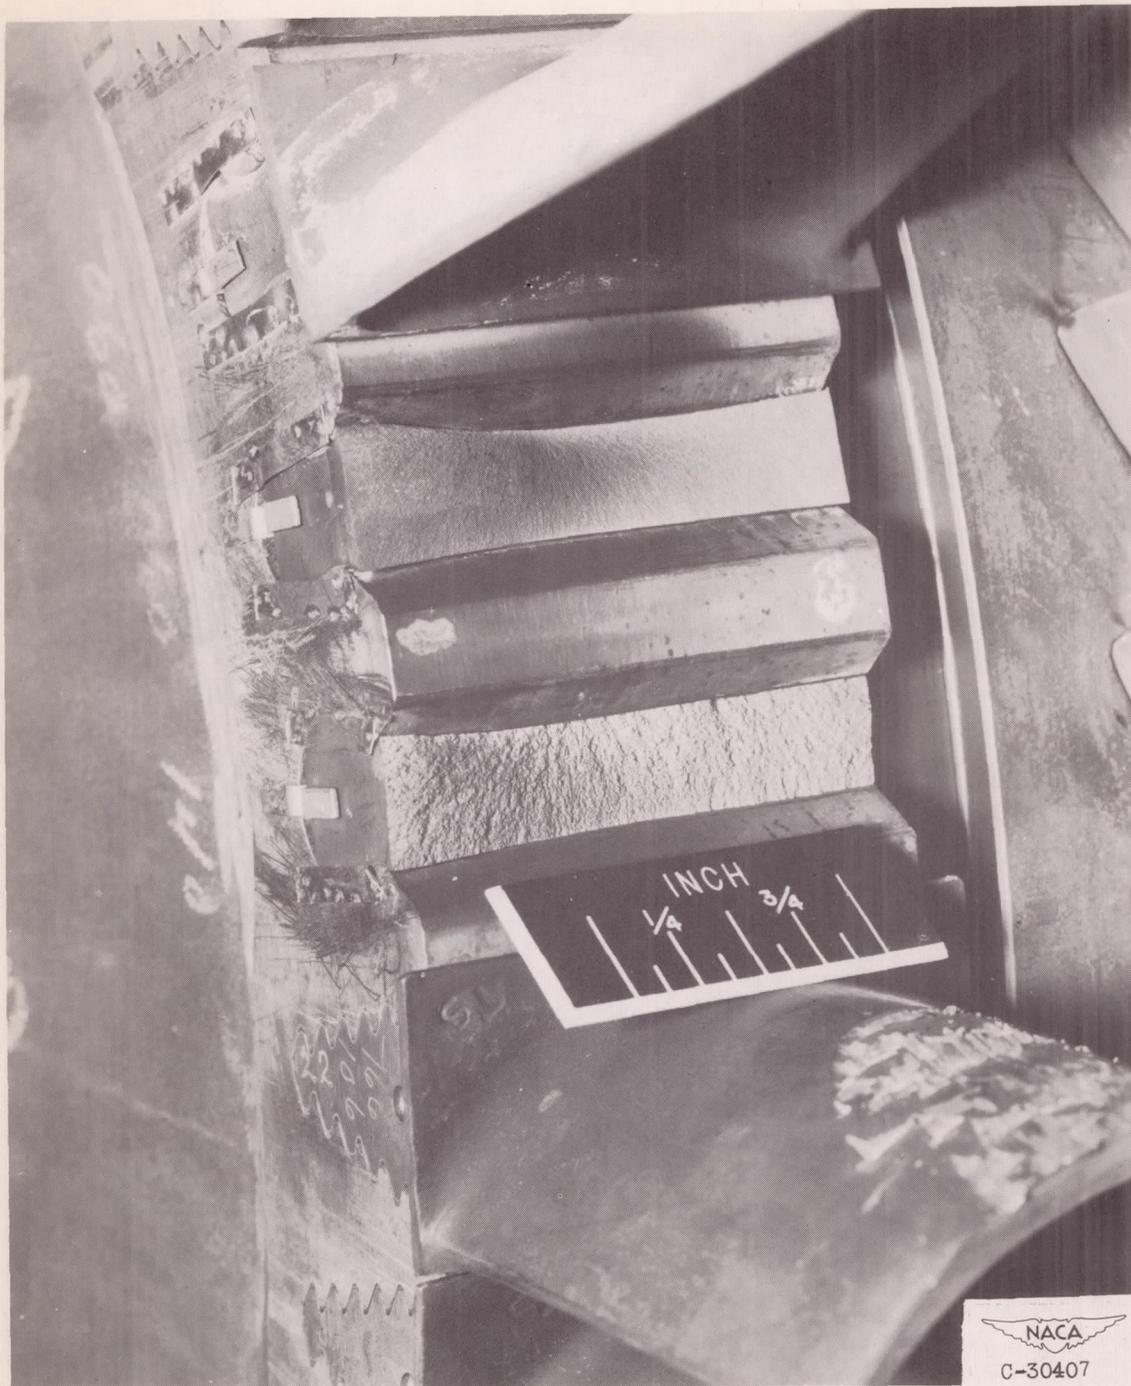
Run 12A. - In order to offset the effect of the heavier-metal blade, half the airfoil in run 12A was cut off the two diametrically opposite metal blades adjacent to the clockwise-most cermet blade in each group of three blades. The results of engine testing the assembly are shown in figure 5. Two adjacent cermet blades failed in the roots after 5 minutes at rated speeds. It is impossible to establish which of the two roots failed first. The difference in grain structure apparent in the figure is caused by different compositions; the lower root in the photograph was made with 50 percent nickel binder while the other was 30 percent nickel.

Figure 5. - Root failures in run 12A.

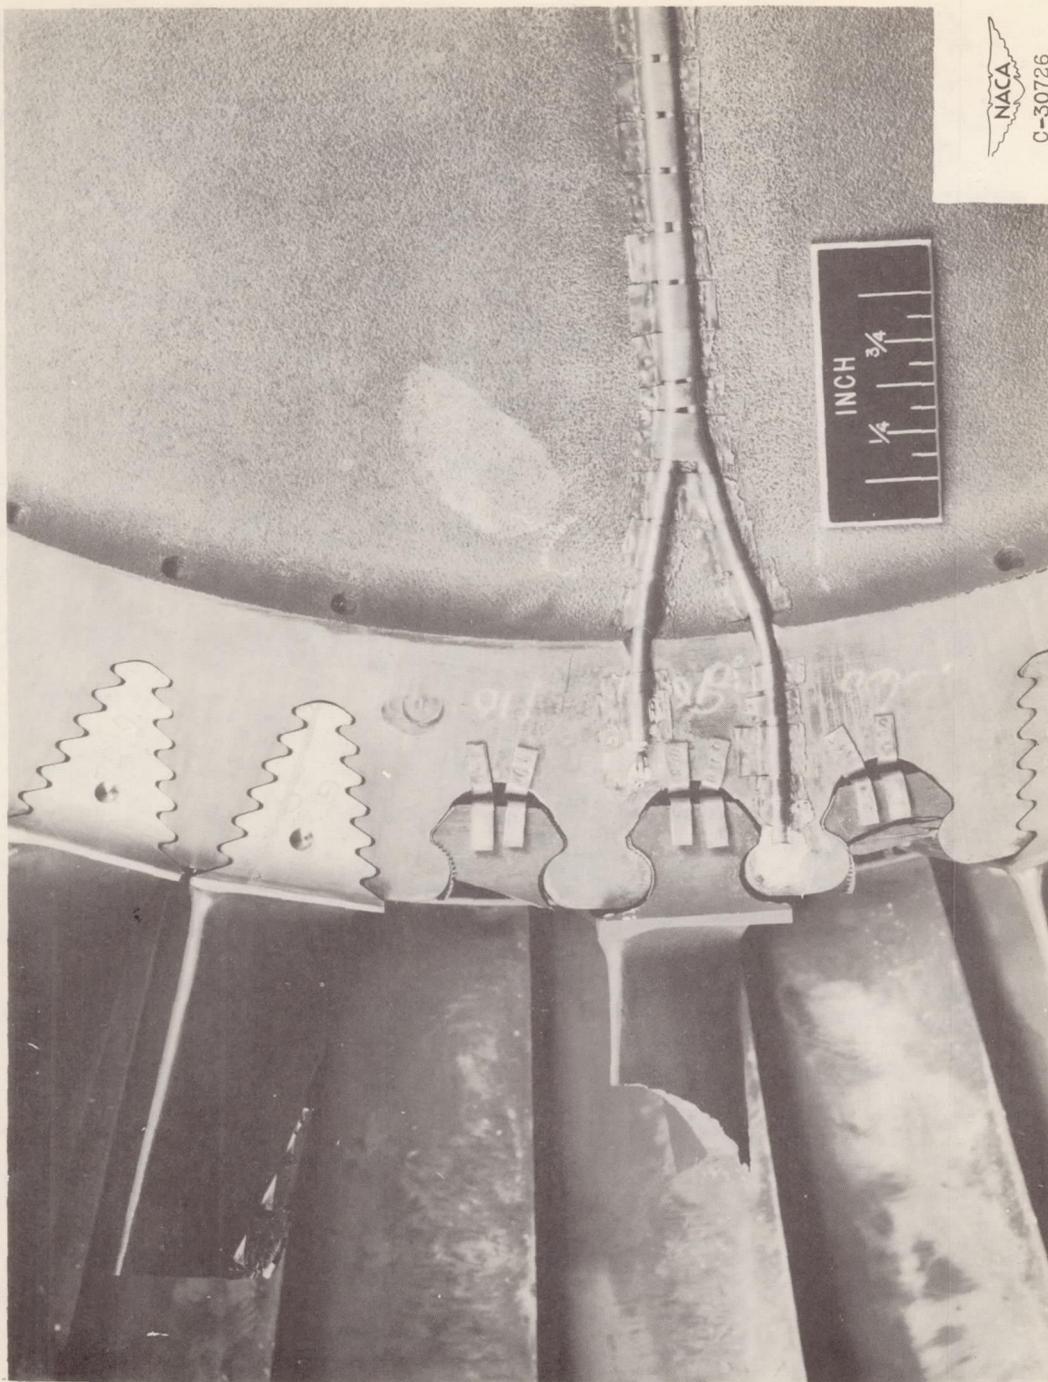
Dovetail blade, run 13. - It was not understood why it appeared impossible to exceed or at least duplicate the 58- and 68-hour runs for the dovetail (run 9) and interlock (run 10), respectively, reported in reference 1. The root designs and the material composition of the later blades were supposedly identical to those of the blades used in the earlier runs. The quality of the material and of the machining was suspected. In an attempt to isolate the poor blades from the good ones, a set of 12 blades was cold-spun to 20 percent overspeed and consequently to 44 percent over the normal operating stress. The six surviving blades (the other six failed in the range between 10 and 20 percent overspeed) were installed in the turbine rotor along with two shortened metal blades. This group of blades (run 15) failed after 16 minutes at 11,750 rpm. Two roots failed, both adjacent to metal blades and both on the same side of the rotor as shown in figure 6. The intervening cermet blade failed in the airfoil. As can be seen in the photograph, the turbine was instrumented with thermocouples to measure temperatures in the vicinity of the cermet root. However, the unit did not operate long enough at rated speed for the rotor temperatures to become stabilized. Figure 7 shows the fracture surfaces of the two root failures and shows small parts of the screen used between rotor and blade. The spalled appearance of the fractures indicates that the compressive stresses due to either bearing loads or thermal expansion, or both, were too high as contrasted with the clean tensile failures of figures 1, 4, and 5.

Figure 6. - Dovetail root failures of run 13.

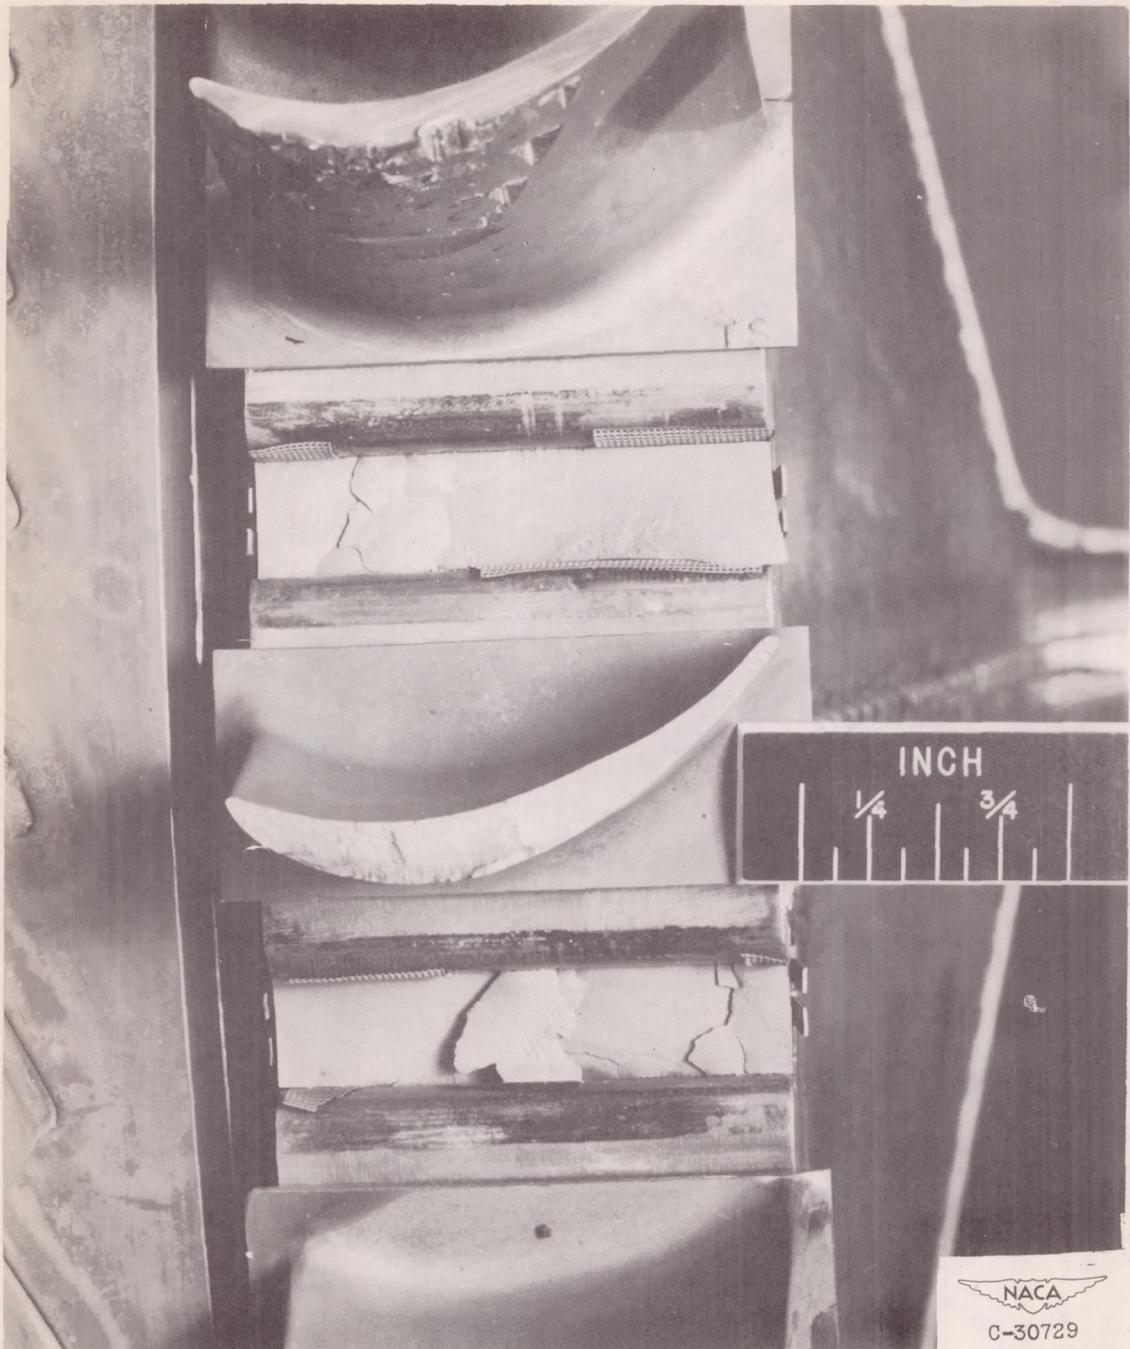
Figure 7. - Fracture surfaces of dovetail roots; run 15.

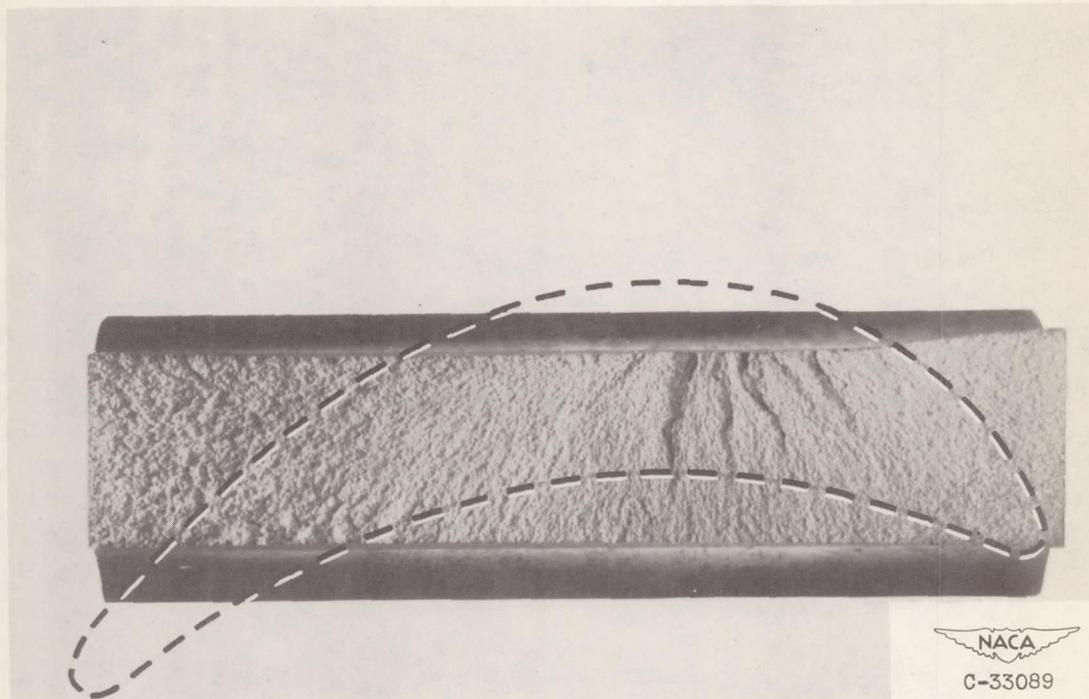
If the profile of the airfoil at its base is superimposed on the photograph of a fractured root surface (fig. 8), it becomes apparent that the failure invariably starts at the location of the largest concentration of mass of the airfoil. The presence of bending stresses in the root neck is evident because the failure generally starts at the

Figure 8. - Airfoil profile superimposed on failure surface.

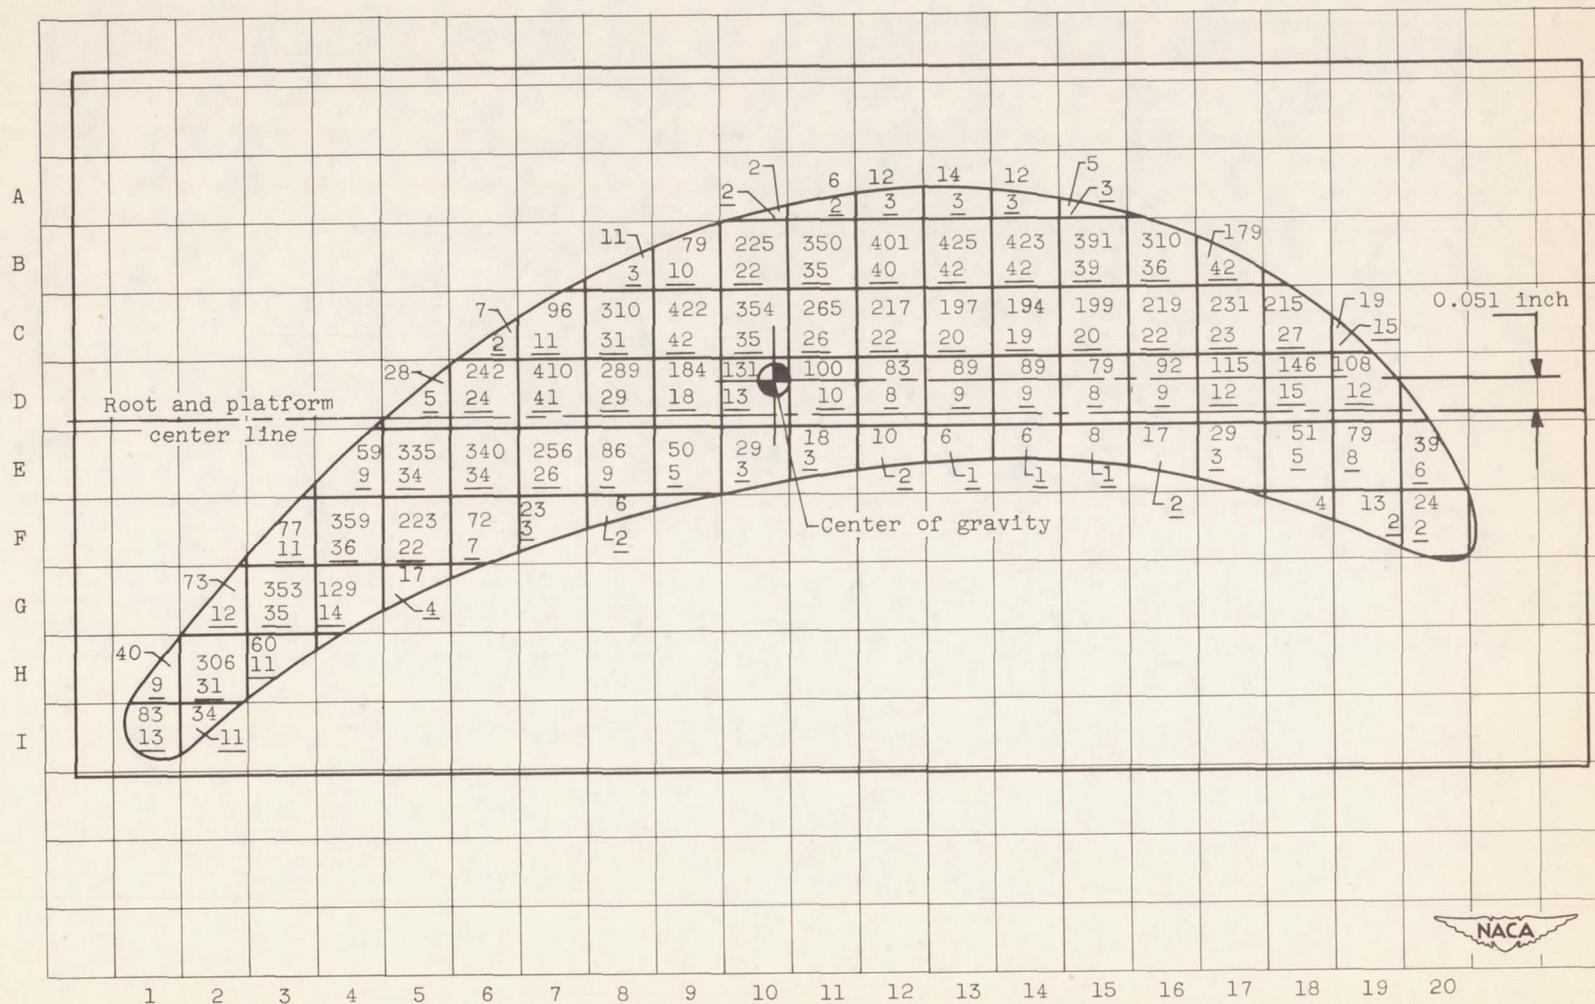
Results of calculation. - The results of the calculations are shown in figure 10. The upper numbers in each square are the total centrifugal forces in pounds acting on each square and the lower numbers (under-scored) are the stresses (in 1000-psi units) that would be acting on the base plane squares if each column were cut free from its neighbors. Actually, there would be a gradual variation in stress from one square to the next. From the magnitude of the numbers presented and their location, it is obvious that the greatest centrifugal loads and stresses are in the region where most of the failures originated. The location of the radial projection of the center of gravity of the whole airfoil is determined by dividing the summation of moments of the centrifugal force of the individual columns times their distance from an arbitrary axis by the summation of the centrifugal forces.

Effect of offset center of gravity. - The procedure described shows the projection of the center of gravity on the base plane to be displaced 0.051 inch in the direction of rotation from the center line of the blade platform and root. This offset introduces a sizable bending moment in the blade root which is only partly compensated for by the gas forces on the airfoil. The gas force per blade as determined in the appendix of this report is 100 pounds at rated speed and

Figure 10. - Centrifugal force and stress distribution at base cross-section of airfoil.

The bending stress resulting from this computation is ± 6990 pounds per square inch. If then the airfoil is shifted 328 divided by 11,300, or 0.029 inch, in the tangential direction toward the concave or pressure side of the blade, this bending stress can be virtually eliminated.

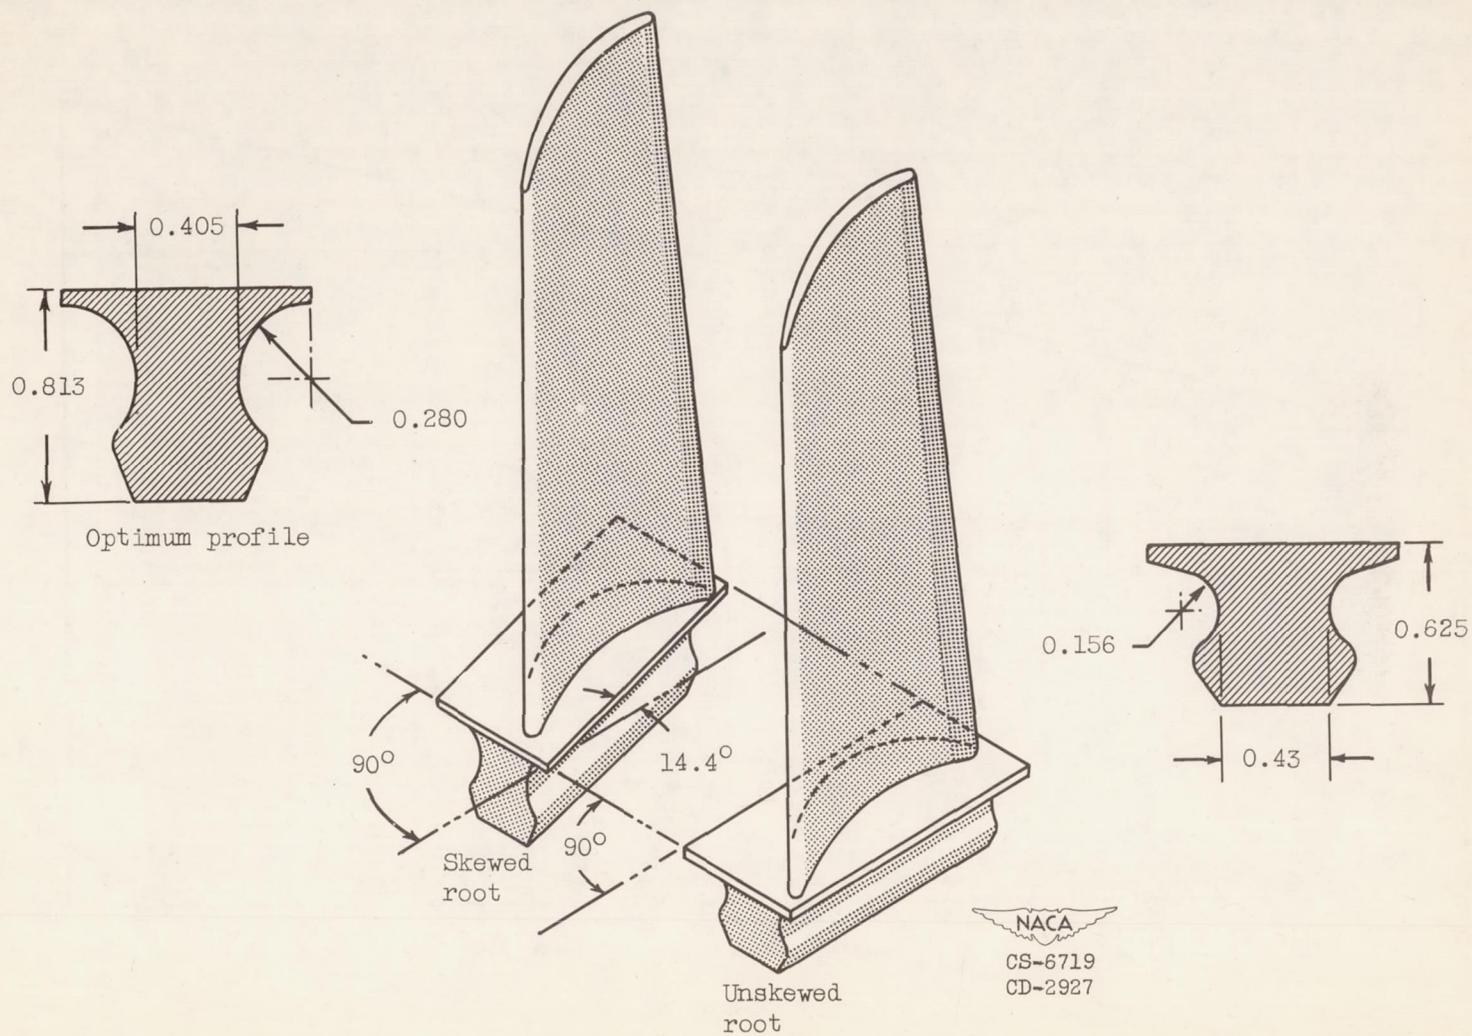
Figure 12. - Dimensions of standard and skewed dovetail cermet blades. (All dimensions are in inches.)

The results of a separate investigation on root profile design are reported in reference 2. In this reference optimum root proportions were determined to give maximum strength in pure tension. The experimental failure load for the small-radius dovetail profile is 37,190 pounds. When the optimum proportions of reference 2 are used, the same load is 41,220 pounds, or an improvement of 11 percent, as established by tensile tests of cermet specimens at 1200° F, reference 4. The increase was caused by a decreased stress concentration factor resulting from increasing the notch radius in the root from 0.156 inch to 0.280 inch. The neck distance in the root had to be reduced from 0.438 inch to 0.405 inch to accommodate the larger-radius root; nevertheless, it is stronger as a result of the lower stress concentration factor. The new root including both the skewing and the new profile is sketched along with the earlier dovetail for comparison in figure 12.

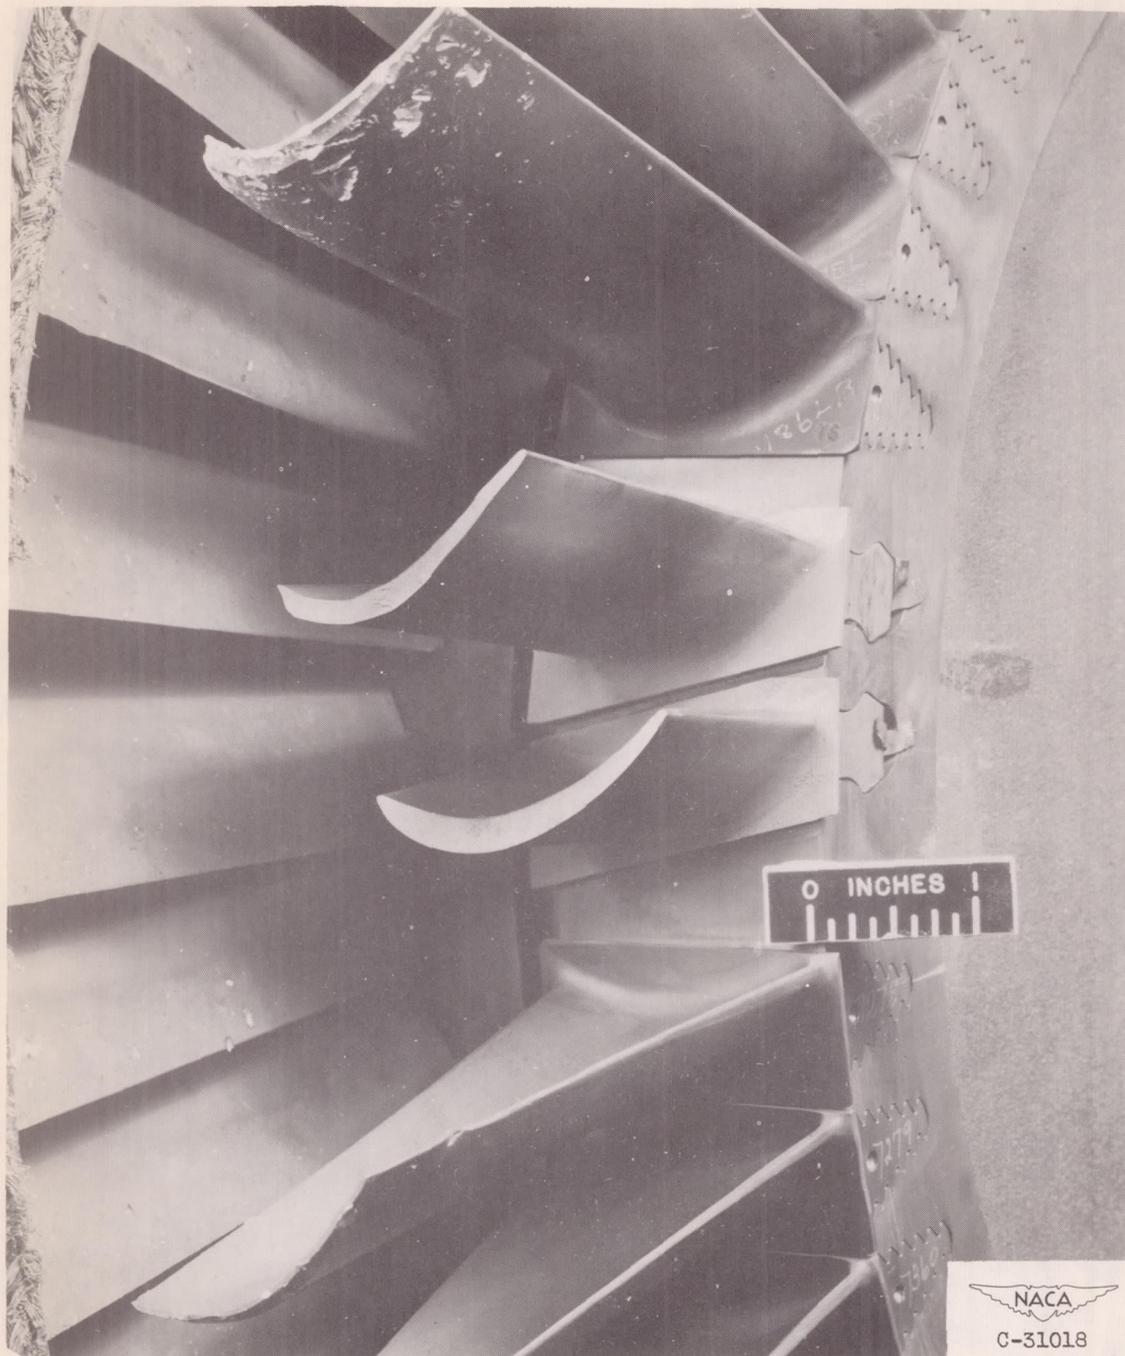
Run 16. - Runs 14 and 15 indicated that an improvement had been accomplished in the redesigned blades but several changes had been incorporated at one time. The root was displaced slightly with respect to the airfoil and was skewed, the notch radius was increased, and attempts had been made to improve the material. To evaluate which changes were primarily responsible for the increased life, six blades of the unskewed interlock design were fabricated from the same material and by the same processes as the cermet blades of runs 14 and 15. These interlock blades were tested in the engine with slightly opened tail cone in the same manner as all earlier tests and the first part of run 14. As noted in the table, these blades lasted only 58 minutes at rated speed, indicating that any material changes were not the major cause for increased life. As shown in figure 16, the failure occurred for the first time between two cermet blades and not adjacent to a metal blade.

Figure 13. - Airfoil failures after 129.5 hours at rated speed; run 16.

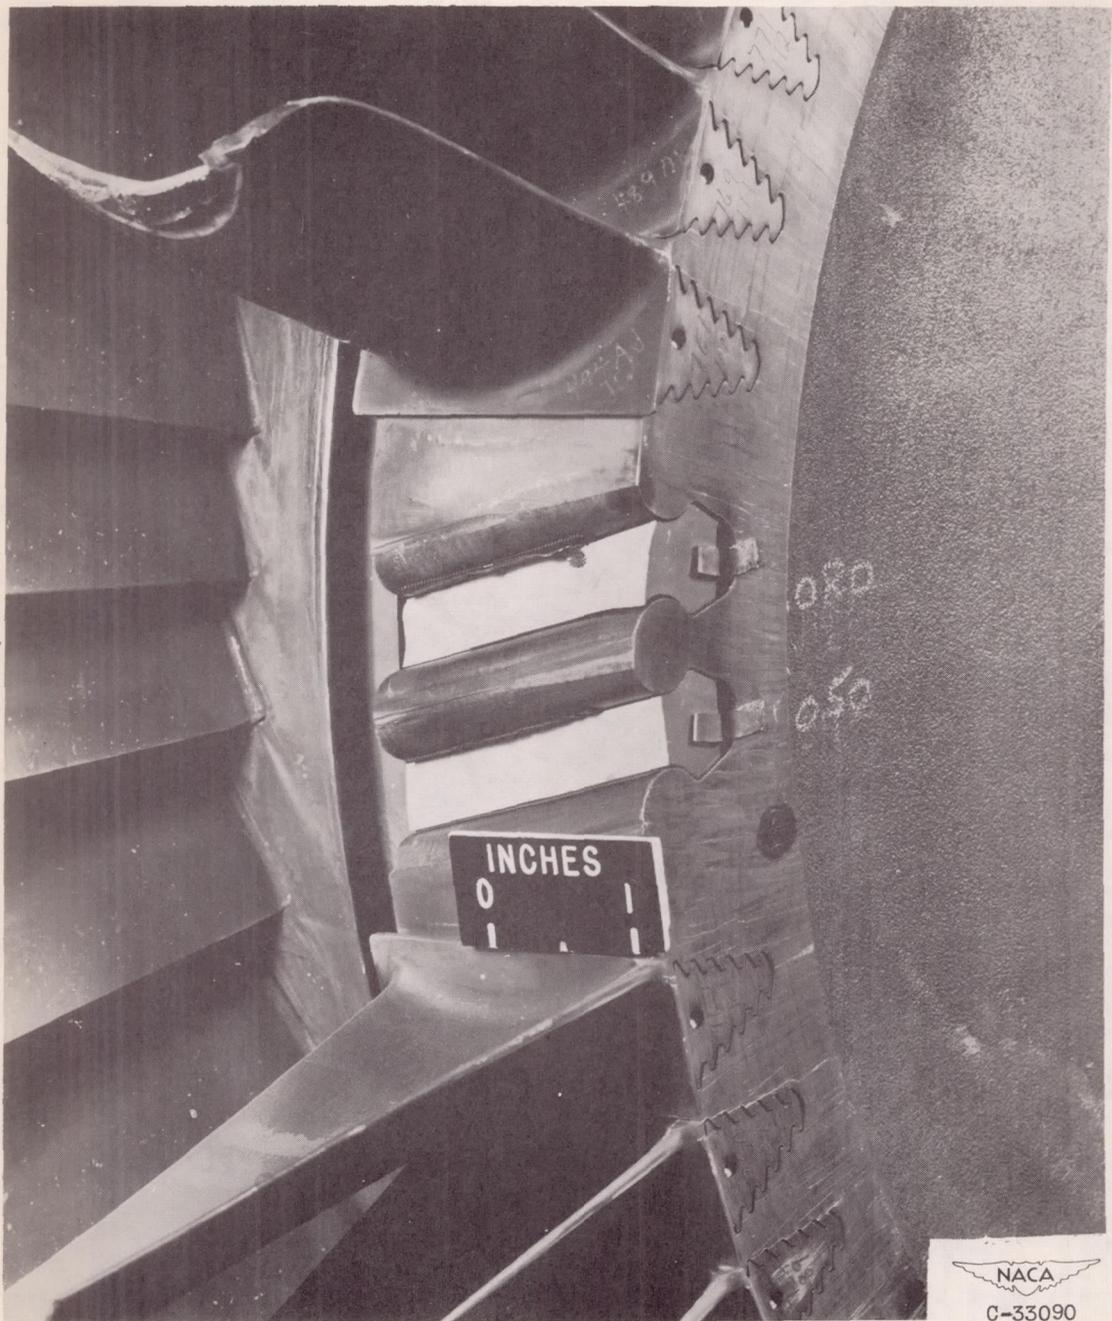
Run 15. - For run 15, the engine was completely rebuilt and four more of the redesigned blades were tested. These blades were subjected to 50 hours at maximum power and speed without mishap. To evaluate the thermal shock properties of the root design and the blade material, the engine was cycled. Cyclic operation consists in running 15 minutes at rated power and speed (11,750 rpm) followed by 5 minutes at idling conditions (4000 rpm), with rapid acceleration and deceleration between these conditions. The cycle was successfully completed 13 times but after 1 minute at full power in the 14th cycle, two of the cermet blades on the same side of the wheel failed in the root, terminating run 15 (fig. 15). It can be noticed in the photograph that one of the fractures is a clean break without evidence of bending stresses. The second slightly rougher break is probably the result of impact from the first blade. The broken tip section of the airfoil of the metal blade shown in figure 15, incidentally, is the first metal blade failure caused by impact from cermet blades.

Figure 15. - Root failures after cyclic operation; run 15.

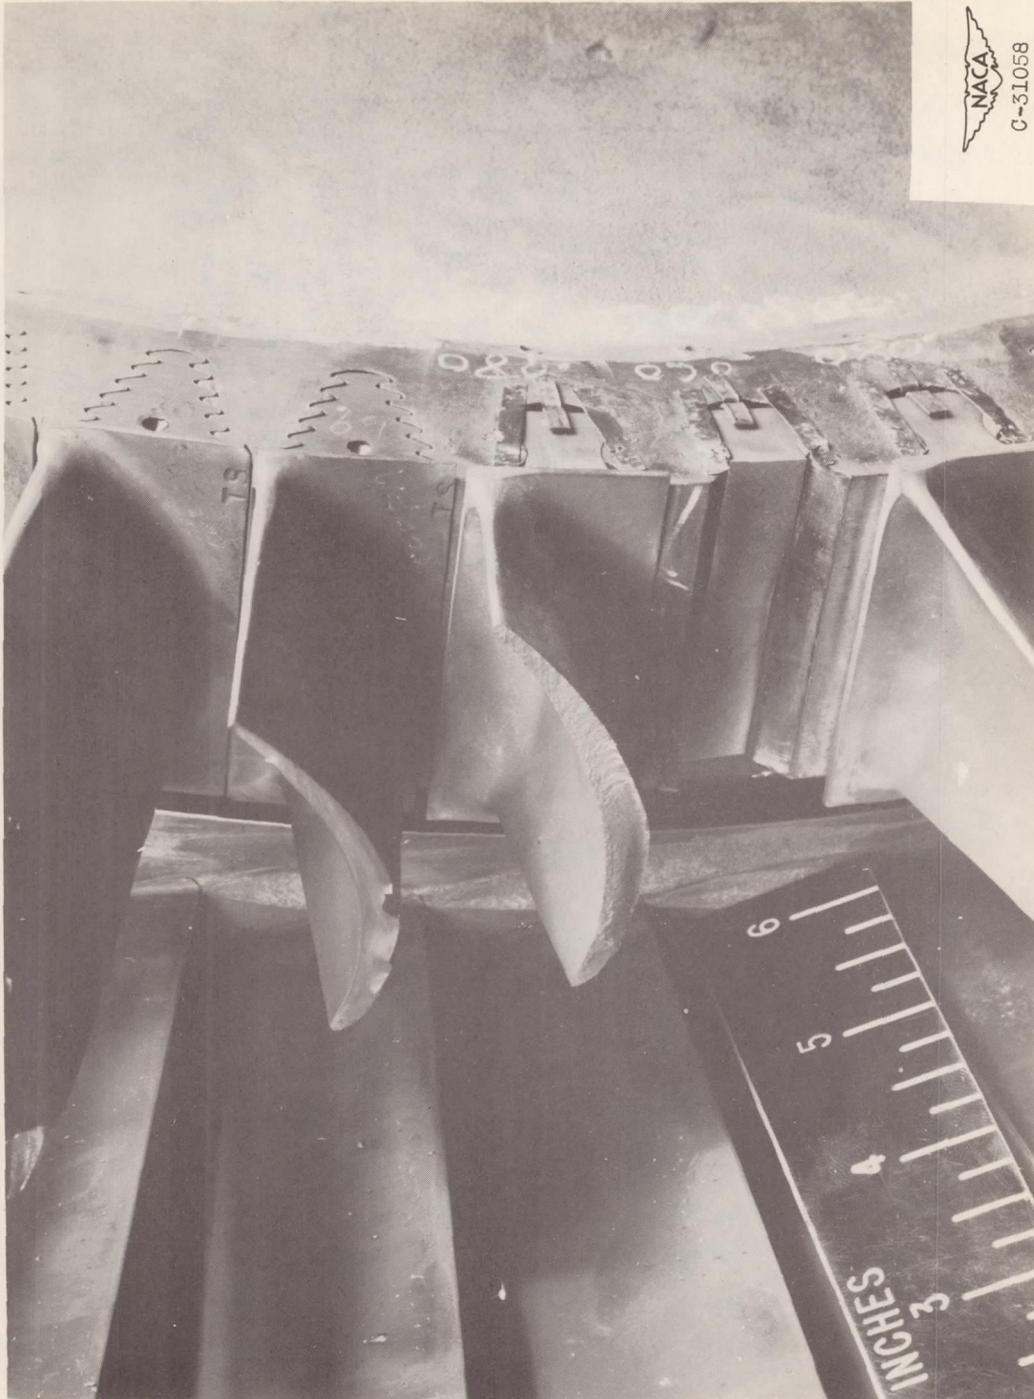
Figure 16. - Failure of interlock root made from refined material; run 16.
