RESEARCH MEMORANDUM

PRELIMINARY INVESTIGATION OF SEVERAL ROOT DESIGNS FOR
CERMET TURBINE BLADES IN TURBOJET ENGINE

II - ROOT DESIGN ALTERATIONS

NATIONAL ADVISORY COMMITTEE
FOR AERONAUTICS

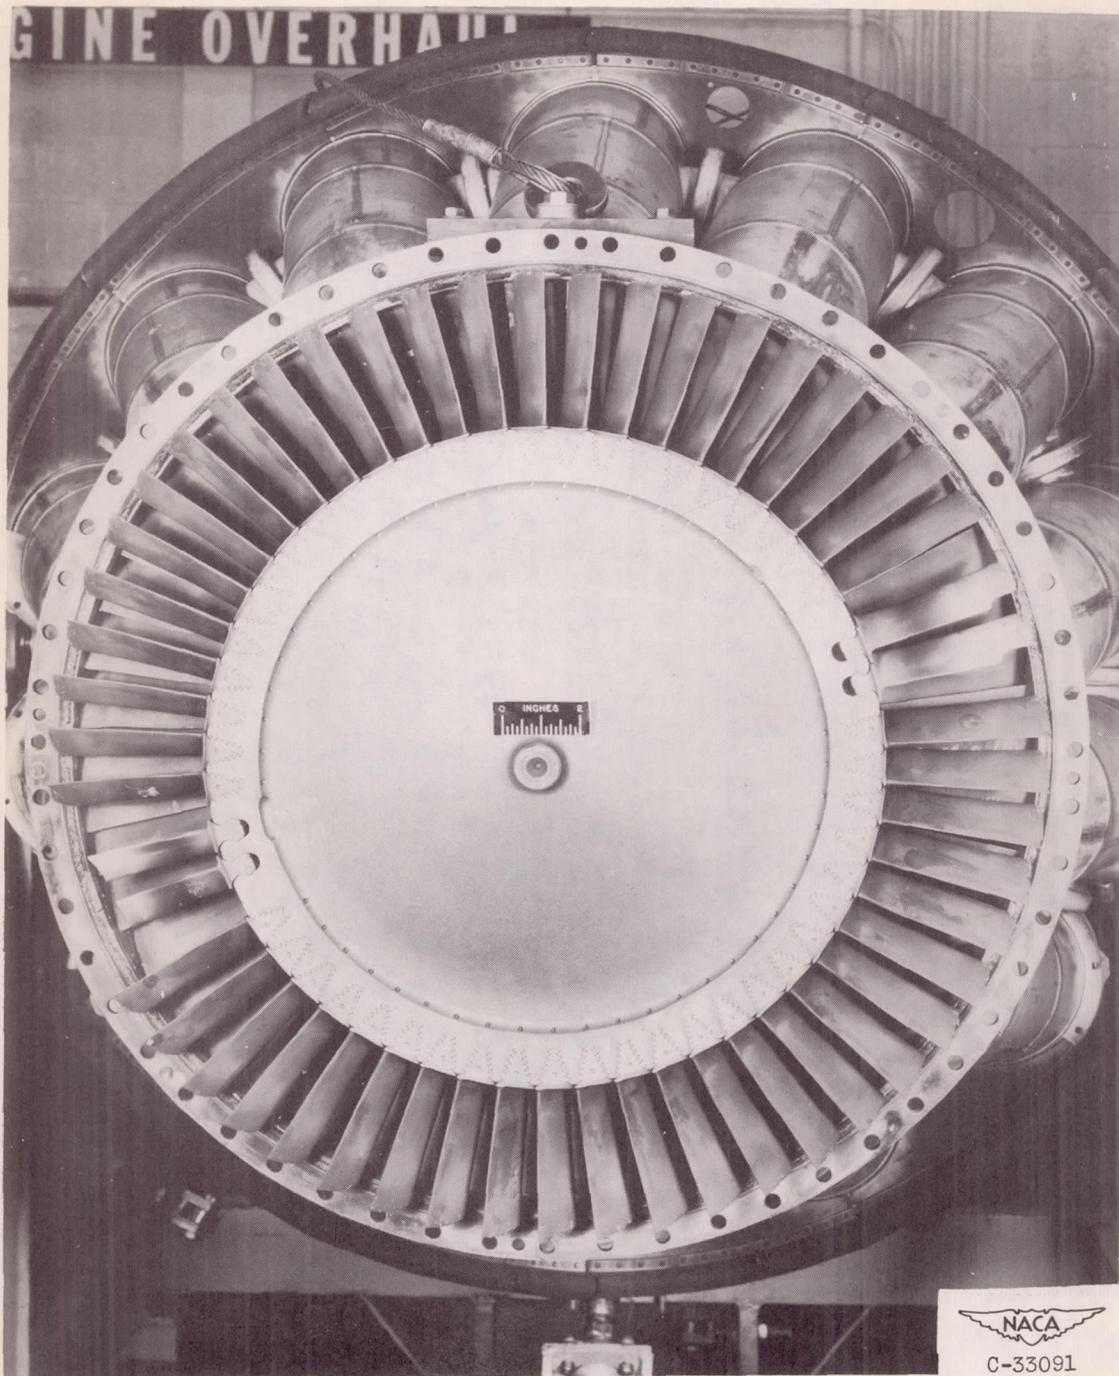
Run 17. - To evaluate the foregoing hypothesis concerning notch radii differences, four skewed-root blades were inserted in a new turbine wheel, two of the large-radius profile on one side of the wheel and two of the small-radius profile on the diametrically opposite side. The intention in run 17 was to run the engine 50 hours at rated speed and power (closed tail cone) and then proceed with cyclic operation. The engine ran 36 hours before the blades were damaged (fig. 17)

as a result of fatigued fragments breaking loose from the combustion domes and liners and passing through the turbine. Even though no cyclic operation was obtained to evaluate the effect of thermal expansion and contraction on the different radii, sufficient operating time was obtained at full power to indicate that probably the displacing and skewing of the root, and not the change in profile, were the primary factors leading to increased blade life.

Figure 17. - Failure of airfoils resulting from fatigue of combustion domes and liners; run 17.

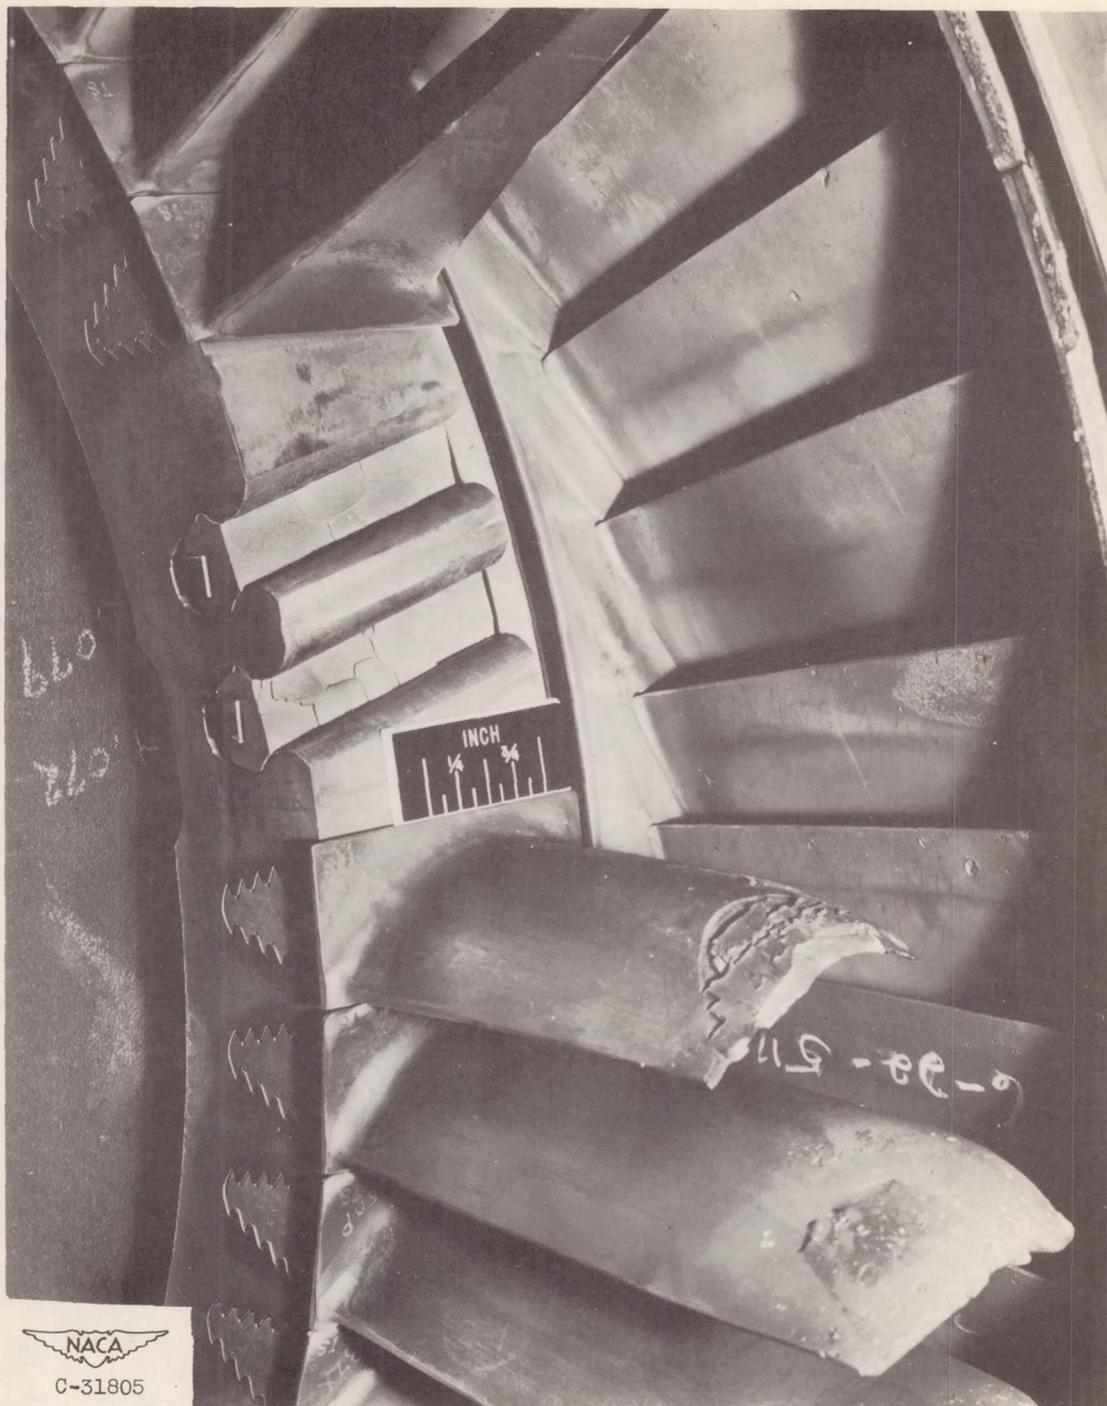
Run 18. - For run 18, the turbine wheel was rebladed in the same manner as in run 17. The decision was made to run only 10 hours steadily at rated condition before beginning cyclic operation. The blades, however, ran only 6 hours before one of the large-radius blades failed in the root and it broke the second large-radius blade by impact as evidenced by the fracture. The failures are shown in figure 18.

Figure 18. - Failure of skewed blades with large radii; run 18.

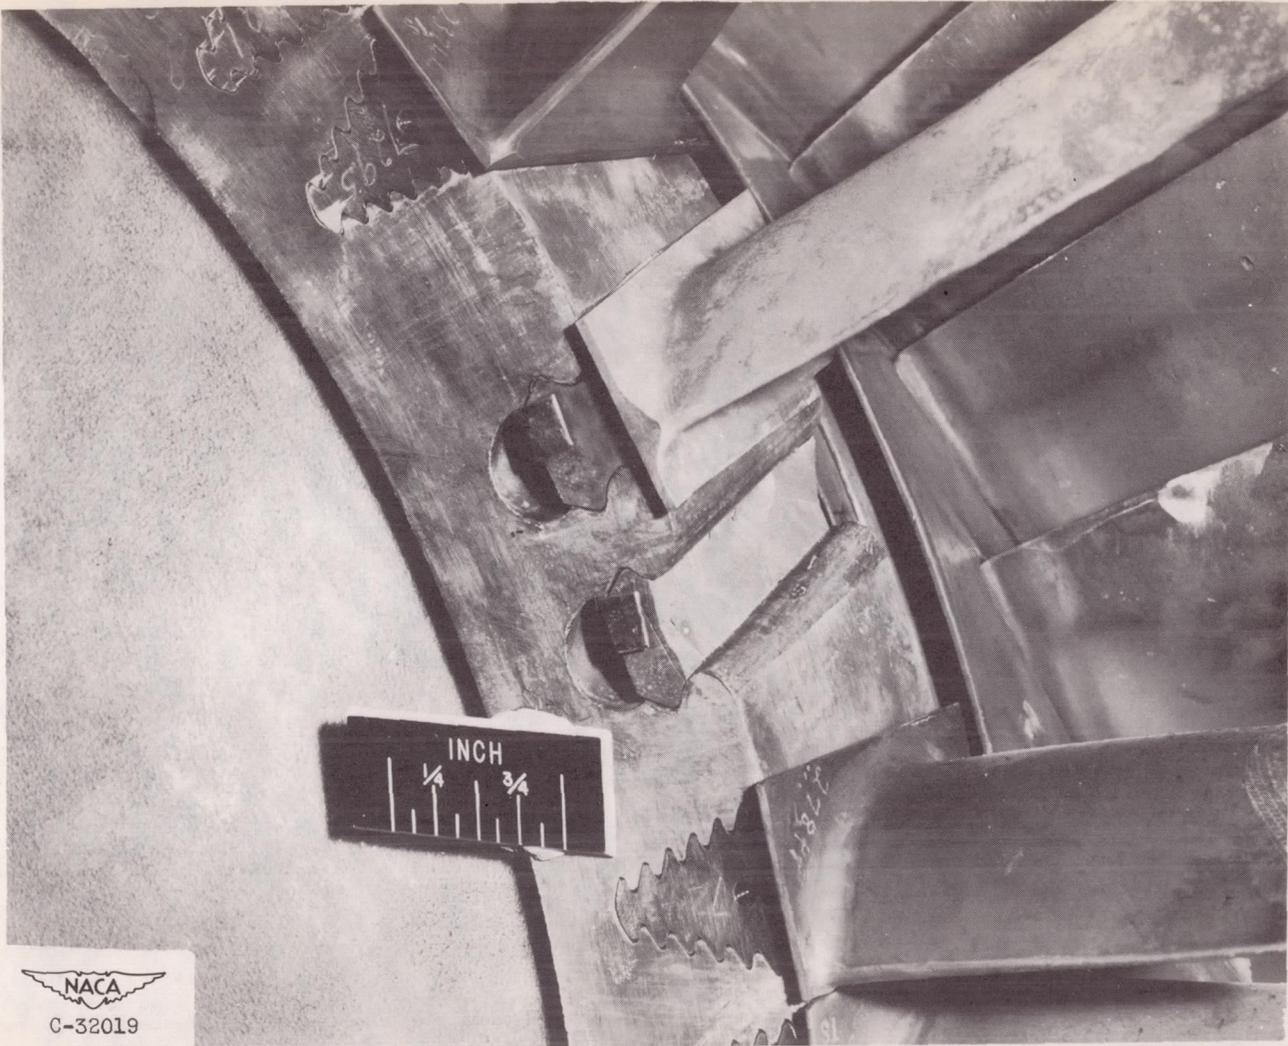
Figure 19. - Failed roots of skewed blades with small radii; run 19.

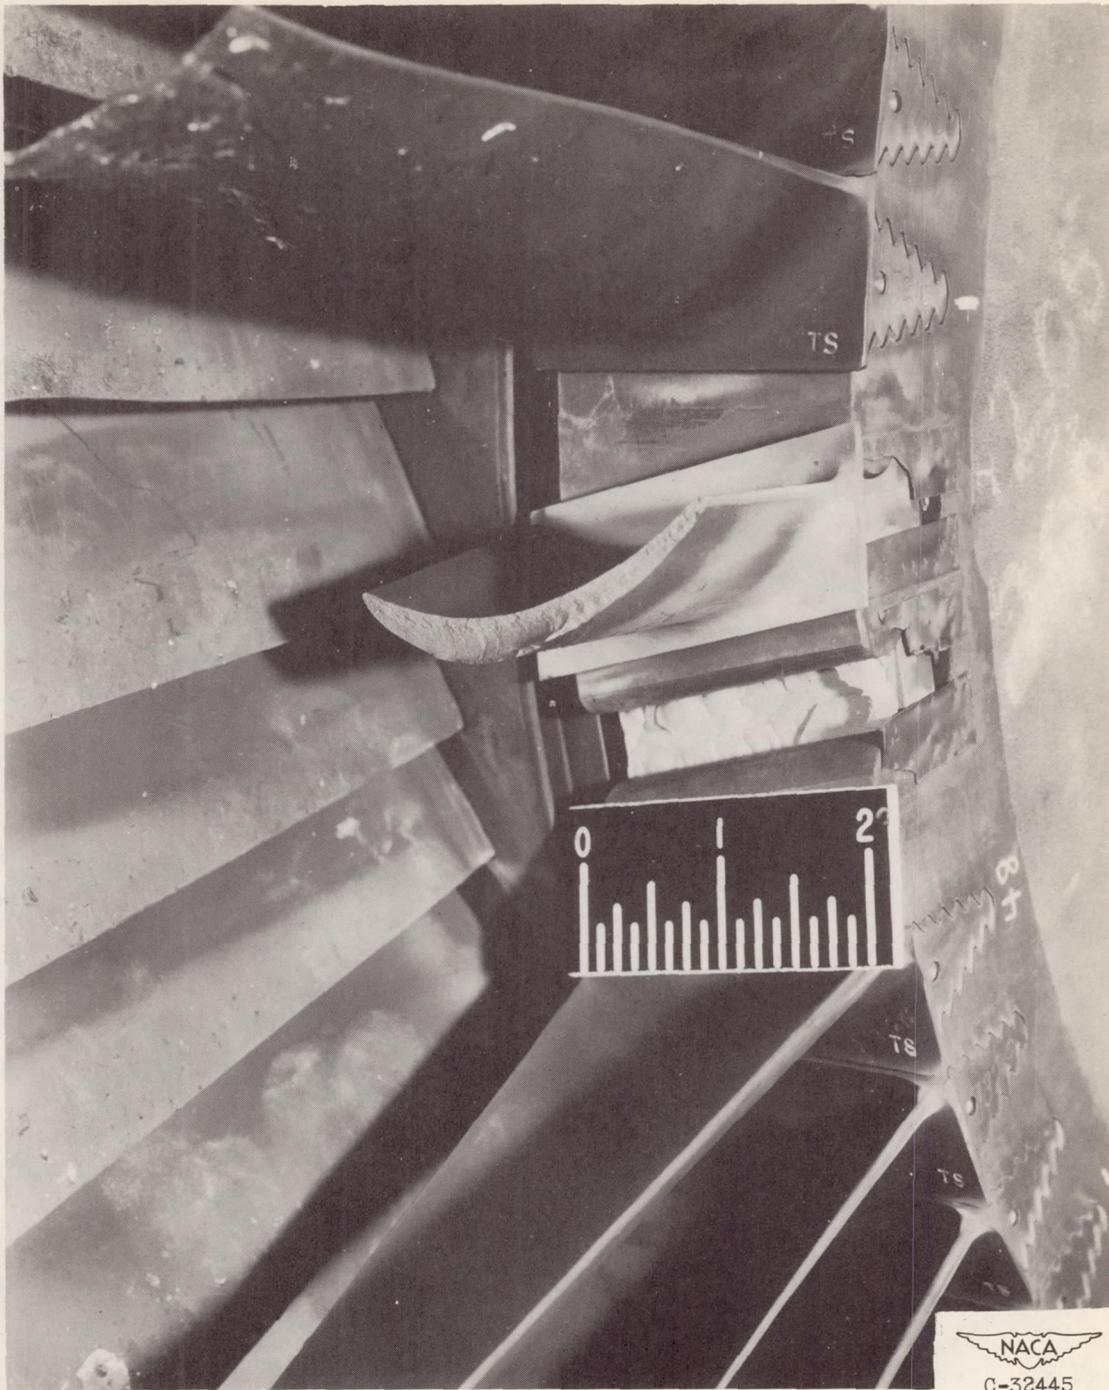
Run 19. - New blades were installed and the run was repeated. As noted in table I under run 19, a small-radius blade failed in the root after only 16 minutes (fig. 20). The cause for this premature failure is unknown.

Figure 20. - Large-radius root failure after 108 cycles of 15 minutes at rated speed and 5 minutes at idle; run 20.
