FULL-SCALE PERFORMANCE STUDY OF A PROTOTYPE CRASH-  
FIRE PROTECTION SYSTEM FOR RECIPROCATING-  
ENGINE-POWERED AIRPLANES

By Dugald O. Black and Jacob C. Moser

NATIONAL ADVISORY COMMITTEE  
FOR AERONAUTICS

November 15, 1955

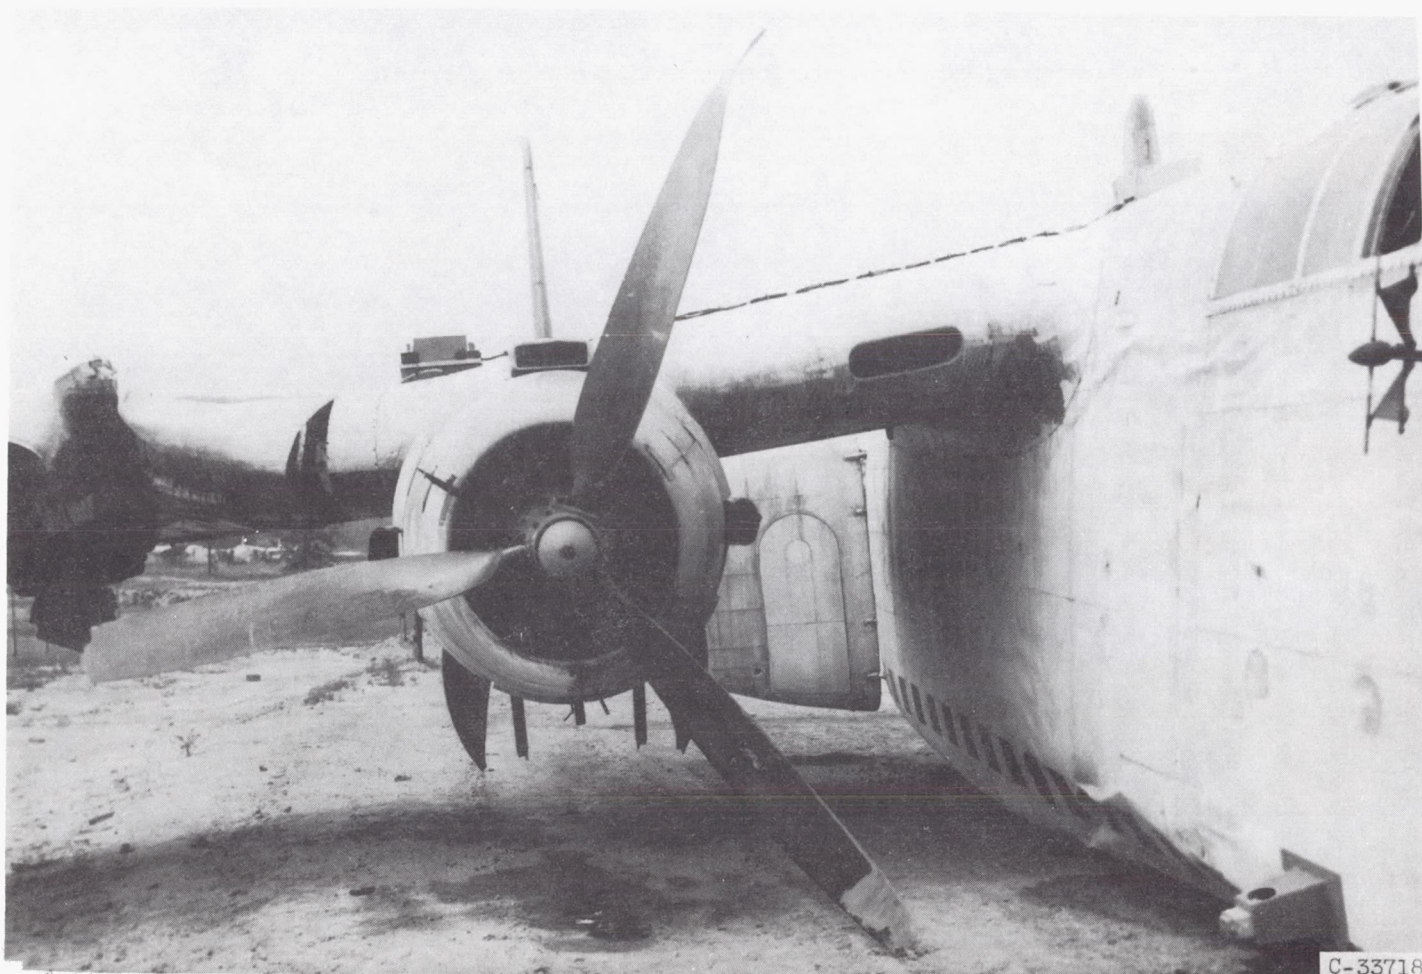
(a) Right engine.

The propellers of both the right and the left engines were bent from impact with the crash barrier as shown by photographs in figures 3(a) and (b), respectively.

Figure 3. - Propeller damage produced by crash barriers.

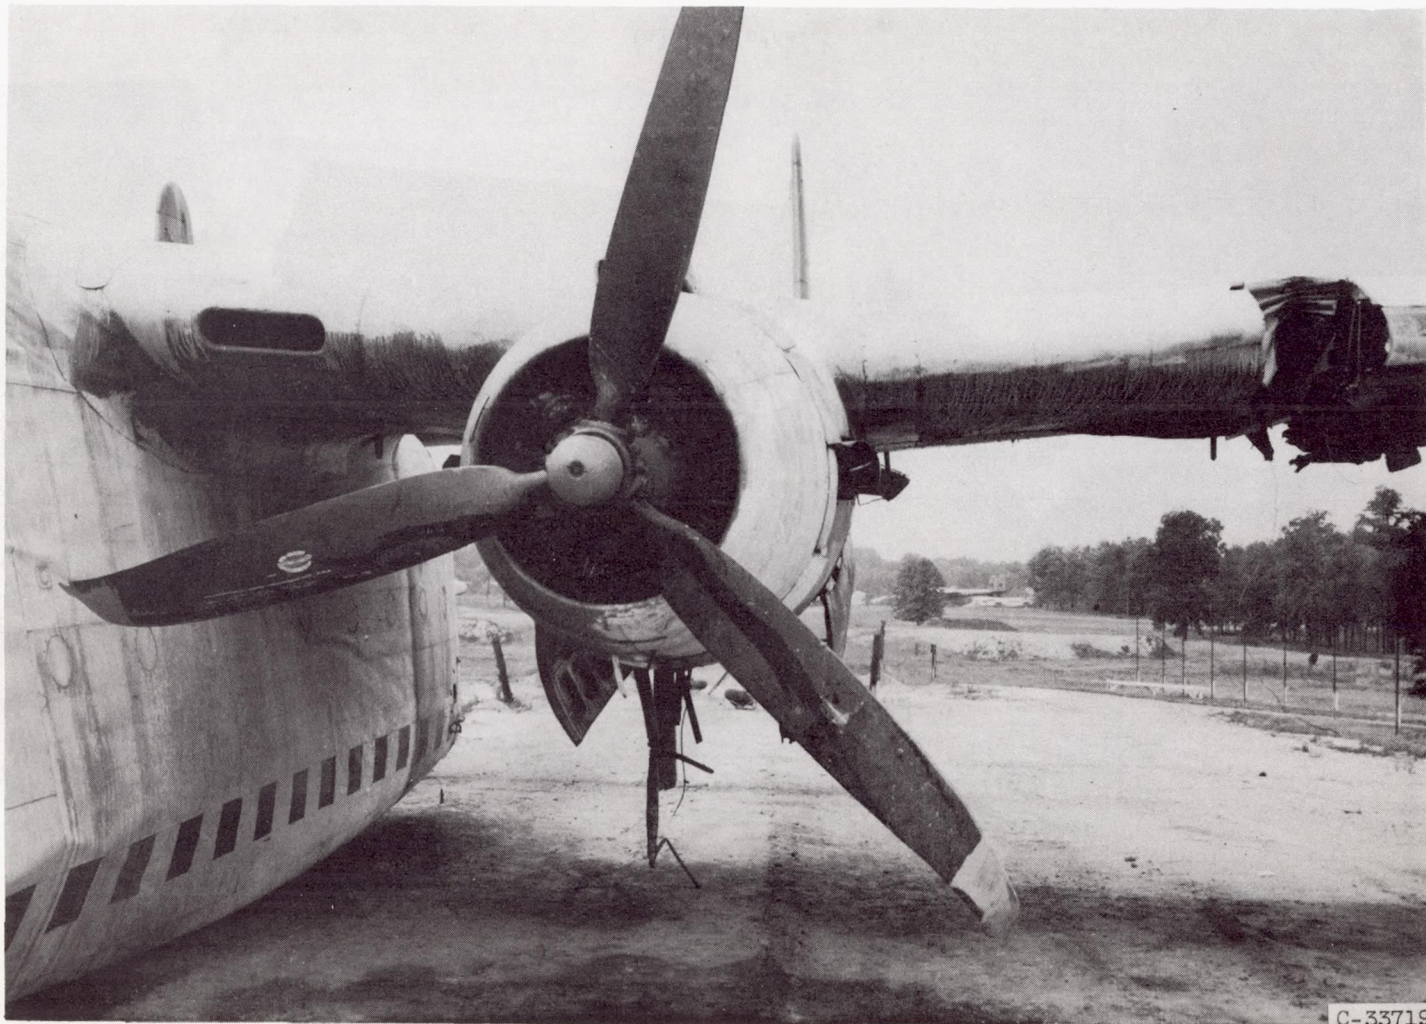
(b) Left engine.

Figure 3. - Concluded. Propeller damage produced by crash barriers.

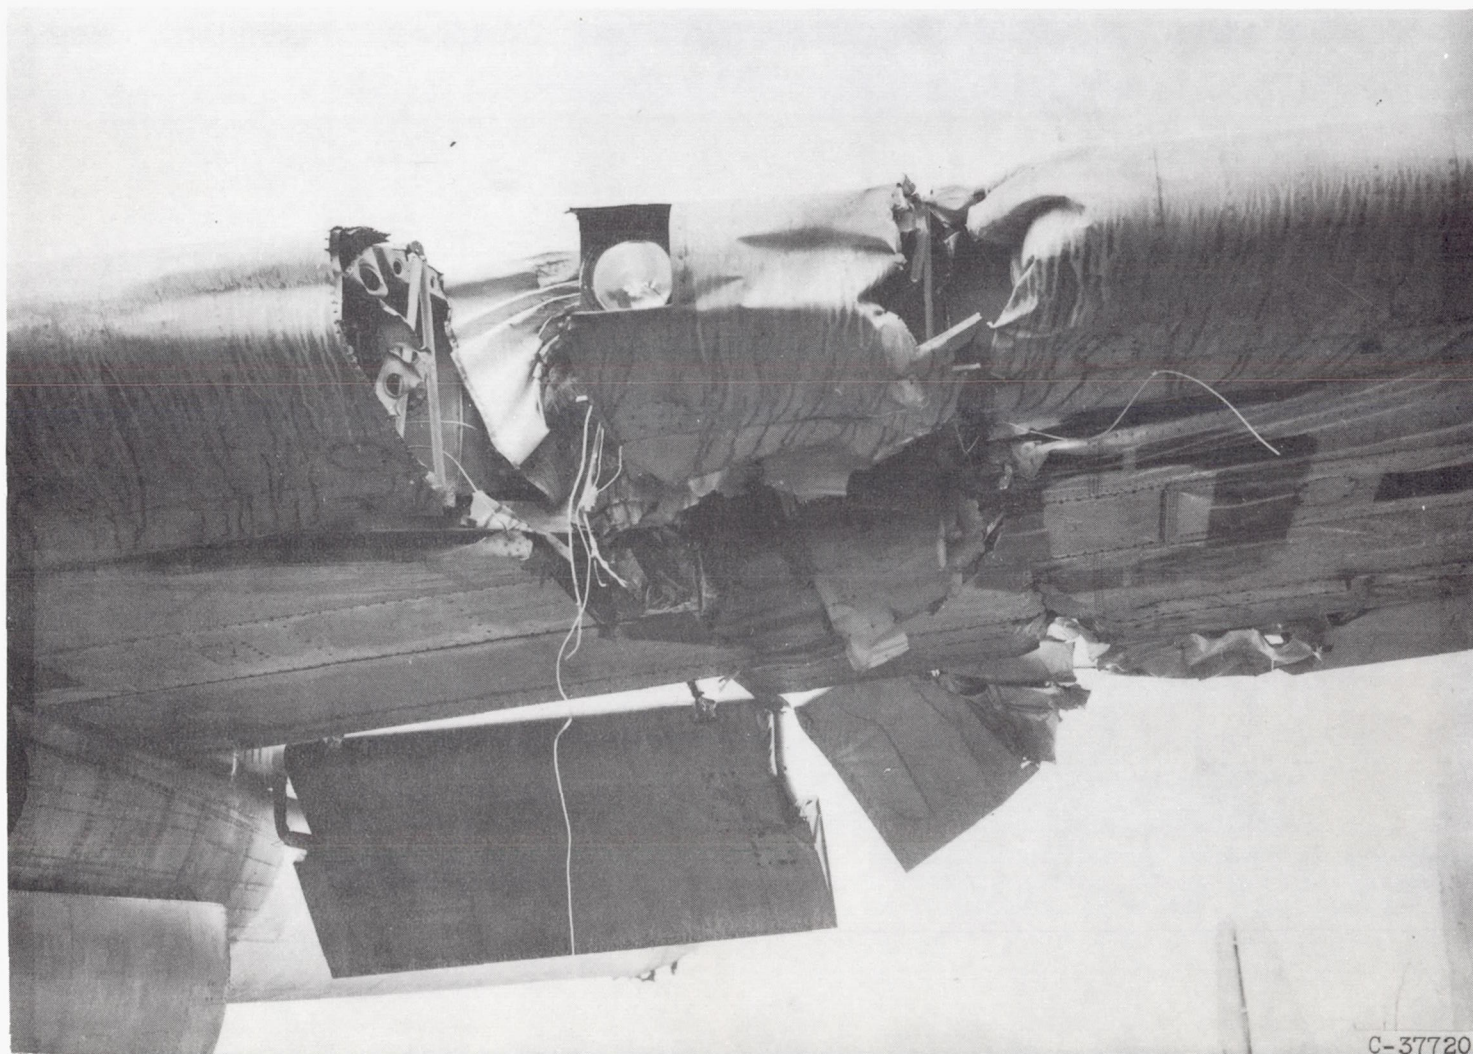
(a) Left side.

Fuel tanks 2 and 5 in both wings were pierced by the pole barriers. The extent of the damage to the left and right fuel tanks and wings is shown in figures 4(a) and (b), respectively.

Figure 4. - Damage to wing and fuel tanks produced by pole barriers.

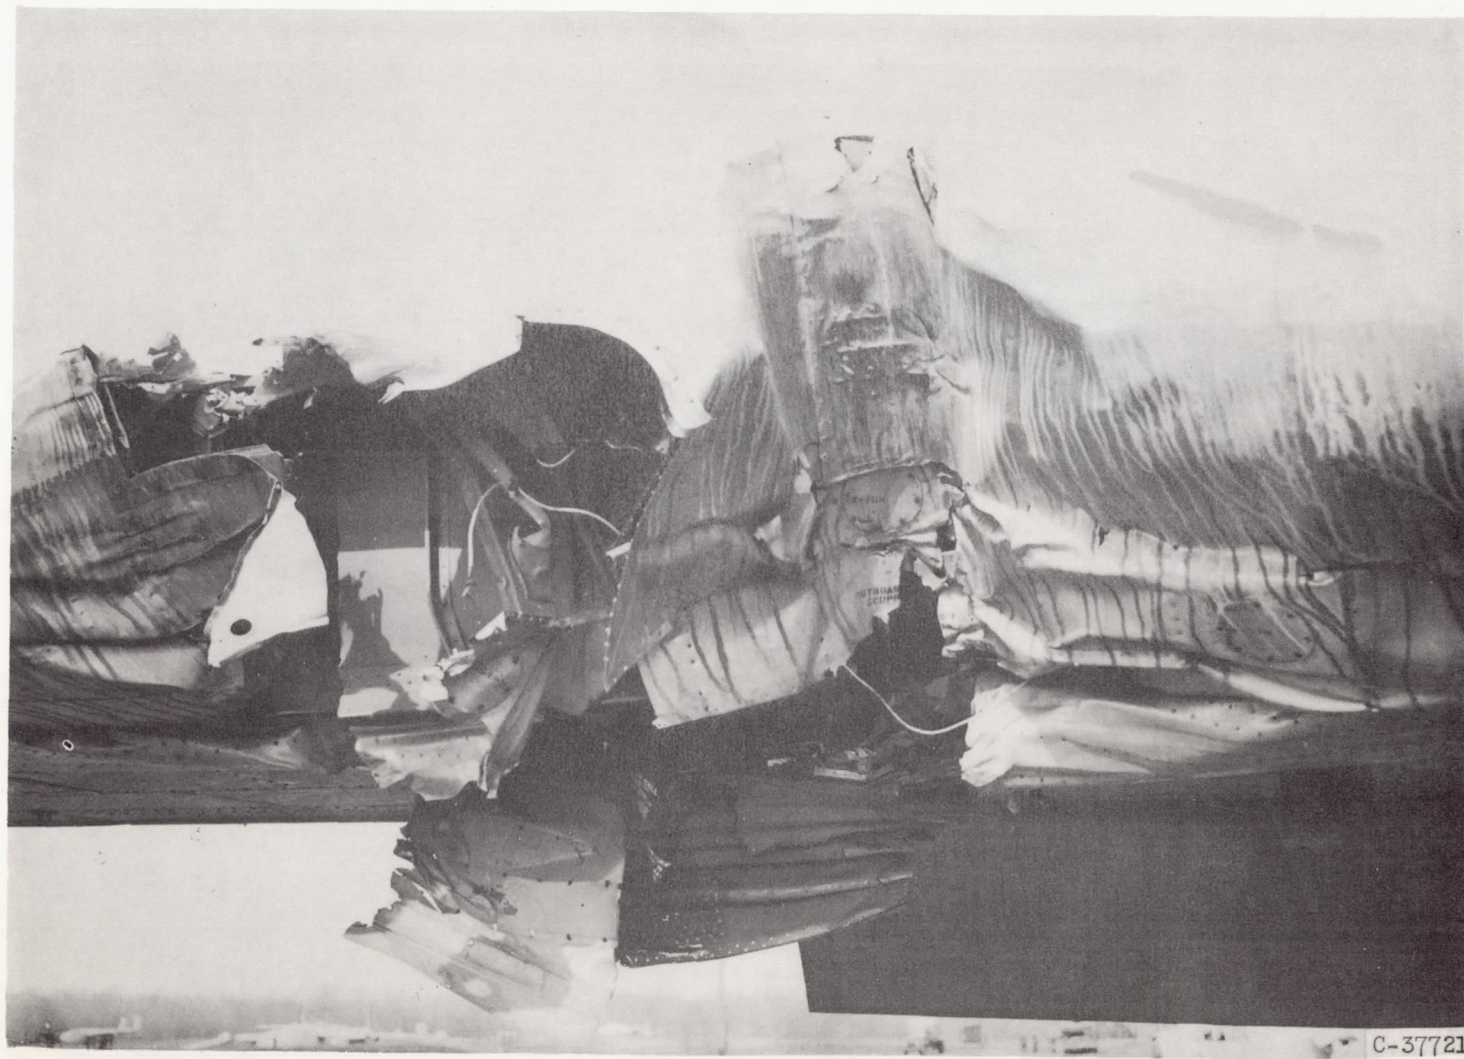
(b) Right side.

Figure 4. - Concluded. Damage to wing and fuel tanks produced by pole barriers.

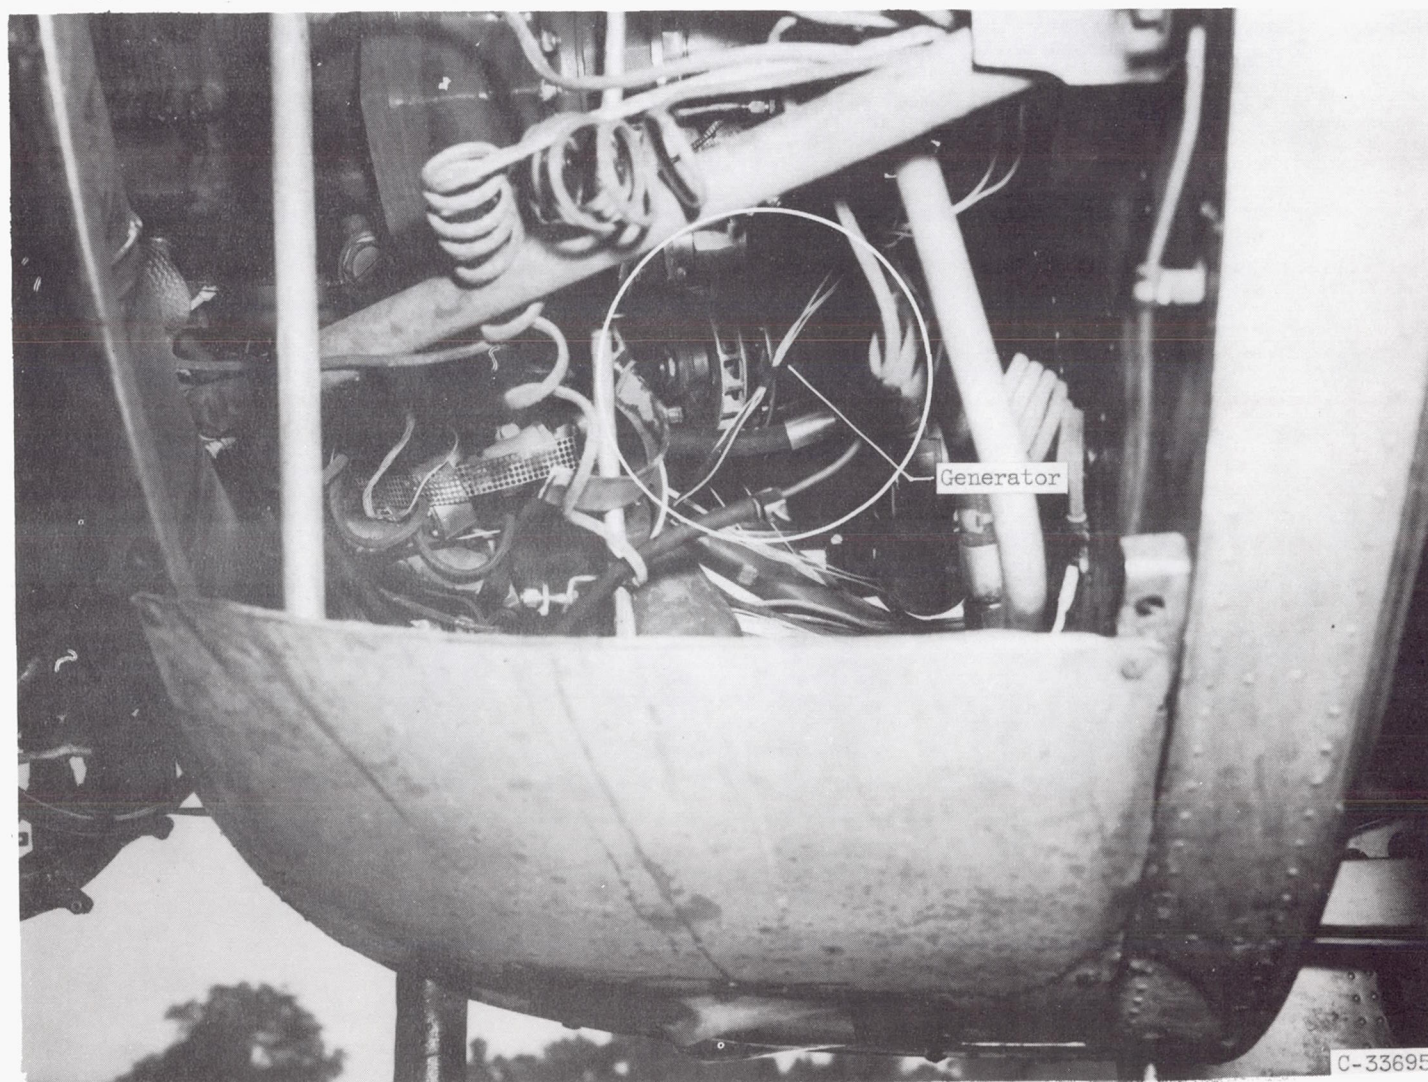
The engine nose-gear accessory housings were not damaged during the crash. Tubes in the right engine mount were slightly bent but not broken. Figure 5 shows the broken generator housing in the right engine nacelle. On the right engine the exhaust-stack connecting sleeves were pulled out of cylinder 14 (fig. 6(a)) and cylinder number 2 (fig. 6(b)). Two of the right-engine exhaust collector-ring mounting brackets were broken away from their support when their mounting bolts were sheared. Figure 7 shows one of these brackets broken from the support. The disruption of the exhaust stacks and shearing of the bolts were caused by the engine's twisting during the crash. The exhaust system on the left engine was not damaged.

Figure 5. - Broken generator mounting flanges in right-engine nacelle.

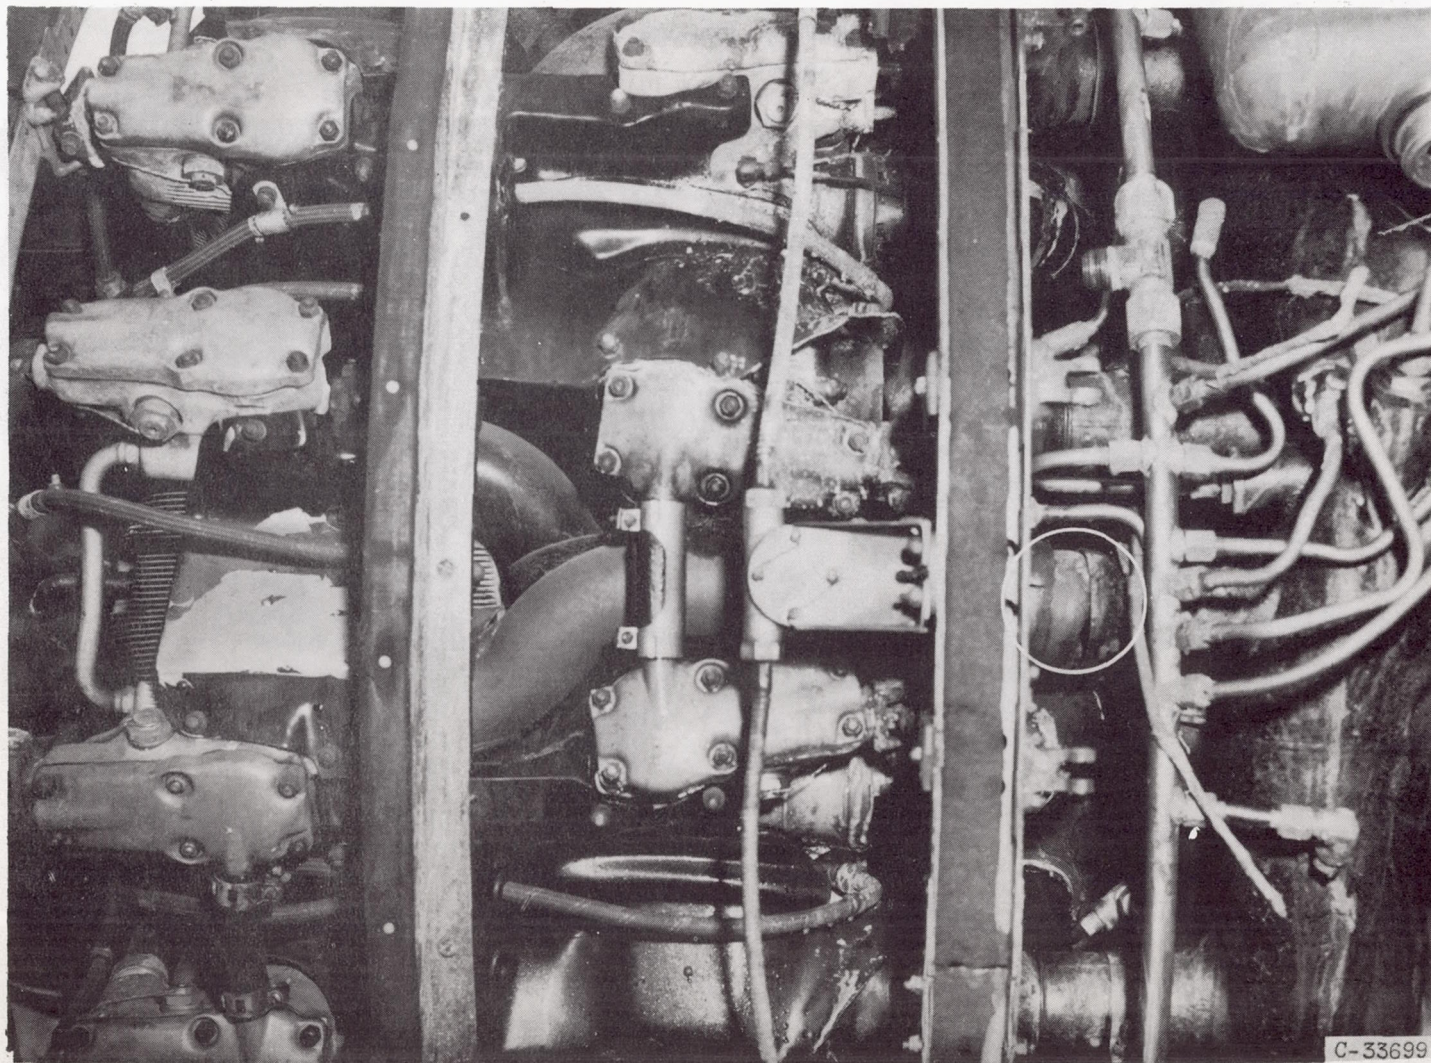
(a) Cylinder 14.

Figure 6. - Gap in right-engine exhaust-stack connecting sleeve.

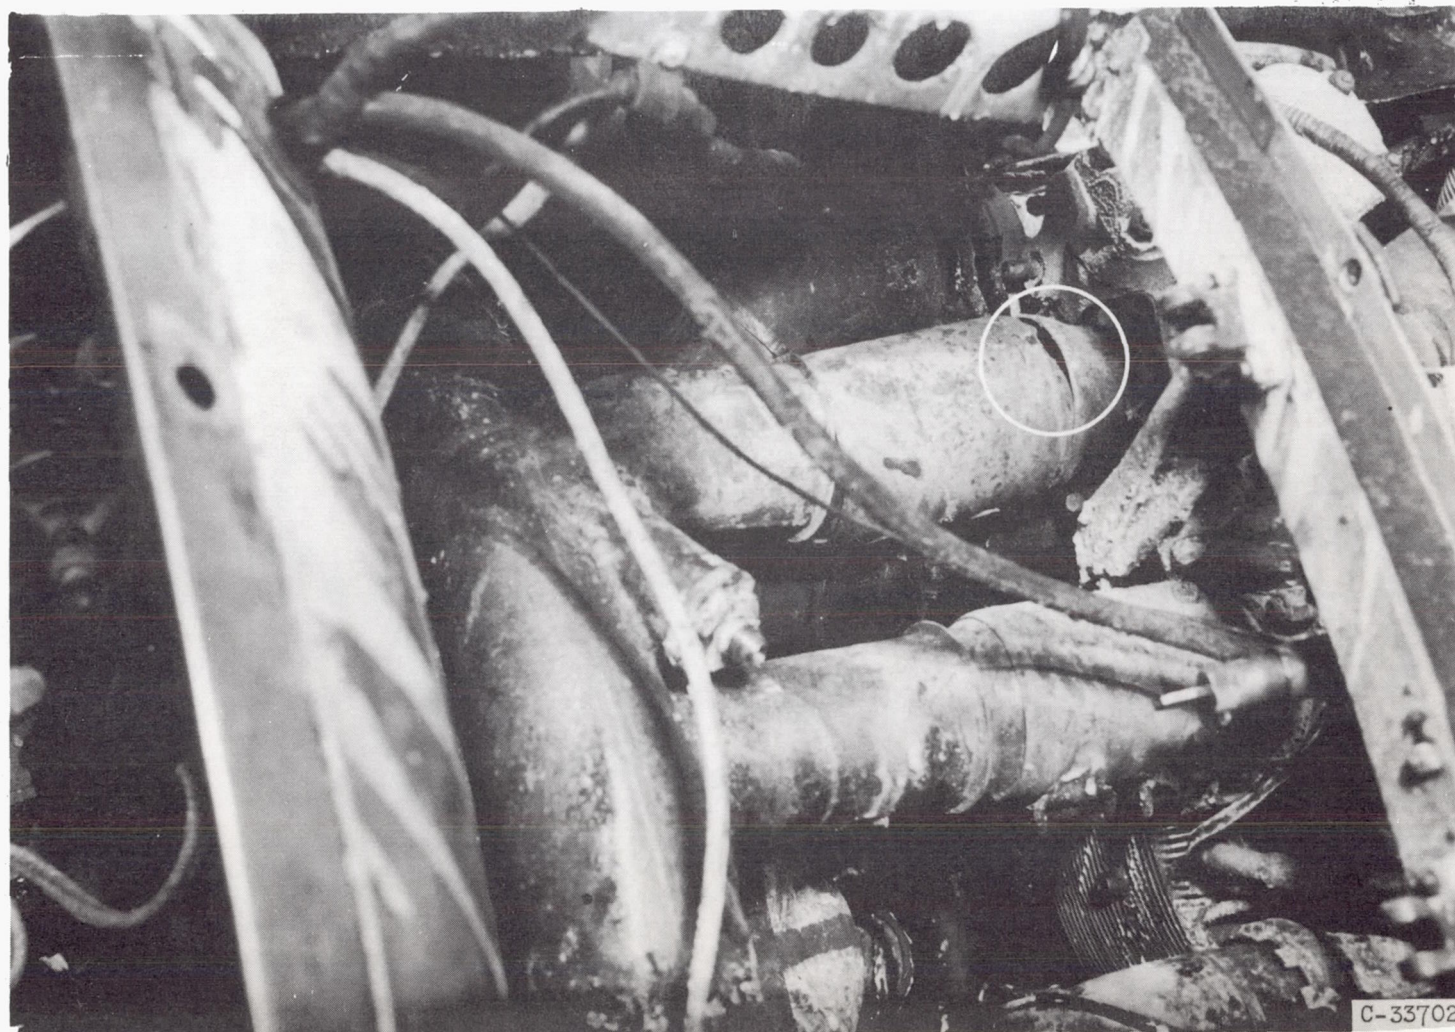
(b) Cylinder 2.

Figure 6. - Concluded. Gap in right-engine exhaust-stack connecting sleeve.

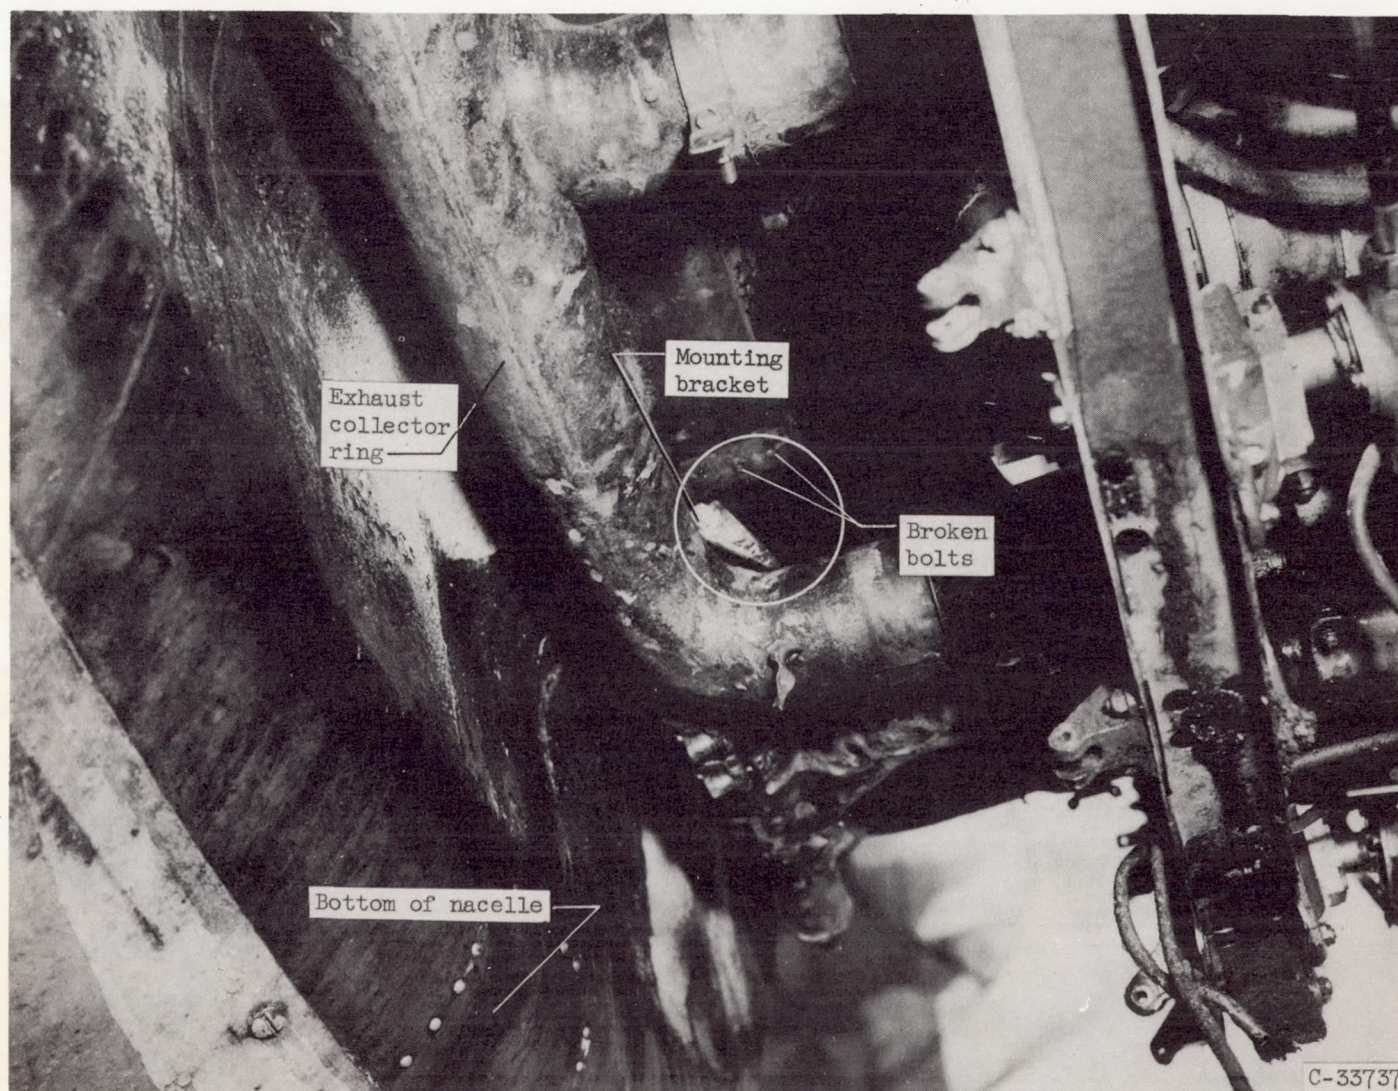
Figure 7. - Exhaust-collector-ring mounting bracket broken from its support.

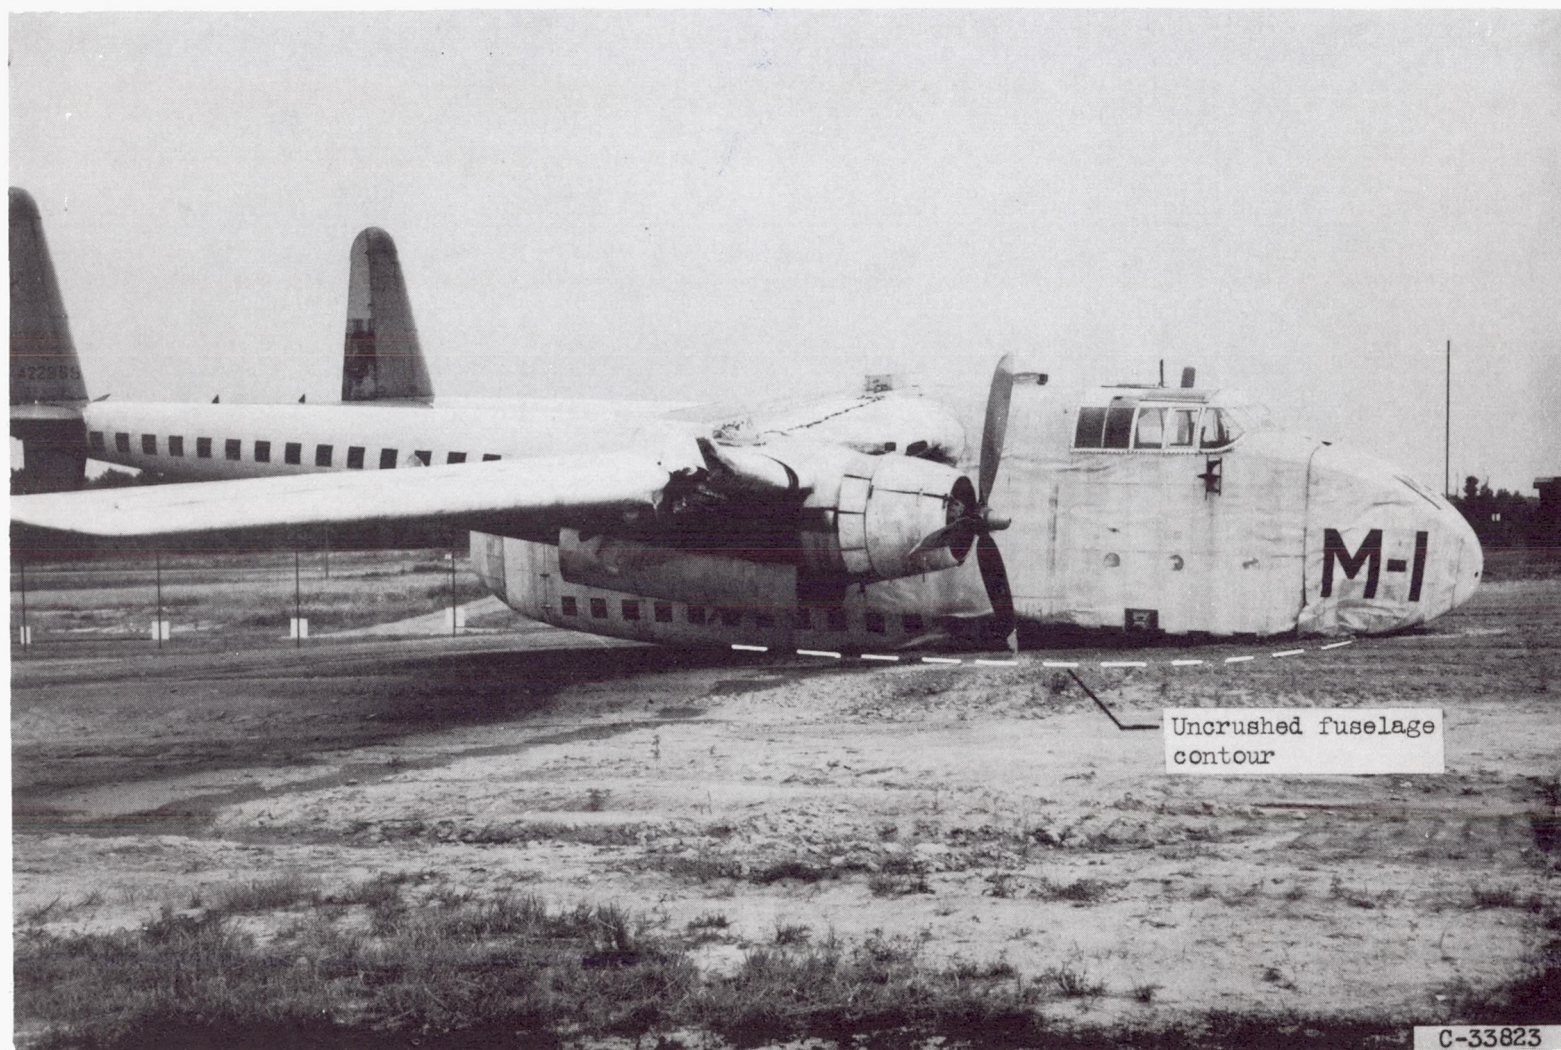
(a) Right side.

The amount of fuselage crushing that occurred during the crash is shown in the photographs of the right and left sides of the airplane in figures 8(a) and (b), respectively. The dotted lines in each figure define the original contour of the fuselage before the crash. In order to determine the extent of the crash damage to the skin and structure on the belly of the airplane, the fuselage was jacked up and examined. Figure 9 is a front view of the fuselage belly showing the damage to the skin and structure. The large opening in the center of the fuselage belly is the nose-gear well. The damage directly behind this opening was caused by the nose-gear strut's being driven rearward by impact with the ground and by the subsequent slide of the airplane. The skin and structure on each side of this opening was twisted and ripped. A front view of the nose gear and front bulkhead in figure 10 shows the structural damage to the bulkhead to which the nose-gear assembly was attached. This entire bulkhead was torn loose by the nose gear as it was driven rearward for approximately 9 feet by the force of the crash. Figure 11(a) shows the buckled floor and the structural damage in the left front portion of the cargo compartment. Damage to the structure in the right front portion of the cargo compartment is shown in figure 11(b).

Figure 8. - Crash-damaged fuselage of airplane.

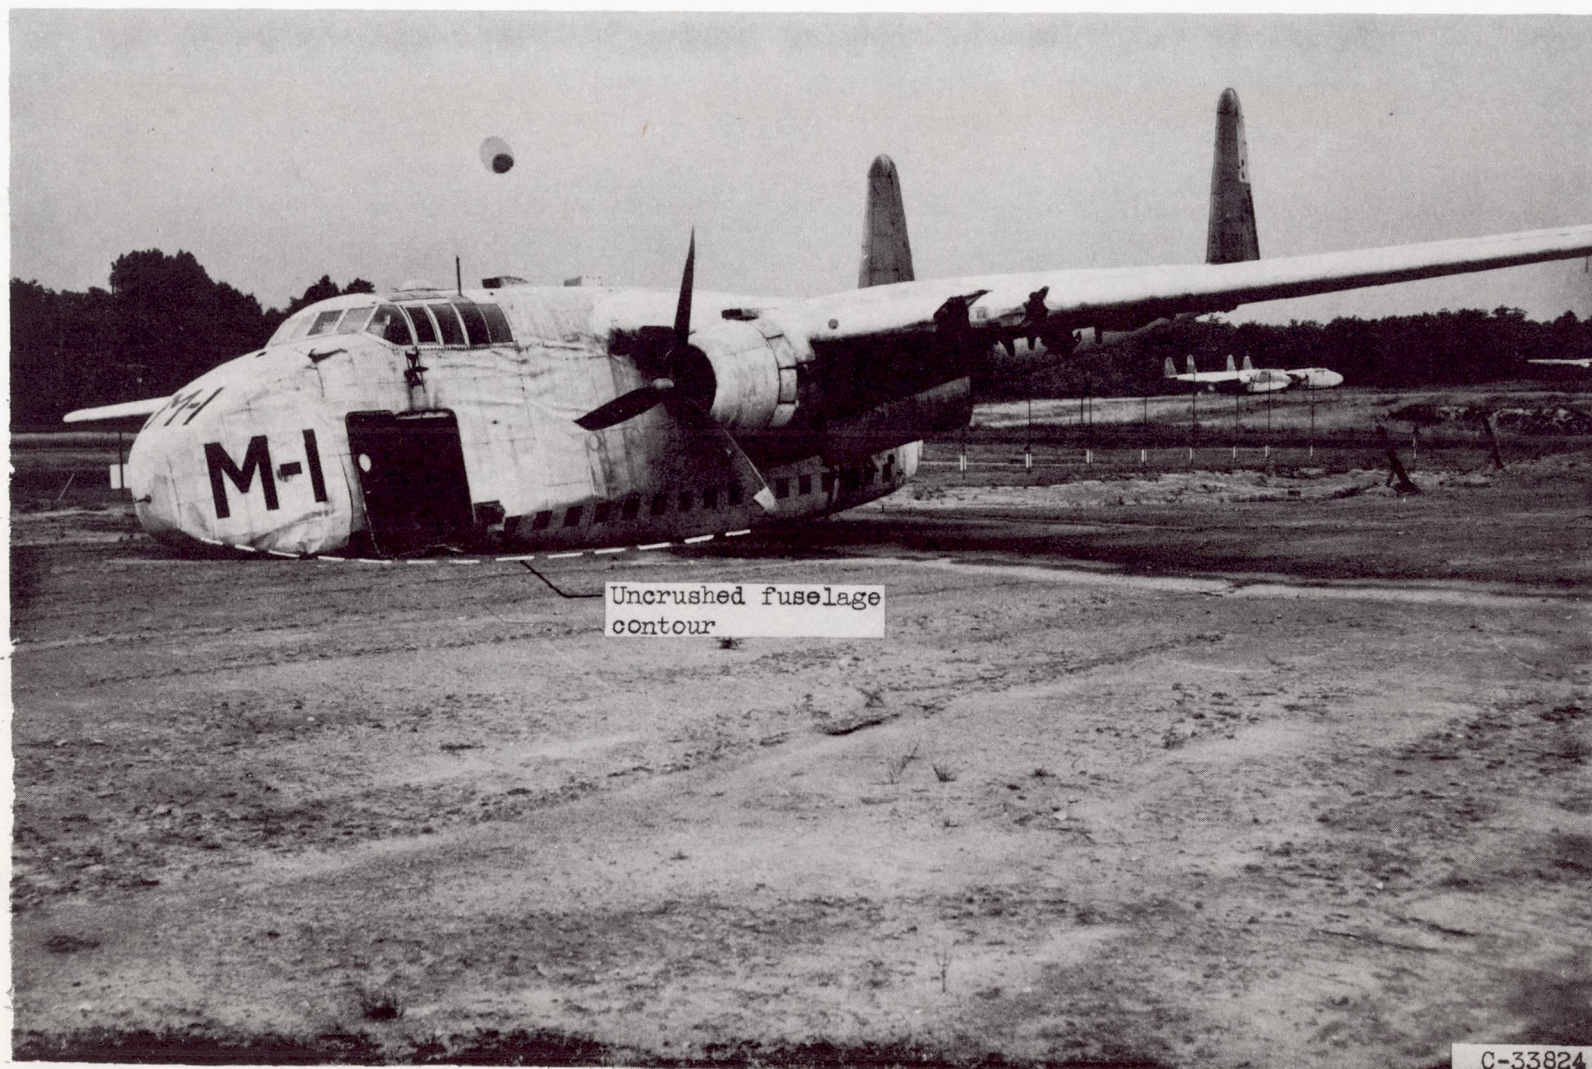
(b) Left side.

Figure 8. - Concluded. Crash-damaged fuselage of airplane.

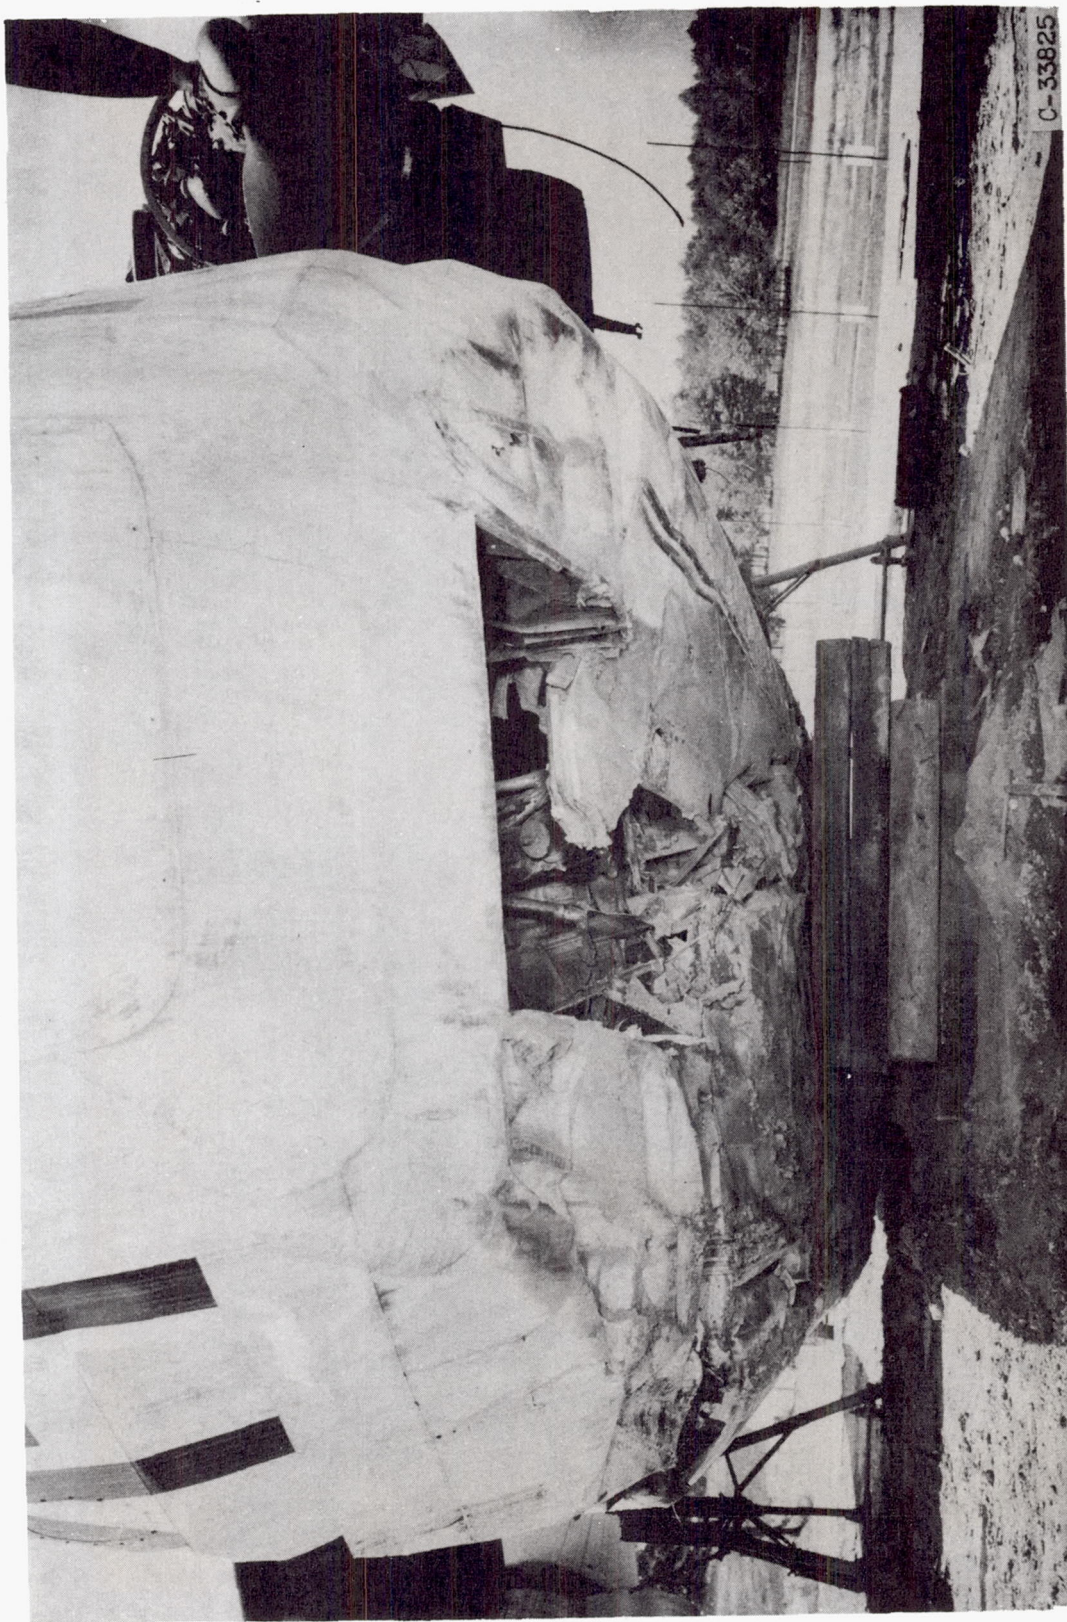
Figure 9. - Crash-damaged belly of airplane.

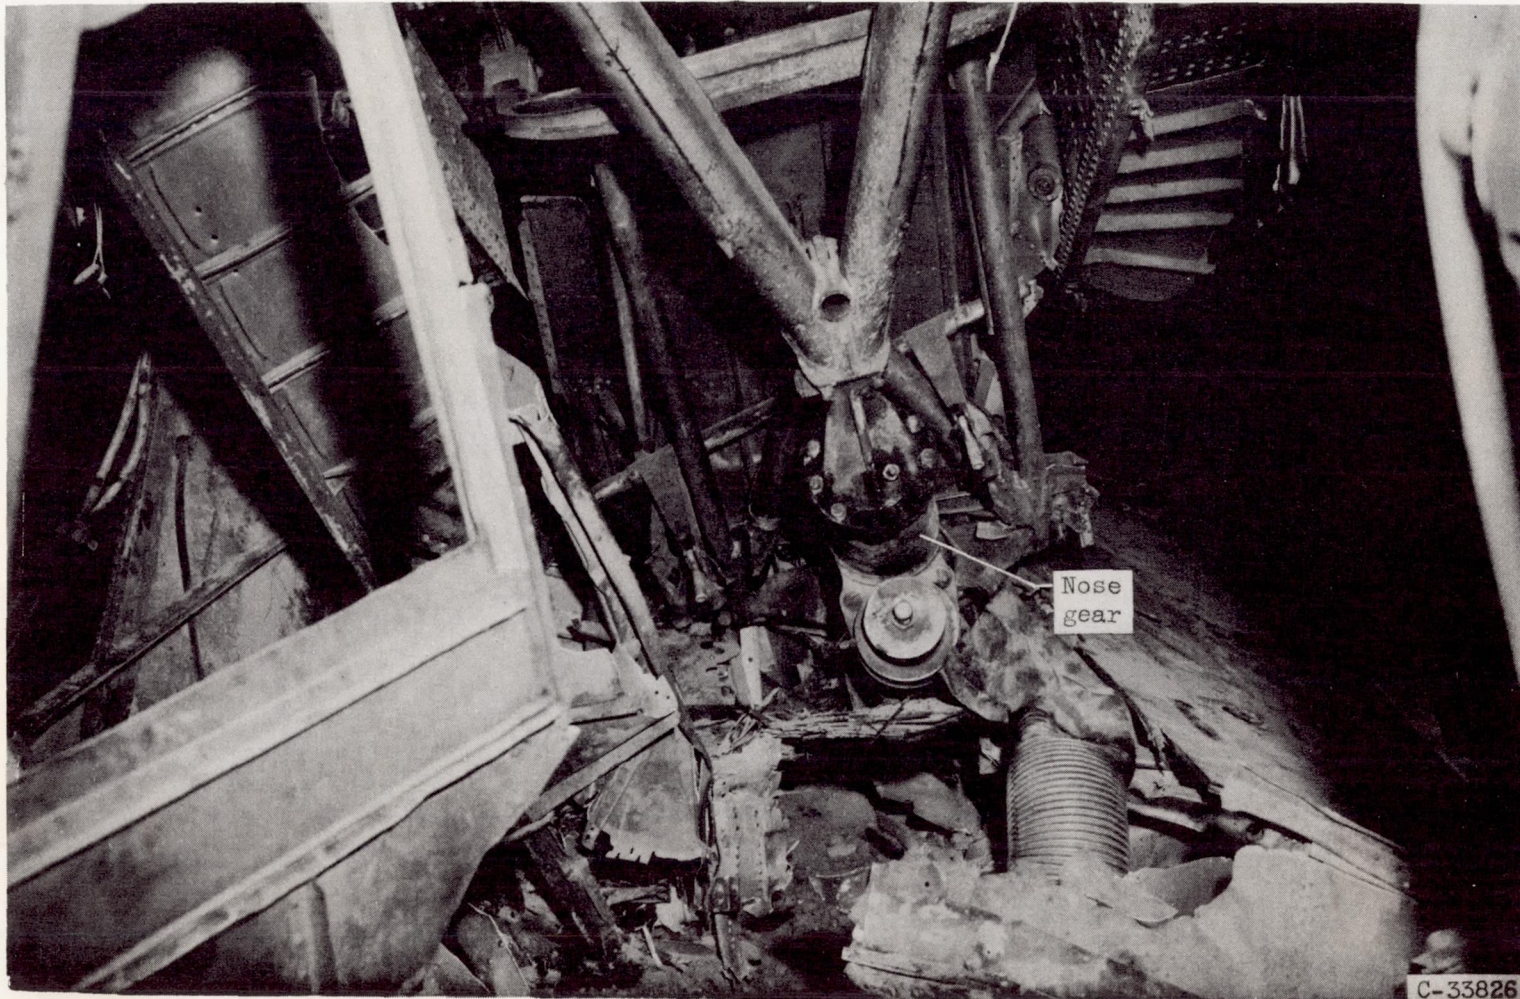
Figure 10. - Crash-damaged interior of nose-gear well.

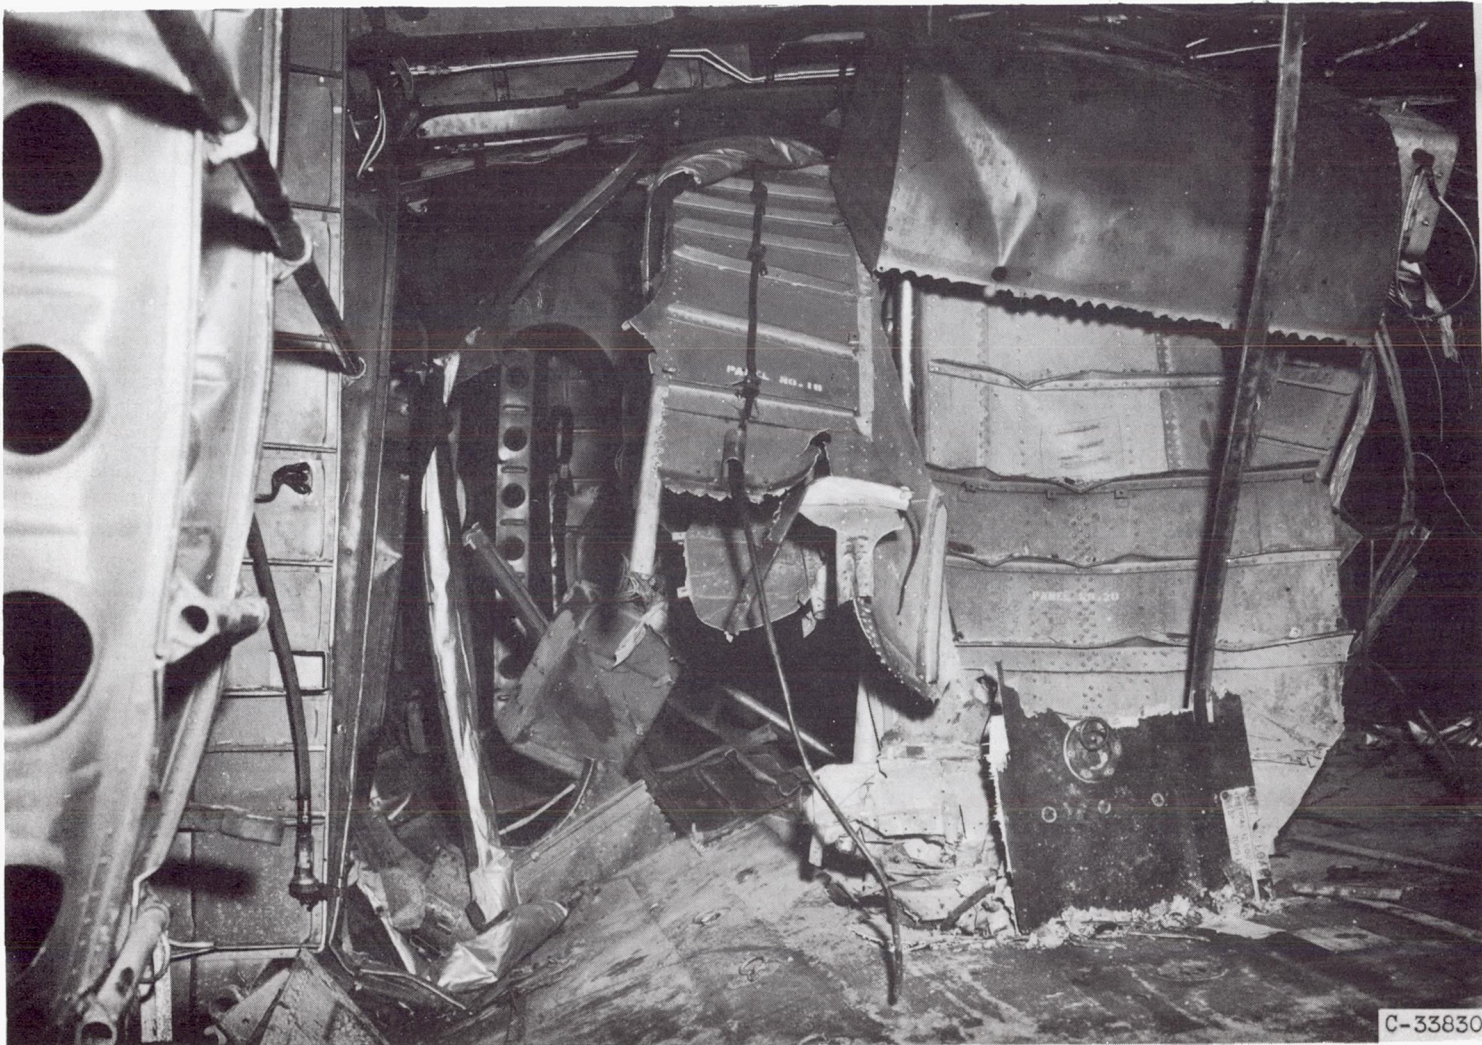
(a) Left front.

Figure 11. - Crash-damaged interior of cargo compartment.

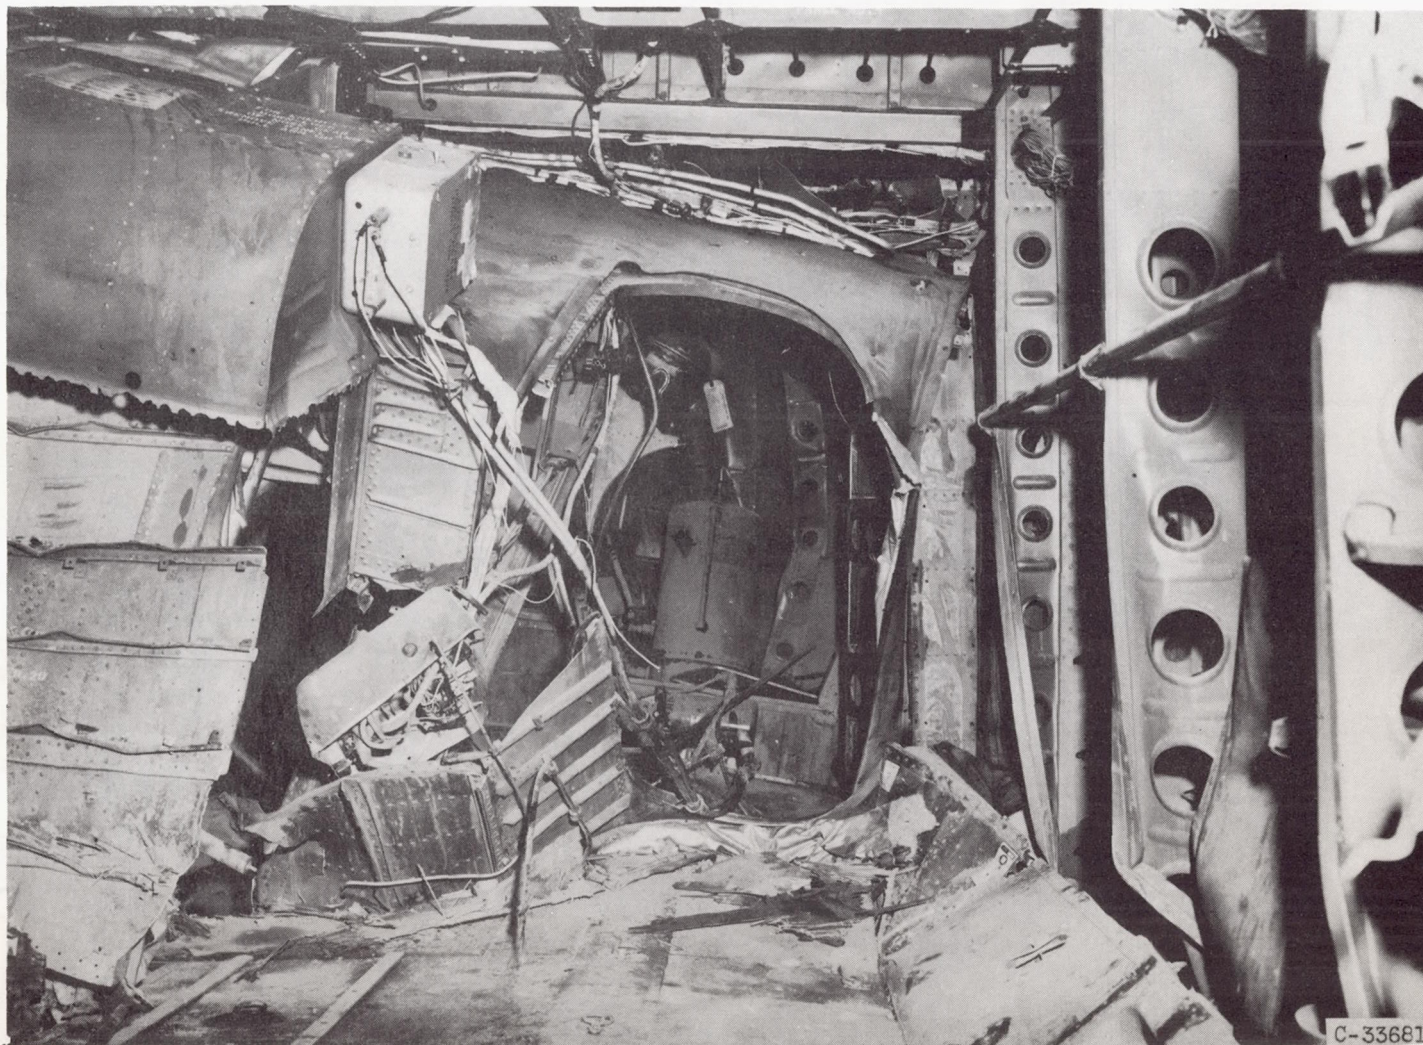
(b) Right front.

Figure 11. - Concluded. Crash-damaged interior of cargo compartment.
