IDENTIFICATION OF FOREIGN OBJECTS DAMAGING  
COMPRESSOR BLADES IN TURBOJET ENGINES

By A. E. Spakowski and J. Graab

Lewis Flight Propulsion Laboratory  
Cleveland, Ohio

January 7, 1957

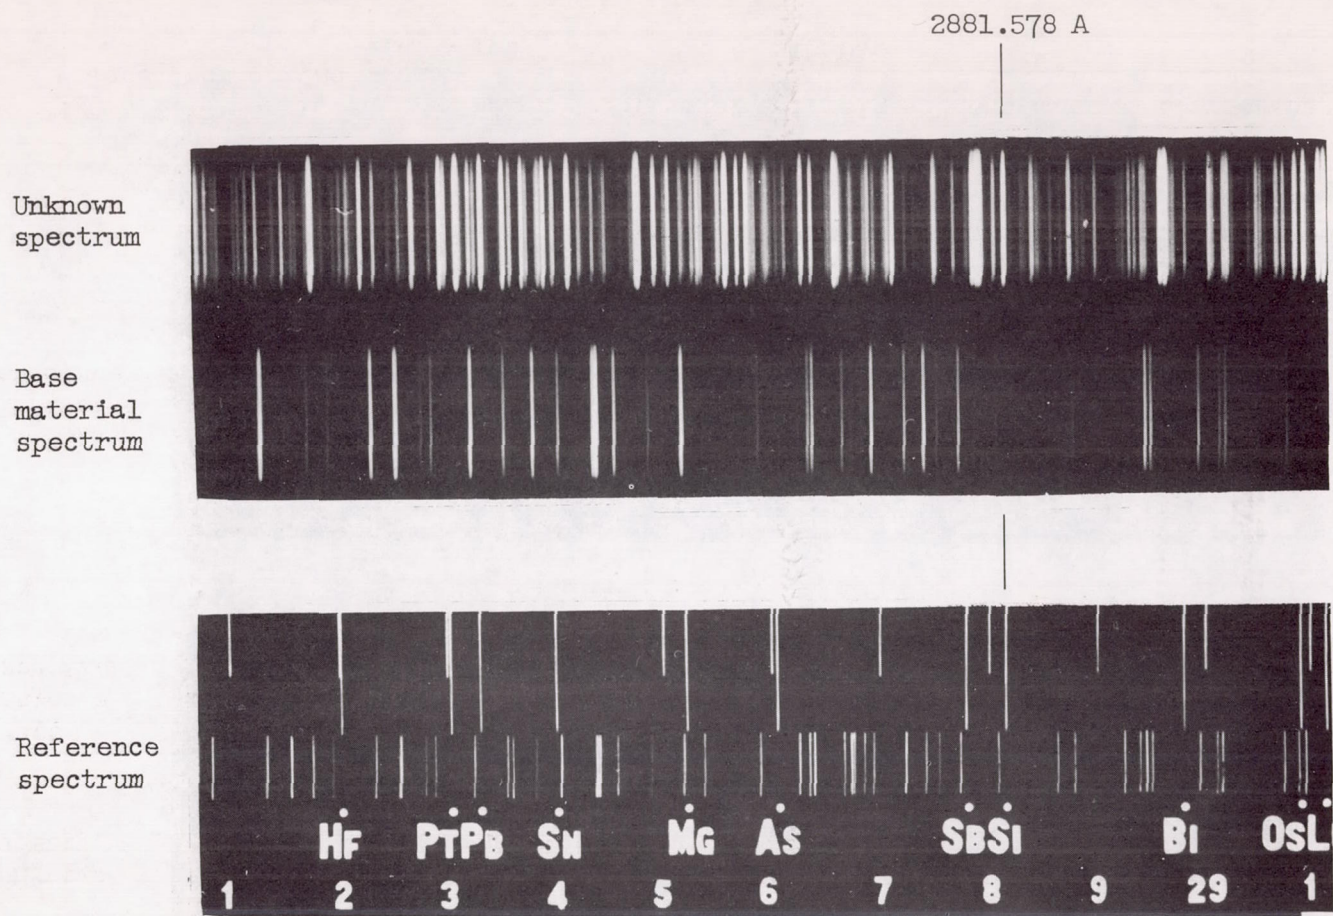
During the course of this study compressor blades became available from two engines that had suffered damage due to the ingestion of foreign objects. These engines were received new and were run entirely in jet, static test stands. The results of the analysis of the damaged compressor blades from these two engines (labeled A and B) are shown in table IV. The compressor of engine A had been severely damaged, and damaged areas where copper and aluminum metal were clearly visible could be easily observed. In testing the spectroscopic method, however, only those areas where minor damage occurred were used. In actual practice every available means would be used to aid in the identification of the foreign material. The compressor of engine A has aluminum blades in the first stages and 403 stainless-steel blades in the remaining stages. A number of damaged areas on each type blade was analyzed; the results in table IV show that the principal element in each foreign material was found. It was known beforehand that engine B was damaged by a titanium carbide cermet with nickel as the binding agent. Upon analysis large quantities of titanium and nickel were found with trace amounts of aluminum and magnesium. The origin of the aluminum and magnesium is unknown.

(a) Identification of silicon.

Figure 1. - Emission spectrum of a foreign-object-damaged compressor blade from engine A.

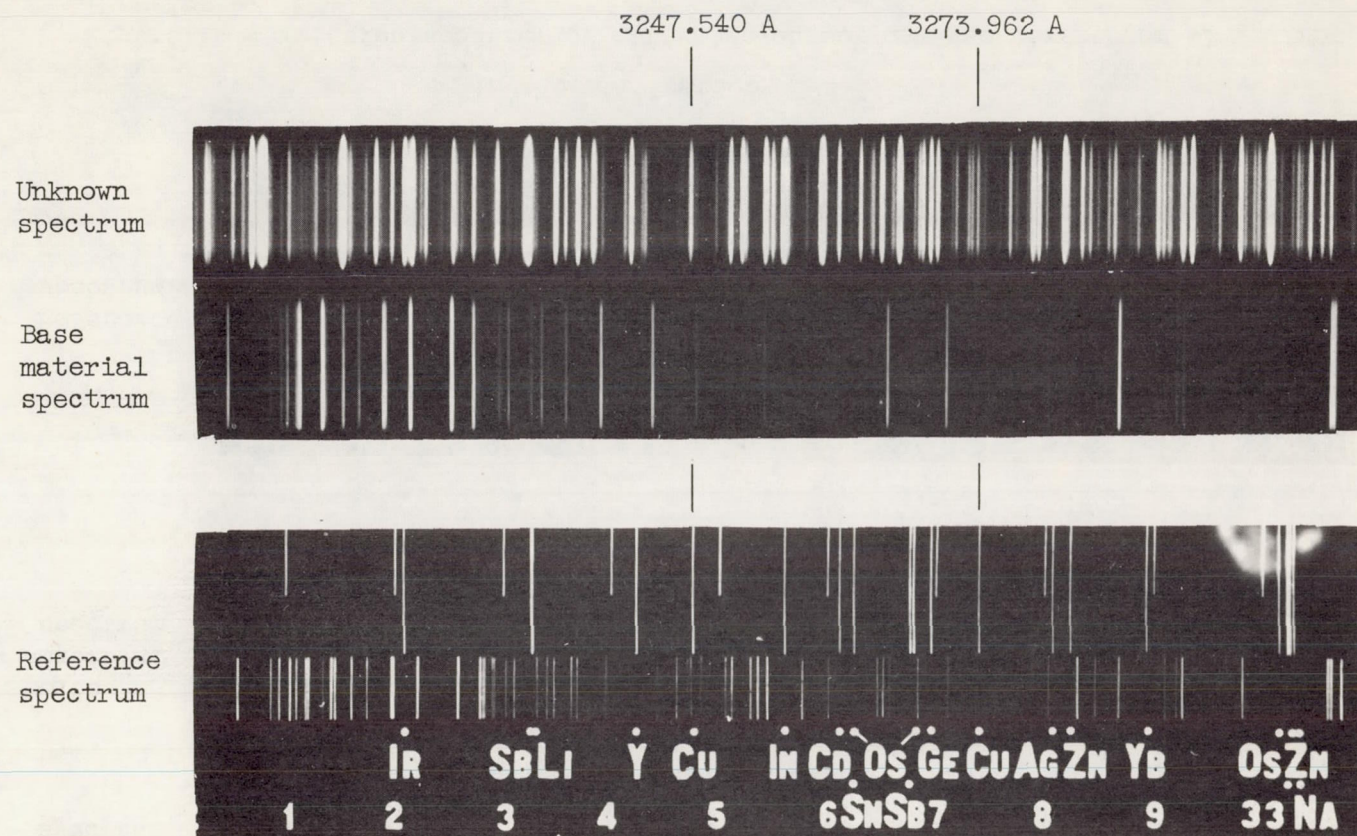
(b) Identification of copper.

Figure 1. - Concluded. Emission spectrum of a foreign-object-damaged compressor blade from engine A.

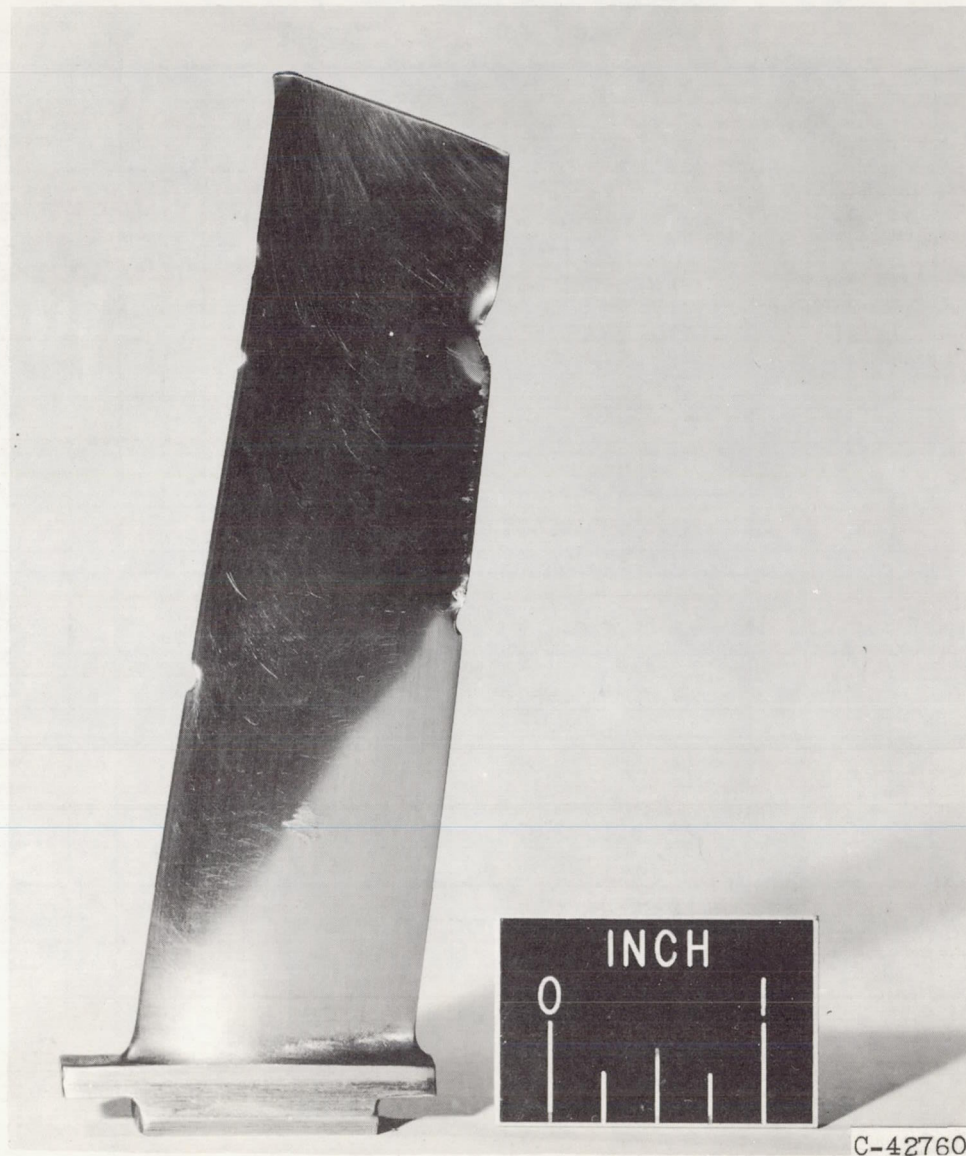
The type of samples that were studied is shown in figure 3, which is a photograph of a typical compressor blade damaged by material ingested through the engine inlet. Damaged areas include nicks in the leading edge of the blade, pits in the body, and dents in the trailing edge. The materials inflicting this damage would leave behind small fragments of themselves, depending, of course, upon their relative hardnesses and striking forces, among other things. A spectroscopic technique was chosen as the one offering the most advantageous approach to the problem. In this method the sample preparation would be negligible, actual analysis time short, and low concentrations of chemical elements could be detected. The first approach was to set up a standard procedure and then attempt to evaluate its merits.

Figure 3. - Compressor-blade damage caused by foreign objects ingested by the engine.
