# RESEARCH MEMORANDUM

EFFECT OF FORGING TEMPERATURE AND HEAT TREATMENT  
ON THE PERFORMANCE OF INCONEL 700 BUCKETS AT  
1625° F IN A J33-9 TURBOJET ENGINE

Lewis Flight Propulsion Laboratory  
Cleveland, Ohio

February 18, 1958  
Declassified March 18, 1960

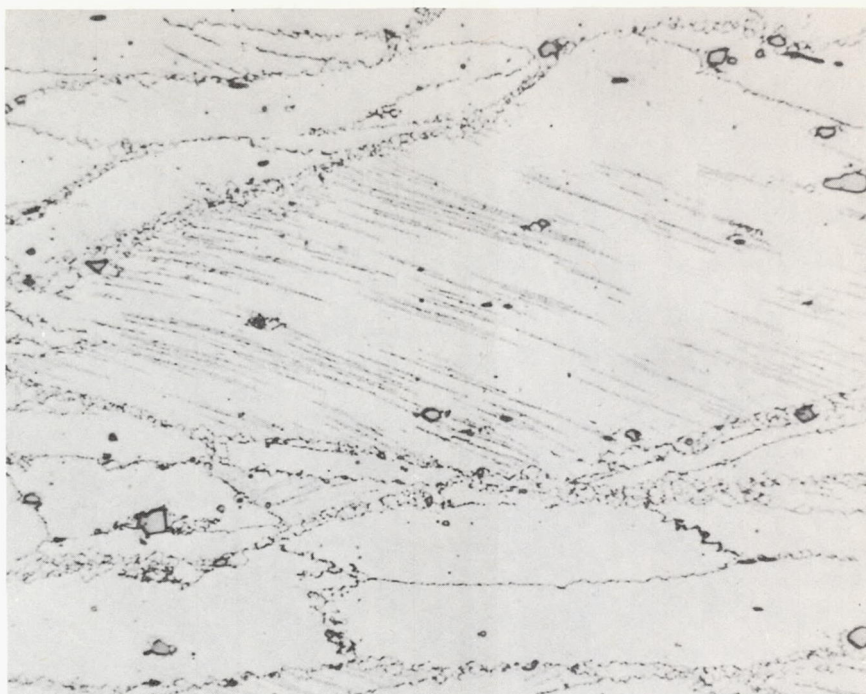
While the structures shown in figure 10 are typical, there were isolated regions within buckets that differed. Examples of these microstructures are presented in figure 11. Figures 11(a) and (b) show slipline precipitates present in the leading and trailing edges of buckets that were forged and aged only (not solution-treated). Various degrees of grain-boundary precipitation in the buckets of all lots are presented in figure 11(c). Precipitation of the magnitude shown in the lower part of figure 11(c) was very rare. The development of void formation at the interface between titanium carbonitride and the matrix in the buckets that were solution-treated at  $2275^{\circ}F$  can be seen in figure 11(d). Figure 11(e) shows a region with sawtooth grain boundaries.

(a) Slipline precipitate found in the leading and trailing edges of lot 1 and lot 5 buckets.

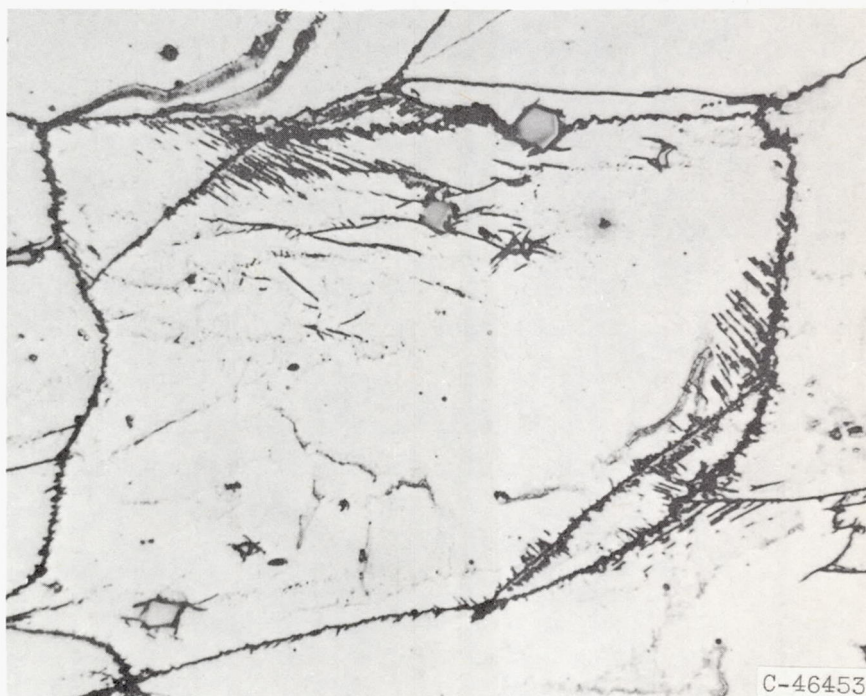
(b) Feathery precipitate found in lot 1 and lot 5 buckets.

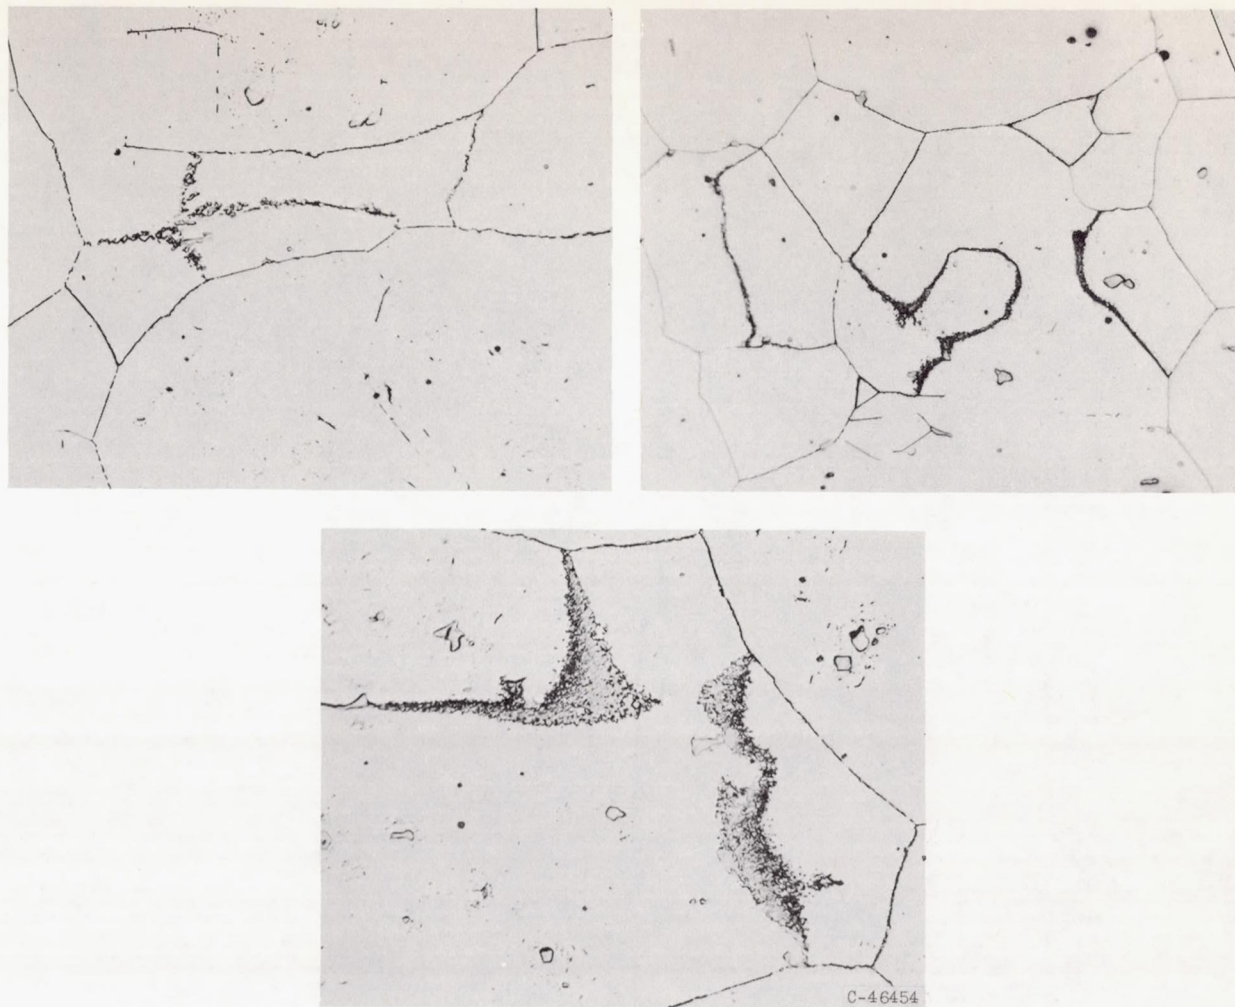
(c) Types of grain-boundary precipitation found in Inconel 700 buckets.

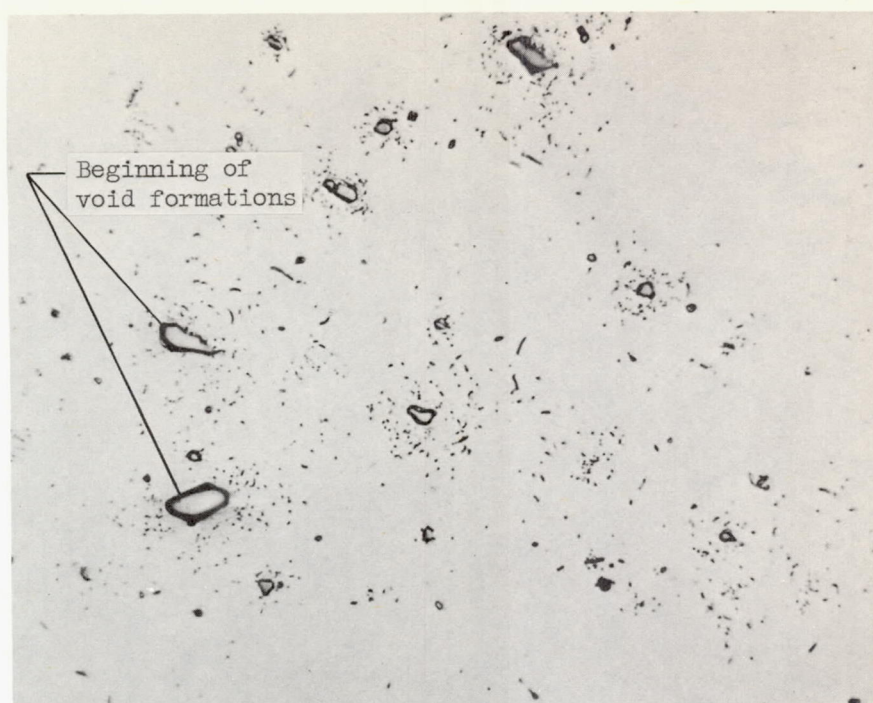
(d) Beginning of void formation in Inconel 700 buckets solution-treated at 2275° F.

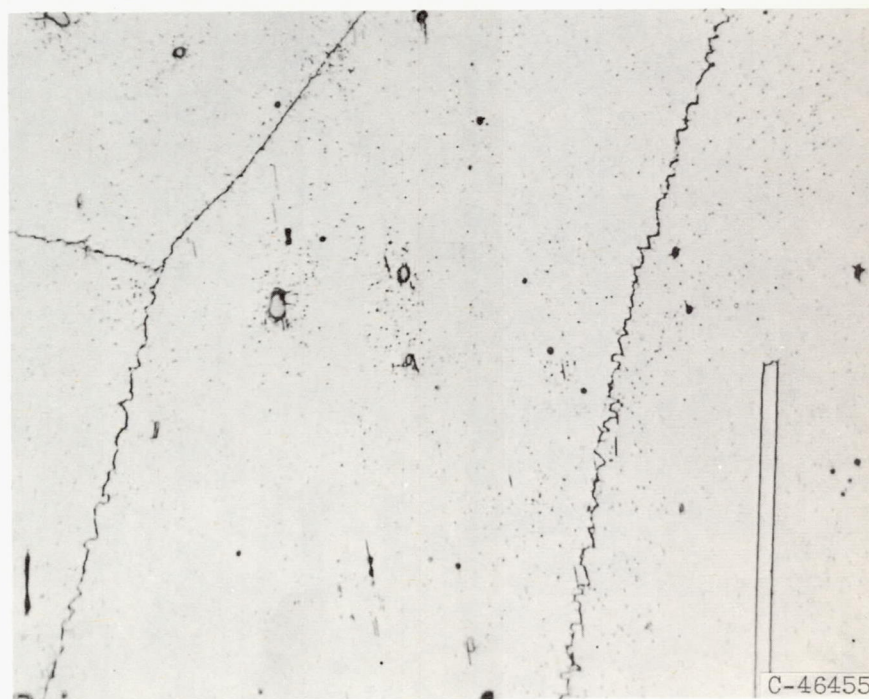
(e) Sawtooth grain boundaries found in Inconel 700 buckets.

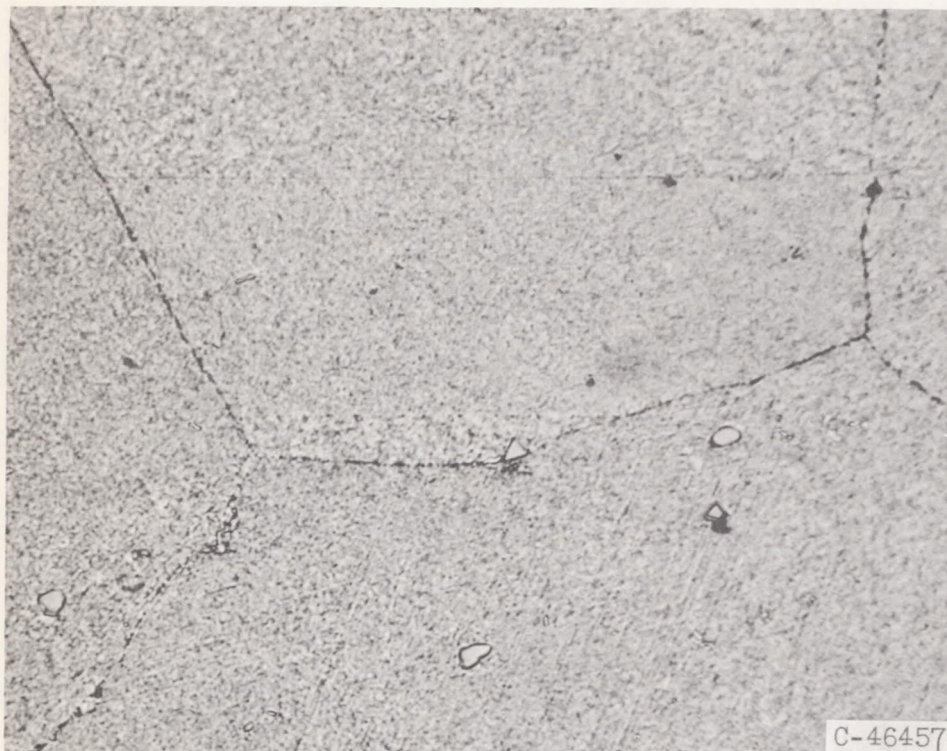
The micro-examination of the failed buckets revealed that appreciable precipitation occurred in the alloy during engine operation. An example of the typical precipitation is presented in figure 12. Occasionally, agglomeration of precipitates occurred in localized sections of buckets. An example of the precipitate agglomeration is shown in figure 13.

Figure 12. - Typical microstructure of failed buckets. (Lot 3 bucket operated 421 hours.) Original magnification, X750.

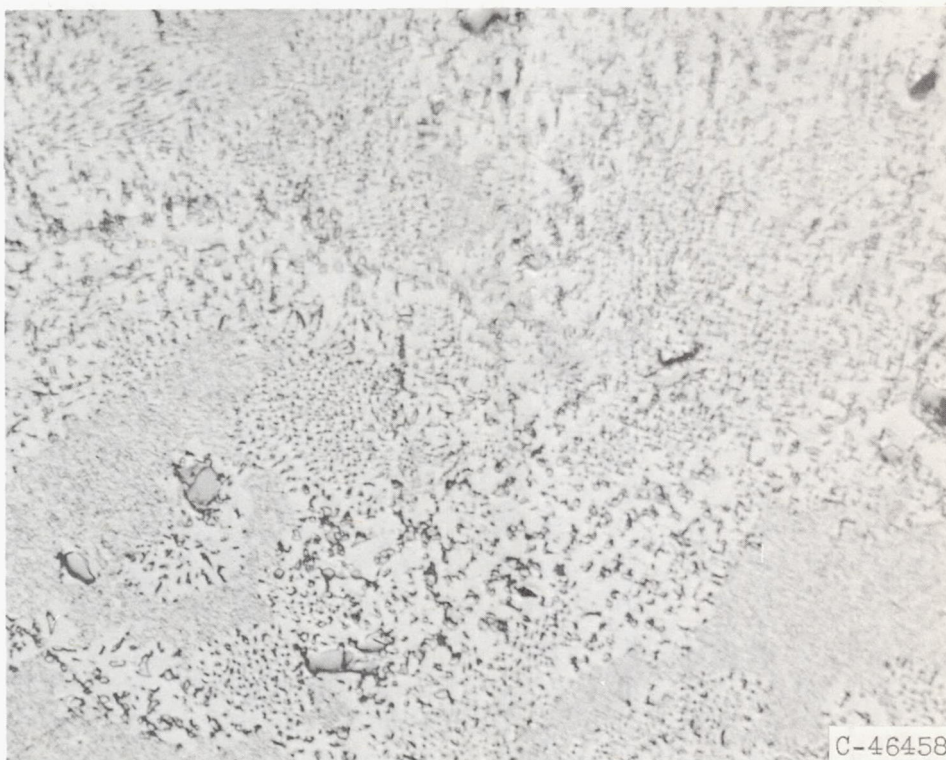
Figure 13. - Agglomeration of precipitates in a failed bucket. Original magnification, X750.

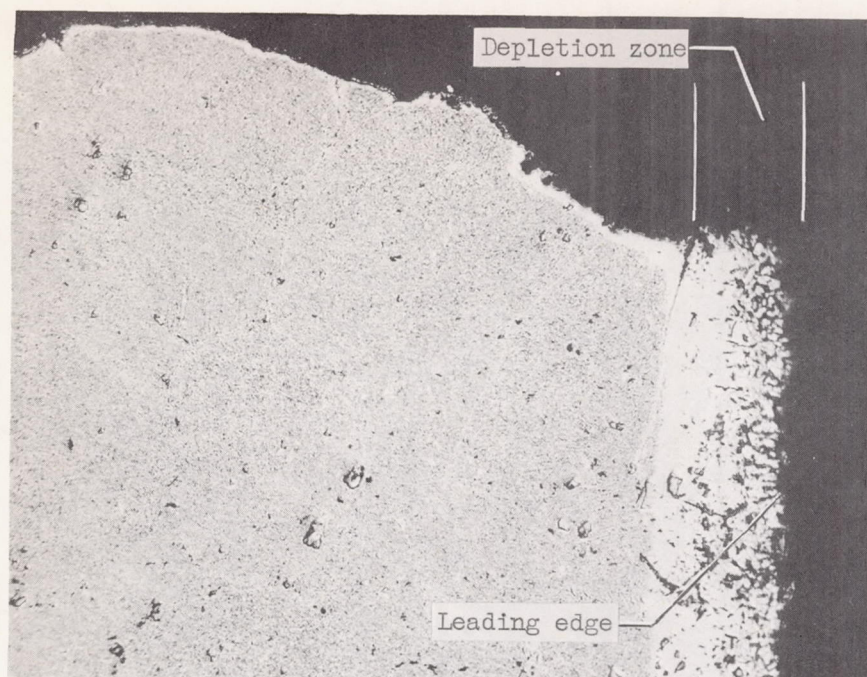
The microstructural studies also revealed that all operated buckets exhibited various degrees of surface depletion that appeared to be related to the operating time. An example of a depletion zone is shown in figure 14(a). Occasionally, needle-like structures (possibly chromium nitrides) were noted in the depletion zones, as shown in figure 14(b).

(a) Depletion zone in bucket that fractured after 245 hours of operation. Original magnification, X250.

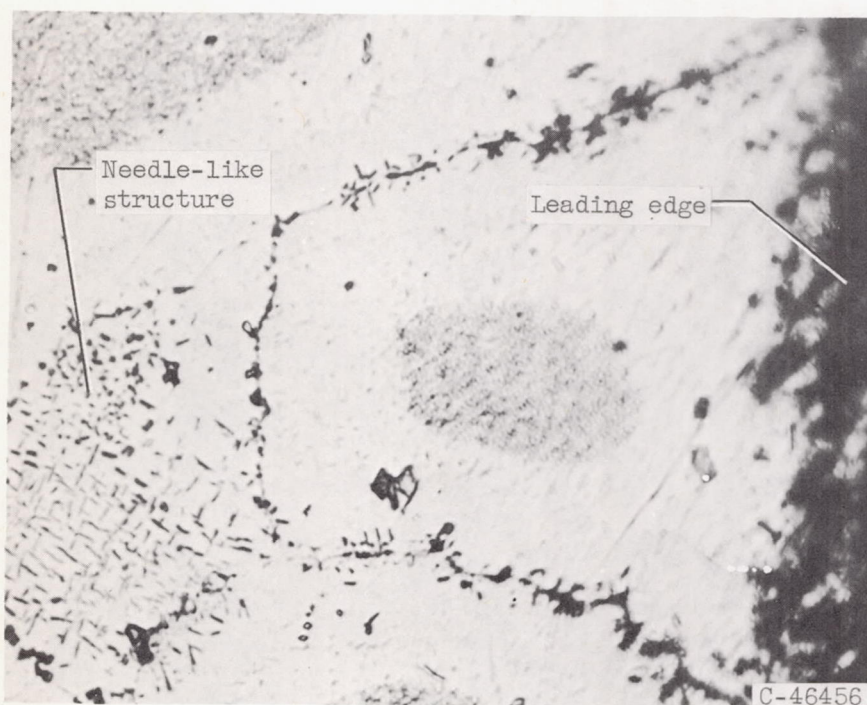
(b) Needle-like structure associated with the depletion zone of operated buckets. Original magnification, X1000.
