NATIONAL ADVISORY COMMITTEE FOR AERONAUTICS

FLUTTER TESTS OF B-34 FIN-RUDDER-TAB SYSTEM

By Theodore Theodorsen and N. H. Smith

MEMORANDUM REPORT

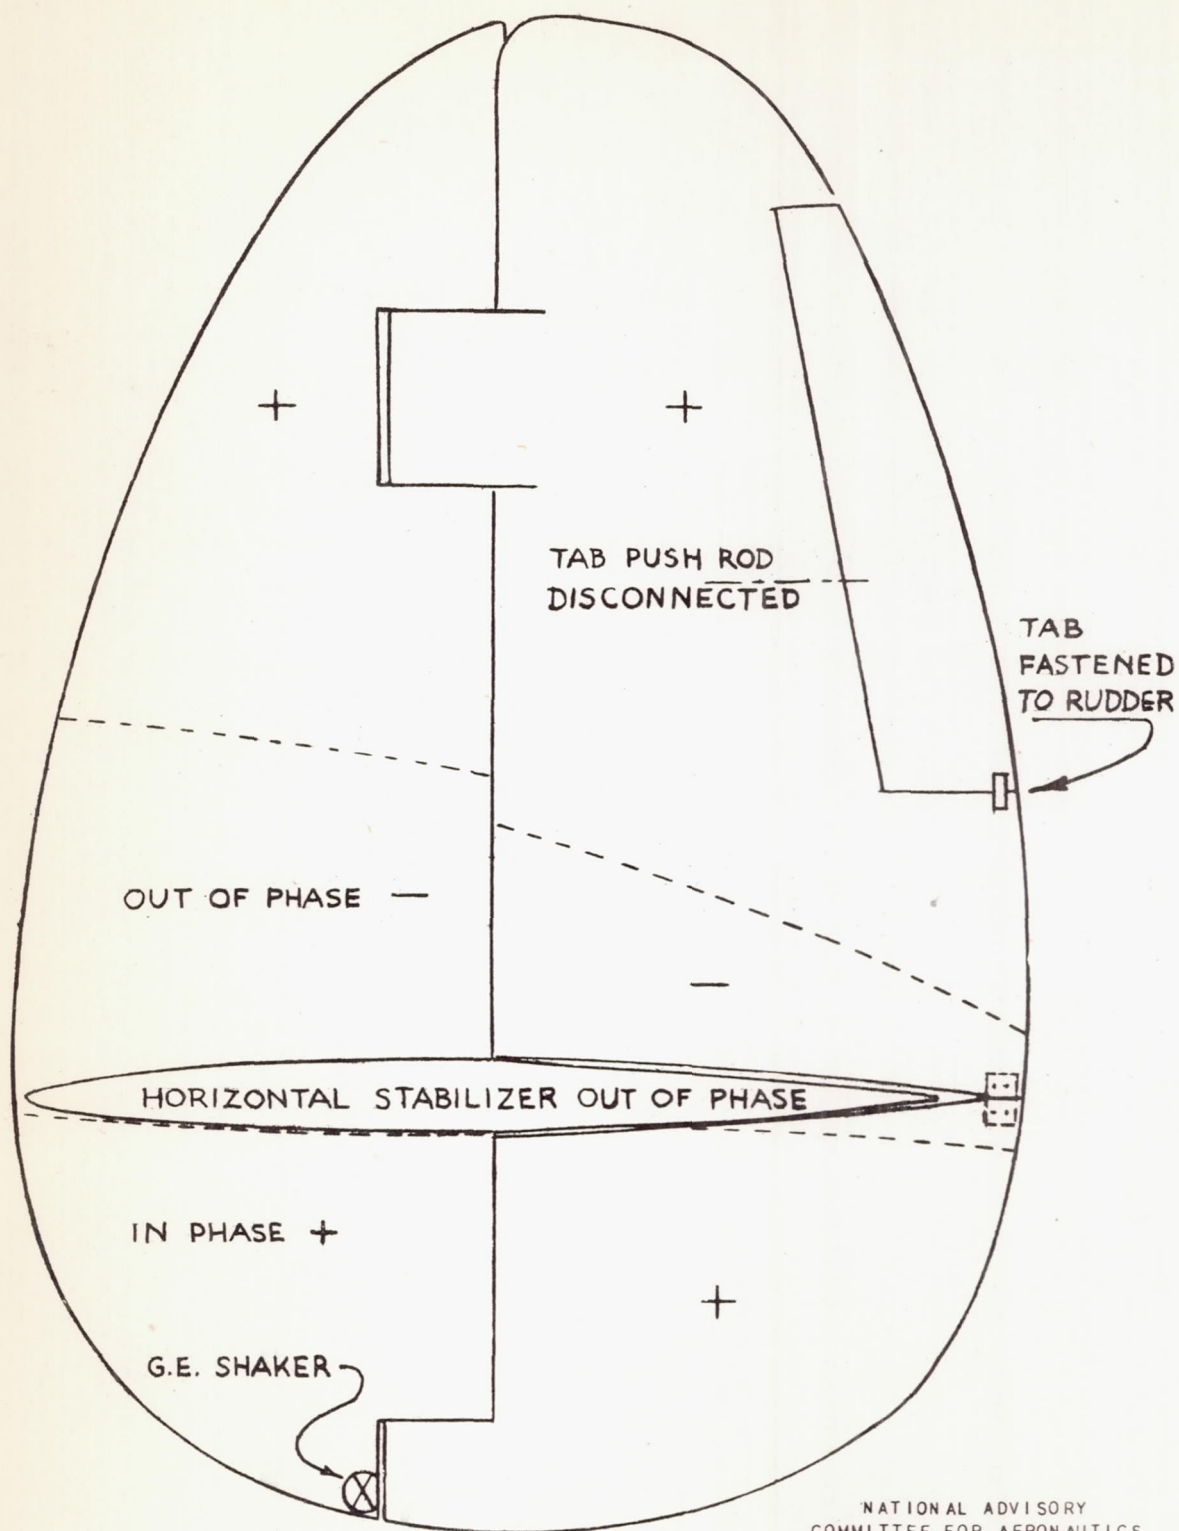
Table II and the oscillograph record in figure 7 show the rudder paddles and the upper-rudder trailing edge to be essentially in phase with one another in the case of the mild flutter. These parts of the rudder are in phase in the vibration mode pictured in figure 1. Also, the tab frequency is very near the frequency for this mode. It is therefore concluded that the flutter mode consisted of a coupling between the tab and the mode of figure 1.

Figure 1.- Mode of vibration at 31.5 cps.

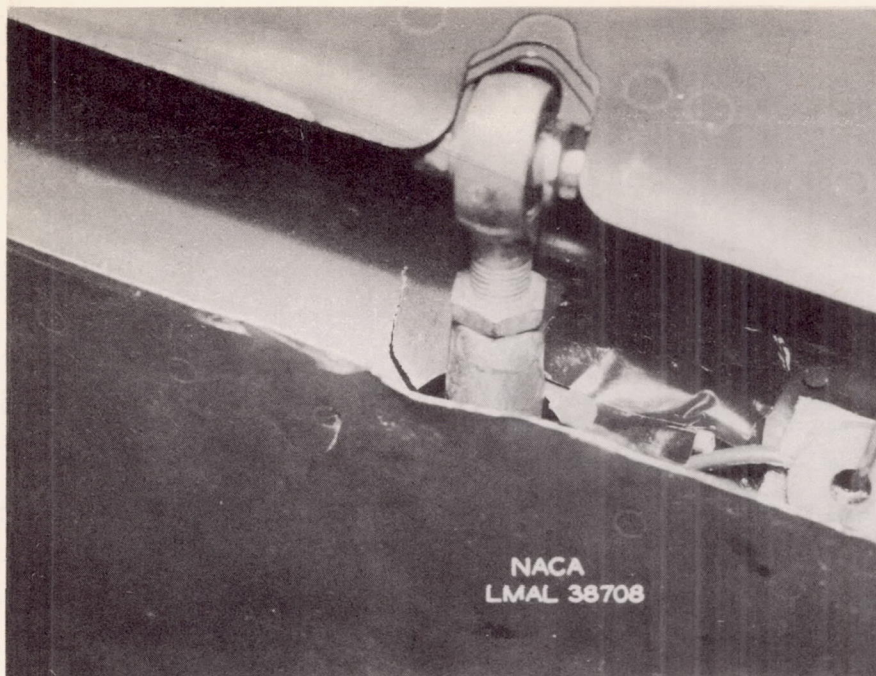
first encountered during a period of rather rapid increase in the speed of the tunnel, and the tab motion became excessive. The flutter caused damage to the rudder trailing edge at the tab push-rod cut-out and the skin of the upper rudder was buckled slightly in the vicinity of the rudder mast. This damage is shown in figure 5.

(a) Damage to trailing edge of rudder.

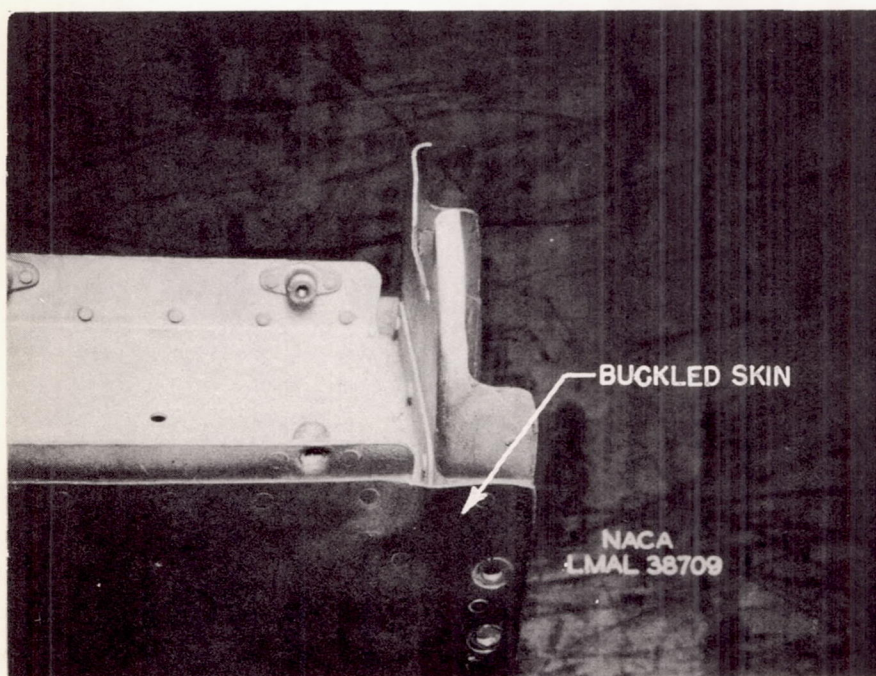
(b) Buckled skin on upper part of rudder.

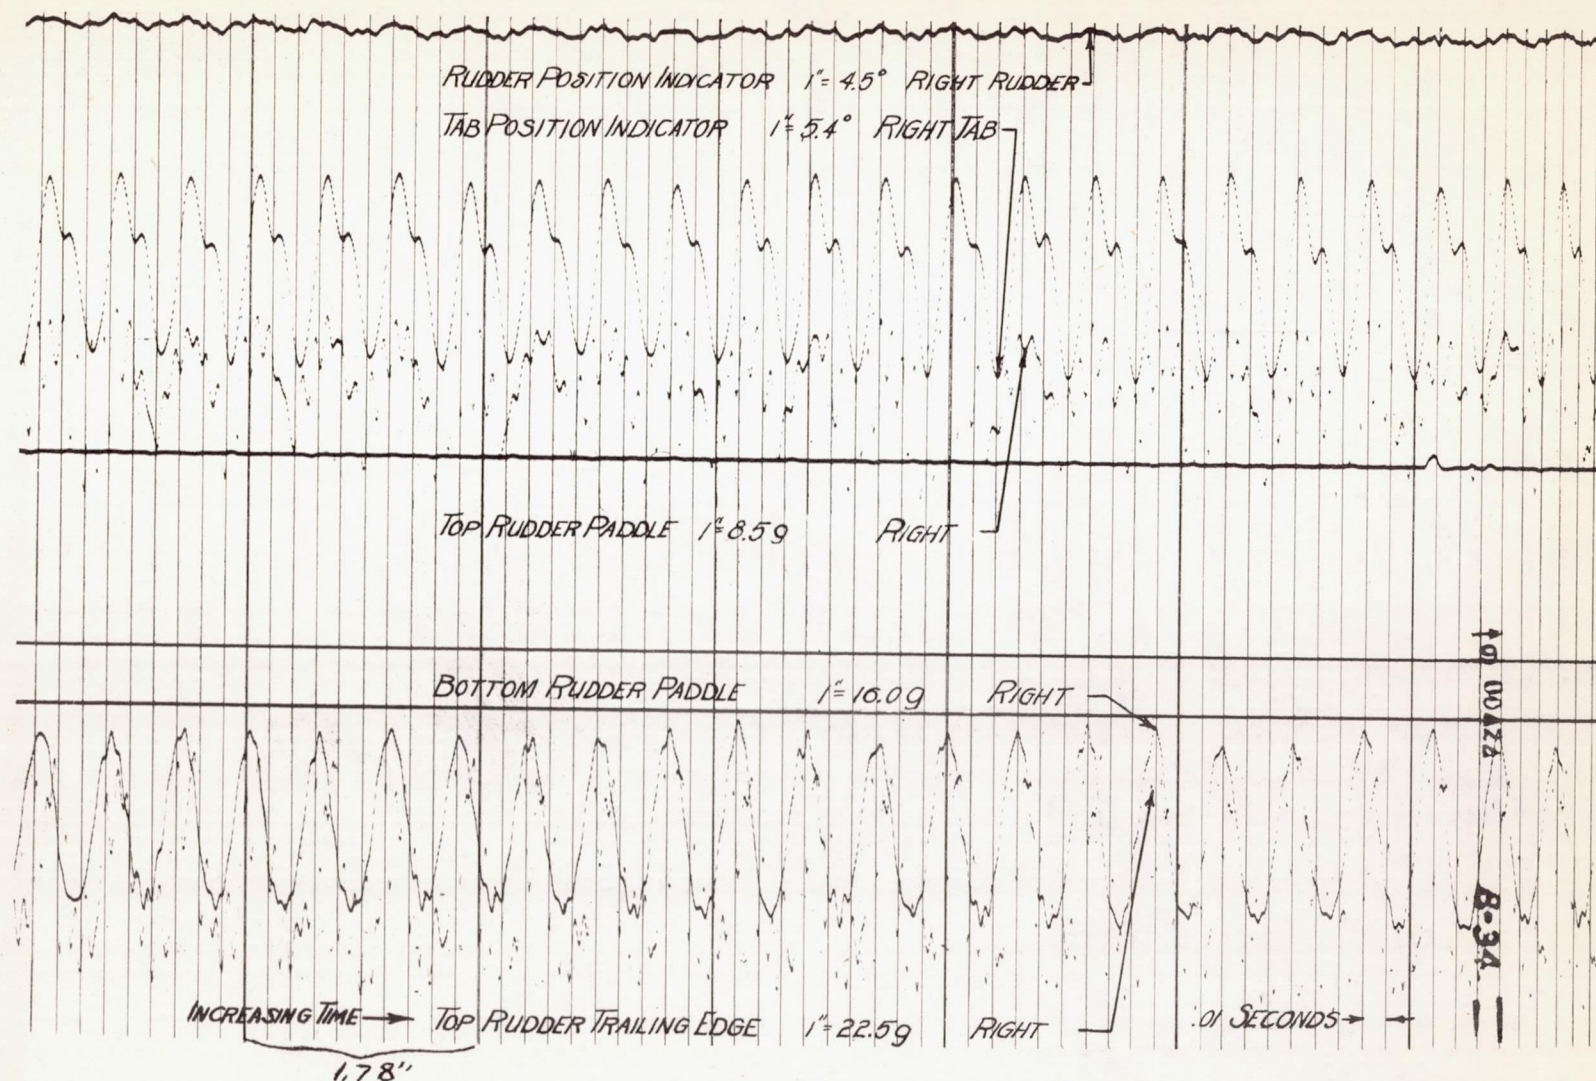
After the vibration tests, the run was repeated without repairs to the rudder surface. The tunnel velocity was increased gradually and oscillograph records were taken frequently. A plot of tab amplitude against tunnel velocity for the range between 260 and 315 miles per hour (tab play, 0.6°) is given in figure 6. A typical oscillograph record of the resulting mild tab flutter is shown in figure 7. The frequency and phases measured from a similar record are given in table II.

Figure 7.- Typical oscillograph record showing mild flutter. Tab play, 0.6° ; velocity, 308 mph; Mach number, 0.392; tab frequency, 32.5 cps.

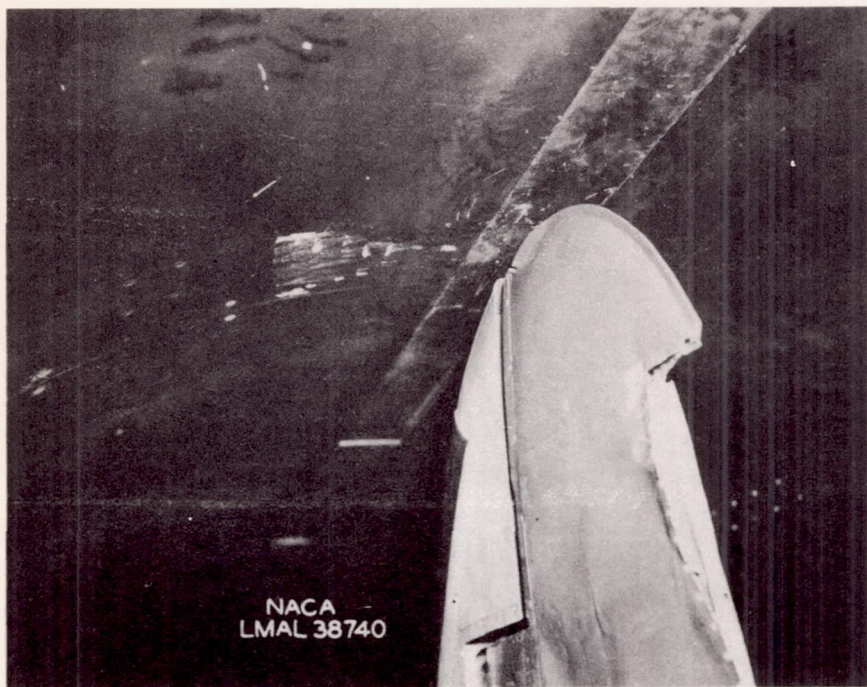
Figure 9.- Large horizontal displacement of fin during severe flutter indicated by marks on top of tunnel.

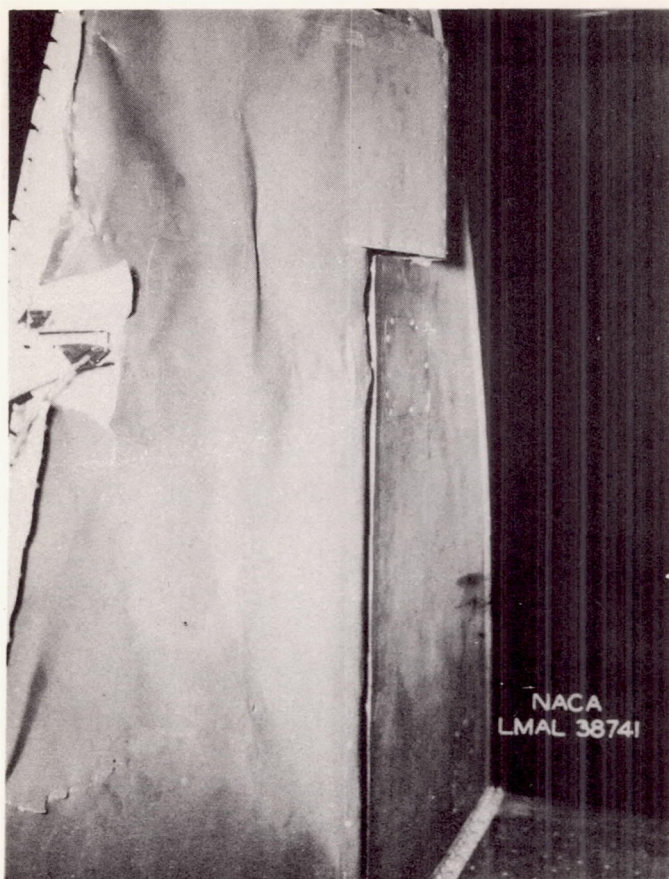
For condition (3), the rudder trim-tab control mechanism was removed from the fin and a spring was substituted in order to study the effect of tab frequency. Vibration tests indicated that the tab frequency was reduced to 19 cycles per second. Severe flutter occurred at a velocity of 368 miles per hour and the upper tail surfaces failed, the tab being blown out completely. The flutter involved horizontal displacements of several inches at the tops of the mount springs, and the top of the fin moved about 1 foot from center as shown in figure 9 by the marks on the top of the tunnel. Figure 10 shows the damaged surfaces. The flutter was so sudden and so violent that the oscillograph records were not taken until

Figure 10.- Damage to tail surface caused by severe flutter.

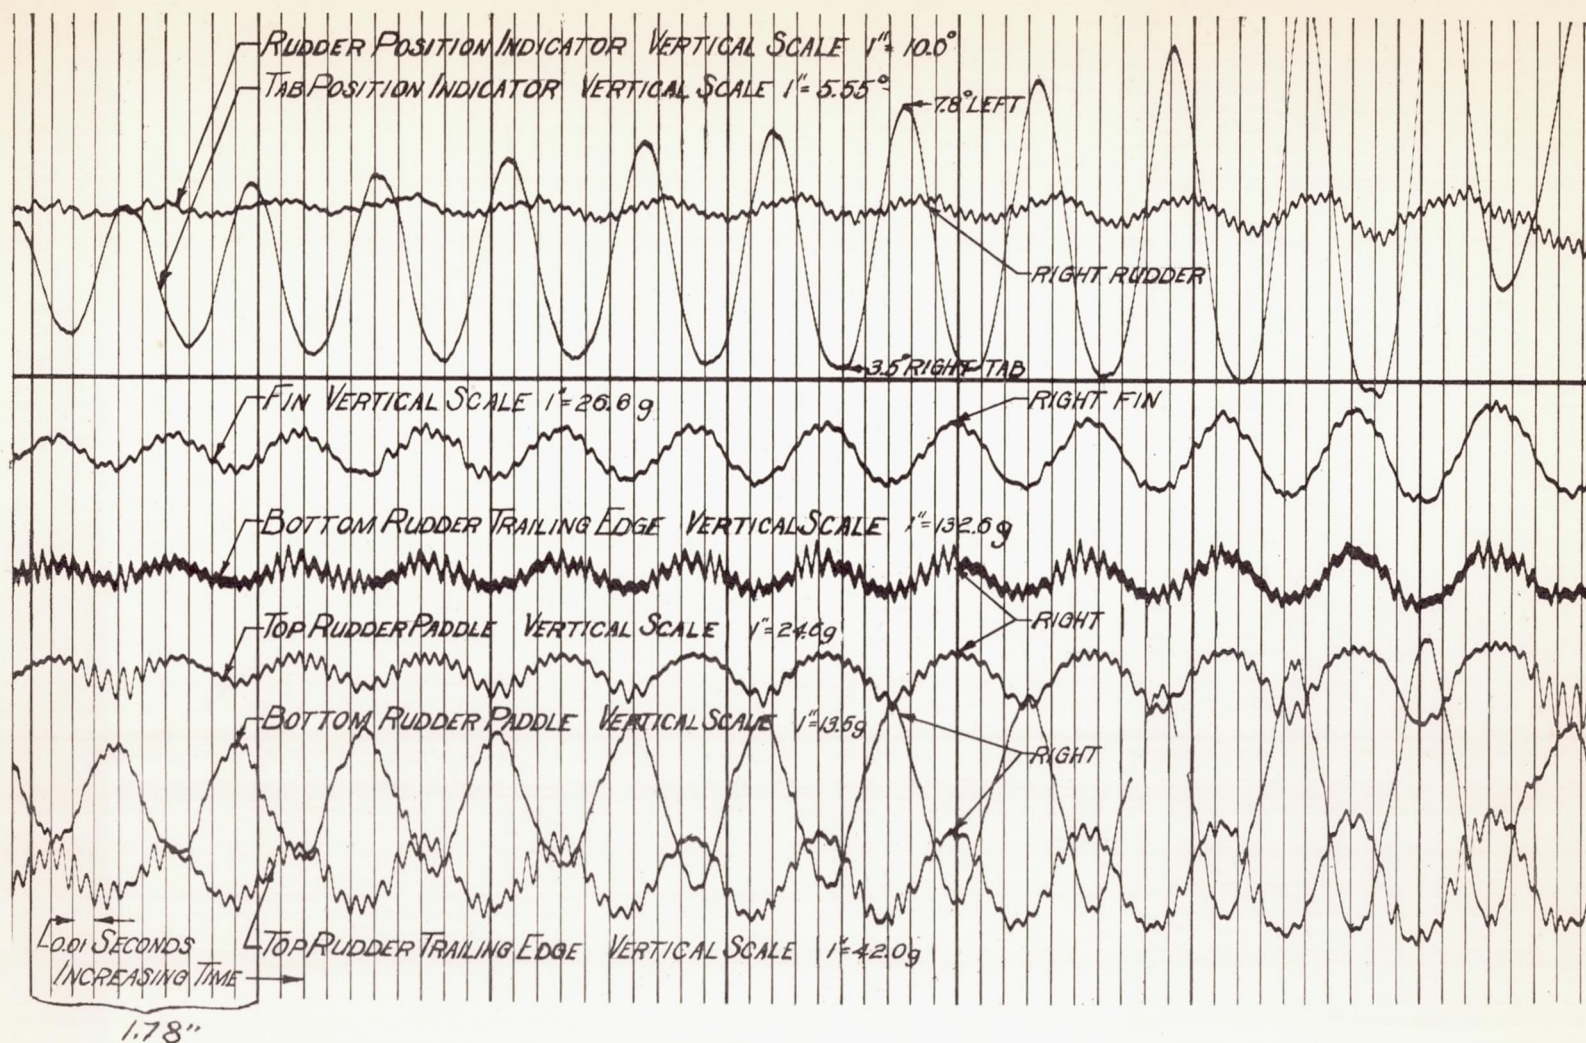
The severe flutter involved large-amplitude motion of the fin and the leaf springs. The coupled frequency of the upper fin vibrating out of phase with the leaf springs is believed to be about 14 cycles per second, since this frequency was found on oscillograph records taken when the fin was given a sharp blow. The tab frequency was about 20 cycles per second, so that a coupling between the tab vibration and the upper-fin and leaf-spring vibration is evident.

Figure 12.- Oscillograph record for case of severe flutter. Tab play, 0.4°; V = 321 mph;
M = 0.411; tab frequency, 20 cps.
