February 1944 as  
Advance Restricted Report 4B02

FLIGHT TESTS OF THE THERMAL ICE-PREVENTION  
EQUIPMENT ON THE B-17F AIRPLANE

By Bonne C. Look

Ames Aeronautical Laboratory  
Moffett Field, California

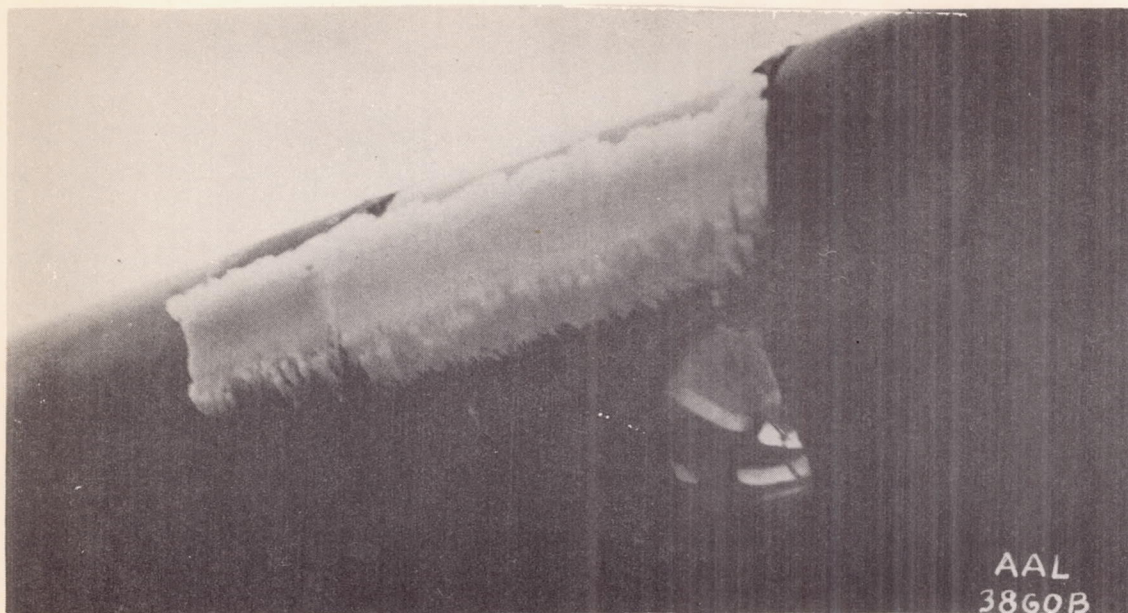
The wing outer panels from stations 19A to 33 were free from ice formations during all the icing conditions encountered. Ice formed on the wing-tip leading edges during all the icing flights. The unheated landing-light cover and the leading edge at the wing splice accumulated ice as shown in figure 16. Figures 17 and 18 are photographs of the right and left wing inner panels and illustrate the partial protection afforded the right wing inner panel, between nacelles 3 and 4, by the ice-prevention system.

Figure 16.- Rime-ice formation on the right-hand landing-light cover and on the unheated leading edge at the wing splice. The photograph was taken after landing from test 7.

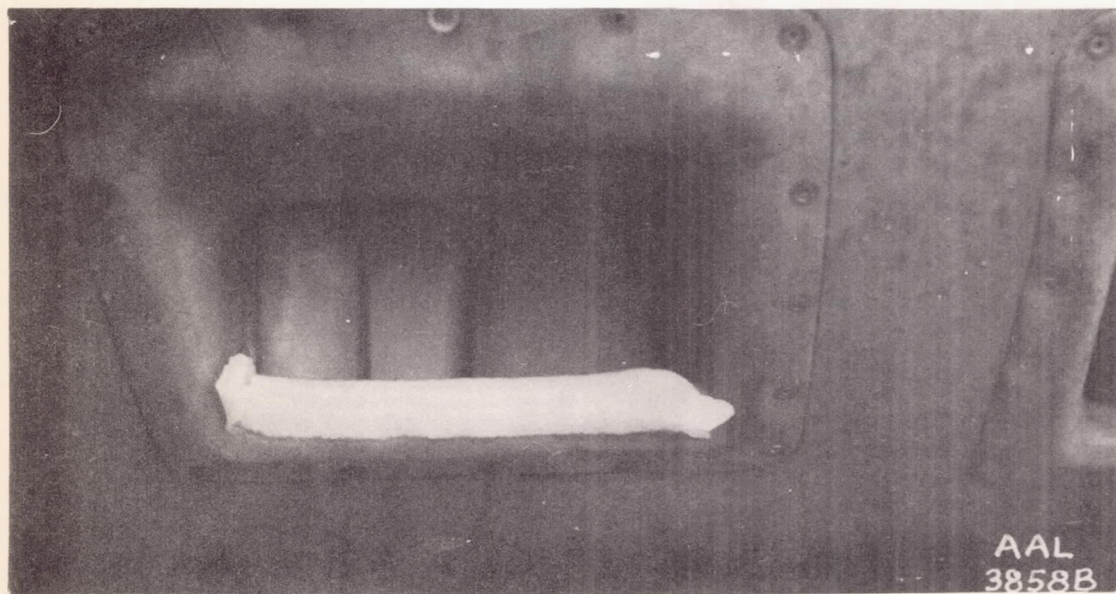
The heated inlets were not visible to the flight personnel during flight, but ice accumulations were observed on these inlets after landing, similar to the formations shown in figure 19, which is a photograph of the intercooler air inlet for engine 1. Figures 20 and 21 show further examples of ice accretions on the air inlets. An accumulation of ice in the elbow of the ducts leading from the air inlets in the wing leading edge to the engines was observed after most of the icing flights. The most severe accumulations were observed after landing

from test 7, at which time figure 19 was obtained and shows ice on the turning vanes in the duct elbow, aft of the inlet. During flights ice was observed to accumulate on the inlets of the oil coolers to the extent that the inlet area was decreased to approximately one-half the normal area. The ice accumulated on the inlets did not appear to affect the operation of the engines during the reported limited flights in icing conditions. However, during extended operation in inclement weather, it is probable that the inlets may become sufficiently obstructed with ice to prevent desired oil cooling and eliminate the carburetor and intercooler inlets as a source of air.

Figure 19.- Rime-ice formation on the lower lip and on the turning vanes in the duct of the intercooler air inlet located in the left wing leading edge outboard of nacelle 1, accumulated during test 7. (Photographed after landing.)

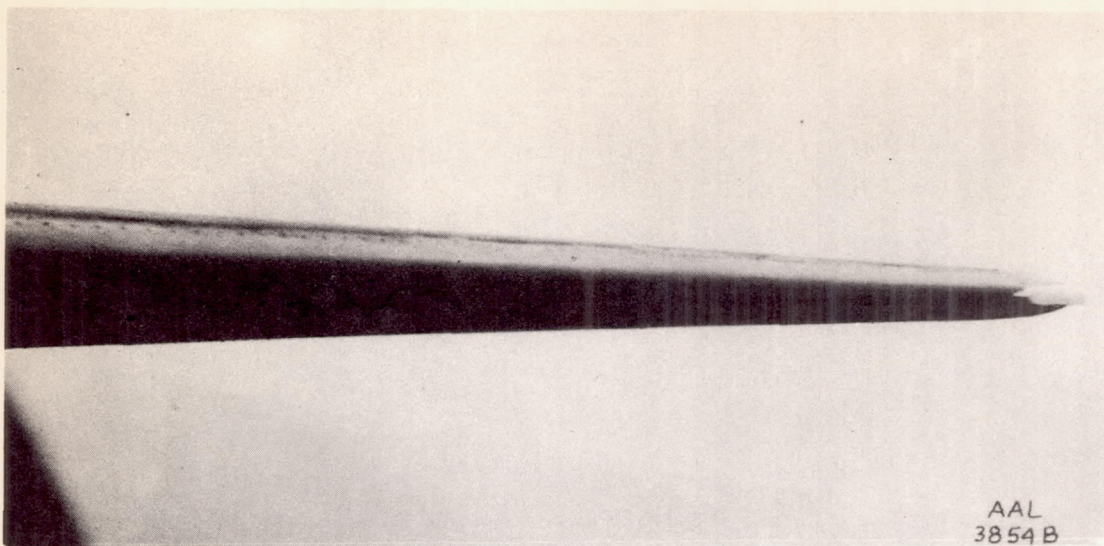
Figure 26.- Rime-ice accumulation on the left horizontal stabilizer during test 7.

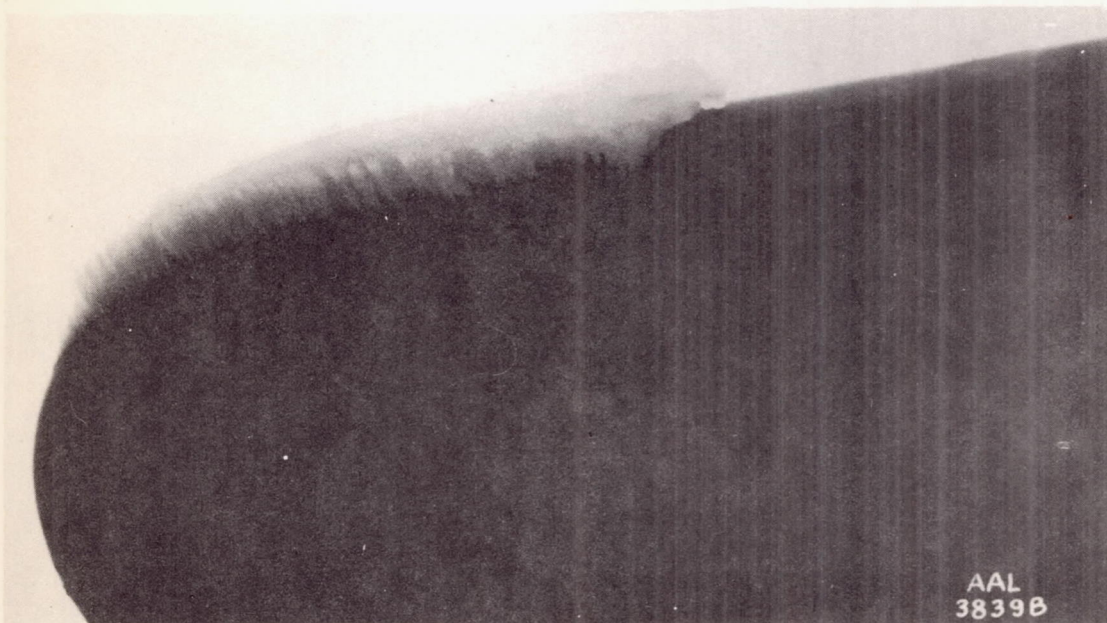
Figure 27.- Rime-ice accumulation on the right horizontal stabilizer tip during test 7. (Photograph taken after landing.)

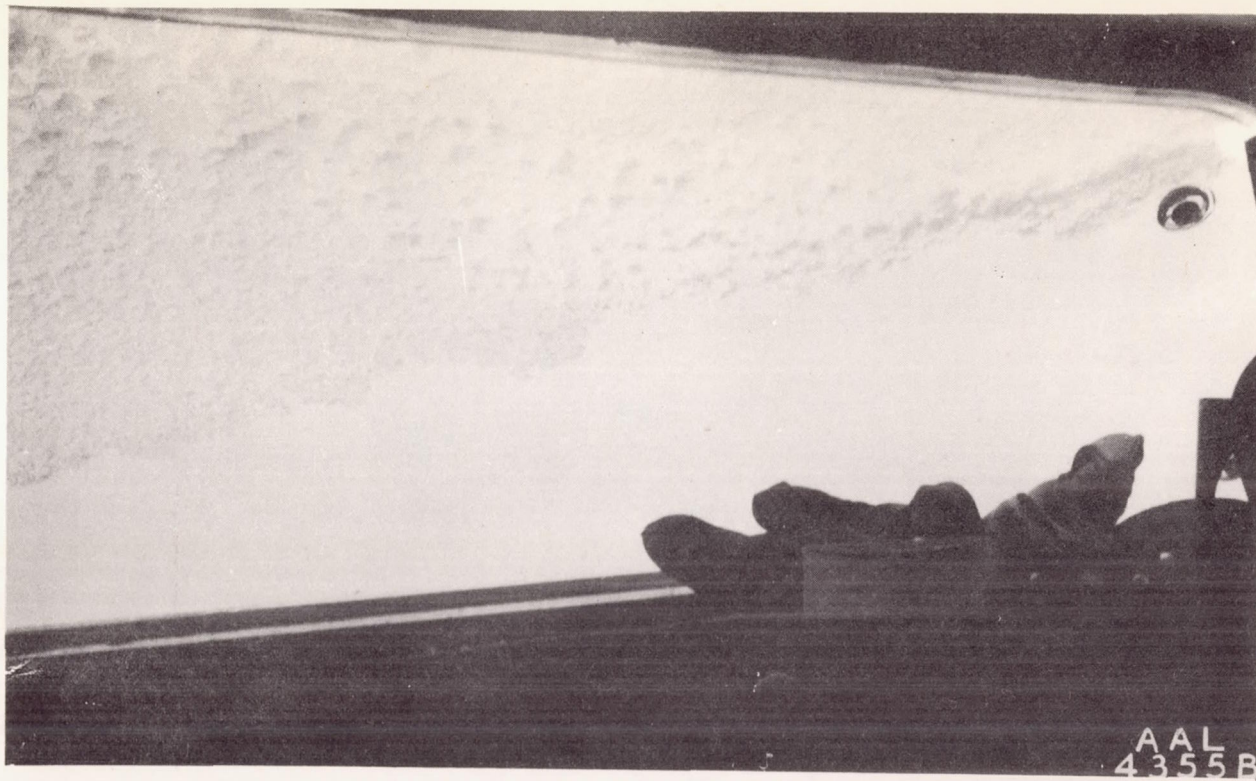
The pilot's heated windshield, adapted from the service windshield and defrosting system, was protected from ice accumulations on the lower portion, as shown in figures 31 and 32. Figure 33 is a view of the windshield exterior, obtained from the aft top window of the bombardier's compartment during test 3, and illustrates the susceptibility of the windshield to icing. Although the pilot's windshield was not completely protected during flight in icing conditions, it was observed to clear more rapidly than did the unheated copilot's windshield when the airplane was flown out of the icing conditions, as shown in figure 34.

Figure 32.- Ice accumulation on the pilot's heated windshield during flight in icing, test 3.

more complete protection, the results of the test indicate that the adaption of the service windshield and defrosting system would not produce an installation which would be satisfactory for all icing conditions. It is probable that, by decreasing the gap between the two panes of glass, a satisfactory heated windshield might be developed which utilizes the same source of heated air as did the reported temporary installation.

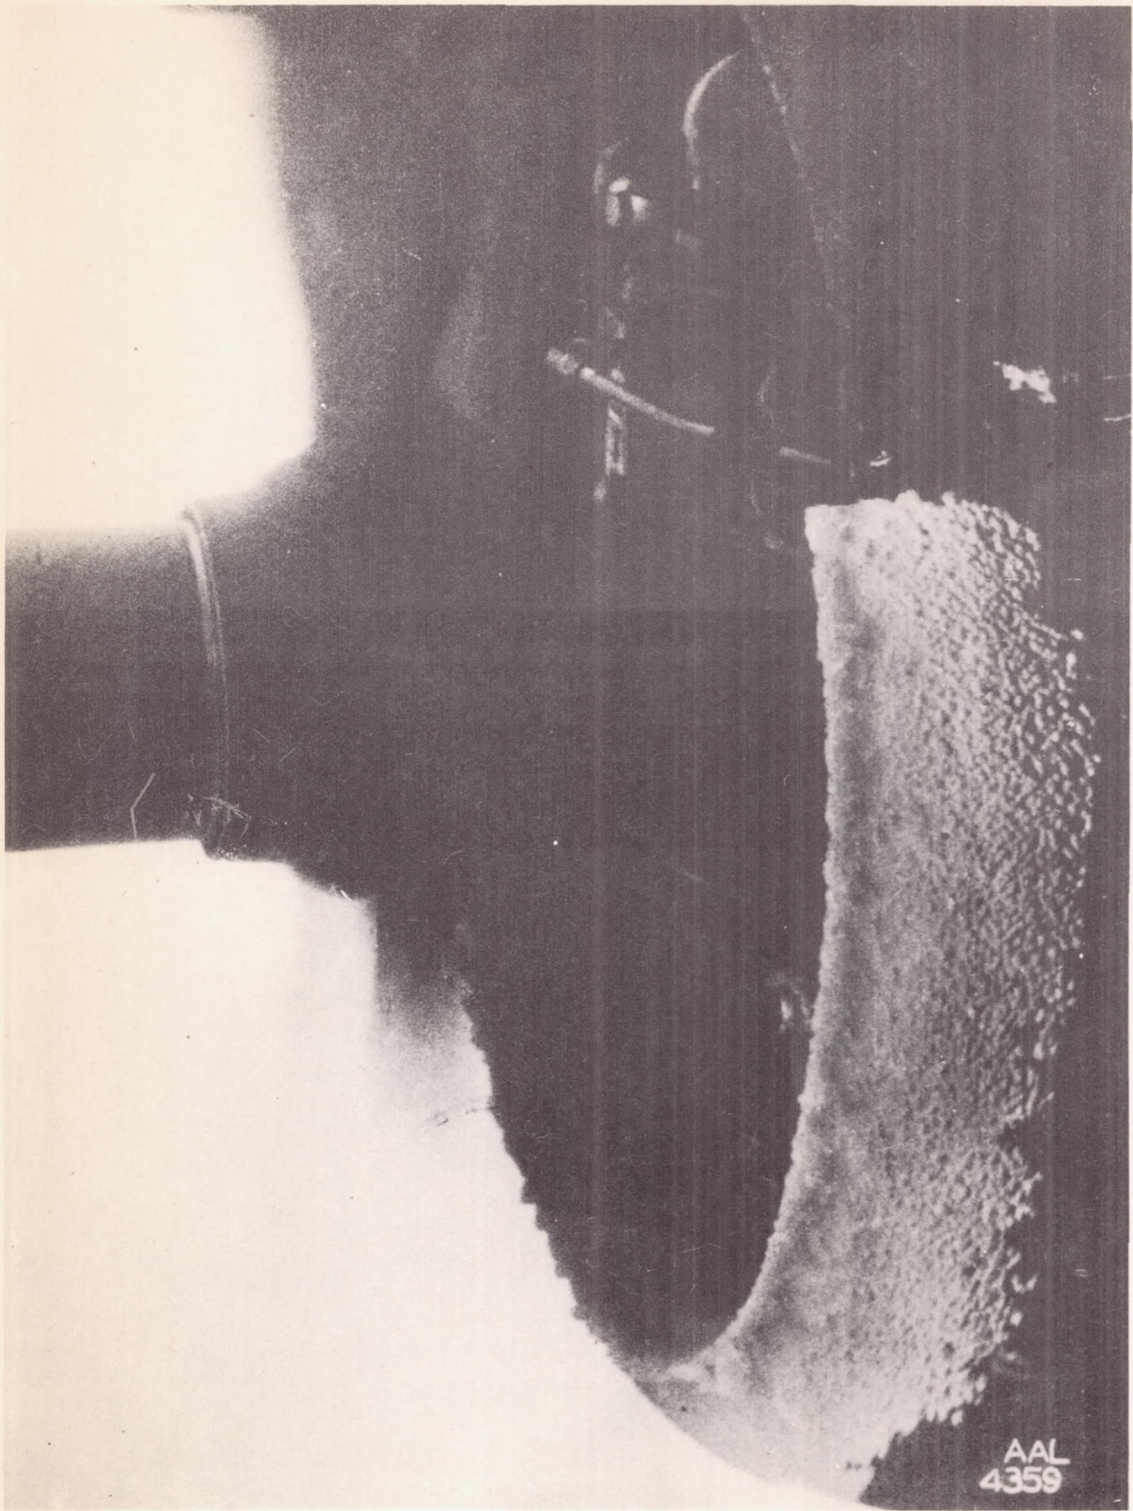
Figure 39.- Ice formation on the right inboard engine cowl accumulated during test 3.

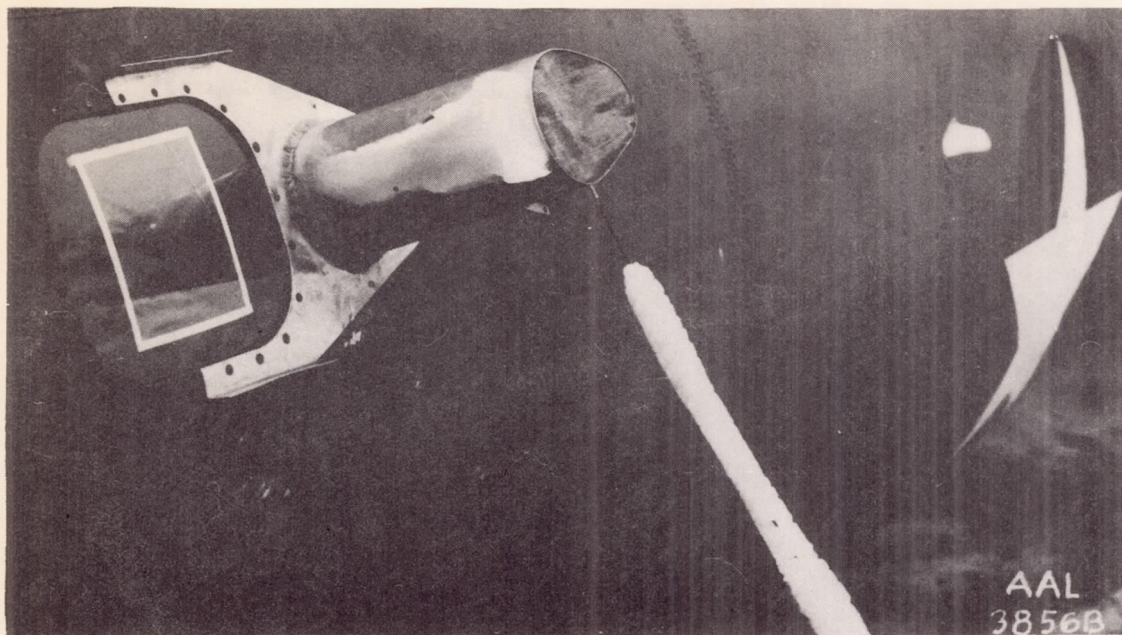
Figure 45 shows the ice-indicating strut which was mounted on the left side of the fuselage at the aft edge of the radio-compartment window. The ice formation on the strut leading edge was accumulated during test 7. Another illustration of icing on the strut is shown in figure 46. The ice formations shown on the strut illustrate the amount of ice which may accumulate on unprotected surfaces during flight in icing conditions. The variation in thickness of the ice on the strut probably was due to interference of the fuselage.

Figure 45.- Ice accumulations on the ice-indicating strut and on the lead-in antenna wire of the liaison radio. Photograph was taken after landing from test 7.

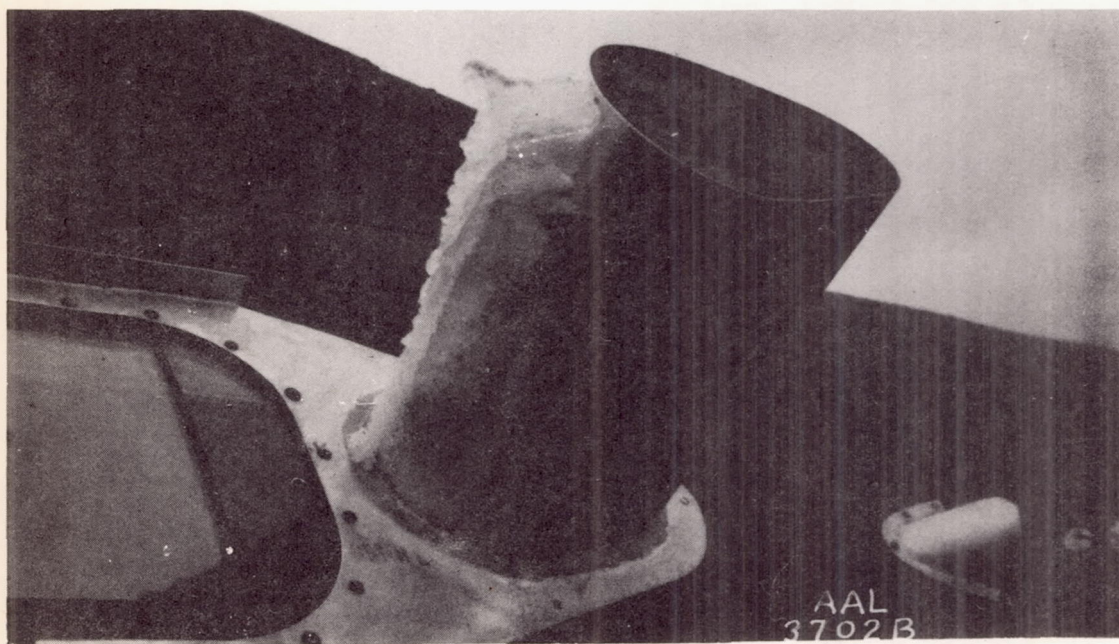
Figure 46.- Ice accumulation on the ice-indicating strut, mounted on the left side of the fuselage at the radio compartment during the flight on February 23, 1943. (Photograph taken after landing.)
