PRACTICAL EXPERIENCES WITH  
LIGHTNING DISCHARGES TO AIRPLANES

By Heinrich Koppe

Zeitschrift für Flugtechnik und Motorluftschiffahrt  
Vol. 24, No. 21, November 4, 1933

TECHNICAL MEMORANDUM NO. 730

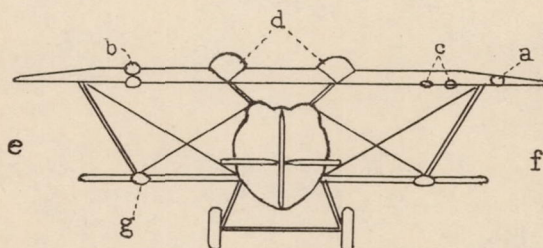
Figure 6.-Double discharge to "Berline-Spad"; pilot Sladek, Oct. 15, 1925

There also is a record of three cases of lightning discharge in airplanes without antenna: two, in wooden airplanes flying through thunderstorm, and one in which lightning hit twice. This particular airplane, a biplane, all wood, (fig. 6) attempted to fly through the front of a thunderstorm. There was first a discharge through the right wings in the clouds, in heavy snowstorm. A few seconds later lightning hit the left wings very severely. The

- a, 1st. stroke. f, left  
 b, 2nd. " g, fusing  
 c, traces and  
 d, fuel tanks welding  
 e, right effect

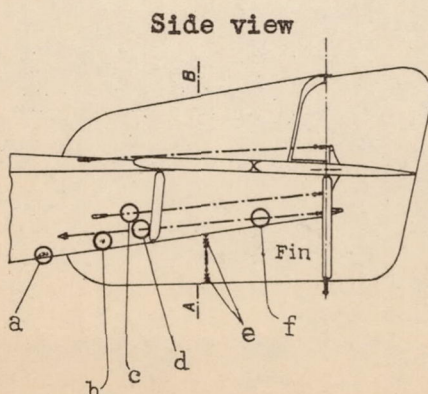
Figure 9.-Damage to a wood-fabric airplane

the electric charge must clear the path to better conductors within the airplane, the outer skin is destroyed. Thus wings covered with wood or cloth were damaged when the path led over the antenna egg or over the wires to the position lights. Such damages (fig. 8a,b) may consist of small, round scorched holes in the wood or fabric, although tearing and ripping off of larger pieces is not unknown. Steel is a poor conductor for the lightning current; for which reason lightning does not follow steel cable very often, but so much greater is the danger of fusion by current contacts. For instance, note the burnt 1 mm steel wire fin braces on the wood-fabric airplane (fig. 9).

- a, tear due to pressure effect  
 b, arc outward, antenna weight burned  
 c, HR-S light trace of fusion  
 d, SR-S light trace of fusion  
 e, brace wires fused  
 f, 3 rudder-cable strands fused

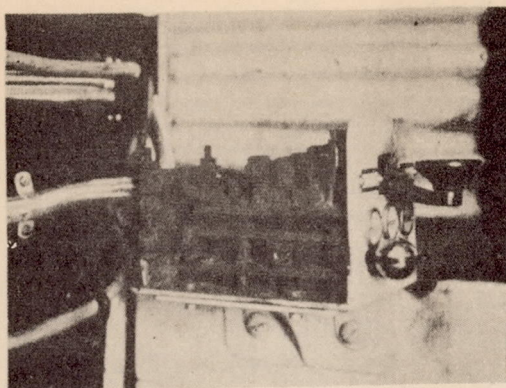
Since the antenna releases the lightning discharge in most cases and offers the discharge the most convenient path the attached radio equipment is above all exposed to damages. They may be harmless sparking contacts, burning of pipes or fuses; but they may equally destroy switches, coils, generators, etc., and even burn out the whole radio. In 19 out of 26 cases the antenna was burnt off at the point where it emerges from the fairlead. In several cases the fairlead itself was more or less damaged. But in all cases the radio was put out of commission. (See fig. 7).

Figure 7. Radio dial and switch burned out.

To shunt minor partial discharges from the radio equipment it is advisable to provide another, similar protection between the antenna reel and the change-over switch.

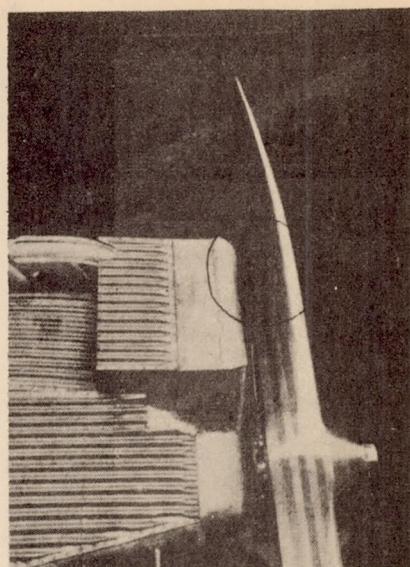
For the same reason the lightning discharge does not follow the engine shaft to the propeller but generally jumps over from the engine, cowlings or radiator (fig. 10). That propellers in particular act as equalizers is well known and confirmed by the frequently observed Saint Elmo's fire. This may readily lead to current contacts with pronounced heating from airplane to propeller, but also from propeller to the surrounding, highly ionized air (fig. 11). Hence the traces of fusion on the radiator, cowlings and other contact points in all-metal airplanes (fig. 12).

Figure 10. Arc from body to propeller.

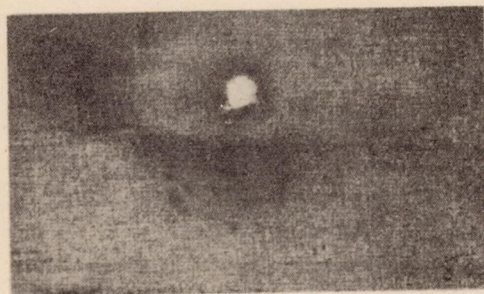
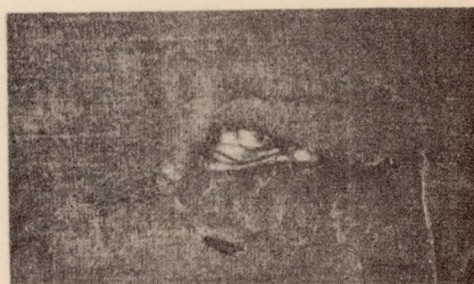
Figure 8. Damage to a wood fabric covering.

(a) Outward arc

(b) Tear due to pressure effect.

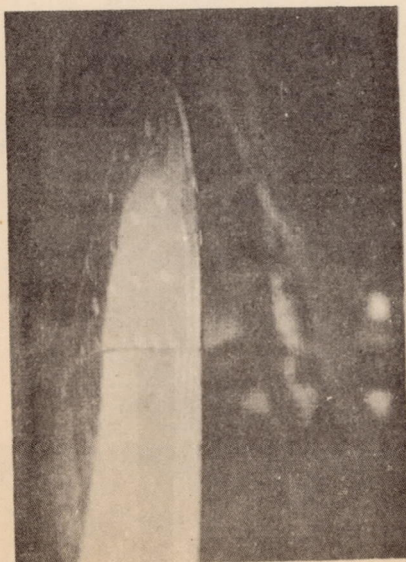
Figure 11. Metal tipping damaged at trailing edge of propeller.

The propeller is very frequently damaged, being a particularly strong equalizing structural component. All-metal propellers are more proof against such damages than metal-tipped wood propellers; in any case the tipping should not be too thin and should form a good connection with the engine. This can be insured by shields and copper rings inserted at the hub (fig. 19). It at any rate prevents the dangerous and destructive arcs.

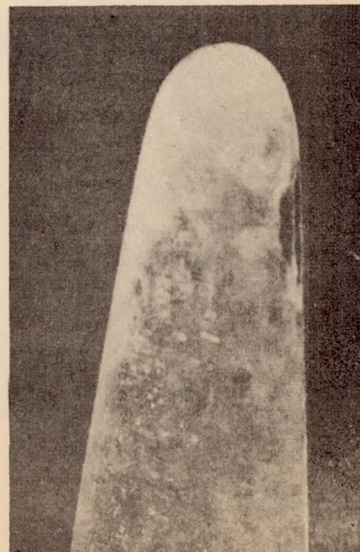
Figure 12. Trailing edge of all metal propeller damaged.

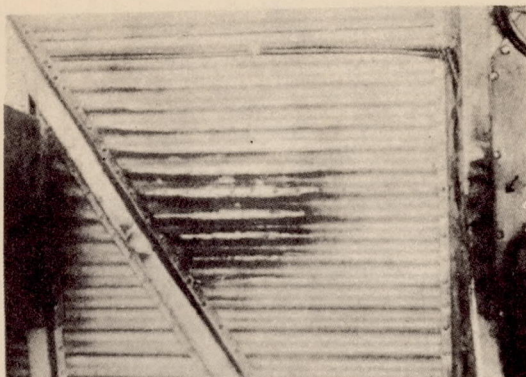
If the lightning follows the antenna into the airplane it generally results in very severe and dangerous damage. Even the all-metal airplane is not immune. When the antenna fairlead forms a convenient direct path to the inside lightning follows it and it merely remains a question of arrangement and design at what point it finds this path inconvenient and tries to find a better one to the engine and the propeller, where it then establishes a contact and usually results in severe and dangerous arcs (fig. 13). This not only produces a fire hazard but it also jeopardizes other vital parts of the airplane (fig. 14).

Figure 13.- Five traces of arc in an all-metal airplane.

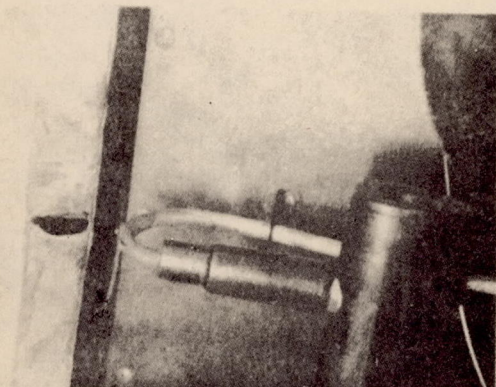
Figure 18.- Arcing of lighting current on a sharp bend.

Still greater security is assured when giving the antenna fairlead a slight forward slope as suggested in figure 20a and b. The sharper the bend in the antenna the quicker will the lightning current abandon it and take the more convenient path offered.

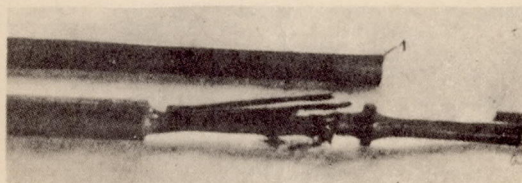
Figure 17. Collapse of antenna fairlead-electrostriction.

Very obviously this was due to the enormous pressure effects which can be explained only by electric phenomena. There also was one very conspicuous example of so-called electrostriction in the above case. The 0.5 mm gage brass antenna fairlead was inwardly compressed with such powerful force (fig. 17a) so as to crush the tube in about 10 close, solid lobes, causing it to split in about 20 small, long strips. The crushing pressure was so great as to leave the imprint of the antenna wire (fig. 17b).

An analysis of the strength and forces on the antenna fairlead crushed by electrostriction would give an amperage of more than 100 kA; according to that the assumptions made for this analysis require perhaps further experimental verification. When Saint Elmo's fire, a steady brush discharge, is observed, which, although it occurs quite frequently in day flying, is seldom noticed, there is a steady direct current flow from antenna to engine, propeller, and wings, etc., or vice versa, depending on the direction of the potential difference. This current is of the order of 0.5 to 3A for large multi-engine airplanes. The potential difference bridged by the lightning protector depends upon the length of the discharge. For a 2 km length one can figure with a potential difference of around 100,000 kV. In most cases, as far as airplanes are concerned, it probably involves the equalization between two space charges within a cloud, although there is a record of an airplane having released lightning discharges between two clouds. Unfortunately lightning discharges to airplanes are not usually accompanied by simultaneous ground observations, except in a few cases. In one case the path of the stroke from the cloud over the airplane could be clearly observed on the ground. The low-flying airplane probably always will cause a discharge to ground. The high-flying airplane produces first a discharge within the strongest electric field which, however, can easily develop to potential balance over a large zone, that is to ground also.

(a) Tubing between two reinforcements.

(1) Undamaged tube.

(b) Collapse at tube end.

(2) Imprint at edge of break.

(3) Fusion of antenna.

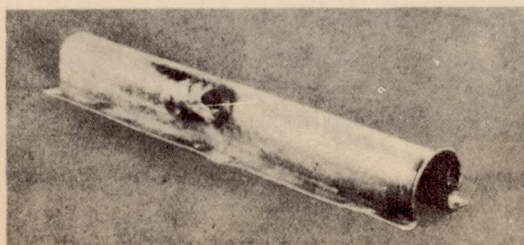
Figure 14.- Arc on control cable housing.

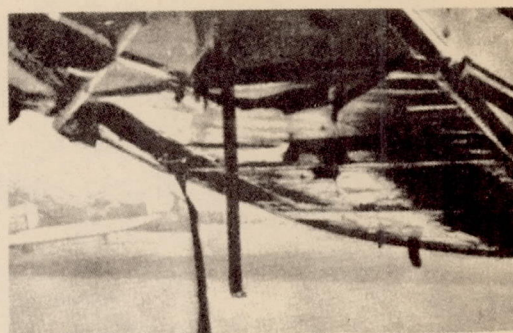
wrought considerable havoc on the airplanes. Nearly all lightning discharges manifested pressure or shock effects, which, however, were frequently less observed under the stronger impression of the other effects or overlooked altogether in the natural startle during the flash.

Figure 15.- Destruction of fuselage covering due to pressure effect (according to L'illustration 10/24/31)

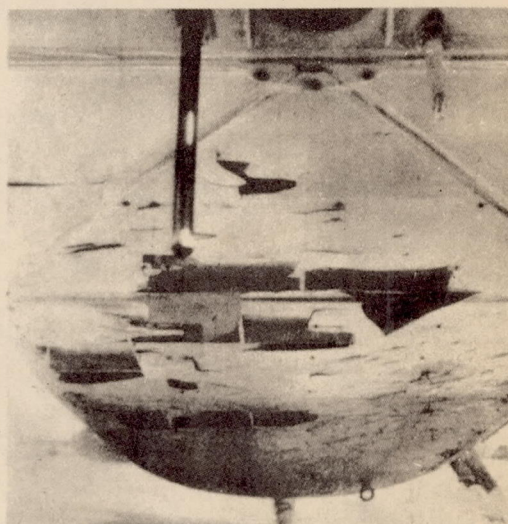
In the previously cited case of lightning striking a twin-engine airplane without antenna, such a strong draught of air blew through the cabin window toward the pilot's seat that parts of the wooden paneling was ripped off and thrown into the pilot's lap. In another case five of the eight windows in the pilot's hood together with their metal frames were torn out and some of them flung into the propellers, thus causing additional damages. In this particular case the connecting doors were either blown open or wedged tight and cloth covering was torn off. In two other cases on airplanes of the same type practically the whole covering on the bottom of the fuselage was destroyed. In the first case (fig. 15) the pilot did not notice the hit except for a hard bump, which he first ascribed to colliding with a large bird until the simultaneous destruction of the radio and other indications of a lightning discharge convinced him otherwise. In the other case (fig. 16) the damages were almost identical. The 1.5 mm heavy plywood covering, nailed and glued to the framework, was wrenched from its base leaving the nails exposed as much as 5 mm.

Figure 16.- Destruction of fuselage covering due to pressure effect.

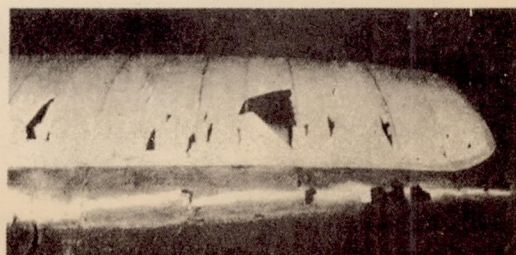
The forces of nature released in a storm are a danger to any work of the human hand, particularly the airplane. But it is less the lightning which we have to fear than the mighty air movements which can toss the airplane about as a powerless ball of the elements to the limit of its strength; more dangerous than lightning are the squalls, the formation of ice and the hailstorms, as striking example of which note the severe damage from hail on a glider which had been carried up into a thunderstorm (fig. 21).

Figure 21.- Damage to glider due to hail.
