BRUSH SEAL BRISTLE FLEXURE AND HARD-RUB CHARACTERISTICS

Robert C. Hendricks, Julie A. Carlile, and Anita D. Liang
National Aeronautics and Space Administration
Lewis Research Center
Cleveland, OH 44135

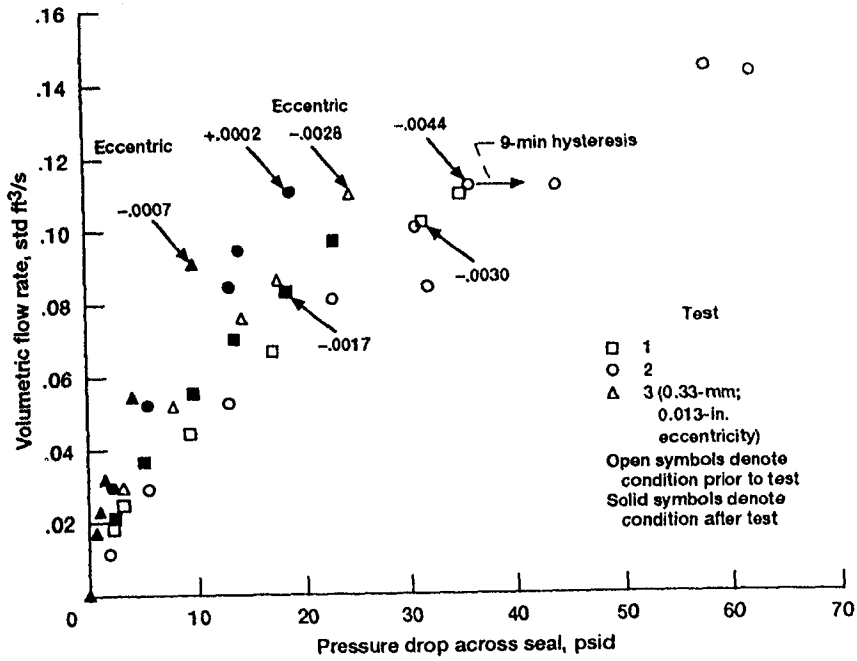
Leakage is characterized in figure 21 in terms of volumetric flow rate as a function of pressure drop across the brush seal before and after each of the three tests. Both pretest and post-test results are provided in the same figure. Because this brush seal was damaged (see APPARATUS section), absolute leakage measurements would require weighing, but the relative leakage should be accurate. The interference fits for the brush seal leakage data for pretests 1 and 2 were nearly the same, resulting in corresponding leakages. While taking data it was found that the brush would stiffen and the pressure drops would increase. Data points illustrating hysteresis (typical in brush seals) are shown. After correcting the post-test 2 data for clearance, these test results agreed with those of post-test 1.

Figure 21.—Pre- and posttest leakage results for smooth rotor.

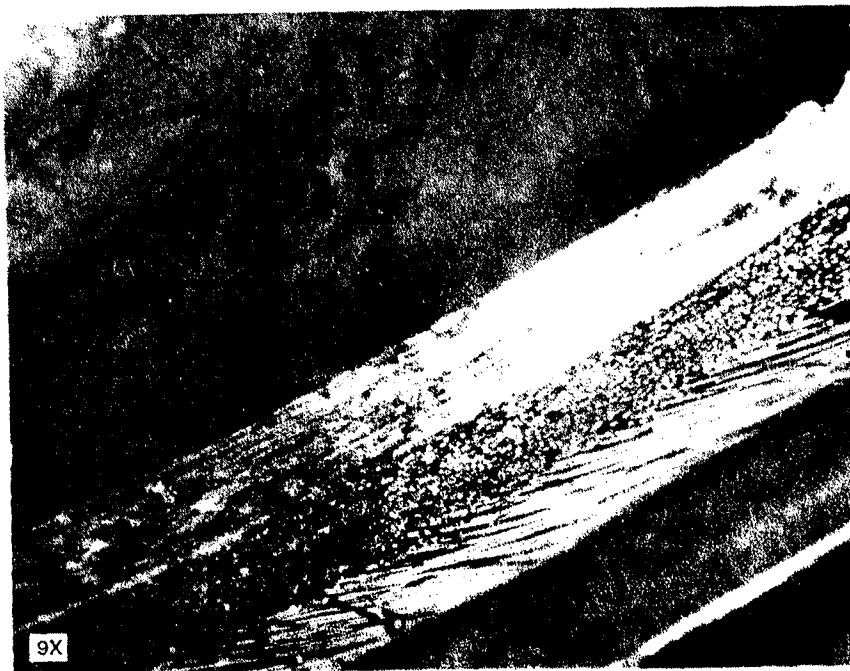
Setting the rotor eccentric in test 3 proved a major problem in cross correlating the leakage results. The estimated initial static eccentricity for the smooth rotor was less than 0.15 mm (0.006 in.), and the smooth rotor and the 40-tooth rotor were assumed to be interchangeable at the same spindle loading. However, the rotor rubbed the fence (backing washer) slightly, requiring an initial static eccentricity of 0.36 mm (0.014 in.) and implying a difference in spindle loading. The rotor was reset to an estimated eccentricity of less than 0.025 mm (0.010 in.). Post-test photographs indicated that the dynamic eccentricity was <0.10 mm (<0.004 in.) and clearly illustrated the fence rub (fig. 22).

Figure 22.—Fence damage sustained during test 3.
