#### **INTEGRITY TESTING OF BRUSH SEAL IN A T-700 ENGINE**

# Robert C. Hendricks, Thomas A. Griffin, George A. Bobula, and Robert C. Bill National Aeronautics and Space Administration Lewis Research Center Cleveland, Ohio, 44135

### SUMMARY

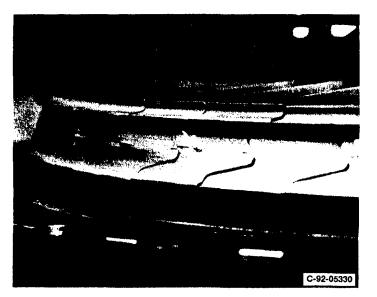
Before proceeding to discuss post-test results, we return to the installation of the brush into the power turbine shroud. Figures 4, 5, and 7 show views of the installed brush seal. The brush was designed for an interference of 0.51 mm (0.020 in.) diametral. The actual interference could not be determined, but estimates of the pretest brush clearance were -0.51 to -1.27 mm (-0.02 to -0.05 in.) diametral. Measurements of the shrouds differed as did those for the rotor. Although the differences were only a few thousands of an inch (mils), they represented a significant percentage of the clearance gap. It was also determined that individual blade sets could have a step change of 0.229 mm (0.009 in.) from one blade set to the next. These surface irregularities are shown in the post-test photograph (fig. 8).

Further assessment of figure 8 shows that the leading edges of the blade sets were polished. Some brush wear was noted and expected because René 80 is hard relative to the annealed Haynes 25 and the heat-sinking capacity of the brush is very small relative to that of the rotating blade sets. The surface irregularities at the rubbing interface can be seen. Although there was some evidence of material transfer, no metallurgical samplings or rotor measurements were taken because of the tight program schedules for the engine operations. This was a major error; however, if there comes a time when the rotor can be looked at, some of the transferred materials may be found still embedded in the rotor even after it has undergone other program tests for General Electric Co.

Figure 8.—Fourth-stage turbine after testing, showing polishing of leading edges.

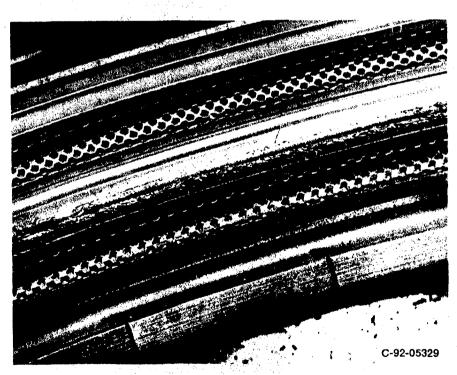
Figure 10 illustrates bristle spreading after testing, with a central core of bristles rubbed (probably clip cut and worn to shape). Although the environment was hostile, the brush did not disintegrate, but bristle pullout could be noted in a few places. Some upstream bristles (two or three rows) show spreading and perhaps one row downstream (toward the exhaust). The remainder of the bristles show wear (or cutting plus wear). Detailed estimates of the bristle stubble heights are given in figure 11(a) as taken from the set of photographs in figure 11(b) corresponding to positions (joint, J+1, J+1.5, J+2, J+2.5, J+3, J+3.5, J+4, and J+4.5) shown in figure 11(a). The last two photographs in figure 11(b) correspond to the minimum stubble height, where the rotor actually rubbed the fence (position J+3); the view is looking toward the bristle stubbles to show the rubbed fence. Figure 11(c) shows wear track and fence rub, and figure 11(d) shows the joint wear track.

Figure 10.—Post-test view of brush seal showing bristle spreading and core of rubbed bristles.

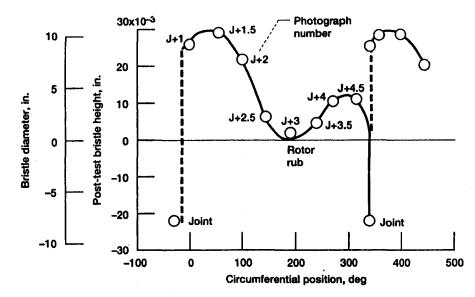
(a) Bristle height versus circumferential position.

Details of the bristles (fig. 12) show an ingrained wear pattern that is characteristic of a high spot in the rotor which cuts a shallow groove as it wears in. Furthermore, the rotor ran eccentric with respect to the seal either during cycling or steady state or both. Plots of bristle measurements show rubbing of the seal ring at 180° to the pinned point and a step across the joint where the end of the split seal rubbed the rotor. The blind installation and operation made it difficult to assess intermediate states of wear or the health of the brush or the turbine shroud/brush interface. Although accelerometer measurements were in bounds, no detailed information concerning the orbital dynamics was available.

Figure 11.---Post-test bristle stub height and backing washer rub. Bristle diameter, 0.0028 in.

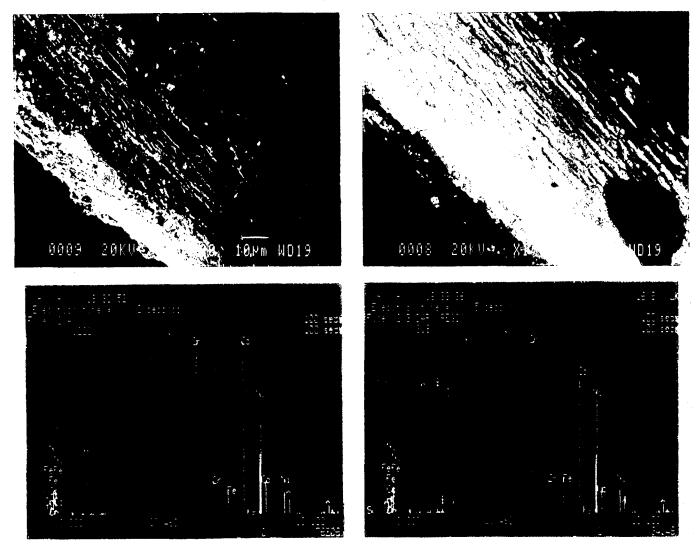
(b) Analysis of bristle 1.

Metallographic results (fig. 13) illustrate some material migration along the bristle and material transfer both from and to the surface. Material smears seem to be in line with a softer material rubbing a harder material even to the point of melting. Thus, one would conclude that the interface became very hot, but the interface followed the classic Block slider problem, where the penetration depth (radial) is very small. Thus, the thermal effect at the interface appeared to be topical, wearing the brush bristles until line contact with the rotor and smear transfer of both materials occurred. Such evidence is presented in figure 14, for an individual bristle that was clipped from the brush. The clipped end was removed from the interface, and the worn end is representative of interface materials. There are material smears, oxidized spots, and apparent pits. It is not clear how the irregularities of the interface affected these results, but it is clear that materials were transferred.

Figure 13.—Post-test metallographic results for single bristle.

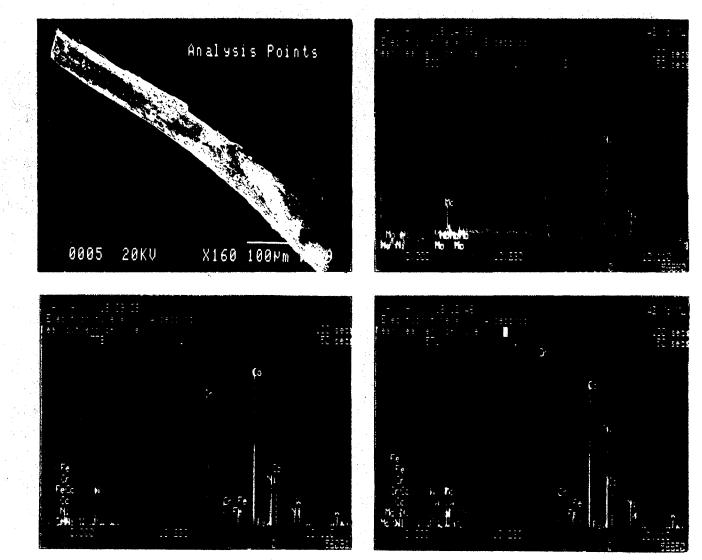
(c) Bristle 1 at increased resolution.

Figure 13.—Concluded.

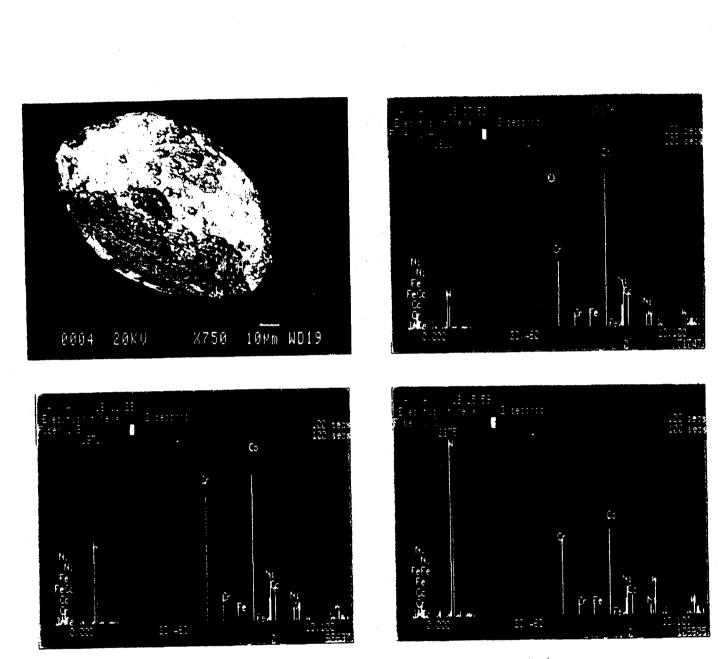
Figure 14.—Post-test metallographic results for bristle tip from wear track.
