TWR-60695  
Revision B

## Final Postflight Hardware Evaluation Report 360T021(RSRM-21, STS-45)

**Final Postflight  
Hardware Evaluation Report  
360T021 (RSRM-21, STS-45)**

This document is the final report for the Clearfield disassembly evaluation and a continuation of KSC postflight assessment for the 360T021 (STS-45) RSRM flight set. All observed hardware conditions were documented on PFORs and are included in Appendices A through E. This report, along with the KSC Ten-Day Postflight Hardware Evaluation Report (TWR-61502), represents a summary of the 360T021 hardware evaluation. The configuration evaluated is documented in TWR-60467. Disassembly evaluation photograph numbers are logged in TWA-1982.

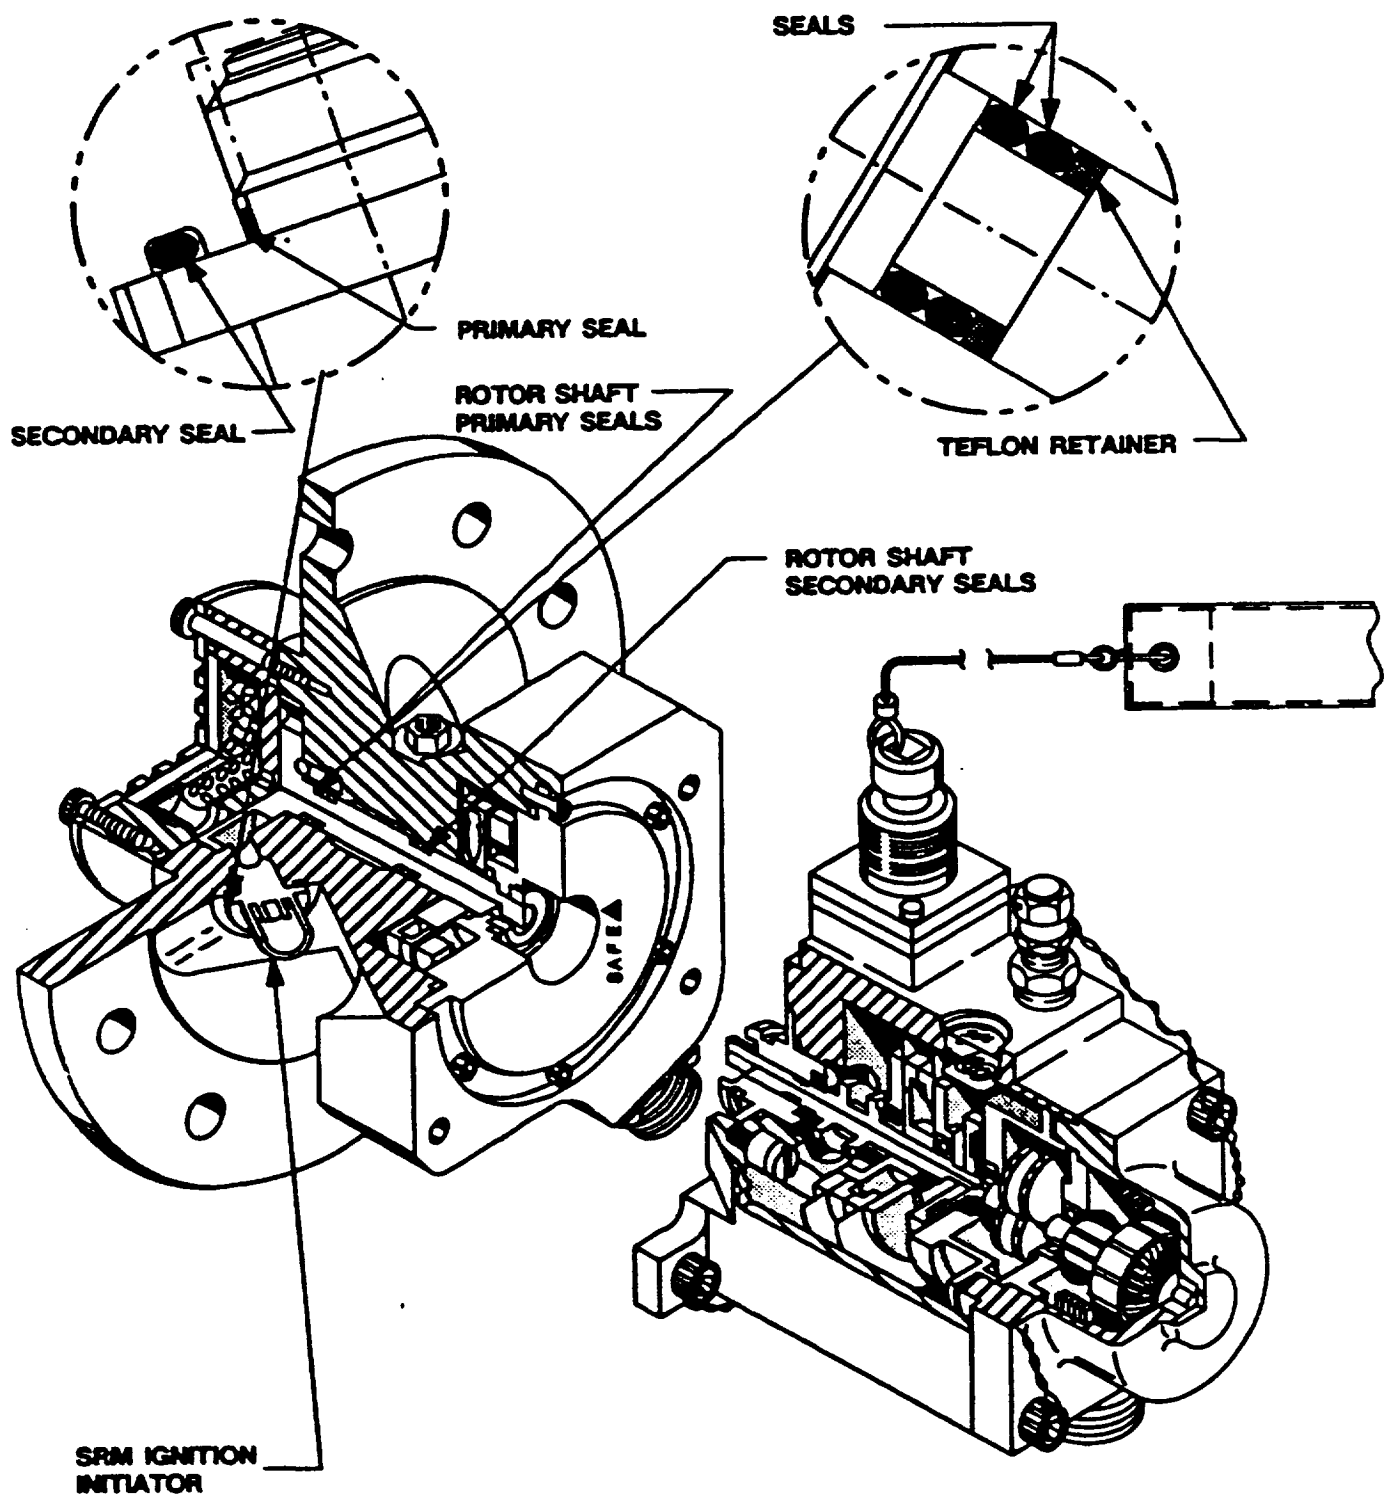
**Figure 2. Safe and Arm Device Seals**

Typical sooting was observed up to but not past the forward primary rotor shaft O-ring. Soot was not observed past any pressure seal.

Medium-to-heavy corrosion was observed on the entire surface of the rotor shaft spring. Corrosion on the spring had not been previously reported. Preliminary PFAR 45C-11 was written.

Foreign material (copper-like) was observed on the OD surface of the rotor shaft secondary seals. The material appears to have been introduced during the leak test of the primary and secondary seals. This B-B was assembled prior to a change implementing use of an in-line air filter which should correct this condition. Preliminary PFAR 45C-12 was written.

Foreign material (green particles) was observed in the ullage cavity region of the rotor. Preliminary PFAR 45C-13 was written.

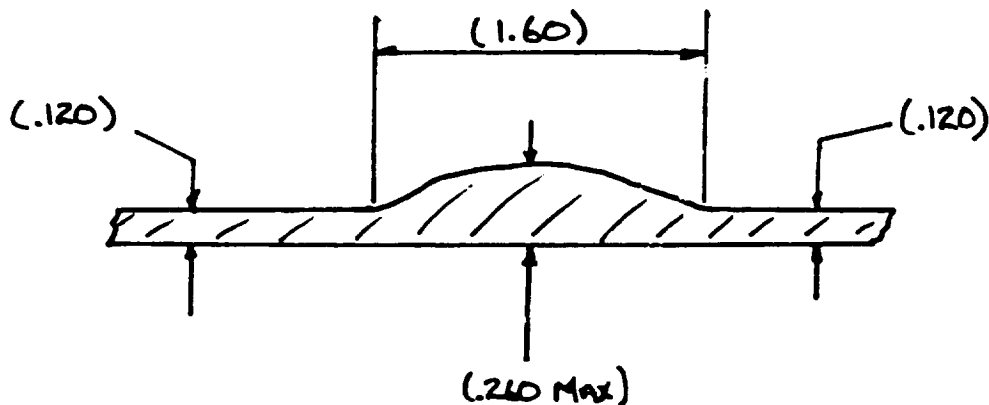
One additional sample was removed from the LH forward center acreage region per AO 4C6-49. A 25-inch long "ridge" in the insulation was noted at 90 degrees, 85 inches forward of the tang. Dissection of the sample showed that the ridge consisted of a localized build-up of insulation. Thickness in this region measured 0.26 inch compared with a nominal of 0.120 inch. No unbonds or other anomalous conditions resulted from the ridge.

A "ridge" was present in the insulation acreeage during post-flight inspection at KSC. A sample was removed per AO 406-59. The "ridge" appeared to be extra thick insulation in this region. A typical cross-section is shown below:

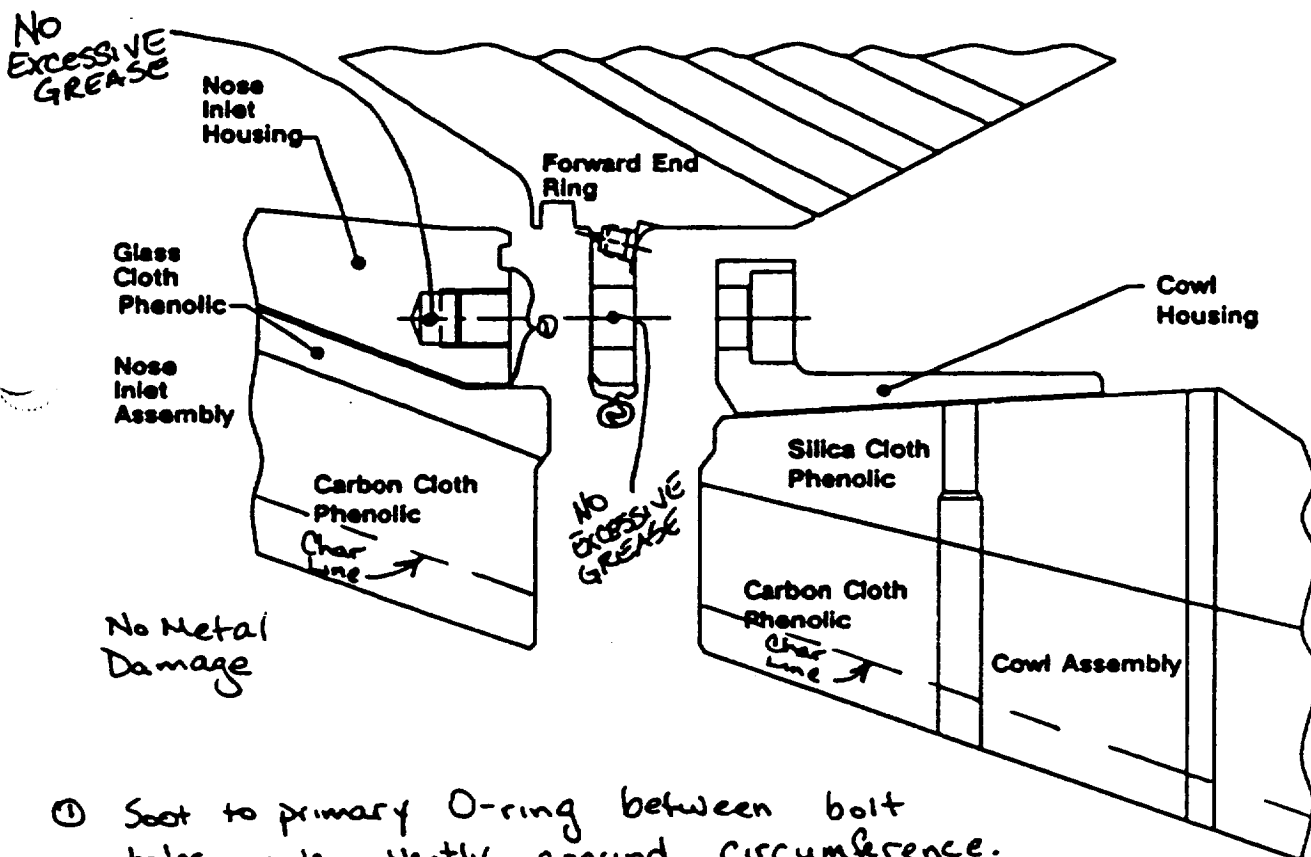
- Typical jack screw marks on Nose Inlet Housing flange
- Light-to-medium corrosion on bearing forward end ring forward I.D. flange interface at 3 jack screw holes.

- ① Soot to primary O-ring between bolt holes intermittently around circumference.
- ② Light-to-medium corrosion and paint chips intermittently, full circumference.

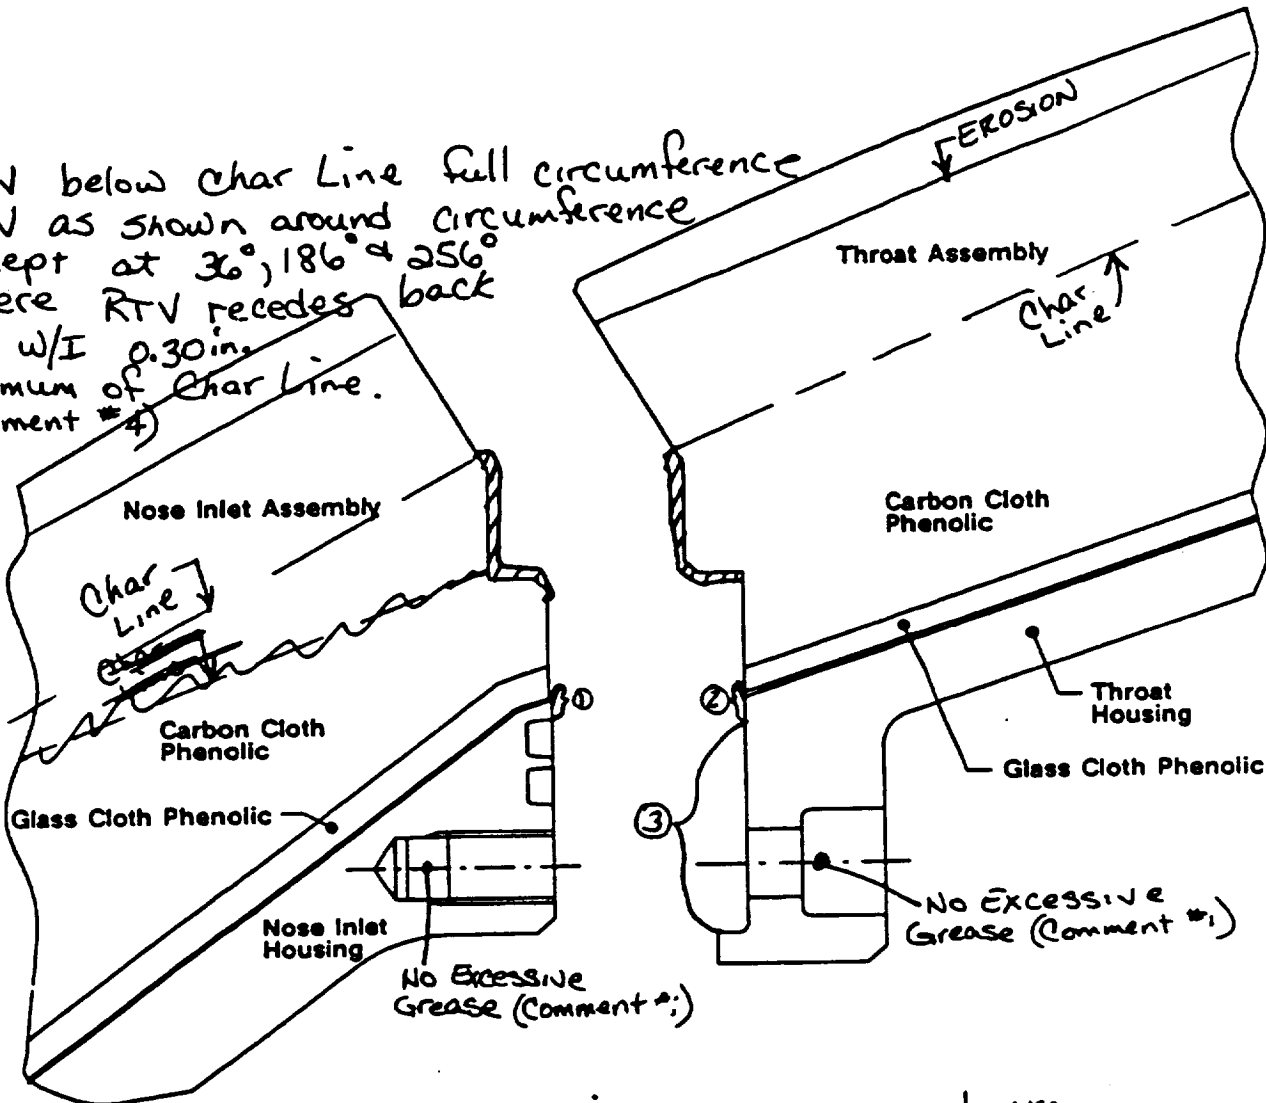
RTV below Char Line full circumference  
RTV as shown around circumference  
except at 36°, 186° & 256°  
Where RTV recedes back  
to w/I 0.30 in.  
Minimum of Char Line.  
(Comment #4)

- ① Typical Aluminum Oxide Corrosion Light to-medium Intermittently, full circumference (Comment #2).
- ② Light corrosion at metal/adhesive interface (Comment #2).
- ③ Good grease coverage with no corrosion or metal damage or metal defects (Special Issue 3.2.3.2) (Comments #2 & #3).

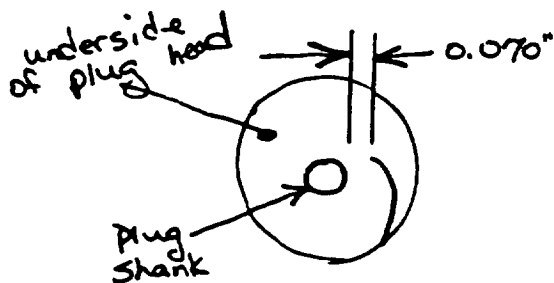
A scratch was observed on the underside of the leak test plug head and could be felt with a 5-mil brass shim stock. The scratch was approximately 0.20 inch long with one end approximately 0.07 inch from the plug shank and was continuous to the outside edge of the plug head. Preliminary PFAR 45C-07 was written.

#1. Scratch running diagonally on bottom side of plug head. Scratch could be felt using the brass shim stock test. Scratch is approximately 0.200 inch in length, starts at  $\approx 0.070$  inch radially from plug shank and goes to outside edge. (See PFAR 45C-07)

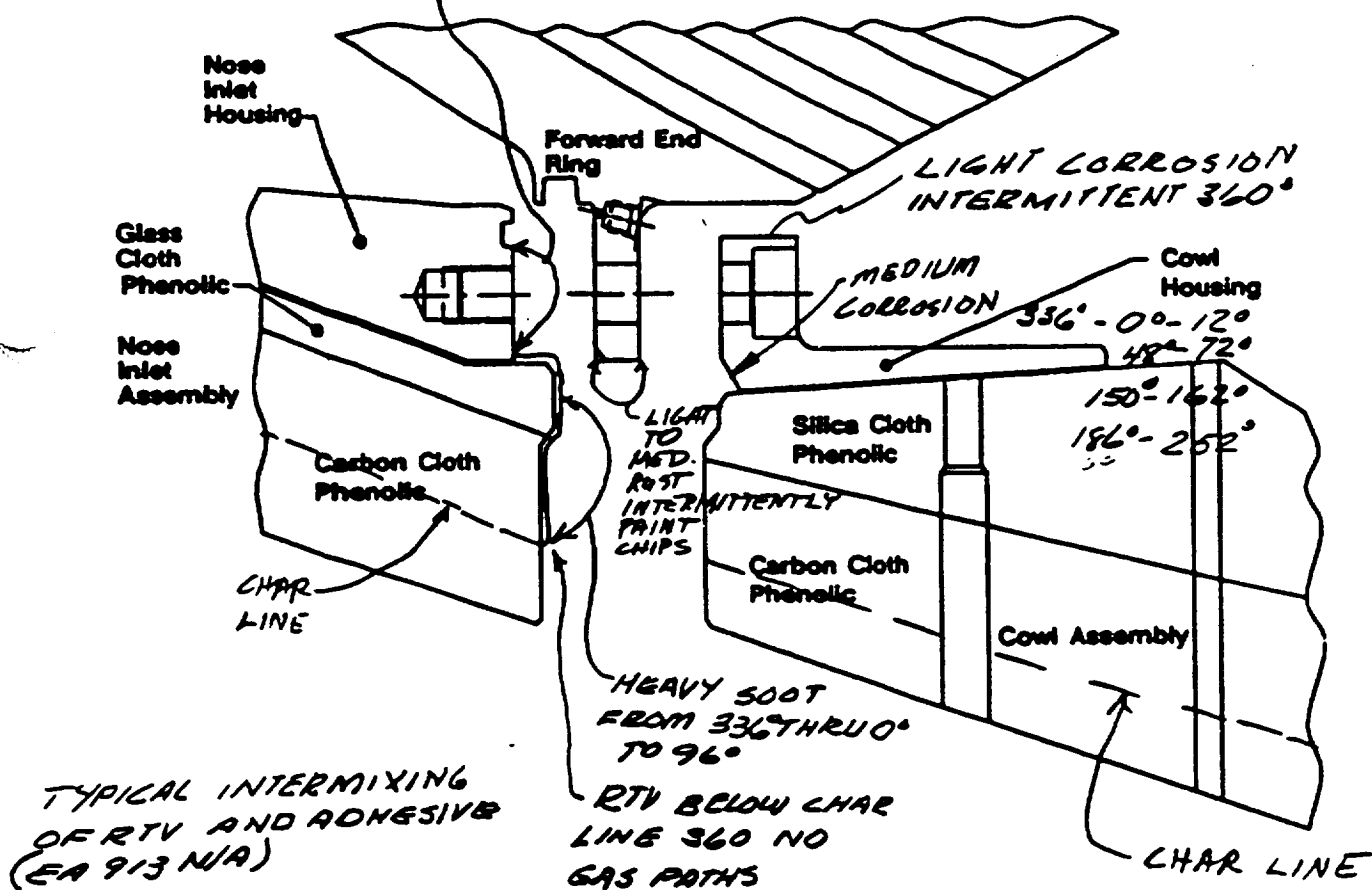
- TYPICAL JACK SCREW SCRATCH MARKS ON NOSE HOUSING FLANGE.
- LIGHT TO MEDIUM CORROSION ON BEARING FWD END RING FWD ID FLANGE INTERFACE AT 3 JACKSCREW HOLES

SOOT TO PRIMARY O-RING BETWEEN BOLT HOLES INTERMITTENTLY AROUND CIRCUMFERENCE.

**NO METAL DAMAGE**

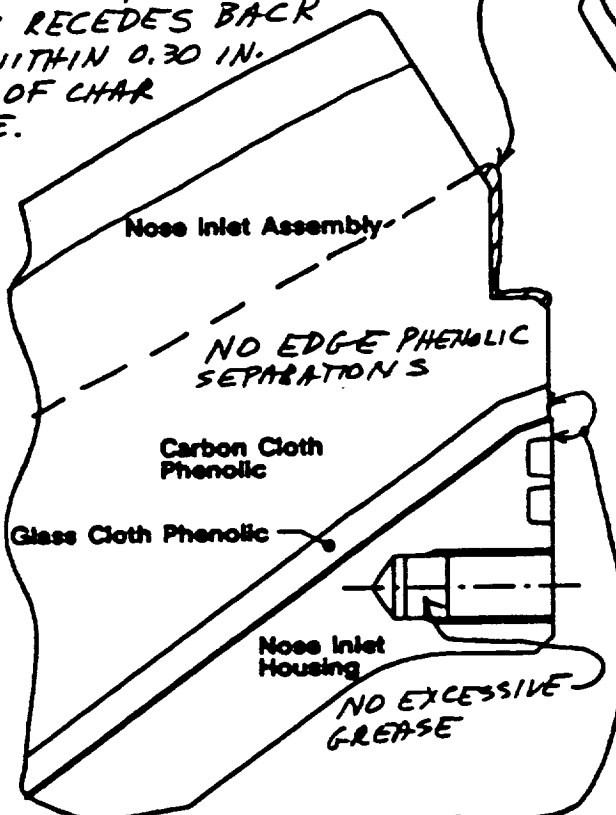
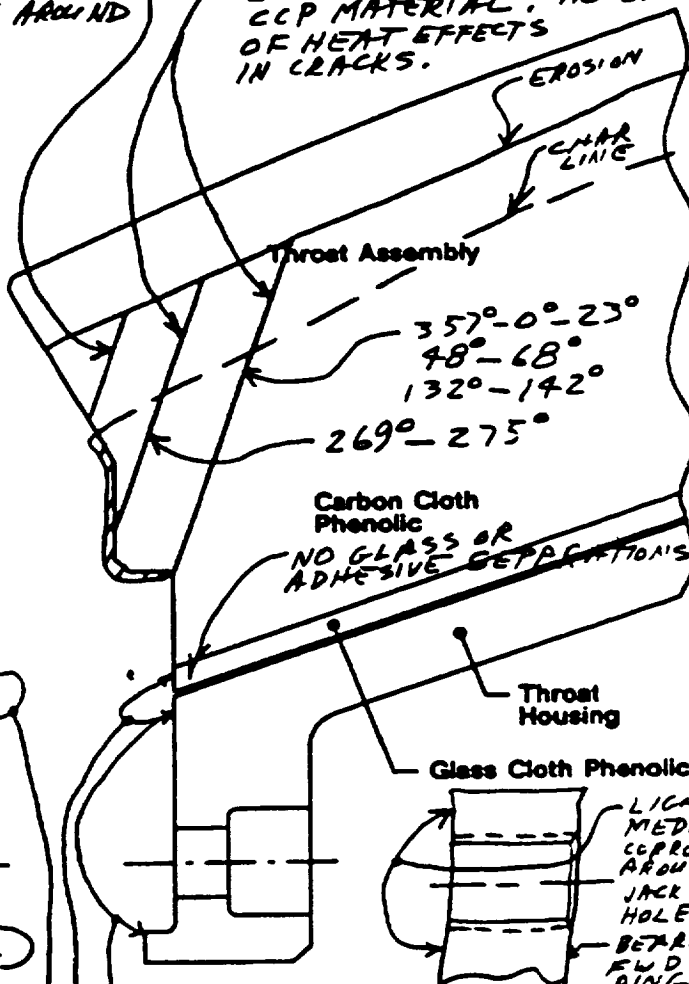
CHARRED CCP DELAMINATIONS  
EXTENDING THROUGH VIRGIN  
CCP MATERIAL. NO EVIDENCE  
OF HEAT EFFECTS  
IN CRACKS.

RTV BELOW CHAR LINE 360°  
RTV AS SHOWN AROUND  
CIRCUMFERENCE EXCEPT AT  
36°, 186° & 256° WHERE  
RTV RECEDES BACK  
TO WITHIN 0.30 IN.  
MIN OF CHAR  
LINE.

TYPICAL AL OXIDE  
CORROSION. LIGHT TO  
MEDIUM.

GOOD GREASE COVERAGE WITH  
NO CORROSION OR DAMAGE

LIGHT RUST CORROSION AT  
METAL/ADHESIVE INTERFACE.

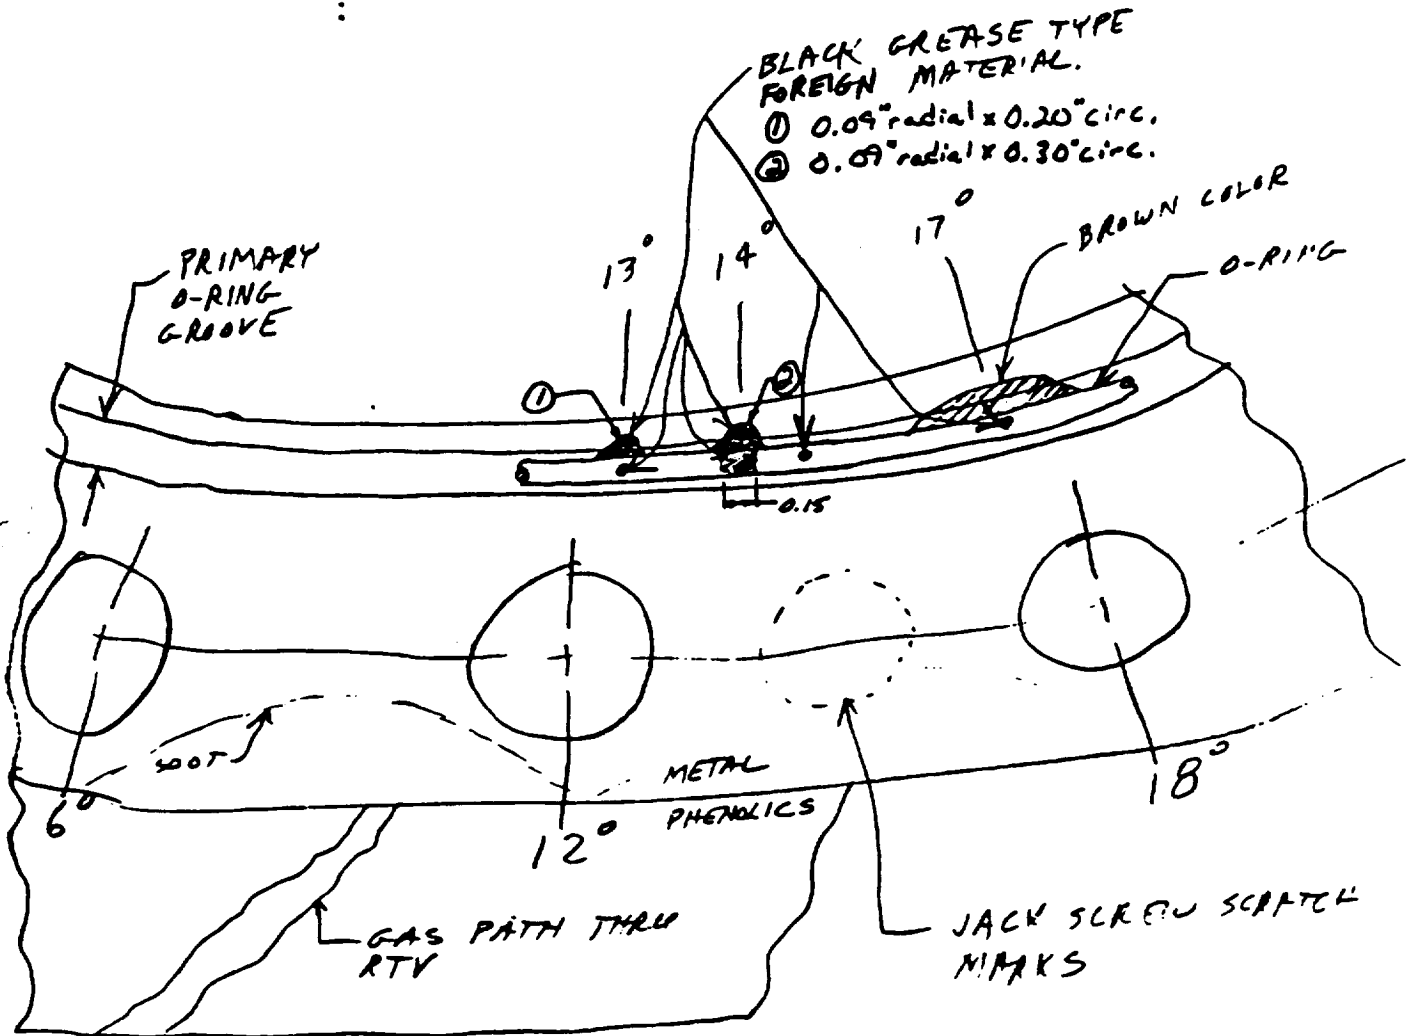
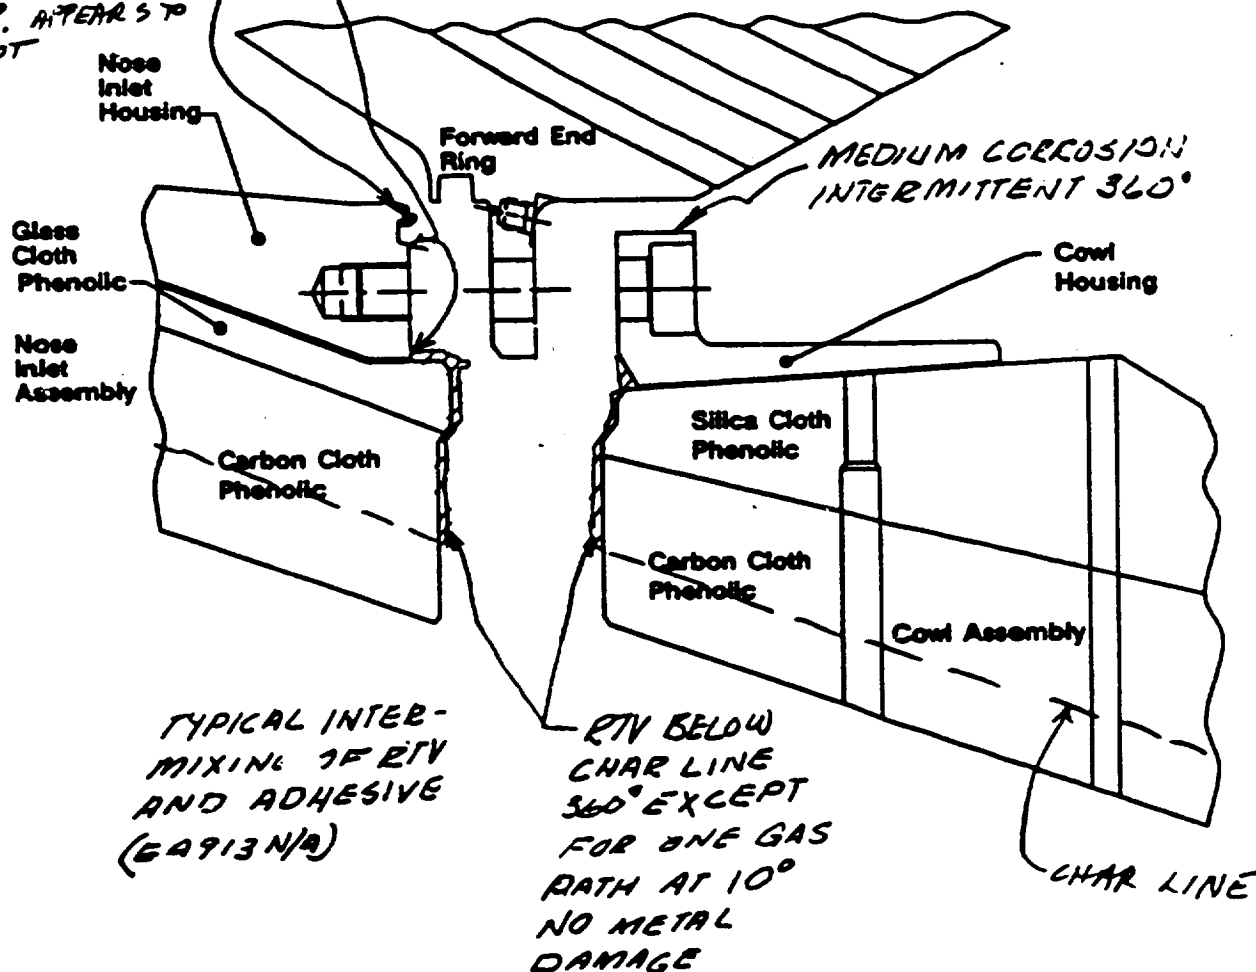
NOSE HOUSING JOINT 2

| Description: FOREIGN MATERIAL PAST PRIMARY O-RING IN JOINT 2 | | |

METHOL CHLOROFORM IN BOLT HOLES AT 6°, 12° & 18° TO DEPTH OF .50 IN MAXIMUM. MC IS USED TO CLEAN JACK SCREW HOLES BY DISASSEMBLY OPERATIONS

3 SPOTS OF DARK GREASE PAST O-RING AT 14°. APPEARS TO BE SOOT

SOOT TO PRIMARY O-RING BETWEEN BOLT HOLES INTERMITTENTLY AROUND CIRCUMFERENCE.

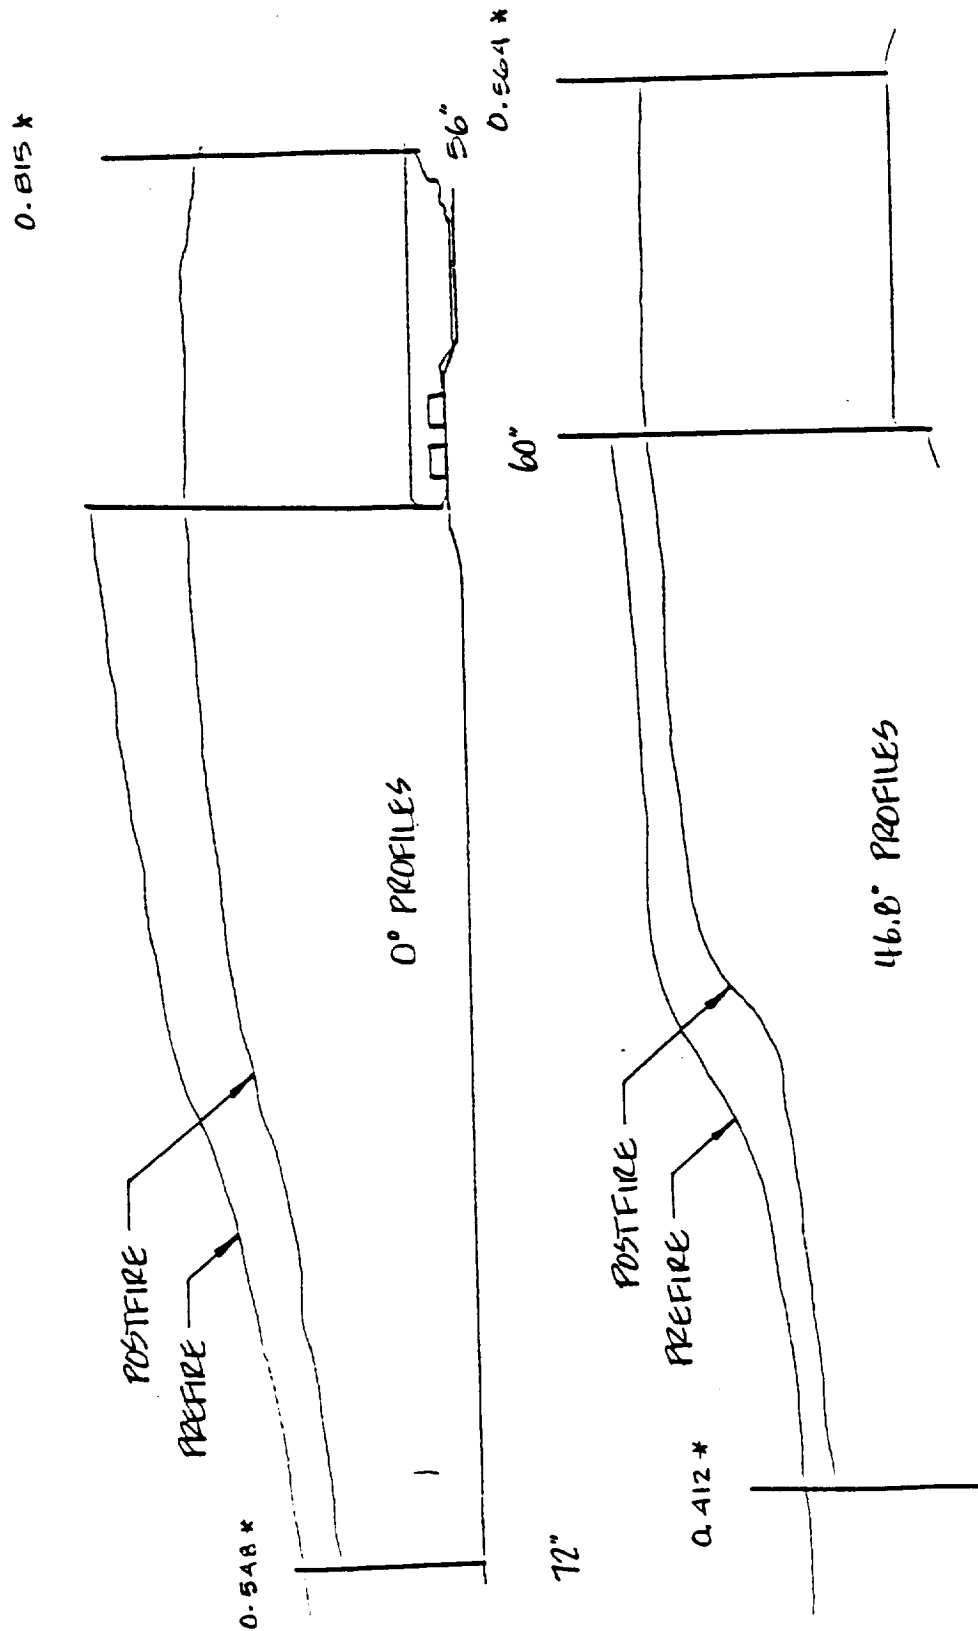
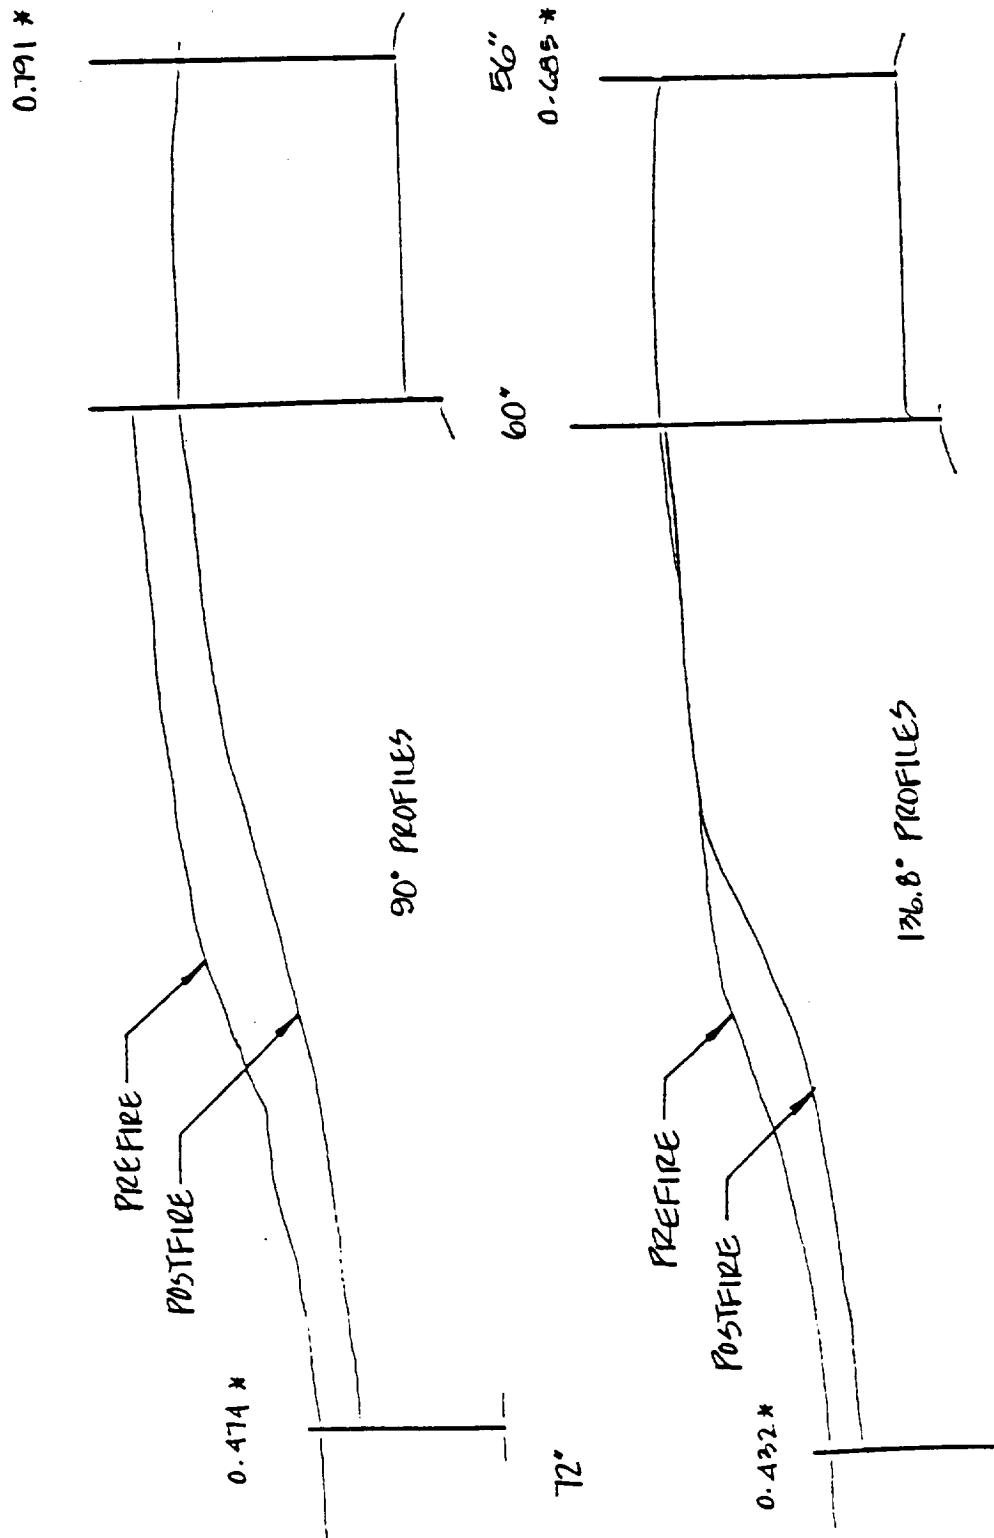
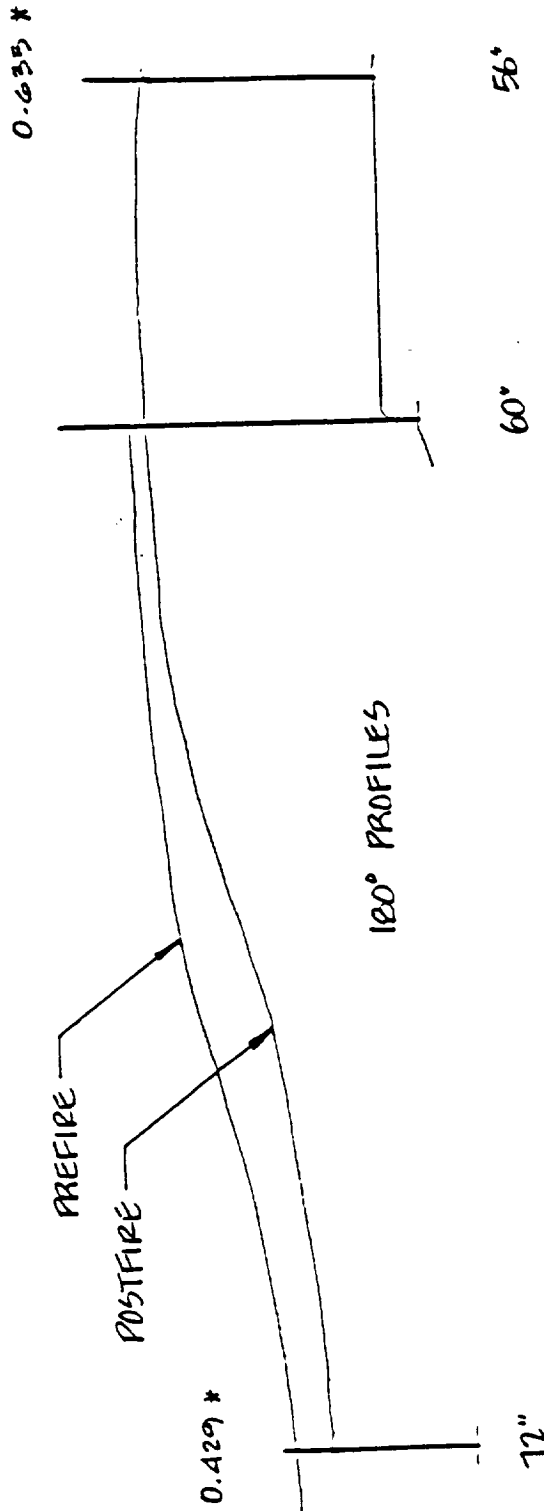
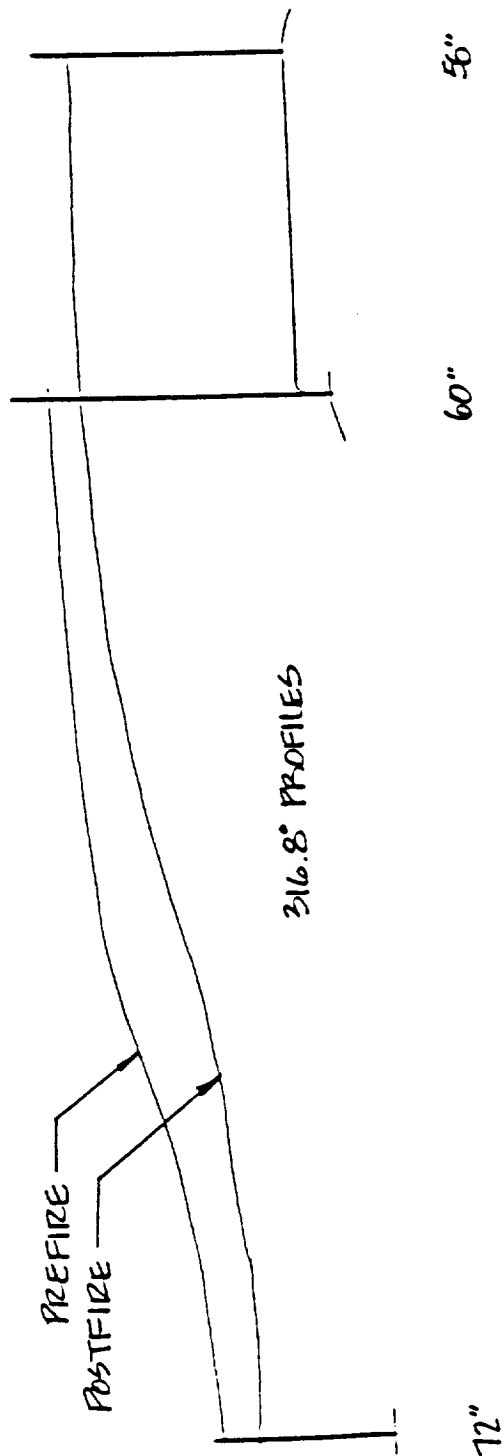
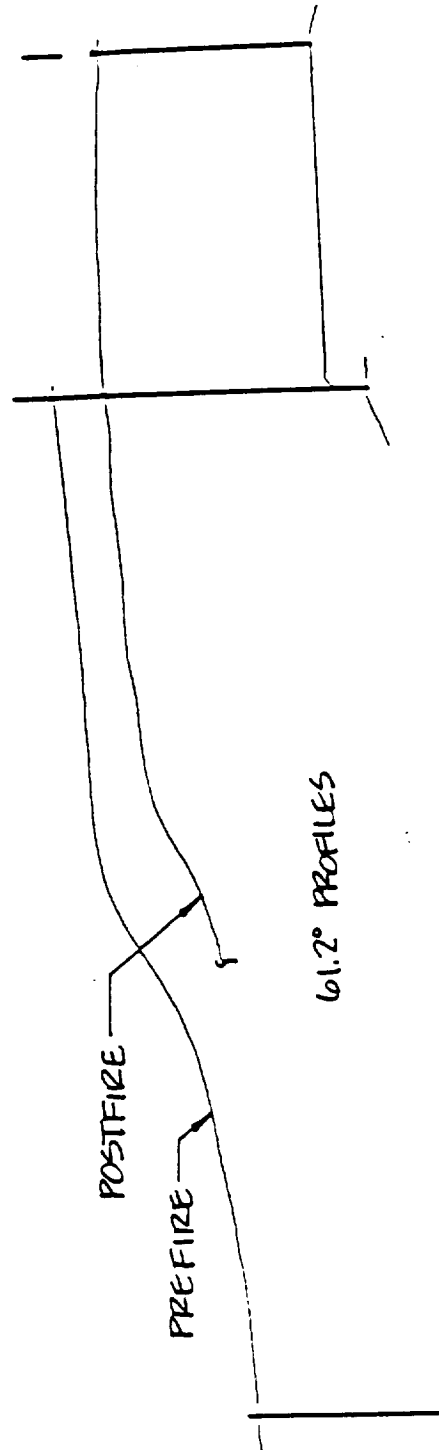
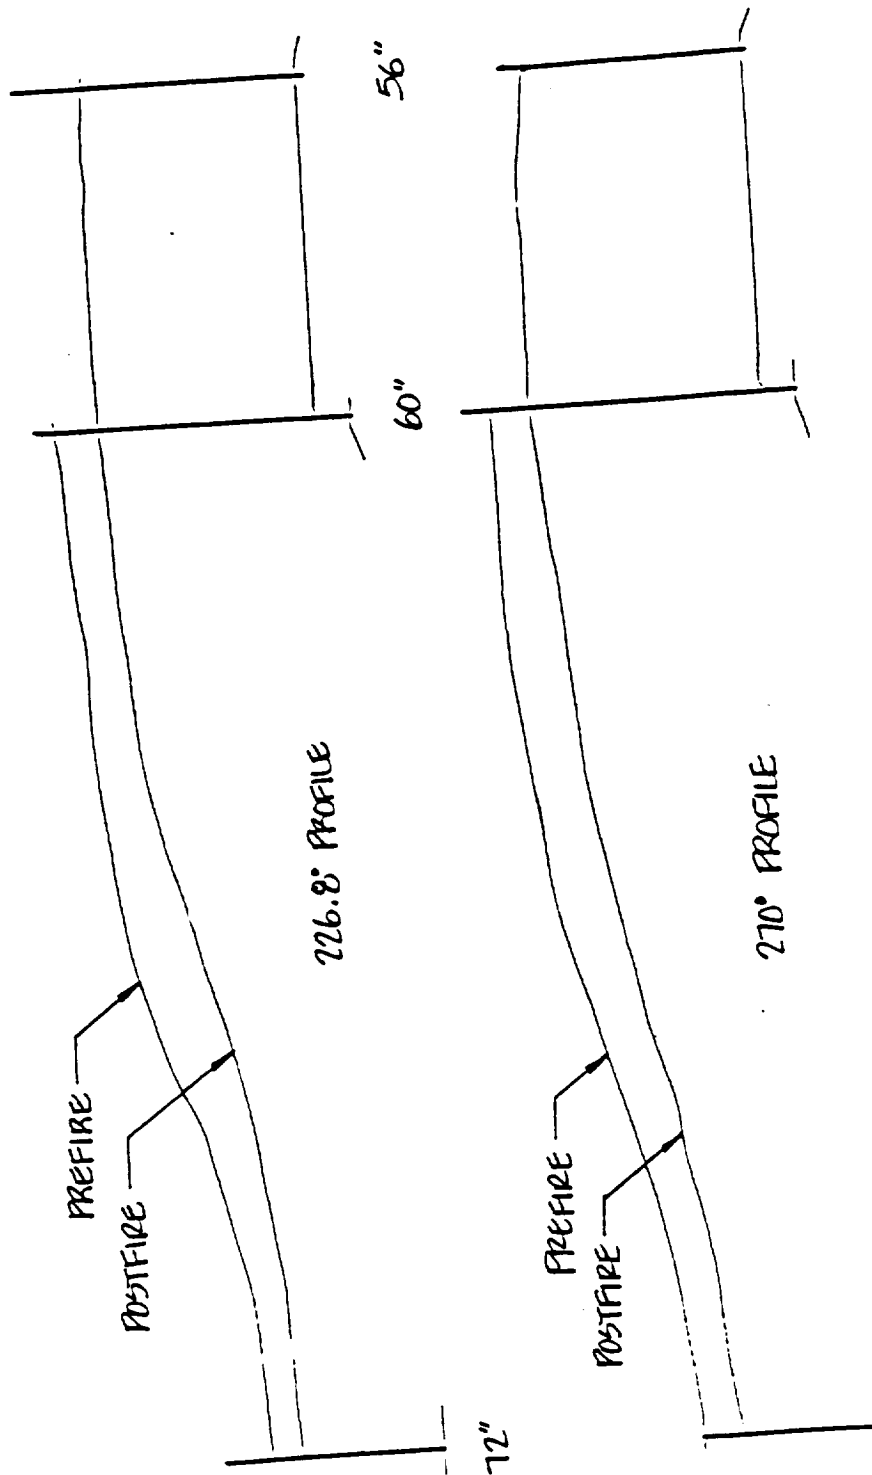
RSRM-21A Aft Dome Factory Joint Prefire vs. Postflight  
Contour Comparison for Asymmetric Erosion Study

**Results:** Asymmetric erosion regions were observed at the aft dome factory joint during postflight inspection at KSC. Profile plots were taken at these areas after segment rinse by Thermal Insulation Design. The prefire profile plots were compared against the postfire plots. The conditions noted prefire were in the same locations as the asymmetric erosion noted postfire. This indicates that the "asymmetric erosion" is primarily a result of prefire insulation layup rather than actual erosion.

As part of the asymmetric erosion investigation, prefire insulation contours were examined on the RSRM-21 aft segments which had recently completed insulation cure. There was a significant difference observed during the visual examination of these two segments. The RSRM-21B segment showed contours which were fairly smooth and uniform, while the forward ramp region on RSRM-21A showed surfaces which was similar to the postflight contours identified on RSRM-13. Prefire contour maps were taken at several locations of the RSRM-21A aft dome factory joint. Comparison plots, shown in Figure 1-5, Appendix E, provide the prefire and postflight contour maps taken on the RSRM-21A aft segment. These plots show that the prefire and postflight contours were very consistent, with

The erosion identified on the forward ramp appears to be a result of normal flow over the factory joint. A propellant void or other defect in this region would result in erosion toward the casewall, as well as into the ramp, which is not evident in these regions.
