MSFC INSPECTIONS OF INSTALLED POLYIMIDE WIRE

Joe C. Landers
NASA George C. Marshall Space Flight Center
Marshall Space Flight Center, Alabama

MSFC INSPECTIONS OF
INSTALLED POLYIMIDE WIRE HARNESSSES

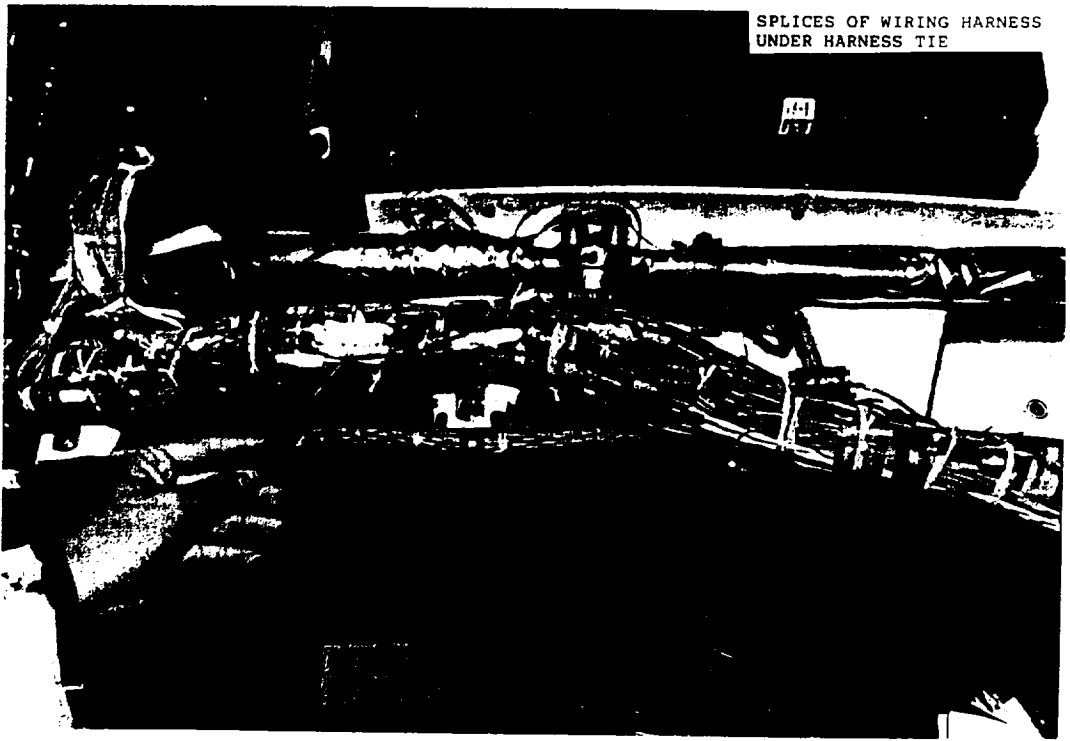
SPICES OF WIRING HARNESS
UNDER HARNESS TIE

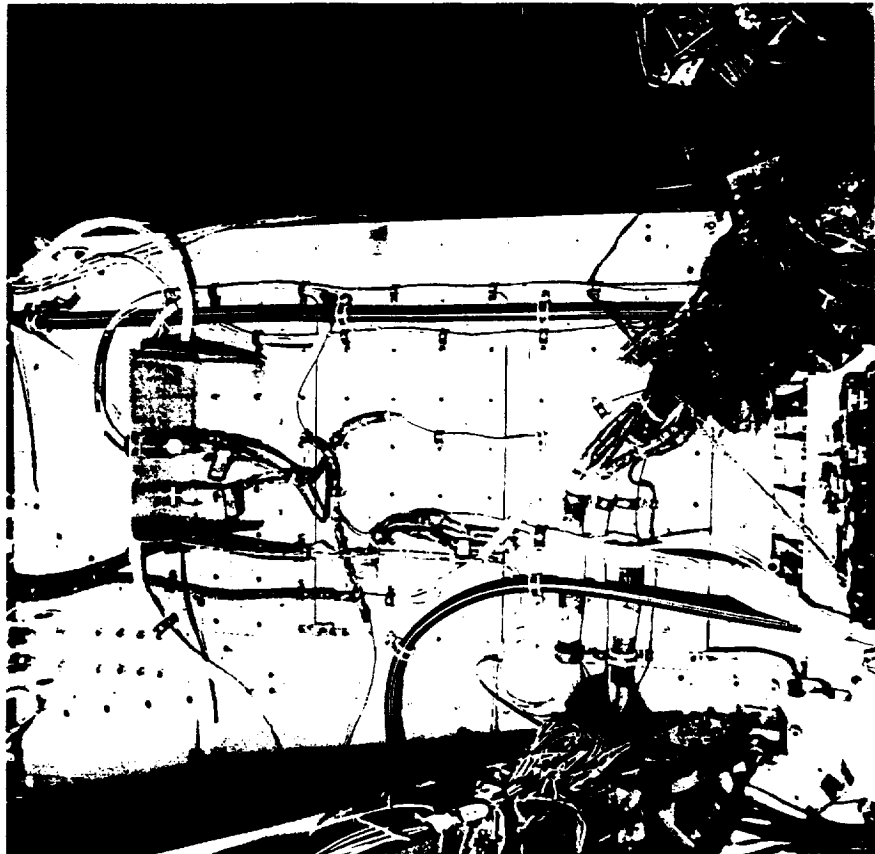
EXCESSIVE LENGTH IN HARNESS
LINES AND IMPROPER SUPPORT OF
HARNESS

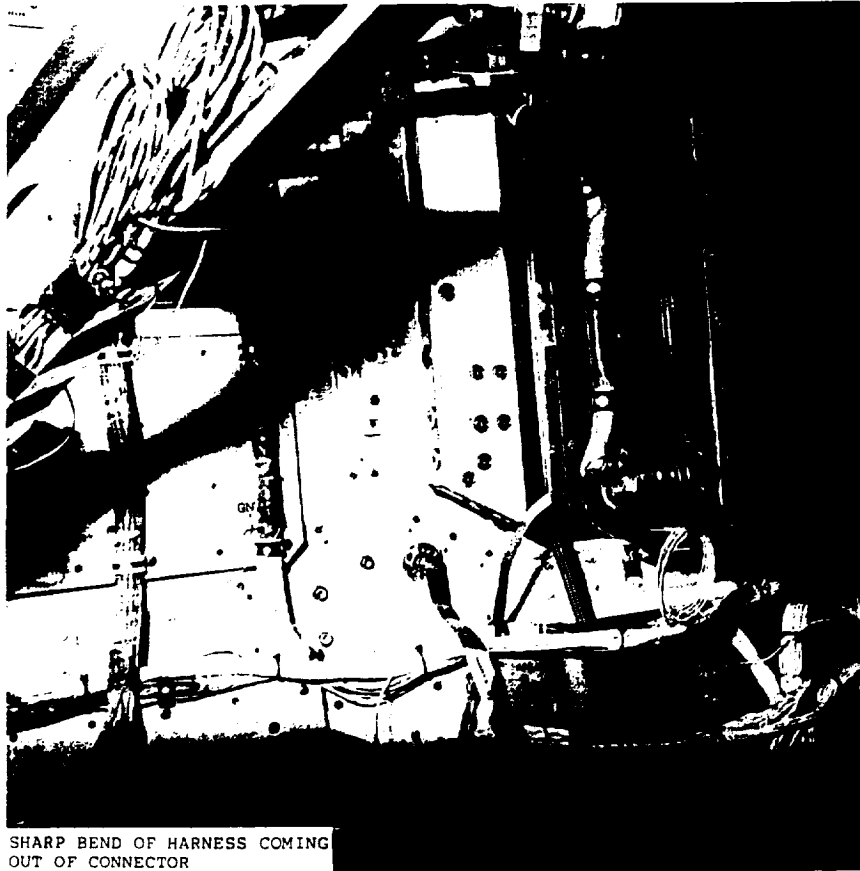
SHARP BEND OF HARNESS COMING
OUT OF CONNECTOR

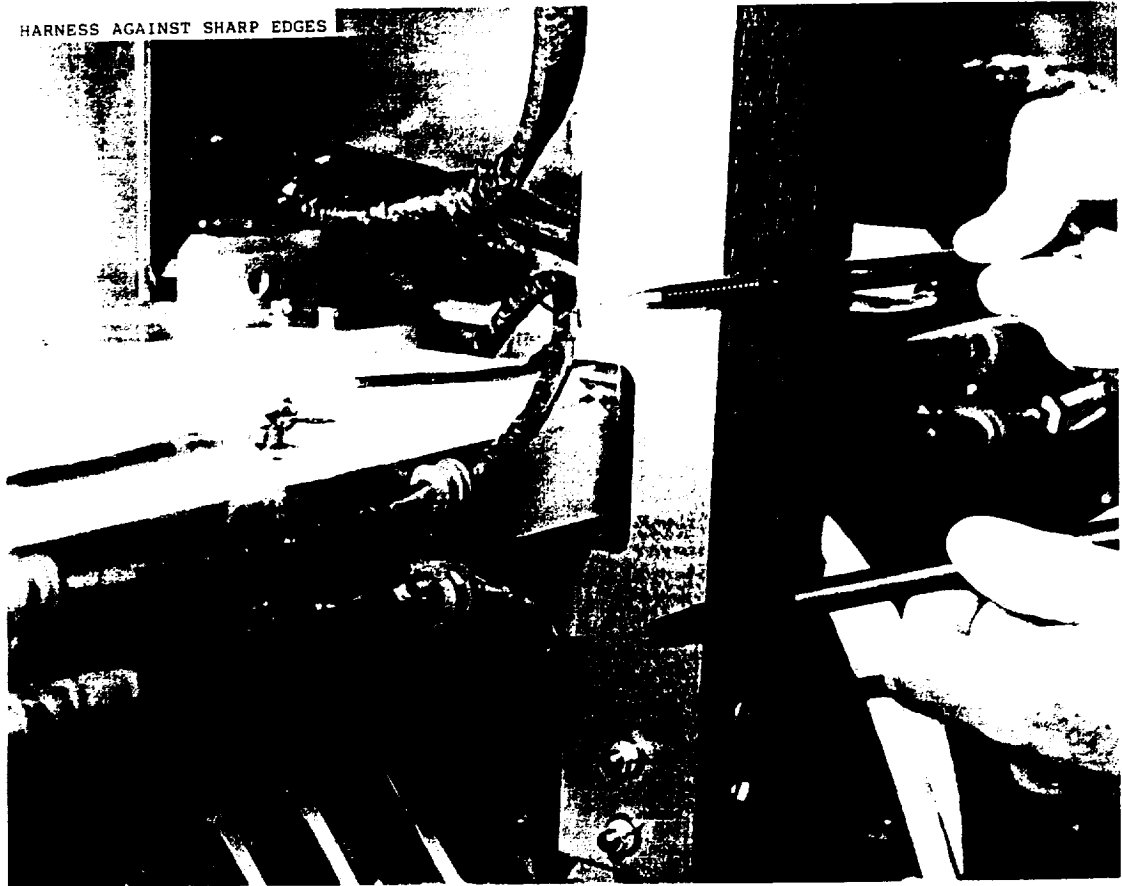
HARNESS AGAINST SHARP EDGES

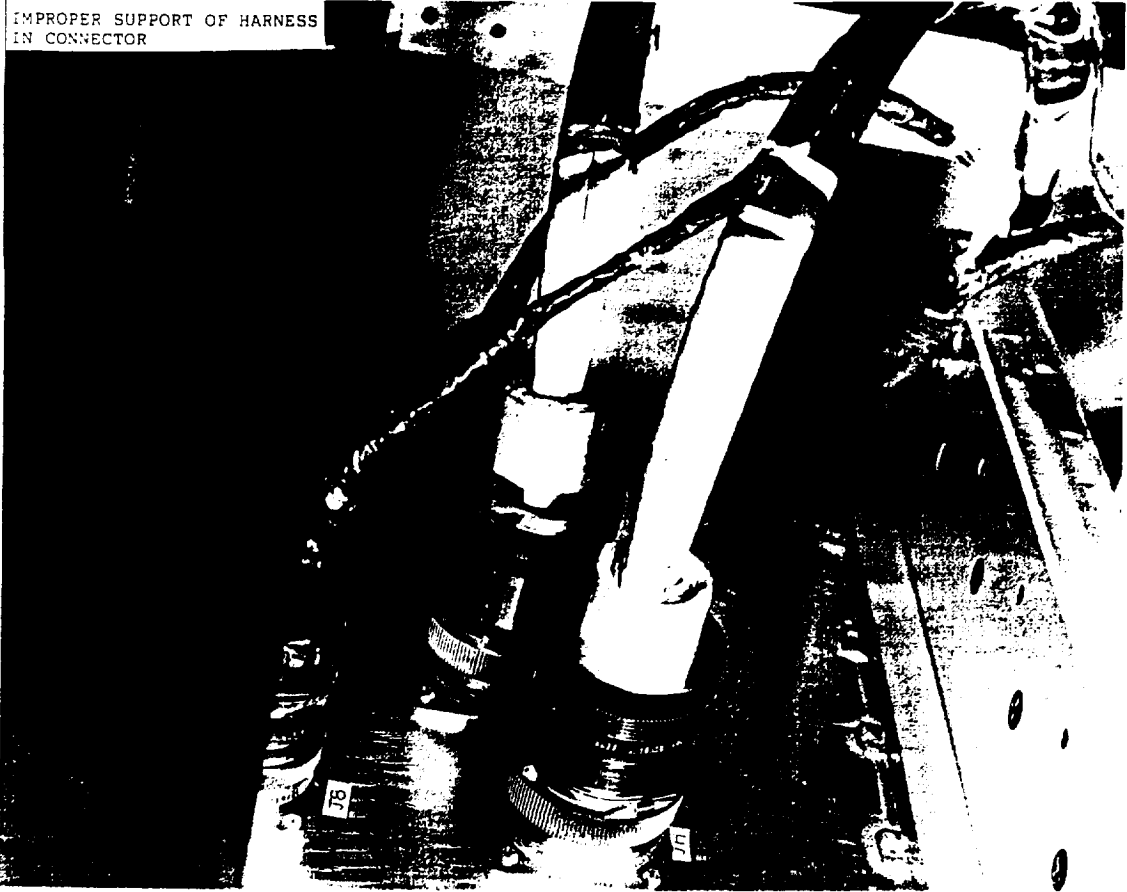
IMPROPER SUPPORT OF HARNESS
IN CONNECTOR

WRONG SIZE HARNESS CLAMP
