# The Characterization of WideSpread Fatigue Damage in Fuselage Structure

Robert S. Piascik  
*Langley Research Center, Hampton, Virginia*

September 1994

National Aeronautics and  
Space Administration  
Langley Research Center  
Hampton, Virginia 23681-0001

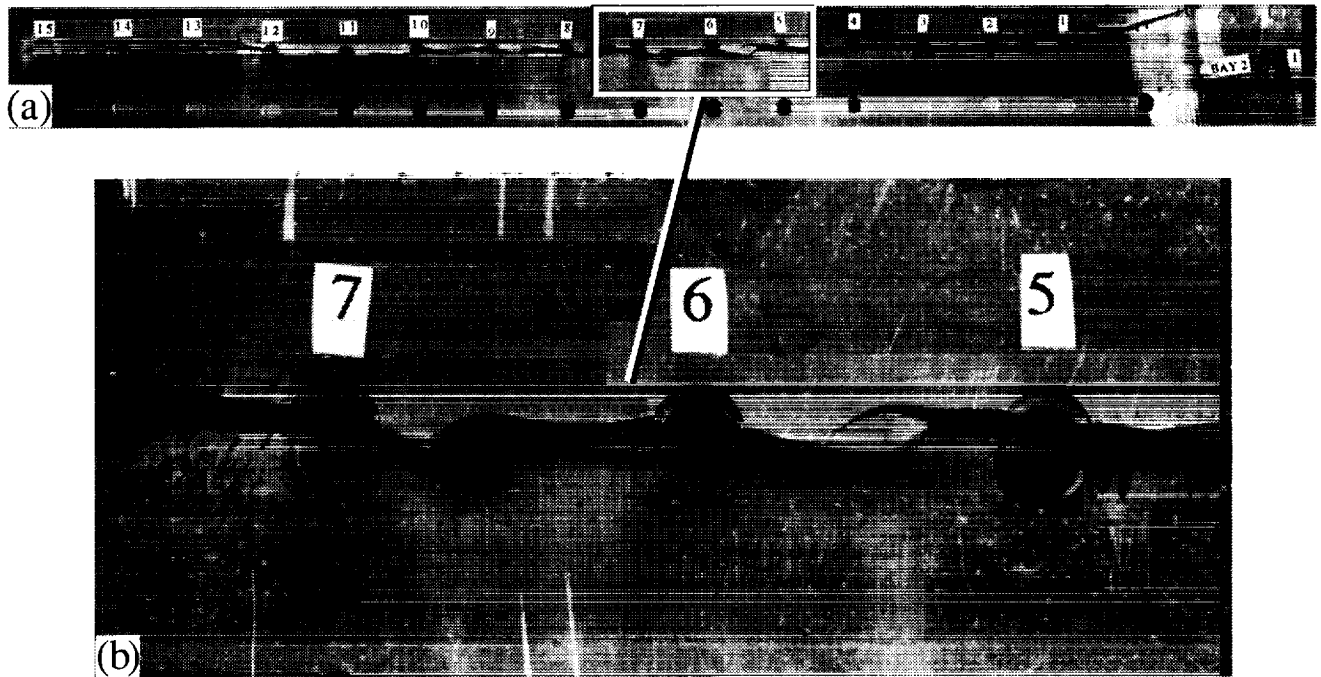
Prior to destructive examination, bay #1 was examined visually (10X) and by eddy current techniques. These laboratory inspections yielded results similar to that obtained by in situ examination. With one exception, all outer skin fatigue cracks were observed in the upper row rivet locations shown in Figure 1. The single exception was observed in the most forward rivet of the second row. The location and description of this outer skin crack was confirmed later by the destructive examination. Subsurface or inner skin fatigue cracking was not detected by NDE. Figure 2 is a photograph showing the long outer skin crack located along the upper row of rivets in bay #1. Figure 2b details the link-up crack path for fatigue cracks propagating from rivets 5, 6, and 7. Interacting "curved" cracks shown in Figure 2b have been observed in the laboratory and modeled by Ingrassia et al. [5].

1. Through-thickness outer skin cracking is primarily contained along the upper row of rivets.
2. All upper row fatigue cracks initiated at the rivet hole horizontal centerline or in the upper half of the hole. The crack propagated nearly normal to the fuselage hoop stress. A curved crack path in middle bay regions, noted in Figure 2, occurred as a result of crack interactions during link-up. Crack link-up of long to short cracks at the outer extremities of the bay exhibited less curvature. The long upper row crack was somewhat deflected by both tear straps; a slight upward crack path was noted at each end of the bay.

3. The upper surface of the long crack was displaced outward, "pillowed". Here, the outer skin was no longer captured by the rivet head. This observation and destructive examination results, discussed later, suggest Mode III displacements had occurred after crack link-up between many rivets, possibly 8 to 10 rivet lengths. Presumably, at long crack lengths, the outer skin can no longer be restrained by the rivet heads and forces due to internal pressure resulted in pronounced out-of-plane displacements. This Mode III effect has been studied by Hui and Zehnder [6].

Figure 2. Photographs showing the fatigue cracking after link-up in bay #1 lap splice joint.

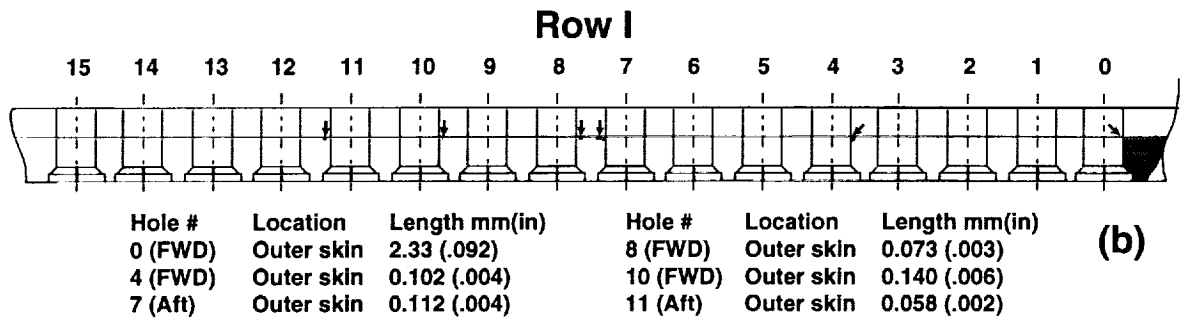
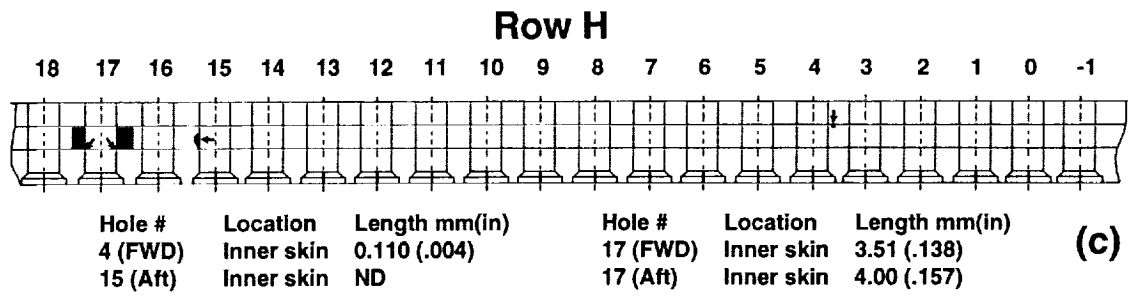
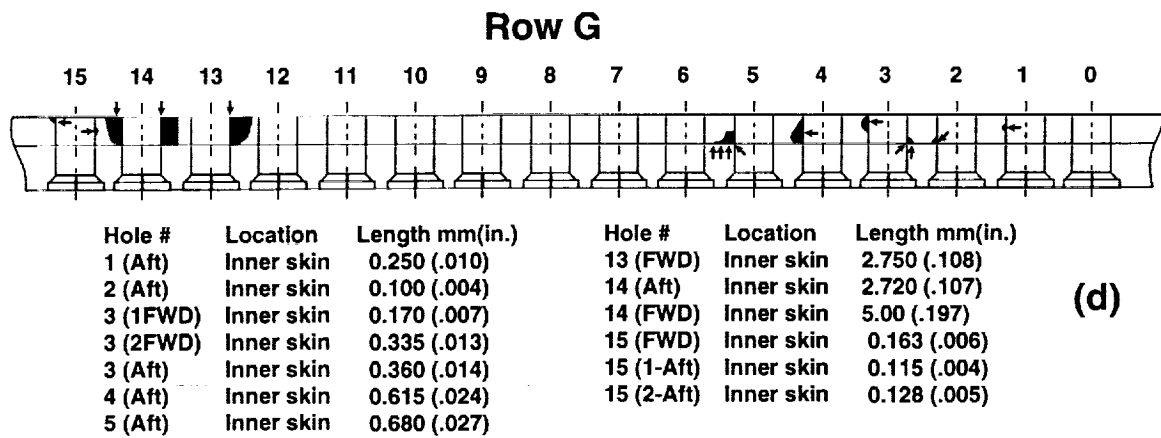
Figure 4 summarizes the results of the destructive examination. Figure 4a is a schematic of bay #1 identifying the four rows of rivets (rows G, H, I and J), the location of the long crack along row J and the location of smaller cracks found in rows G, H and I during the destructive examination. Figures 4b, 4c and 4d are schematics (not drawn to scale) of each rivet row detailing the location, initiation site (arrow) and length of each fatigue crack. Crack depth was computed from the point of initiation to the point of greatest crack depth (length) or, for through-thickness cracks, from the rivet hole surface to the point of greatest crack depth. In rows G, H and I, 17 holes of the 52 examined were found to contain fatigue cracks. A total of 23 fatigue cracks were found in rows G, H and I. Row I contained six outer skin cracks; the crack located at hole position "0" was detected by eddy current inspection. All other fatigue cracks in row I were small and located under the rivet head. Row H contained four inner skin fatigue cracks, two through-thickness cracks located at positions 17 and 18 and small cracks at positions 4 and 15. Row G exhibited cracking in eight rivet holes. Hole locations 13 and 14 contained through-thickness fatigue cracks. The remaining six holes contained smaller surface and corner cracks. The site of crack initiation varied; Row I contained outer skin cracking that primarily initiated along the mating surface between the outer and inner skin, Row H contained inner skin cracks that initiated at rivet hole corners, rivet hole surface and outer/inner skin surface, and Row G contained cracks that initiated at rivet hole corners, rivet hole surfaces and outer/inner skin surface.

Detailed examination of the fracture surface from the long crack contained in upper row J (Figure 4a) revealed that outer-skin fatigue cracks initiated along the lap splice joint interface, identical to that shown in Figure 5c. Further examination of the fatigue fracture surfaces from each rivet hole revealed a thin region (ligament) exhibiting evidence of ductile tearing located along the outboard surface of the outer skin. Figure 6 shows the fracture morphology of upper row fatigue cracks at different stages of propagation from rivet holes located in adjacent bay #2. From Figures 6b, 6c and 6d, a pattern of fatigue crack propagation has been derived for the upper row locations and illustrated in Figure 6a. Figure 6d shows a third outer skin crack of approximately 3.8 mm (0.150 in) in length. Here, the subsurface crack had formed an outboard surface ligament similar to that observed in the upper row on bay #1. These results show that outer skin cracks initiate at the inner/outer skin interface (arrows in Figures 6b, 6c and 6d) and propagate in a subsurface manner depicted in Figure 6a.

Figure 4. Illustrations showing the location of fatigue cracks in bay #1.

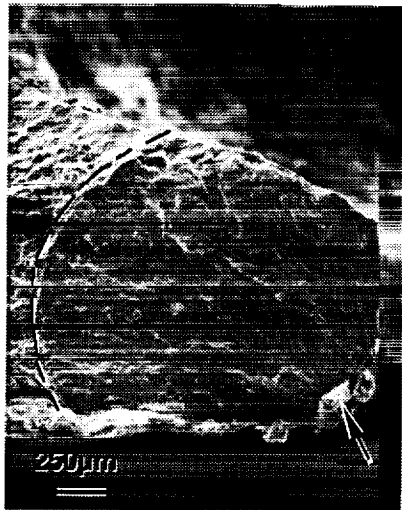
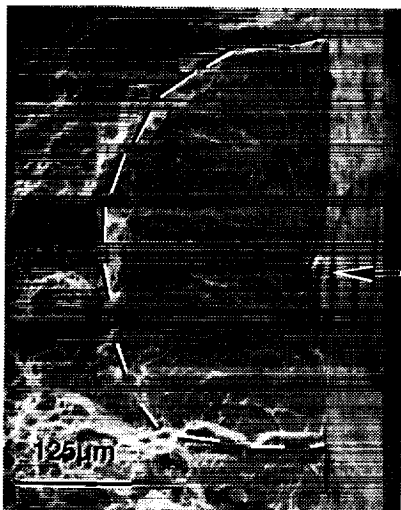
The SEM micrographs shown in Figure 5 illustrate the typical transgranular morphology and location of fatigue cracks observed in the outer and inner skin of bay #1. Outer skin countersink cracking, located in region b in Figure 5a, is shown in Figure 5b. Typically, countersink cracks initiate at the inboard corner of the rivet hole marked by the arrow in Figure 5b. Here, the inboard corner of the countersink exhibits disturbed metal and possible evidence of local clad thinning. The outer skin surface cracks, shown in Figure 5c, initiate at surface clad discontinuities marked by the arrow. These surface cracks are located at the outer/inner skin interface near the rivet hole countersink identified by region c in Figure 5a. Evidence of surface clad abrasion (fretting) was observed at the point of crack initiation, i.e., clad surface disturbed metal, black oxide debris at the outer/inner skin interface and secondary microcracks at the clad metal interface in some cases. Rivet hole surface cracks, region d in Figure 5a, typically initiate at surface discontinuities identified by the arrow. Inner skin corner cracks, located at region e in Figure 5a, initiate at corner discontinuities identified by the arrow in Figure 5e.

Figure 5. Schematic and SEM micrographs showing the location of fatigue cracking, crack initiation site (arrows) and fracture morphology of fatigue cracks in bay #1.
