**NASA/ASEE SUMMER FACULTY FELLOWSHIP PROGRAM**

**MICROSTRUCTURAL ANALYSIS OF CRACKS GENERATED DURING  
WELDING OF 2195 ALUMINUM-LITHIUM ALLOY**

George E. Talia, Ph.D.

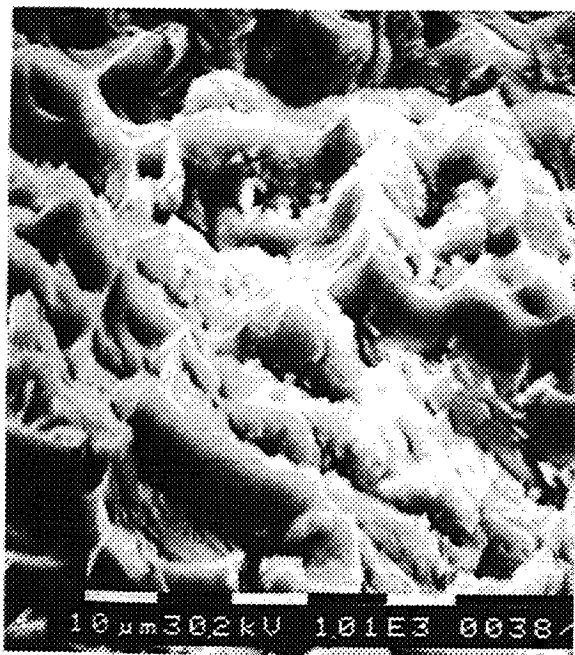
Repairs of defective welds sometimes produce new cracks, to be designated as "repair induced cracks." For subsequent SEM observations, repair induced cracks were torn open in a tensile mode. Figure 1(a) presents a view of "repair induced crack" fracture surface, indicating a ductile fracture, where the surface shows a combination of "melting" and "tearing" areas. Figure 1(b) illustrates another portion of the fracture surface, where melting is predominant. EDS microanalysis observations show that the melted areas present less copper and more nitrogen and oxygen than the tearing areas. The above fractographic observations revealed internal porosity with additional evidence of melting and gas pressure.

Figure 1.- Fractographs of a repair induced crack presenting (a) ductile fracture and (b) evidence of grain boundary melting.

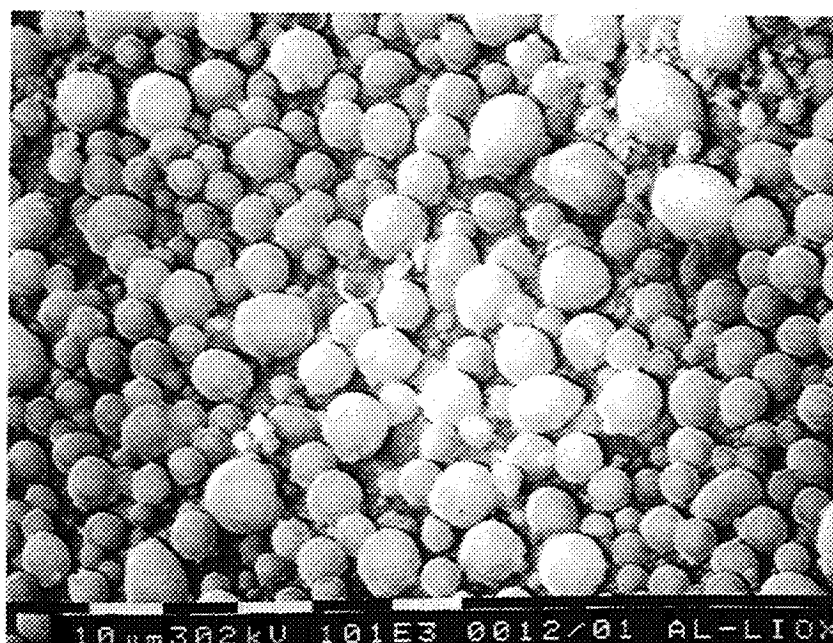
"Smut" outside the "repair induced crack," is shown in Figure 2. Its presence suggests fluid eruption from inside the crack. A high content of oxygen and nitrogen in the smut suggests a reaction inside the crack between nitrogen/oxygen/air and the crack wall. This reaction may generate gas pressure responsible of the eruption of low melting point smut outside the crack.

Figure 2.- SEM micrographs showing "smut" observed near the repair crack.

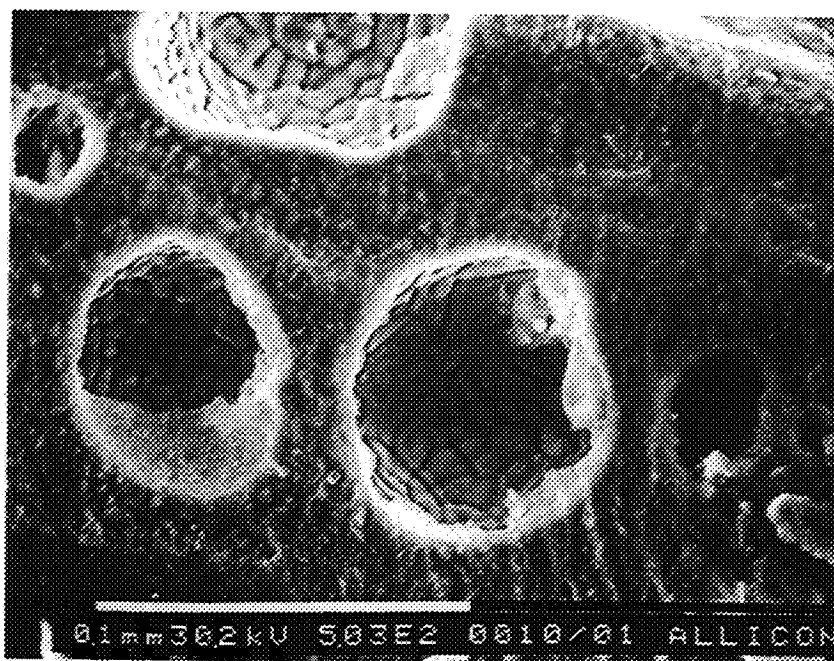
During the course of the study, a few samples of 2195 Al-Li welded specimens accidentally welded without the back shielding were examined. Air-contamination resulted in pore and blister formation. Typical SEM observations of the surface are presented in Figure 3. The root surface exhibits large and small blisters, and evidence of melting. The blisters are surrounded by matter as if matter erupted from inside, similar to the smut observed previously. It is conjectured that presence of a nitrogen/oxygen/air reaction causes melting and generates enough gas pressures in these blisters to cause eruption of melted matter to smut. In the interior of the blister, high nitrogen, magnesium, and oxygen, and decreased copper is measure. An optical micrograph cross section is presented in Figure 4, showing internal blister formation, and evidence of melting or partial melting induced by air contamination. The spherical form of the pore/blister indicates gas pressure acting.

Figure 3.- Blisters on the free surface of a contaminated weld showing evidence of surface melting and gas pressure.

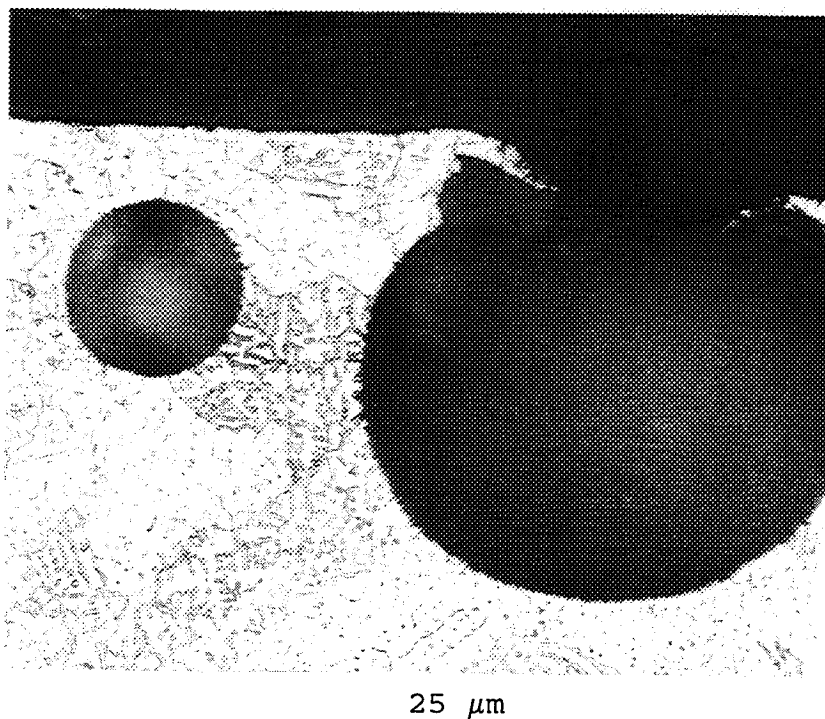
Figure 4.- Internal and external blistering in a 2195 alloy weld bead caused by air contamination.
