EVALUATION OF THE FUSELAGE LAP JOINT FATIGUE
AND TERMINATING ACTION REPAIR

Gopal Samavedam*, Douglas Thomson*, and David Y. Jeong**

SUMMARY

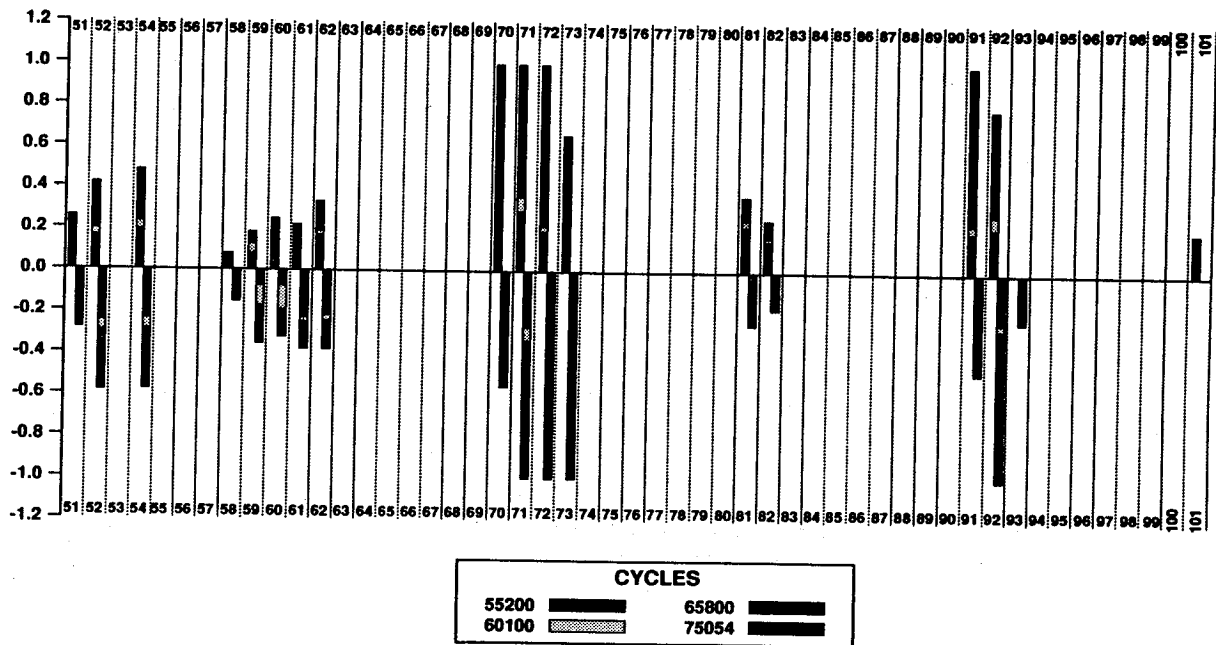
Figure 2. Distribution of cracks in the upper rivet row.

Cracking in the upper row of rivets was first observed after 37,000 cycles. Figure 2 shows the distribution of cracks along the upper rivet row at different points in time as the panel was cycled. The abscissa represents the rivet location where rivets have been numbered sequentially from the left to right on the test panel.

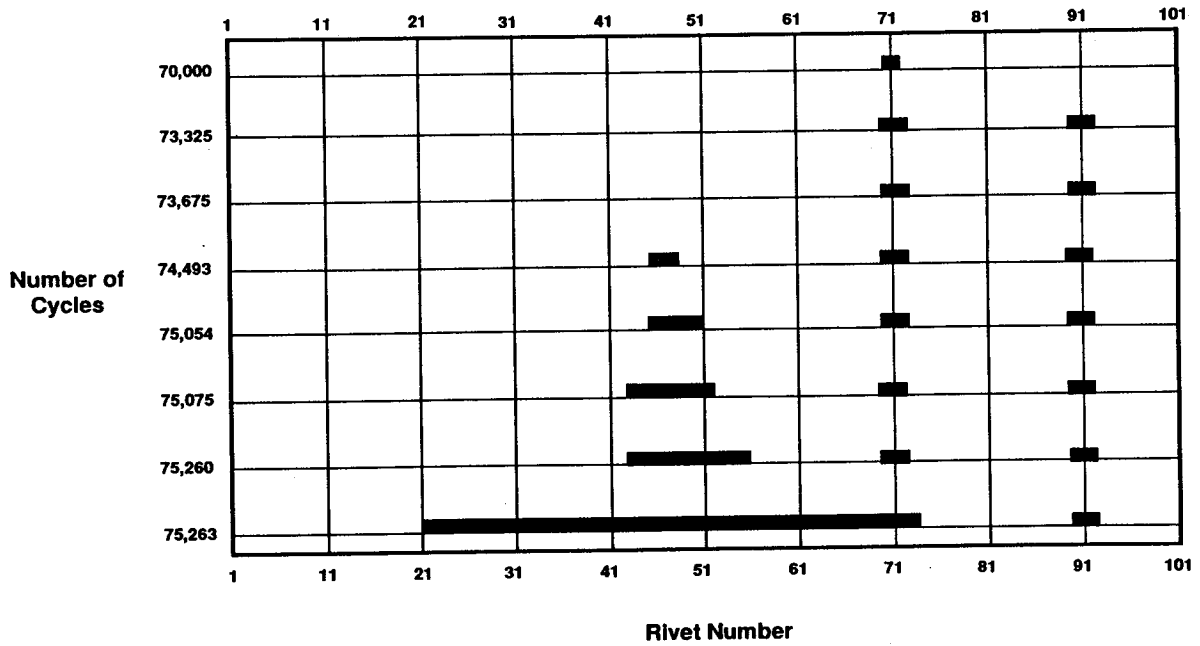
Figure 3. Sequence of multiple crack linkup events.

Figure 3 shows the sequence of multiple crack linkup events which led to failure of the panel. The first linkup of multiple cracks was observed after 69,400 cycles in the ligament between rivets 71-72. Similar linkups occurred in ligaments 91-92 after 73,325 cycles later, and in ligaments 46-47 and 47-48 after 74,493 cycles. Panel failure occurred after 75,263 cycles when several multiple cracks linked together to form a single crack over 50 inches in length.

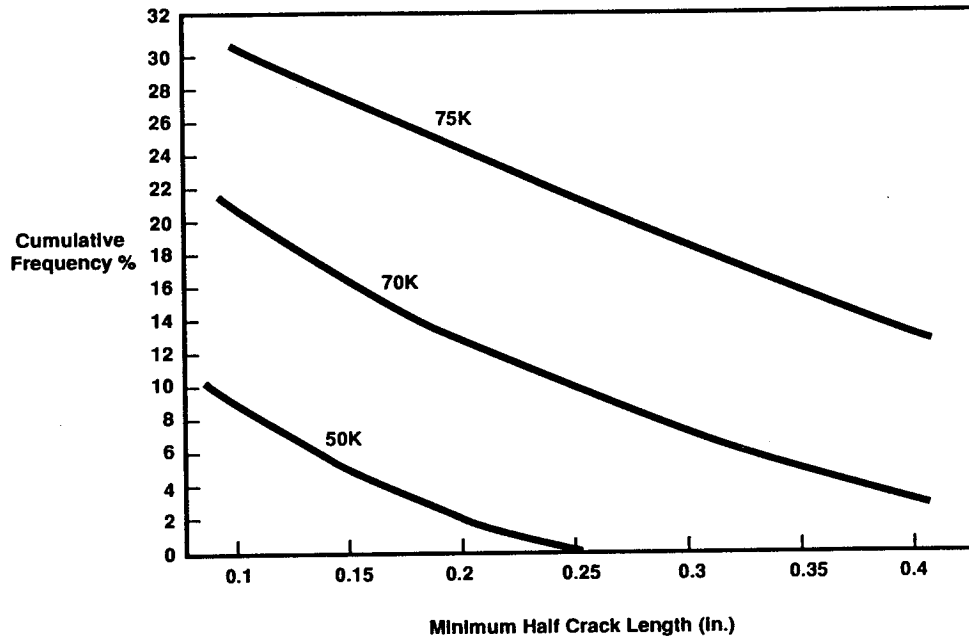
Figure 4. Cumulative frequency of cracking in baseline test.

The cumulative frequency of cracking along the upper rivet row can be plotted as a function of minimum crack length and of total cycles. Figure 4 shows this type of plot for 3 different points in time during the life of the panel. Thus, after 50,000 cycles, 9% of the rivets in the upper row had cracks greater than 0.2 inch. Further, after 70,000 cycles (or when 93% of the panel fatigue life had been consumed), 13% of the rivets in the upper row had cracks greater than 0.4 inch, while 3% of these rivets were greater than 0.8 inch. The cumulative frequency of cracking is simply a function of cycles and load levels.

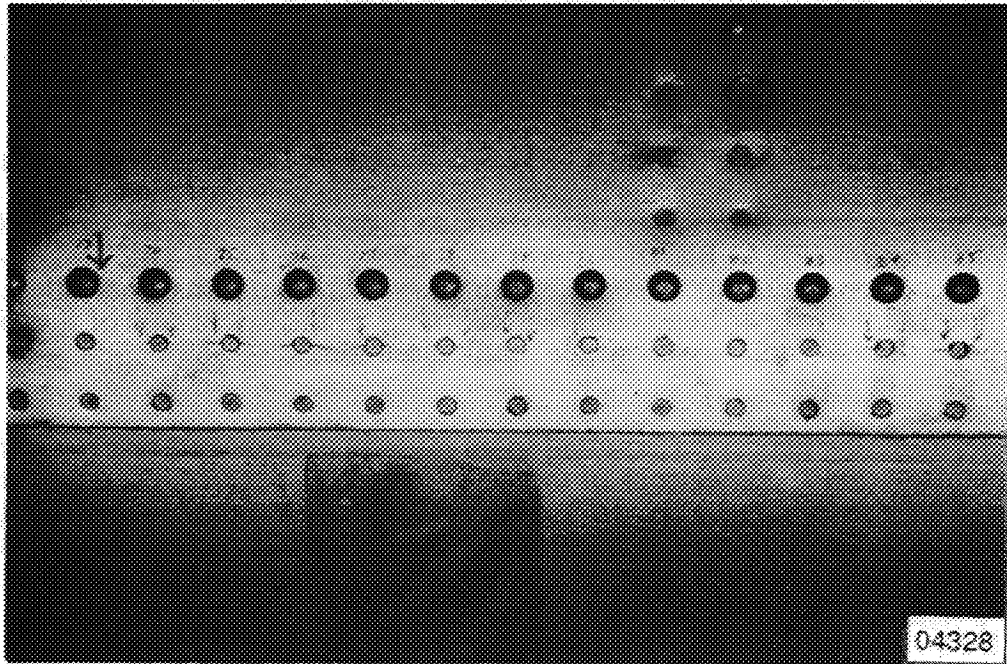
Figure 5. Middle rivet row cracking in terminating action repair test.

Cracking was observed in the *middle* row of rivets in the lap joint 37,800 cycles *after* the terminating action had been applied. Figure 5 shows a photograph of cracks in the middle rivet row of the panel with the terminating action repair. Middle rivet row cracking was also observed during fatigue tests conducted on flat lap splice coupons [4]. In Reference [4], the effect of different lap joint design parameters on the formation of multiple cracking was investigated in the laboratory. Middle row cracking was not observed, however, until after substantial cracking had occurred in the upper row. In addition, middle row cracking in a fuselage lap splice was observed in the Aloha airplane, as reported in Reference [1].

The terminating action was applied to an initially undamaged test panel after 30,000 cycles, which is within specifications of the AD. Thus, all of the countersunk rivets in the upper row along the lap joint were drilled out and replaced with universal head rivets. Although three small cracks (all of which were less than 0.020 inch in length) were found at the time of the repair, they were completely drilled out when the holes were enlarged to accommodate the universal head rivets.

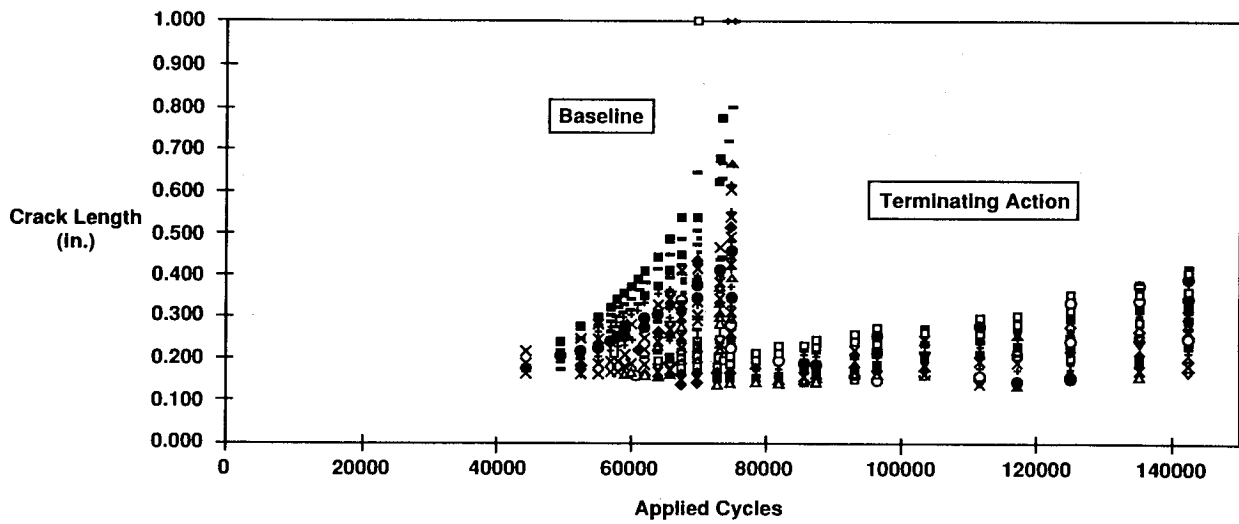
Figure 6. Crack growth rates observed during full-scale fatigue tests.

The application of the terminating action appears to retard the rate of crack growth. Crack growth curves for the baseline panel are compared to those for the terminating action repair panel in Figure 6. The rate of middle row crack growth *after* the terminating action is about one-third of upper row crack growth rate without the terminating action. Table 2 compares crack growth rates from other sources of data as well.

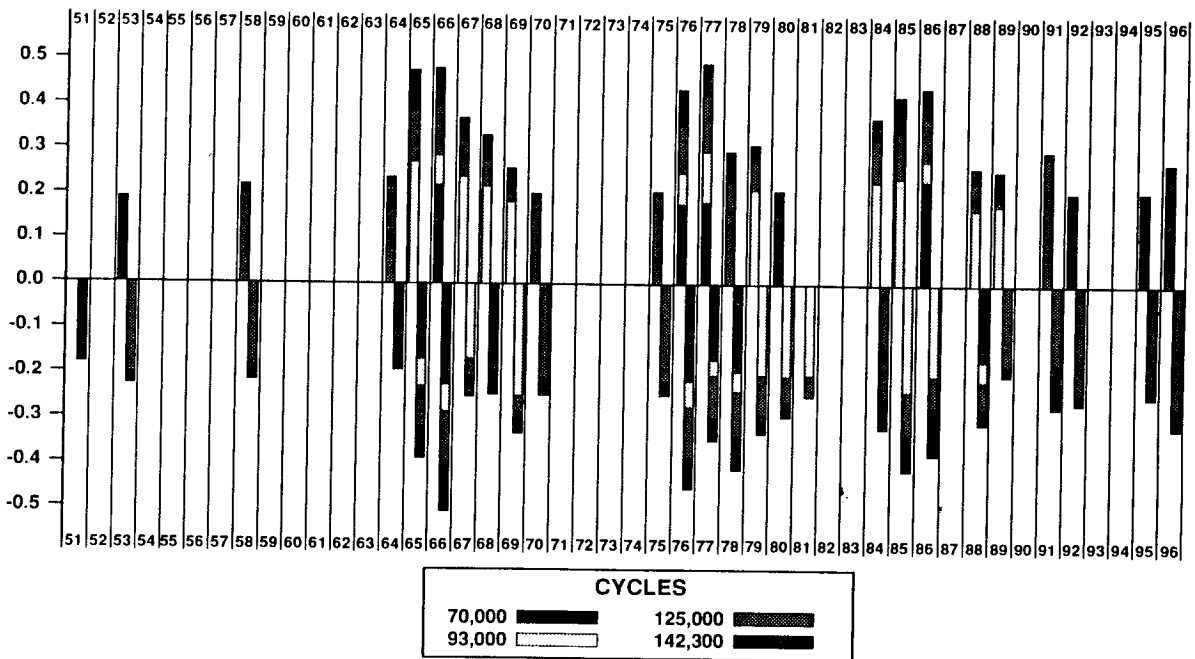
Figure 7. Distribution of cracks in middle rivet row in terminating action repair test.

Figure 7 shows the distribution of cracks observed in the middle rivet row during cycling of the panel. (For purposes of comparison, the scale for crack length in Figure 7 is different than Figure 2.) Cracking appears to be concentrated in the midbay areas with relatively few cracks over the tear straps. This distribution is in contrast to the fairly random distribution observed in the baseline test.

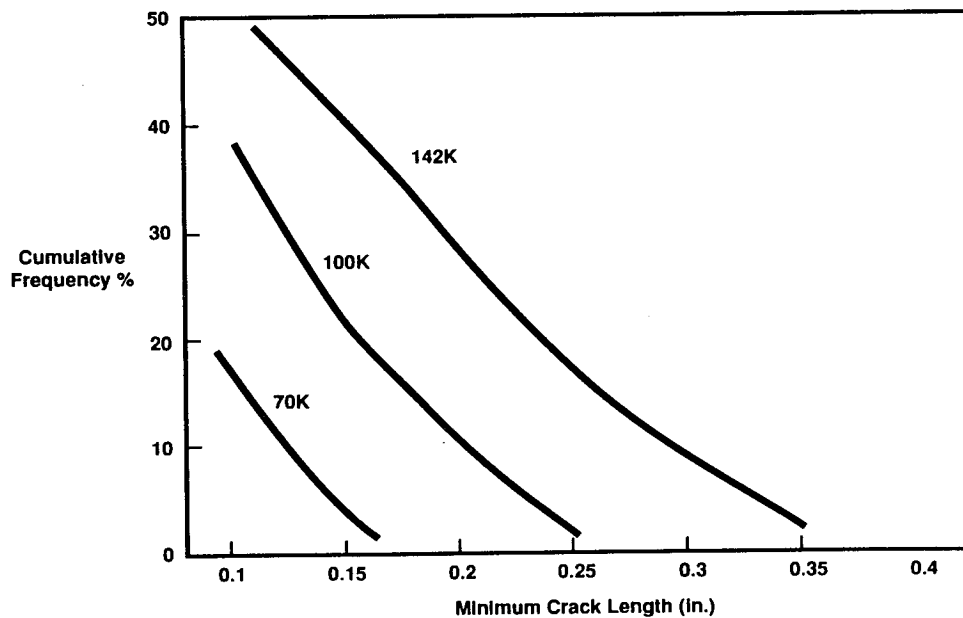
Figure 8. Cumulative frequency of cracking in terminating action repair test.

Figure 8 shows the cumulative frequency of cracking in middle rivet row as a function of minimum crack length at 3 instances of time during the progression of the test. After 70,000 cycles, 17% of the rivets in the middle row had cracks greater than 0.2 inch in total length. At the termination of the test, 50% of the cracks had cracks greater than 0.30 inch.

The panel was fatigued for a total of 142,883 cycles. At that point, eighty-nine (89) cracks were found along the middle rivet row of the lap joint, but no linkup of cracks occurred. The longest of these cracks was measured to be 0.41 inch. The underside of the panel was inspected and no damage was found. Moreover, no cracks were detected in the upper row of rivets.
