MATERIAL INSPECTION OF EURECA
FIRST FINDINGS AND RECOMMENDATIONS

Marc Van Eesbeek, Michael Froggatt and Georges Gourmelon
ESA/ESTEC
Noordwijk
The Netherlands

This paper gives the first results of the Post flight materials investigation on the European Retrievable Carrier (EURECA) after a stay of 11 months in LEO.

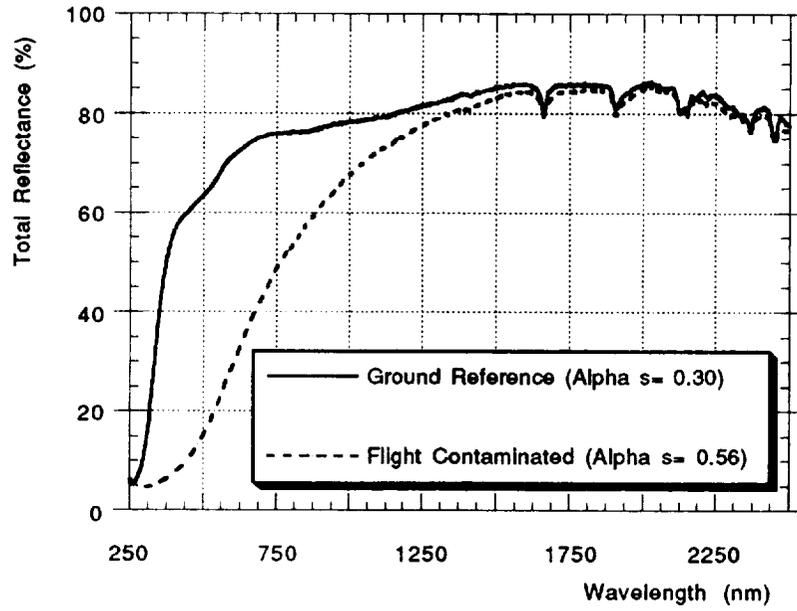
Fig. 2 BETA CLOTH

On several optical instruments a degradation of the performances was reported during the flight. Contamination of the front optics was visible and will have contributed to these losses; however, it also appeared that several of the front filters showed failures at interfaces between the different layers. The pure contamination related degradation was highly wavelength dependent (see Fig. 2.).

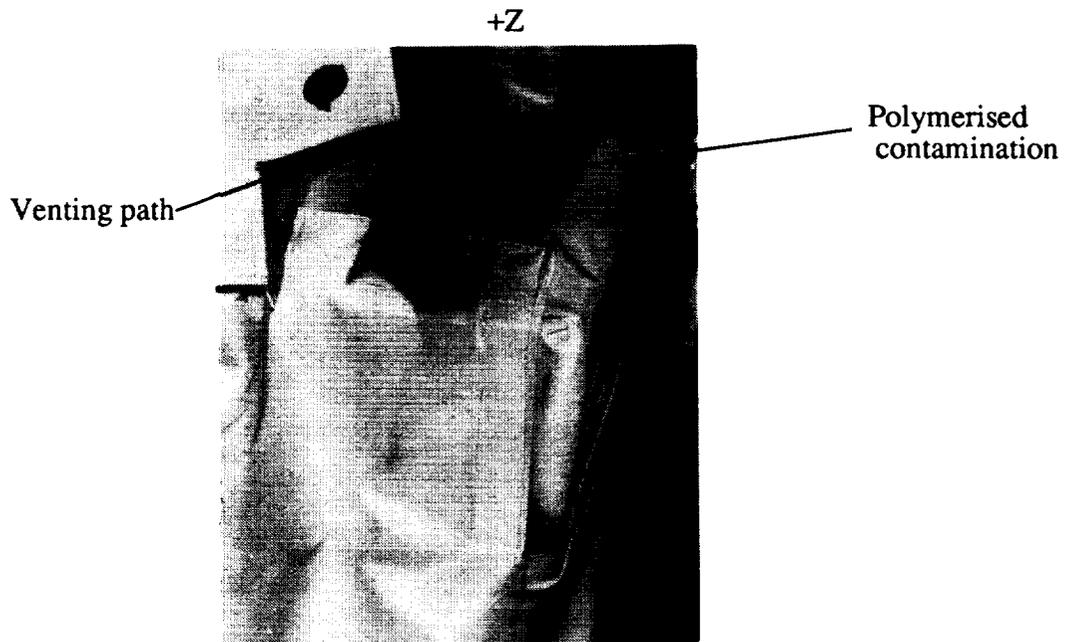
There are signs of outgassing from within the spacecraft (see photos 1 to 5). These signs sometimes called "nicotine stains" or brown stains emanate from different unintentional venting holes, e.g. around Attitude and Orbit Control System (AOCS sensors), the Atomic Oxygen Sample Tray (AOST) experiment, Protein Crystallisation Facility (PCF) dome, the Advanced Solar Gallium Arsenide Array (ASGA), GRAPPLE fixture etc.

PHOTOGRAPH N° 3. View of brown stain caused by outgassed material being polymerised by UV irradiation after condensing on Beta cloth. (NASA photo)

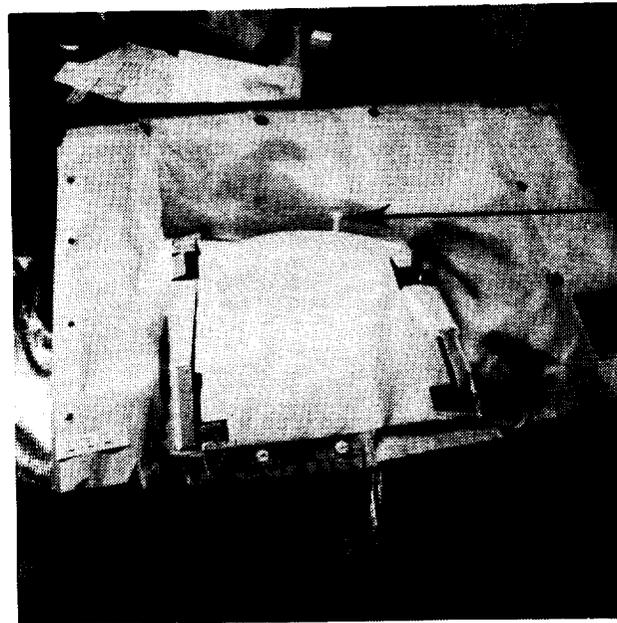
Image of
grapple fixture

The GRAPPLE fixture shows signs of UV/ATOX degradation of the grey paint, a blend of Chemglaze black paint TT-C-542 type 2 and a Chemglaze white paint TT-C-542 type 1 (Ref. 4), with a shadowing effect, possibly from the grab arm. The paint is powdering and faded. NASA is investigating if outgassing from the RMS arm has discoloured the GRAPPLE plate.

PHOTOGRAPH N° 5. View of UV degradation and outgassed material deposited and polymerised on the MLI surrounding the grapple fixture. Notice the image caused by the shadow of the grapple on the MLI. (DASA ERNO photo)

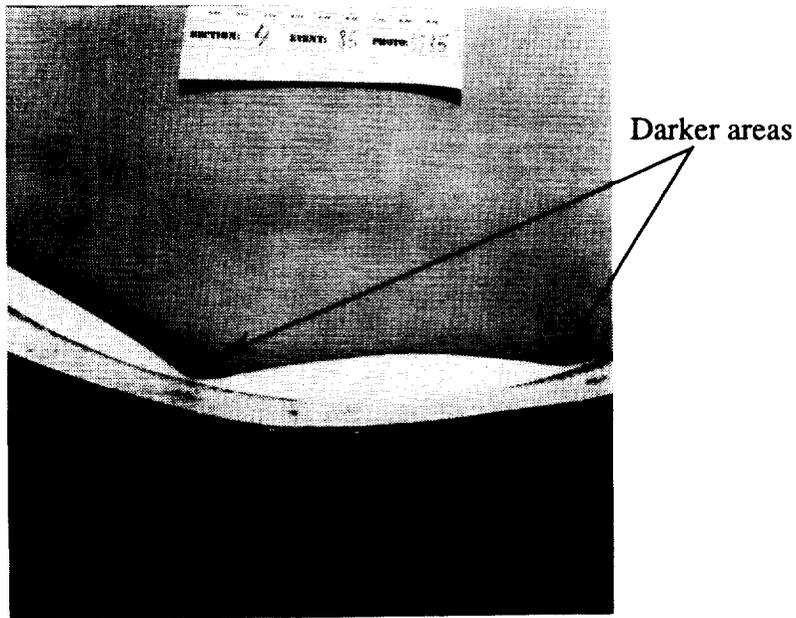
Very prominent degradation of outgassing products is visible on PCF dome where the blanket meets the PSG120FD white paint (see photo 7). Some concentration effect of this degradation is due to multi-reflections in small V-grooves formed between both blanket and dome. The degradation on the top side (+Z) of the dome resulted in an increase in α varying between 0.13 and 0.20, while on the side this increase was limited to 0.04.

PHOTOGRAPH N° 7. View of UV degradation and outgassed material deposited and polymerised on the interface between the white PSG120FD paint on the PCF dome and the surrounding MLI. Notice darker areas caused by multi reflections in small V-grooves between blanket and dome. (DASA ERNO photo)

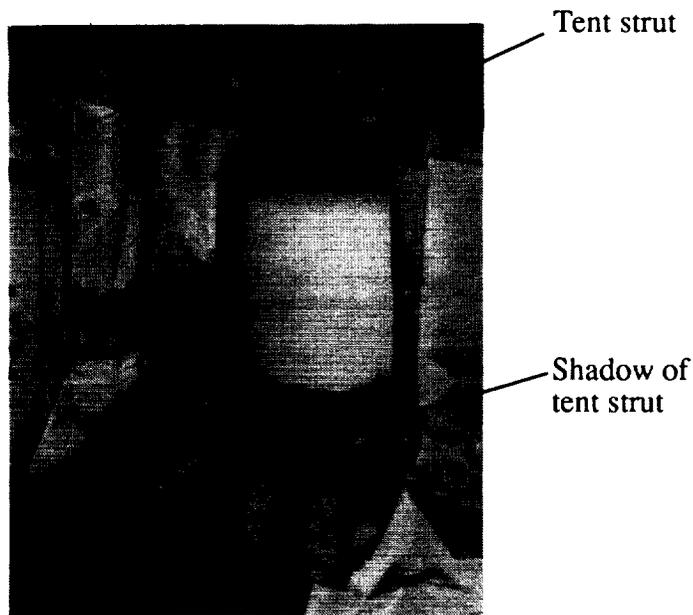
The darkening of the MLI in the area of the PCF can be seen in photo 8 where the contrast is obvious between the shaded area below the strut of the payload tent and the exposed area.

PHOTOGRAPH N° 8. View of PCF dome and the surrounding MLI. Notice the shaded area below the payload tent strut where the Beta cloth is not degraded by UV irradiation or polymerised contaminants. (NASA photo)
