**STRUCTURAL TESTING OF THE
TECHNOLOGY INTEGRATION BOX BEAM**

C. F. GRIFFIN

**LOCKHEED AERONAUTICAL SYSTEMS COMPANY
MARIETTA, GEORGIA**

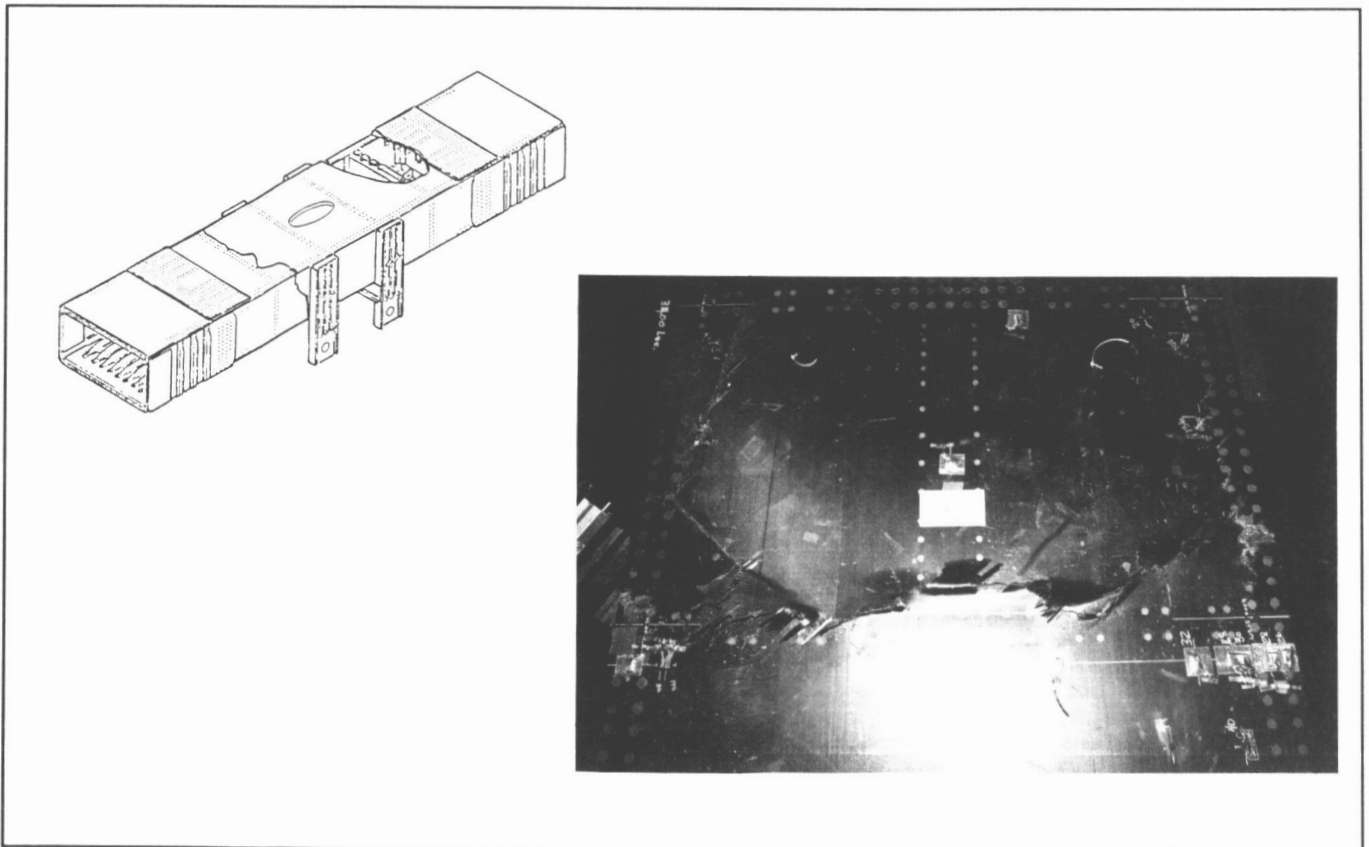
Upon completion of the test program, a review was made of the load-strain data, and the box failure locations were visually inspected from the exterior and interior of the box. For the no-impact damage condition, structural analysis had predicted that the minimum margin of safety for the upper cover was at W.S. 45 for a bearing/bypass failure mode at the cover to spar cap joint (see Figure 7). However, all of the axial strains measured near the failure location, previously presented in Figure 11, were considerably less than the average open hole compression strength for this material and laminate orientation. A review of the inspection records indicated there were no anomalies in the covers or spars at the failure location. The spar cap and spar web had higher margins of safety than the cover at this location.

Additional structural analysis, quality assurance tests and panel tests are being conducted on the box to determine the cause of the premature failure. Analysis completed to date points to the hat runout as the most likely detail which initiated the failure.

Figure 12. Upper Cover Failure at W.S. 45

stiffener runout in the central section of the cover. It is hypothesized that the load path eccentricity at the stiffener runout caused higher than predicted local bending stresses which resulted in a premature failure in the upper cover. Additional structural analysis and tests are continuing to substantiate this hypothesis.

In addition to the suspected design detail problem at the hat runout in the upper cover, data from the test program also indicated a local bending around the access hole in the upper cover. The access hole reinforcement design concept should be revised to minimize the load path eccentricities in that area. Another design change recommended is to use an intermediate modulus fiber such as IM7 in place of the AS4 for the spanwise plies in the covers and spar caps. Trade studies have indicated that this change would result in a substantial weight savings compared to the current design and more than offset the weight added to modify the design details associated with the hat stiffener runout and access hole reinforcement.
