DAMAGE TOLERANCE OF A GEODESICALLY STIFFENED ADVANCED COMPOSITE  
STRUCTURAL CONCEPT FOR AIRCRAFT STRUCTURAL APPLICATIONS

Marshall Rouse and Damodar R. Ambur  
NASA Langley Research Center  
Hampton, VA 23665-5225

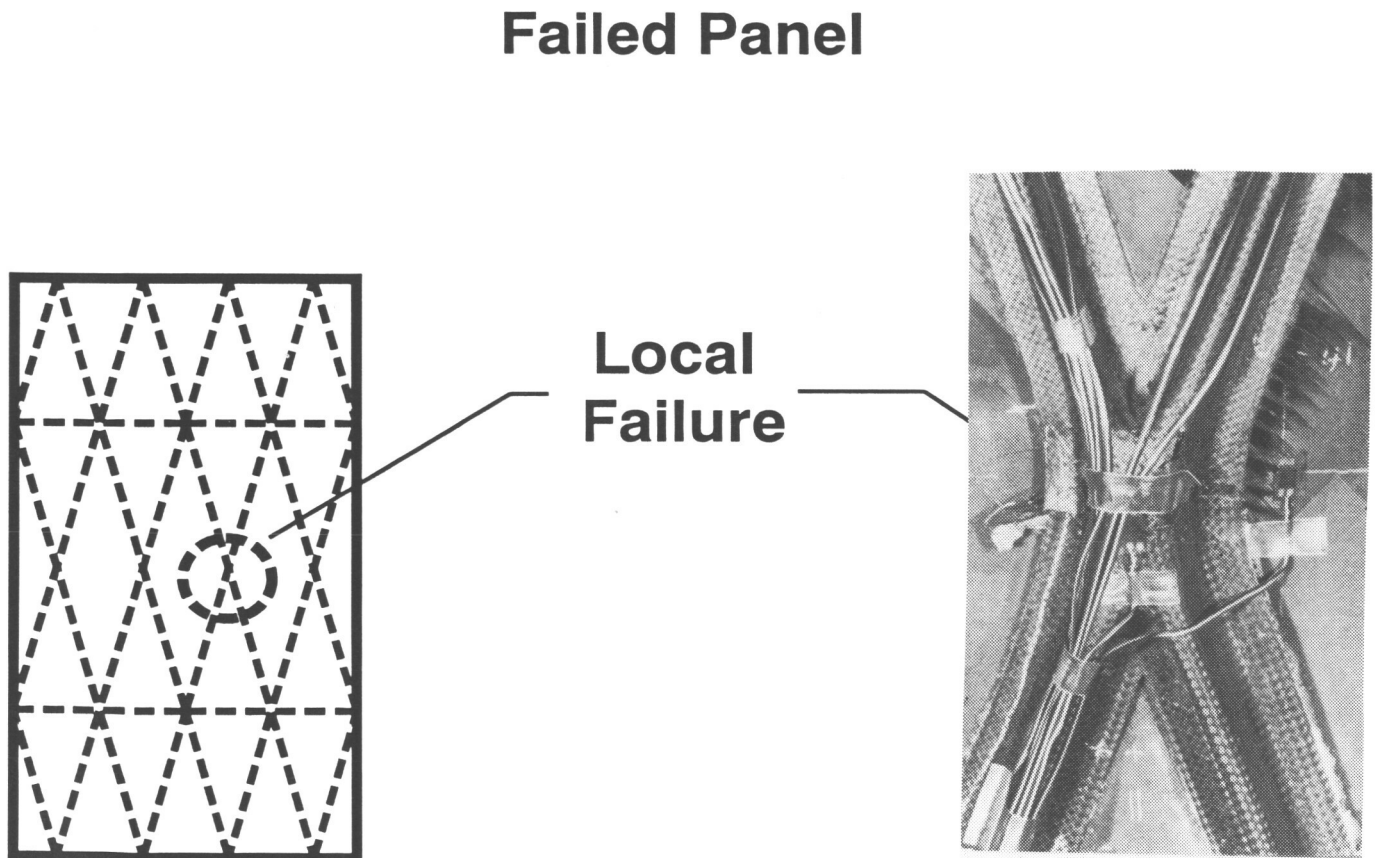
Figure 6. Failure characteristics of a geodesically stiffened compression panel

Typical failure characteristics of the geodesically stiffened compression panel tested without impact damage are shown in Figure 6. The photograph on the left of the figure shows the skin side of the failed panel. The panel failed due to separation of the skin from the stiffeners across the middle of the panel in addition to the failure along the fiber cross-over region. The photograph on the right of the figure shows a close-up of the local failure mode of the panel. The skin-stiffener separation at a stiffener intersection is shown here.

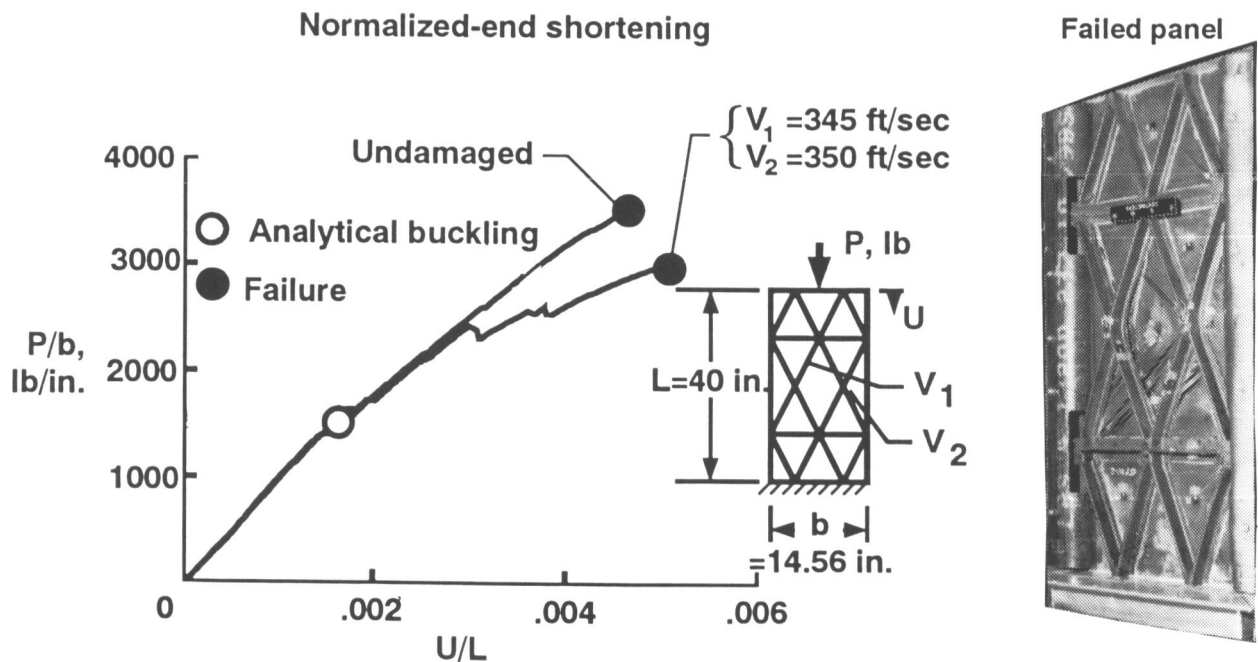
Figure 7. Summary of results for panels tested with low-speed impact damage

Experimental results for a geodesically stiffened compression panel subjected to low-speed impact damage are presented in Figure 7. A 14.56-inch-wide panel was subjected to low-speed impact damage at two locations near the skin-stiffener interface prior to testing. Aluminum spheres 0.5 inches in diameter were used as the impact projectile in this investigation. The panel was impacted at a point midway between intersecting stiffeners at a velocity  $V_1$  of 345 ft/sec and at the intersection of two stiffeners at a velocity  $V_2$  of 350 ft/sec. The plot on the left of the figure shows normalized end-shortening as a function of normalized applied load. Failure of the undamaged and impact damaged panels are represented by the filled circles. The analytical buckling load of an undamaged panel is represented by the open circle. The results show that the impact damaged panel failed at a value of normalized load of approximately 2,900 lb/in. which is slightly lower than the failure load of the panel tested without low-speed impact damage. The photograph on the right of the figure shows the failed impact damaged panel. The photograph shows that the panel failed in a similar mode to the undamaged panel that was described in Figure 6. The results presented in figure 7 suggest that the presence of low-speed impact damage did not significantly influence the stiffness or strength of this geodesically stiffened compression panel.

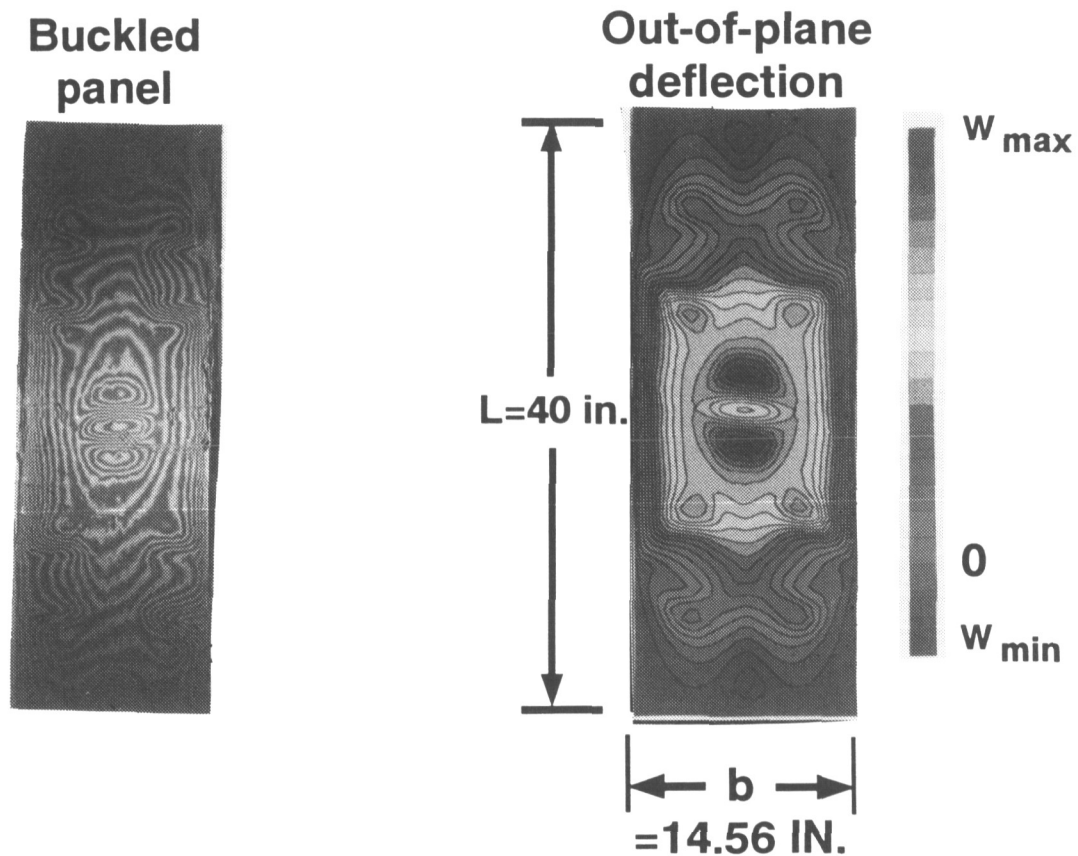
Figure 9. Experimental and analytical out-of-plane deflection results.

Finite element results of out-of-plane deflections  $w$  at approximately 1.5 times the buckling load and a photograph of the corresponding moire-fringe pattern are presented in Figure 9. A photograph of the moire-fringe pattern on the skin side of a 14.56-inch-wide panel is shown on the left of the figure. This photograph shows that the rhombic skin panel buckled into three halfwaves at the center of the panel. The analytical out-of-plane deflection contours viewed from the stiffener side of the panel presented on the right of the figure compare well with experimental results. The out-of-plane deflection results presented in the figure also indicate that the center region of the entire panel deformed out-of-plane during loading. Also, the buckle pattern exhibits a noticeable skew.
