TEST RESULTS FROM LARGE WING AND FUSELAGE PANELS

**Ram C. Madan and Mike Voldman
Douglas Aircraft Company
McDonnell Douglas Corporation
Long Beach, CA**

SUMMARY

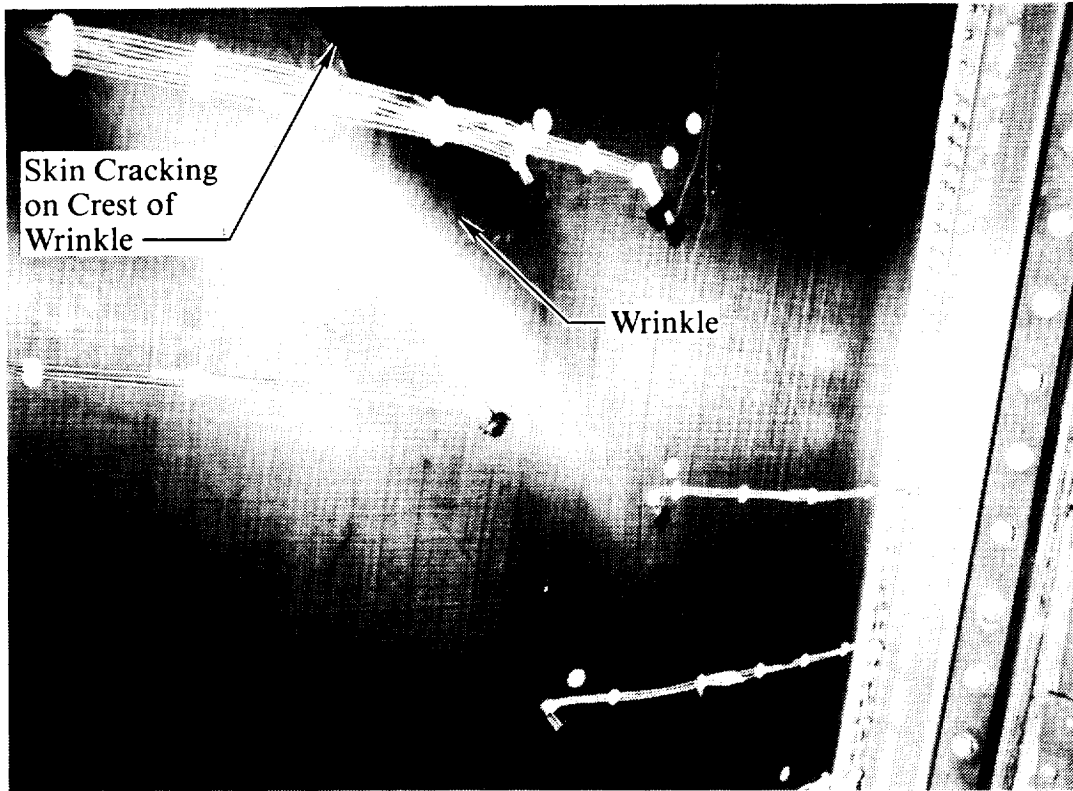
Figures 7 through 11 show close-up pictures of the damage in different parts of the panel. Almost all the damage occurred across the main tension diagonal where a big wrinkle was formed, as shown in Figure 7. The impacted area happened to be away from the main diagonal and did not influence the onset of damage, nor was this area damaged as the panel failed. The damage shown in the upper right corner of Figure 8 and upper left corner of Figure 9 can be attributed to the high intensity of compressive stress in that region. The failure propagated along the main diagonal and subsequently caused the longerons to debond and break. Figure 8 shows the skin wrinkled, broken, and delaminated under the longerons and the skin longeron broken in the area where it separated from the skin. Figure 9 shows the skin delaminated in the corner and broken along the crest of the wrinkle. Figures 10 and 11 show the stringers broken and debonded from the skin. Typical damage on the shear tees and frames is shown in Figures 12 and 13.

Figure 7. Buckling wrinkle in ATP fuselage shear test panel

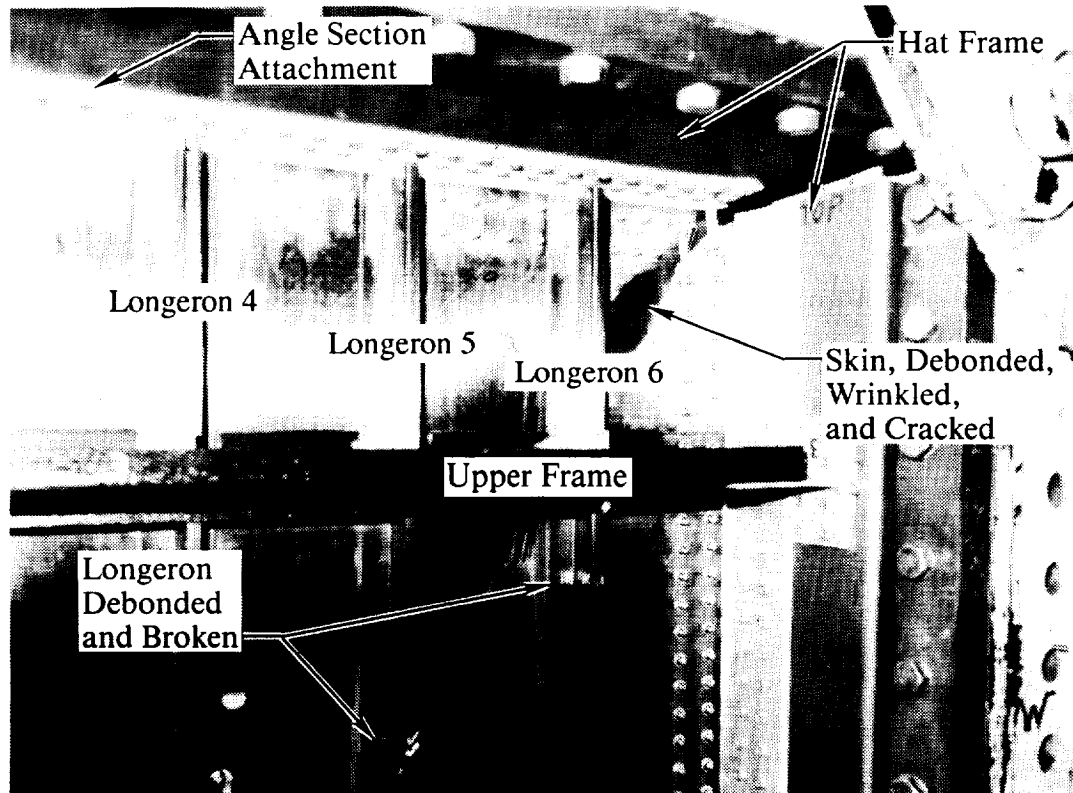
Figure 8. Damage in upper right corner of ATP shear panel

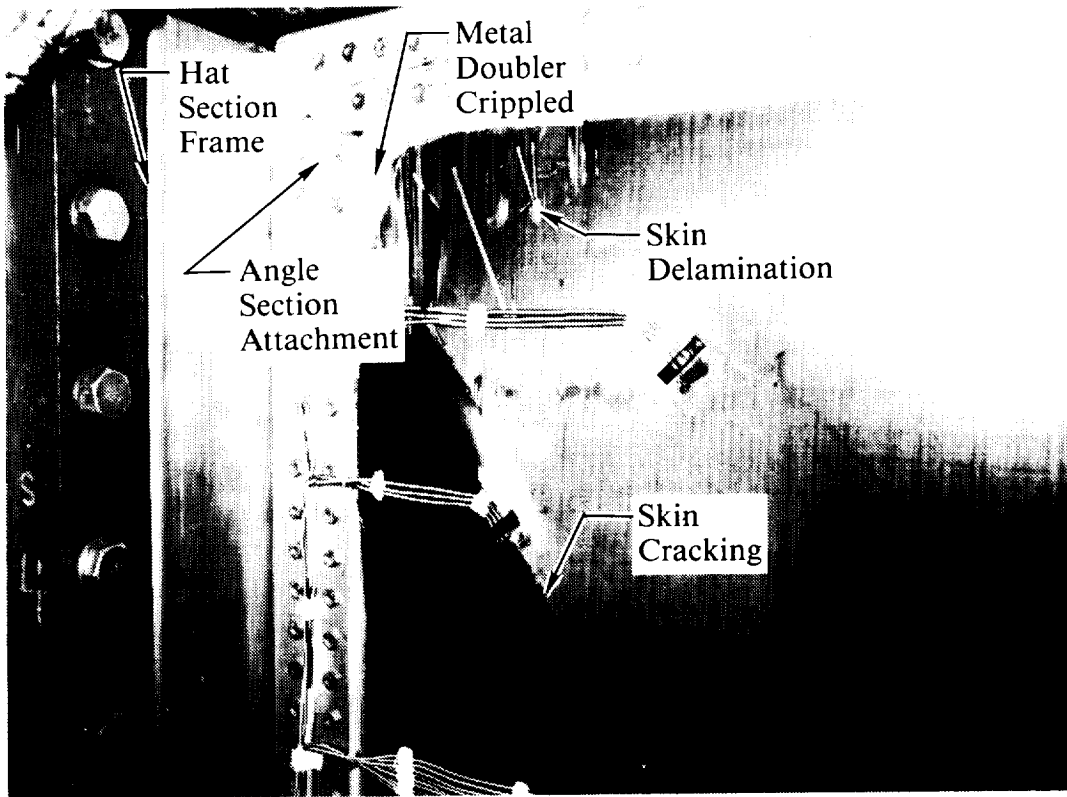
Figure 9. Damage in left top corner (skin side) in ATP shear panel (pinching effect)

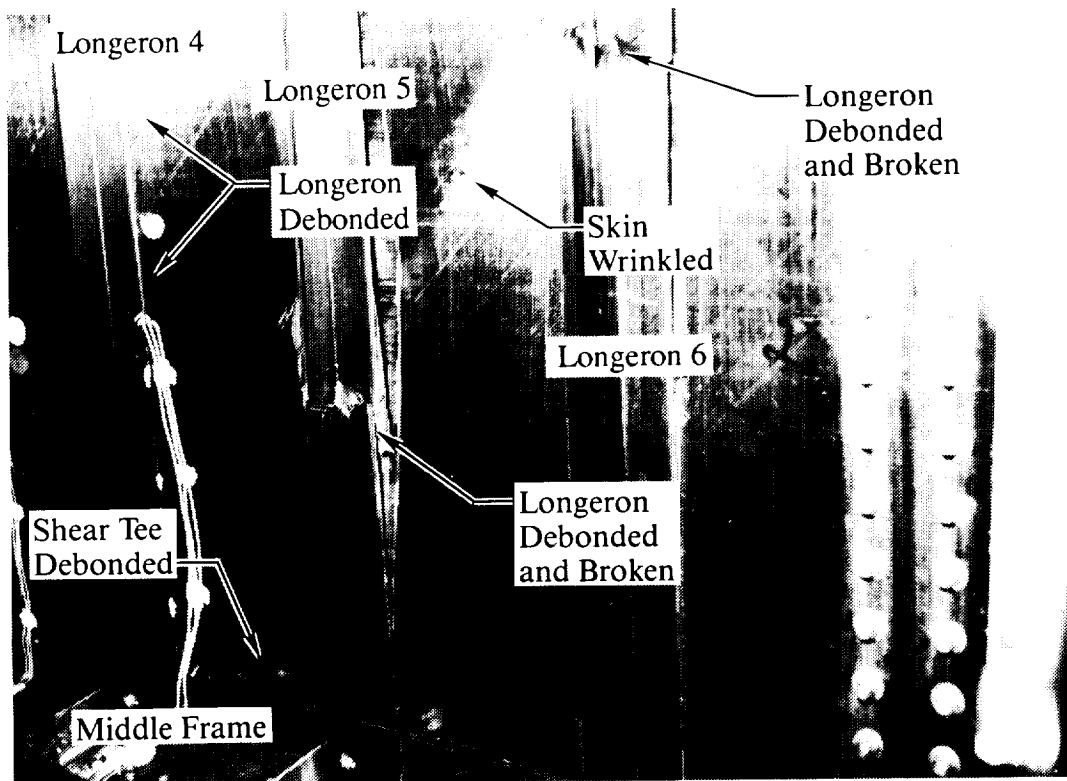
Figure 10. Damage above midframe in ATP shear panel

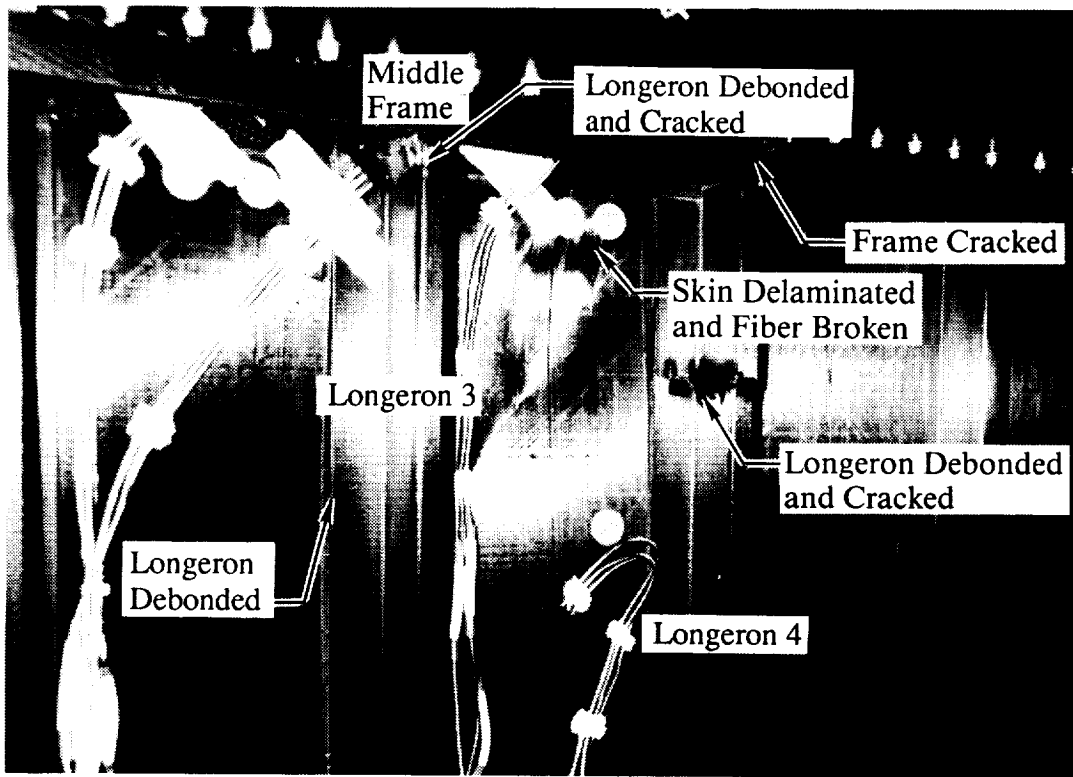
Figure 11. Damage below midframe in ATP shear test panel

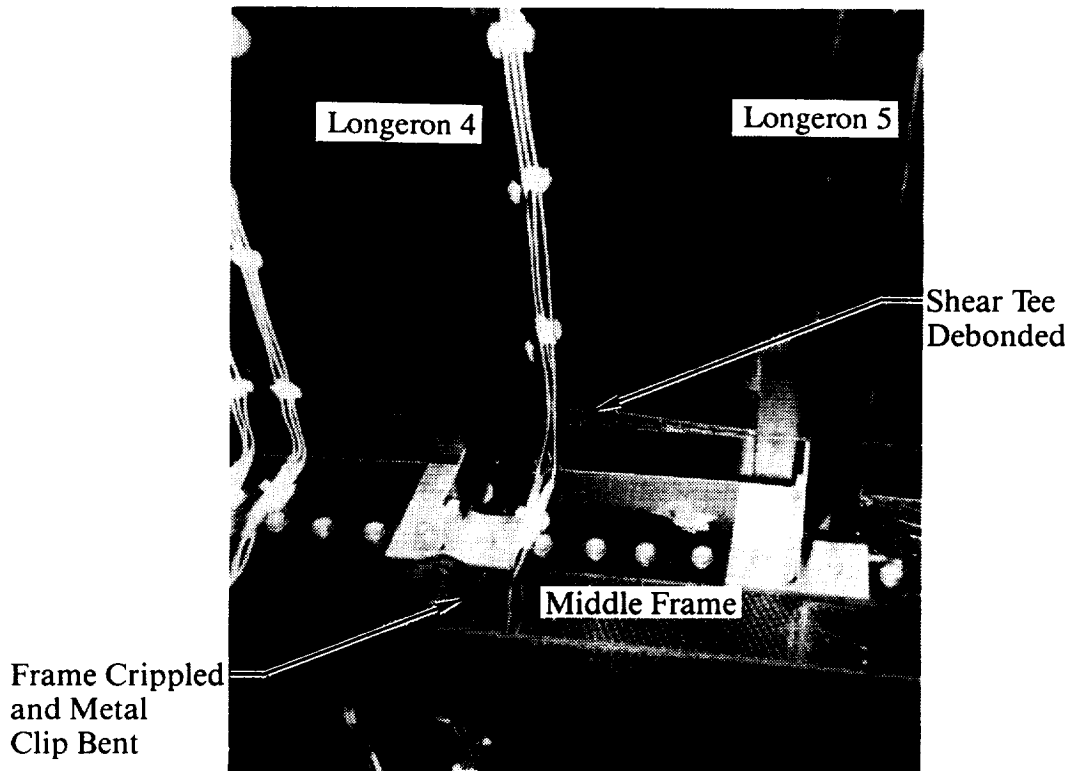
Figure 12. Damage above midframe in ATP shear panel

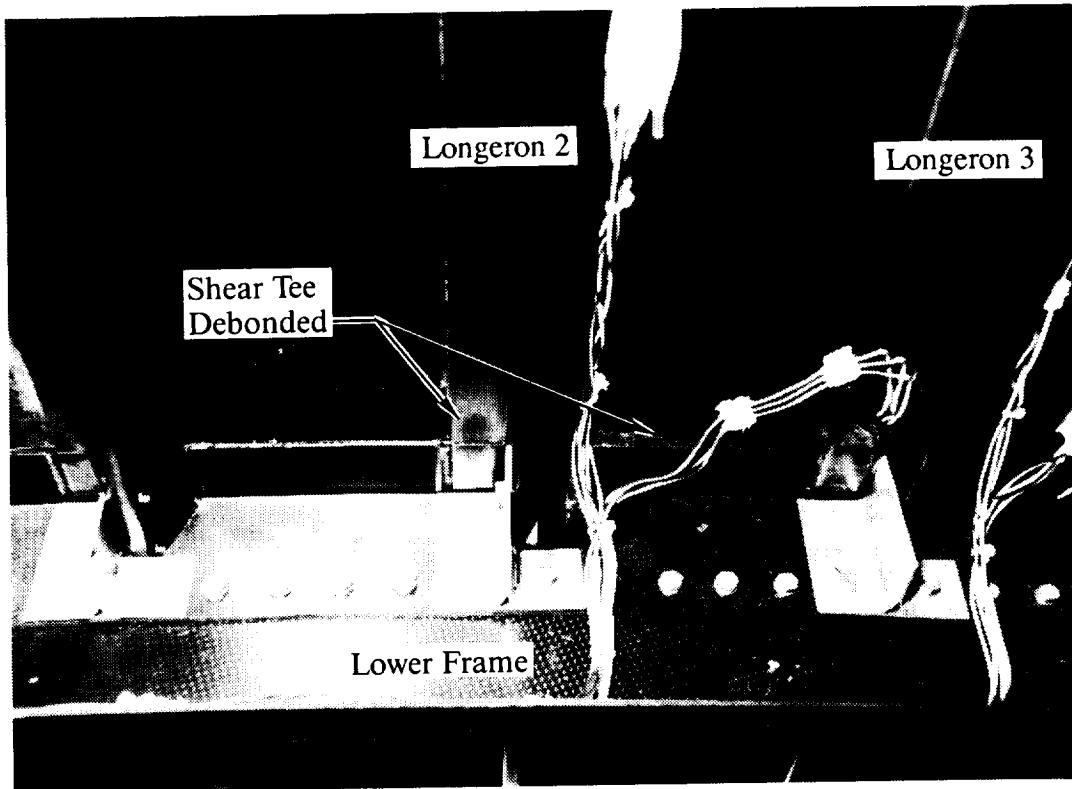
Figure 13. Damage in ATP shear panel test at midframe

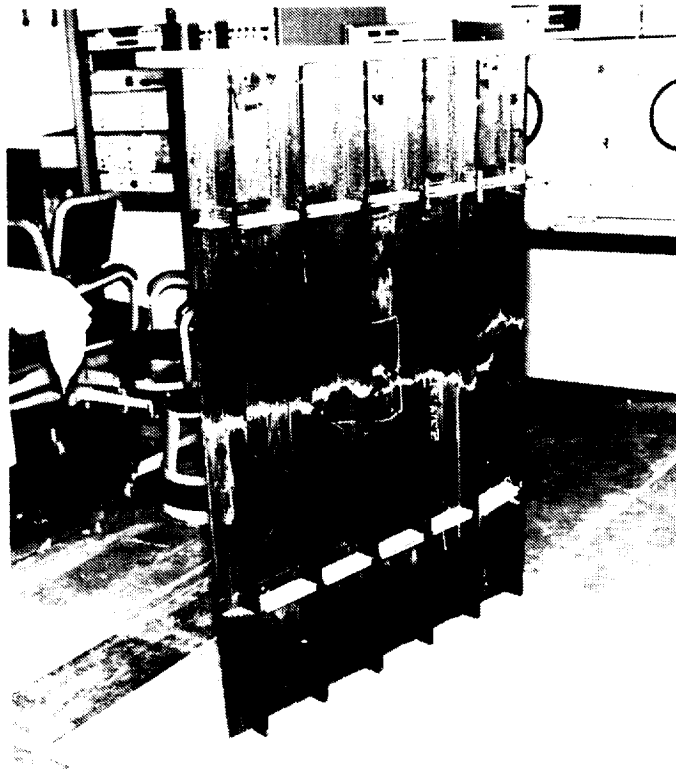
A summary comparison between the six-stringer RTM panel and the five-stringer prepreg panel is given in Table II. Although, as previously mentioned, the strain achieved exceeded the design level, it is considered probable that the failure strain would be even higher had the panel not failed prematurely. Photographs of the panel after the failure are shown in Figures 26 and 27.

Figure 26. Six-Stringer RTM wing compression panel after the test (stringer side)

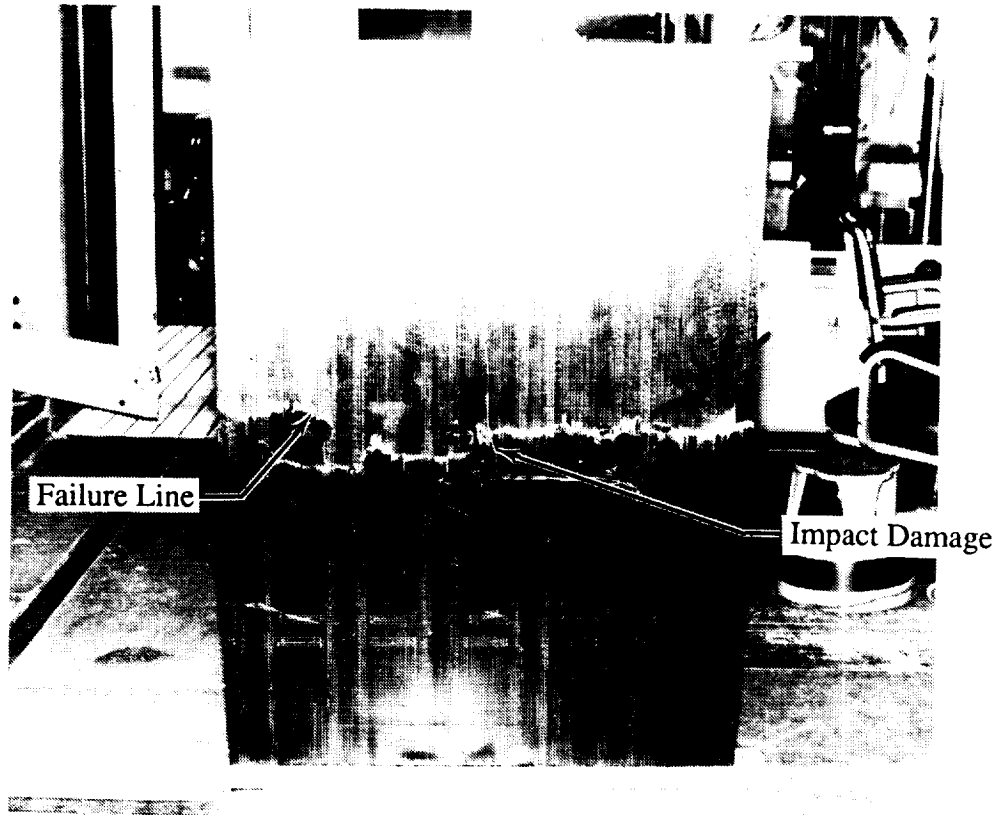
Figure 27. Six-stringer RTM wing compression panel after the test (skin side)
