The Failure Analysis, Redesign, and Final Preparation of the Brilliant Eyes Thermal Storage Unit For Flight Testing

T. Lamkin, Brian Whitney
USAF Phillips Laboratory
Kirtland AFB, NM

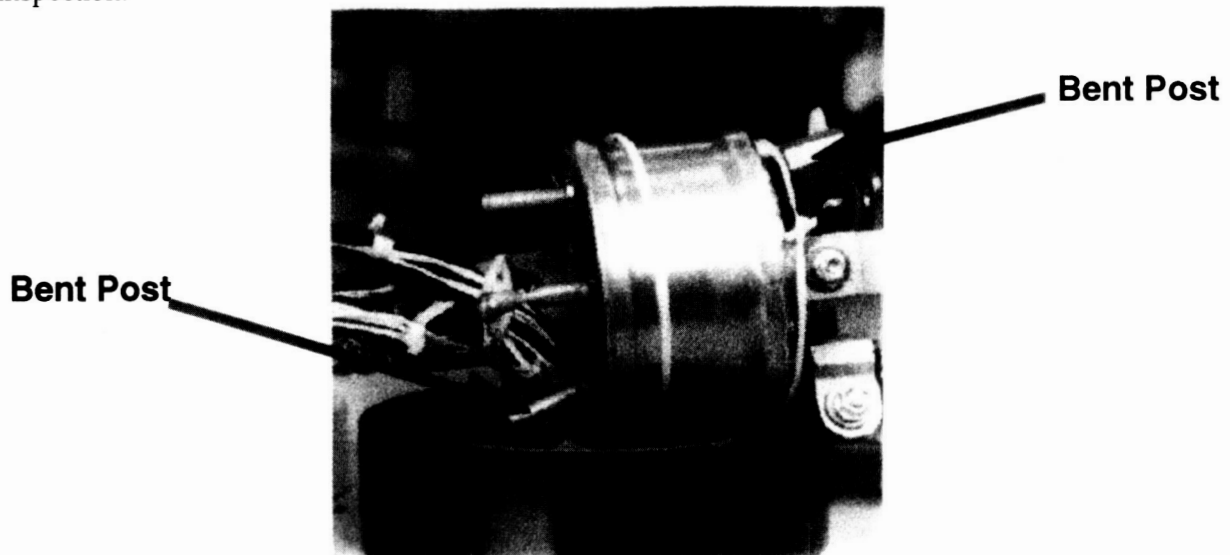
Figure 3: Mounting Post Damage

After further disassembly and analysis, the clevaces on the three S-glass strap mounting posts (Fig 1) on the Q-meter side of the BETSU showed signs of failure. These three posts were integral parts machined into the top of the BETSU canister. It was discovered that two of the posts were cracked, about .150" up on the Q-meter side. The third post was bent almost completely over (40 deg) from normal. In addition, initial observation indicated one of the three posts on the opposite side of the BETSU (heater side) was also bent.

A special tool was fabricated to straighten out the posts, but a penetrant test prior to straightening indicated more subtle problems existed with the two of the posts (see figure 3). These two posts exhibited numerous cracks, a typical crack being .050" long, with a .004 to .006" open gap and had a .020" to .060" depth. One post was on the heater side of the BETSU @ the 4 o'clock position, with the other one on the Q-meter side @ the 12 o'clock position.

The two posts which had multiple "cracks" were repaired in the following manner. Each crack was ground out about 1/4 of the post depth, and then welded by (TIG) process. Cold, wet rags were used as a heat sink, and finally the welds were ground and cleaned. However, the main, front Q-meter side post was a more challenging repair. This post was bent and cracked so bad that it
