NASA Reference Publication 1374

Electronic Systems Failures and Anomalies Attributed to Electromagnetic Interference

R.D. Leach and M.B. Alexander, Editor

July 1995

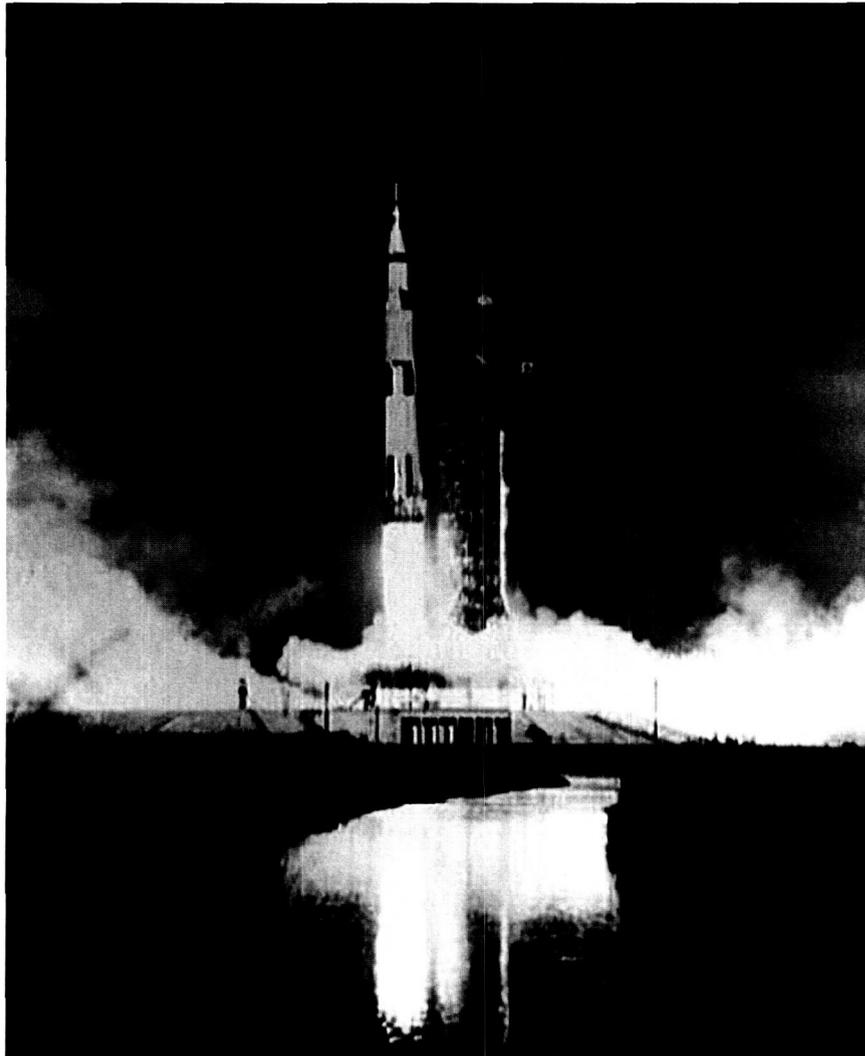
Figure 1. Saturn V launch.

During on-pad checkout at the Kennedy Space Center (KSC) prior to one of the early developmental test flights of the Saturn launch vehicle, the range safety receivers detected an extraneous signal. Because these receivers processed commands for engine cutoff, arm, and destruct, a thorough investigation was conducted to determine the cause of this unintended signal transmission. The problem appeared to be the production of spurious signals originating from the sum and difference combinations possible when signals frequencies are mixed. Although technically these spurious signals are not beat frequencies (associated with sound energy), this particular case is known within NASA as the beat frequency case and is maintained in this report by that title. The spurious signals were caused by the multitude of transmitters located on board to collect test data. Analysis determined that spurious signal frequencies very near the frequency of the range safety receivers were produced by a combination of frequencies from several telemetry transmitters in combination with one of the vehicle's tracking transponders. Further investigation determined that mixing sources for the signals were the hinged cable tray covers and chain handrails on the gantry. This insight and analysis proved to be useful later. With a Saturn vehicle on pad, the range safety receivers detected a spurious command signal for engine cutoff from a Titan launch vehicle checkout on the next pad. The Titan was using the same modulation frequencies on a different carrier frequency for its range safety receivers. A signal sent to the Titan vehicle was also received by the tracking transponder on the Saturn vehicle. The retransmitted signal of the transponder was mixed with certain telemetry signals resulting in the false engine cutoff command. After this incident, the decision was made to fly with the culprit transponder inactive (eventually it was removed from the vehicle). Later, both

telemetry and range safety transmissions were moved to a higher frequency range where the production of spurious signals did not interfere with the range safety system.⁵

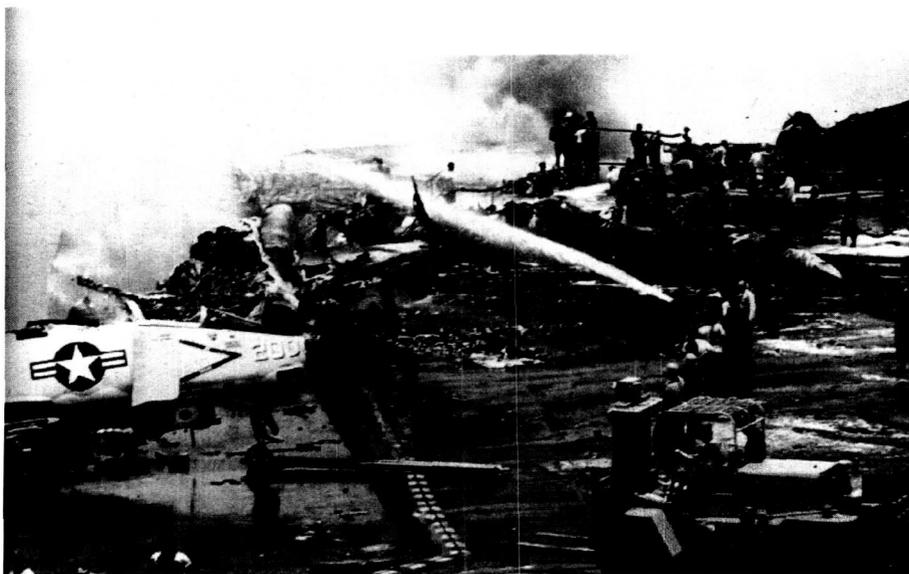
Figure 3. Aftermath of U.S.S. *Forrestal* EMI incident.

In 1967 off the coast of Vietnam, a Navy jet landing on the aircraft carrier U.S.S. *Forrestal* experienced the uncommanded release of munitions that struck a fully armed and fueled fighter on deck (fig. 3). The results were explosions, the deaths of 134 sailors, and severe damage to the carrier and aircraft. This accident was caused by the landing aircraft being illuminated by carrier-based radar, and the resulting EMI sent an unwanted signal to the weapons system. Investigations showed that degraded shield termination on the aircraft allowed the radar frequency to interfere with routine operations. As a result of this case, system level EMC requirements were revised to include special considerations for electroexplosive devices.¹²

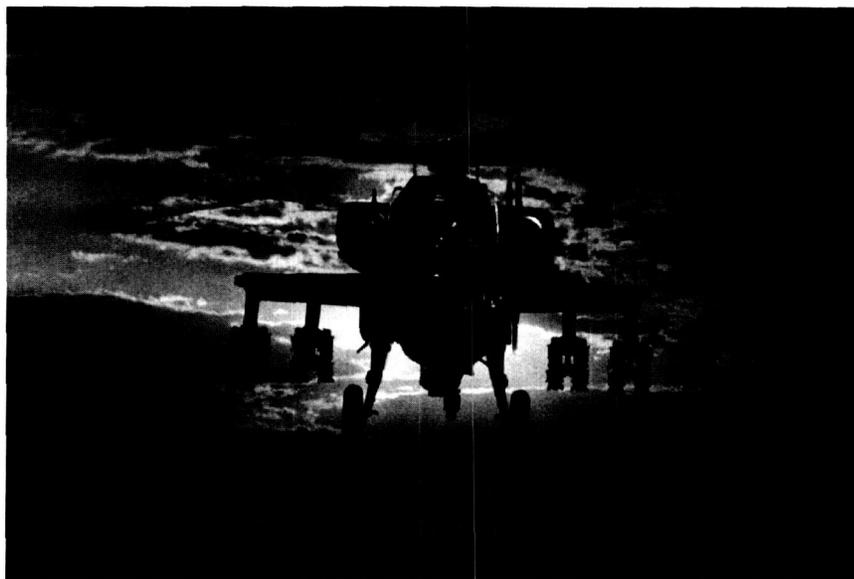
Figure 4. AH-64 *Apache* attack helicopter.

The *Apache* helicopter (fig. 4) was designed primarily as an airborne antitank weapon to provide quick-strike capability against tanks and armored vehicles. The *Apache* is essentially an electronic device with multiple electric and electronic systems that control navigating and fighting abilities. During early missions, pilots complained that HIRF signals interfered with electronics. In one case, EMI triggered an overspeed condition that could have resulted in double engine failure. Subsequent reports showed that the aircraft was susceptible to low-level emitters such as commercial microwave, television, and airport and missile radar. At one point, the Army concluded that the *Apache* should not be used on aircraft carriers. After determining that the source of unwanted signals was coupling in the I/O cables, the shielding was redesigned; but not before many costly aircraft were built with EMI deficiencies.¹²

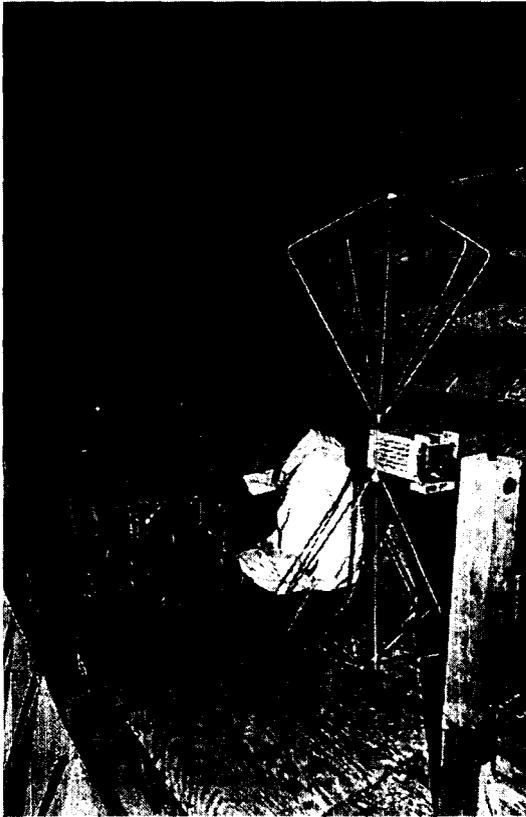
Figure 5. Testing a wheelchair for EMI.

Wheelchairs came under the scrutiny of the FDA (fig. 5) because of reported erratic, unintentional powered-wheelchair movements. These movements included sudden starts that caused wheelchairs to drive off curbs or piers when police, fire, or CB transmitters were activated near the chairs. Although no fatal injuries have been reported, FDA has ordered manufacturers of motorized wheelchairs to shield them from EMI and to educate users on the potential EMI hazards.²¹
