# Debris/Ice/TPS Assessment and Integrated Photographic Analysis of Shuttle Mission STS-73

Gregory N. Katnik, Barry C. Bowen, Jill D. Lin, Vehicle Engineering/Mechanical System Division/ET-SRB Branch, Kennedy Space Center, Florida

20 October 1995

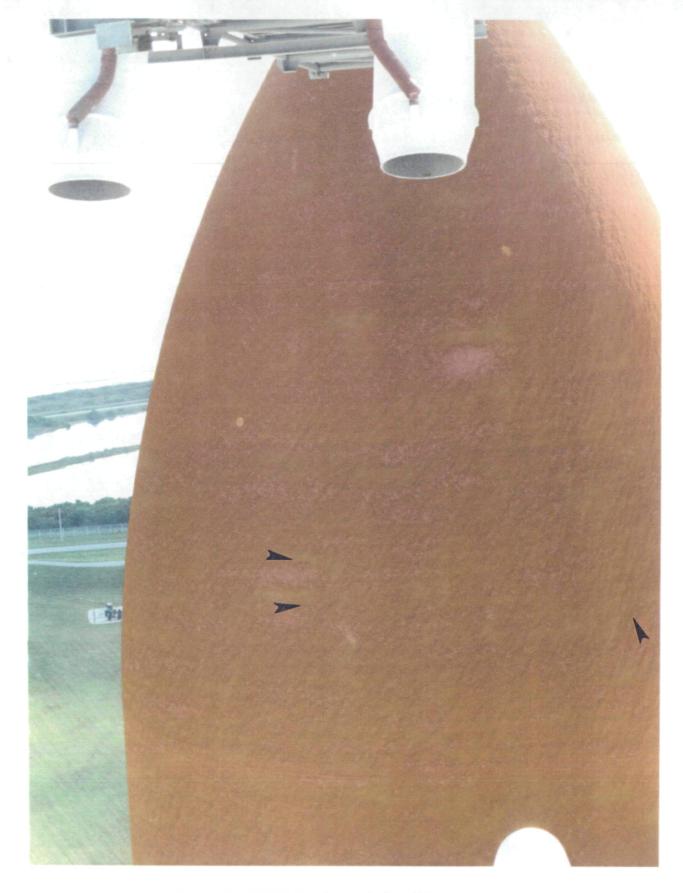
Photo 2: ET-73 Pre-Launch Condition

Damage to acreage TPS was detected on the LO2 tank and believed to have been caused by woodpeckers. The cavities, which averaged 1-inch in diameter and 0.5-inches deep, were located in three places on the -Y side.

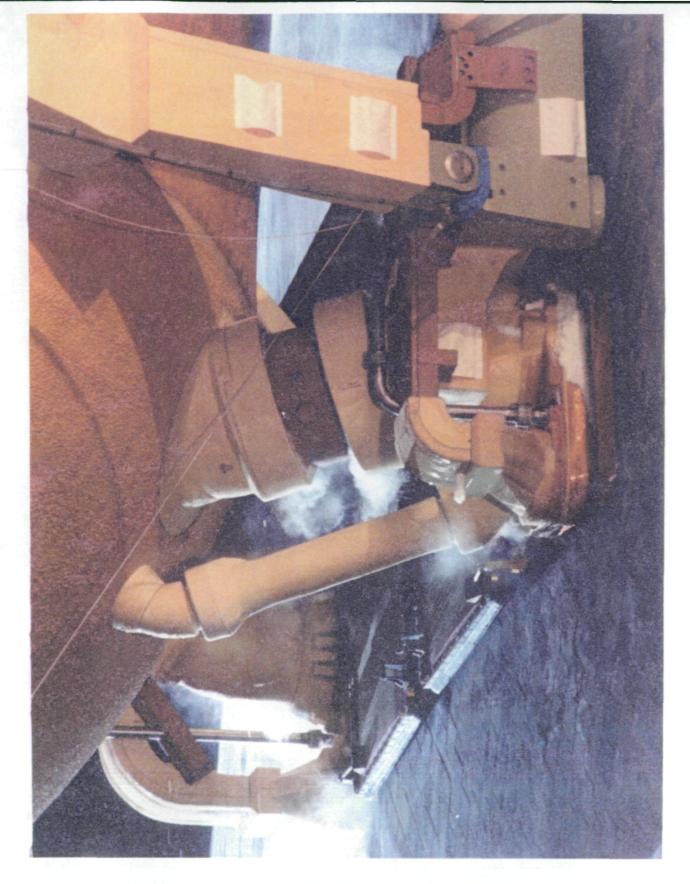
Photo 3: ET/ORB LH2 Umbilical - Second Cryoload

Typical amounts of ice/frost had accumulated on the LH2 ET/ORB umbilical purge barrier top and outboard sides. Typical ice/frost fingers were also present on the pyro canister and plate gap purge vents. No unusual vapors or cryogenic drips had appeared during tanking, stable replenish, and drain.

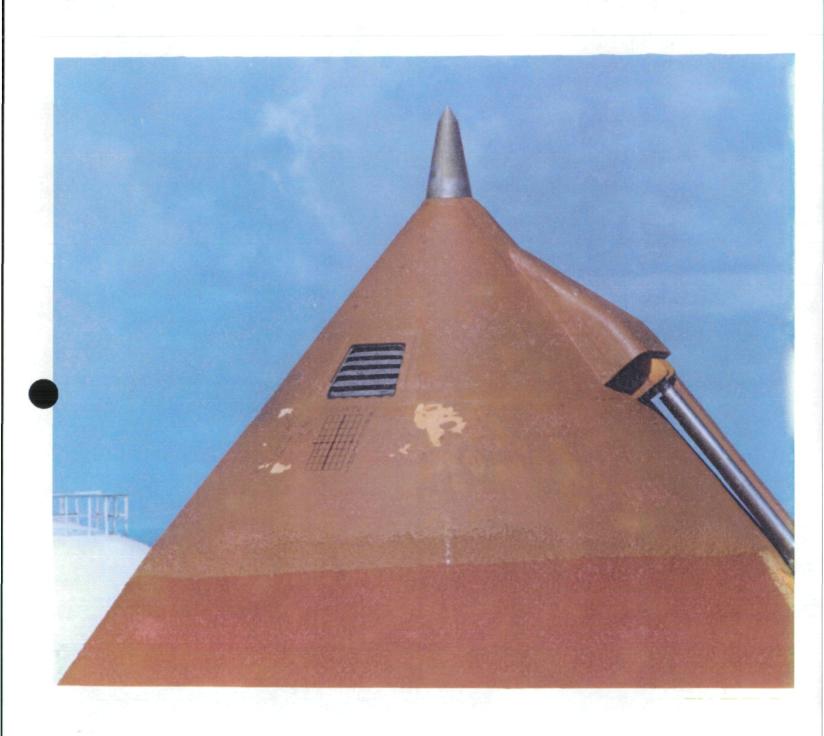
Photo 4: Missing Topcoat from Footprint Area

Although ET nose cone topcoat was missing from the southwest GOX seal footprint area, no TPS was damaged. There was no evidence of TPS erosion due to fretting or blowby.

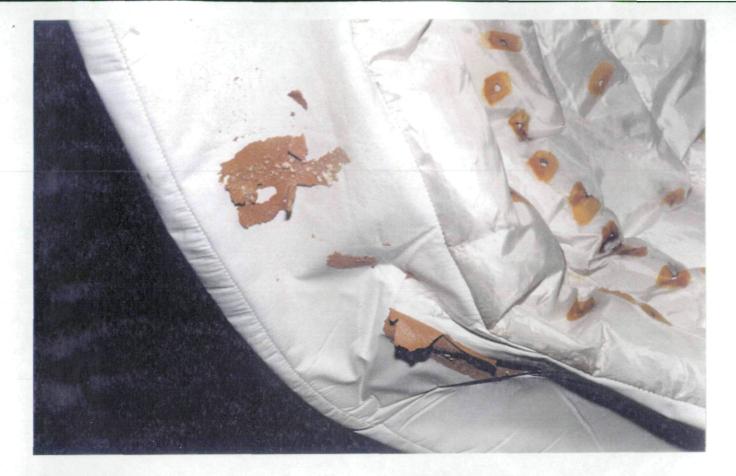
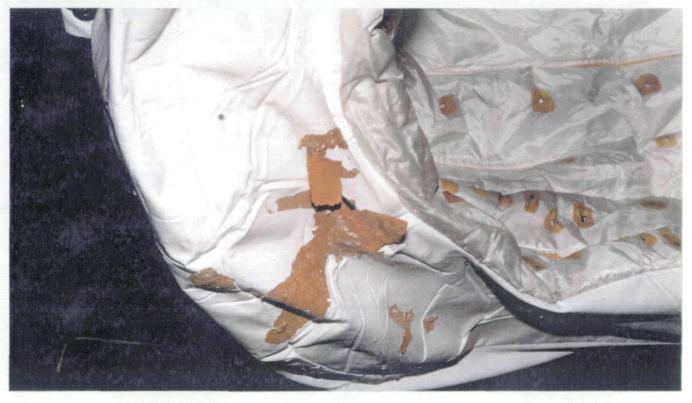
Photo 5: Topcoat Adhered to GOX Vent Seals

Topcoat adhered to both GOX vent seal interfaces.

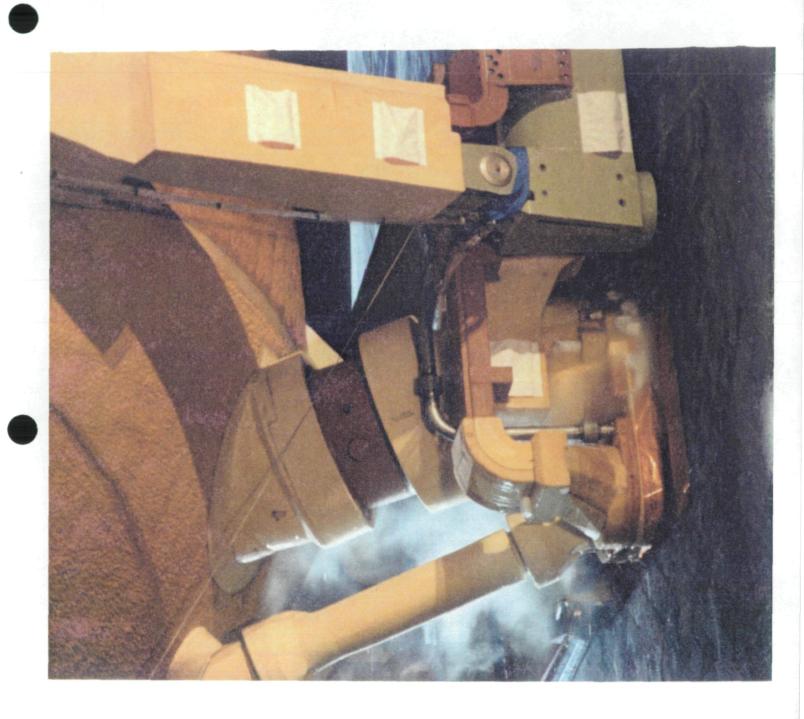
Photo 6: ET/ORB LH2 Umbilical - Third Cryoload

Typical amounts of ice/frost had accumulated on the LH2 ET/ORB umbilical purge barrier top and outboard sides. Typical ice/frost fingers were also present on the pyro canister and plate gap purge vents. No unusual vapors or cryogenic drips had appeared during tanking, stable replenish, and drain.

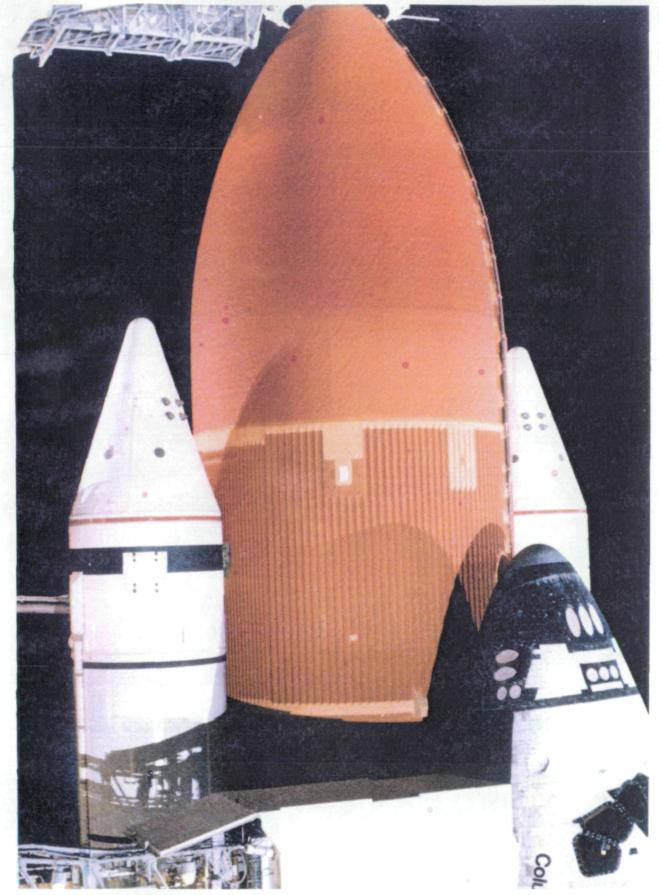
Photo 7: ET-73 Cryoloaded for Launch

There was no acreage ice or frost given the ambient weather conditions at this time of year. There were no protuberance icing conditions outside of the established data base.

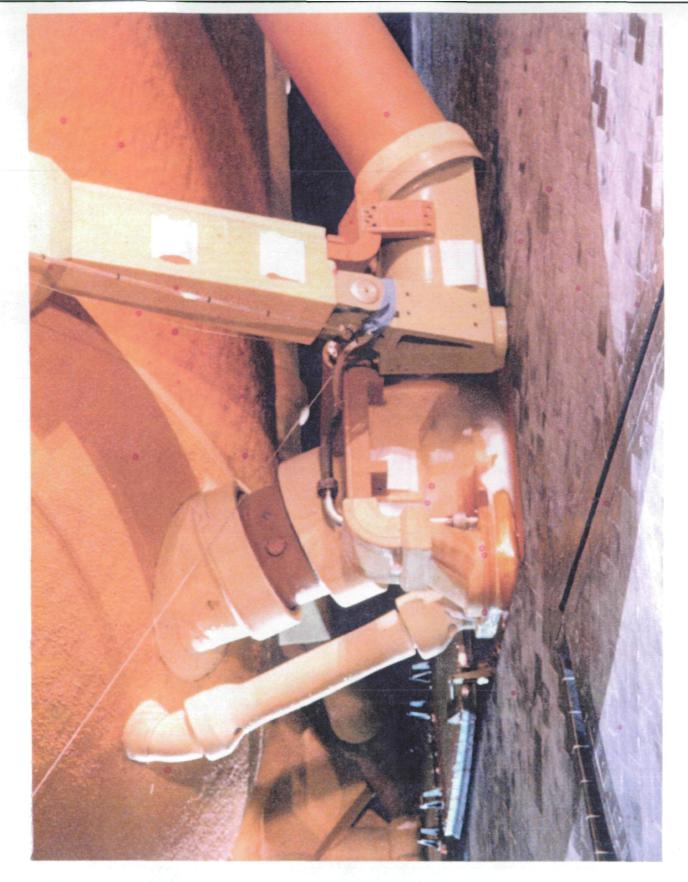
Photo 8: ET/ORB LH2 Umbilical

Less than usual amounts of ice/frost had accumulated on the LH2 ET/ORB umbilical purge barrier top and outboard sides. Typical ice/frost fingers were present on the pyro canister and plate gap purge vents. No unusual vapors or cryogenic drips had appeared during tanking, stable replenish, and launch.

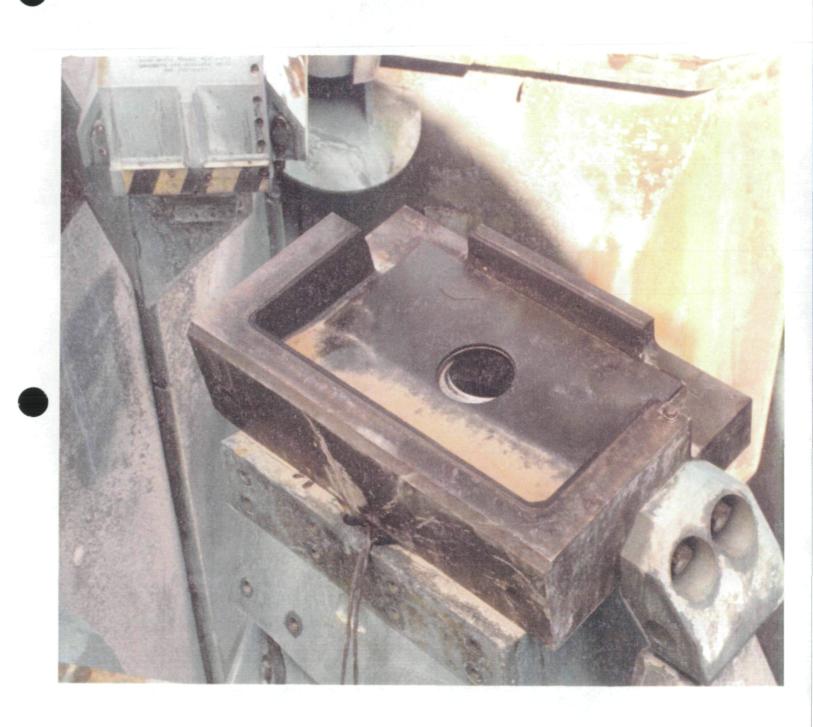
Photo 9: Aft Skirt Shoe Shim

Although the aft skirt shoe shim material was intact, the new material, which is somewhat darker than the material used prior to BIO74, exhibited a bubbled appearance after launch.

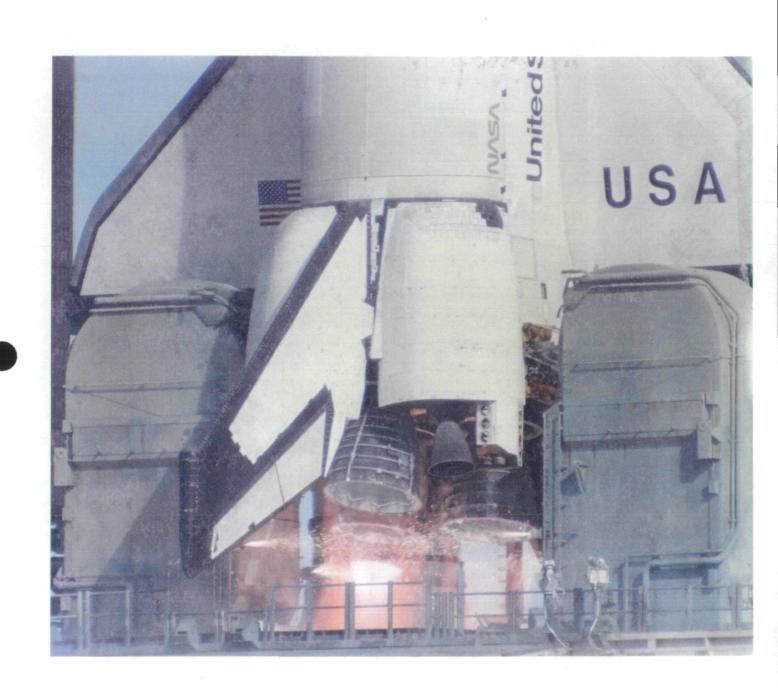
Photo 10: SSME Mach Diamond Formation

SSME ignition appeared normal with the exception of Mach diamonds forming in a 2-3-1 sequence. This was caused by the Phase II/Block I mix of SSME's with slightly different startup times.

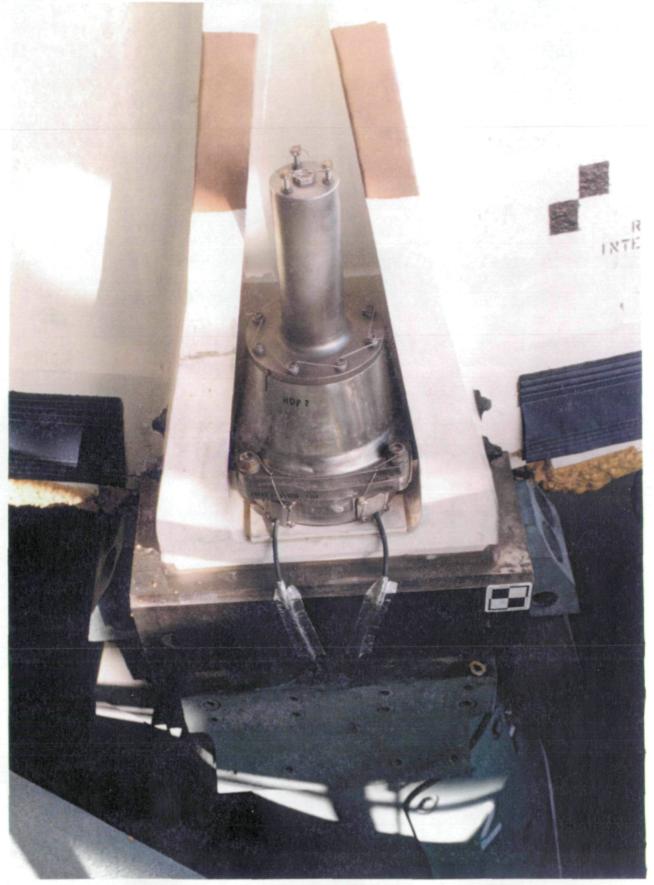
Photo 11: Holddown Post #2 Configuration

Pre-Launch configuration of the holddown post with the stud hang-up

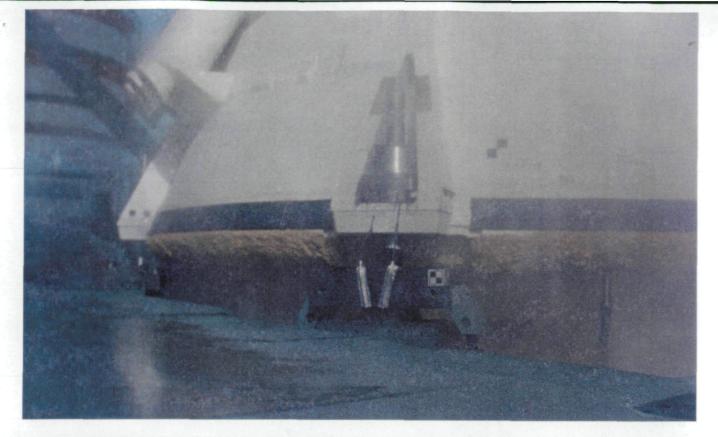
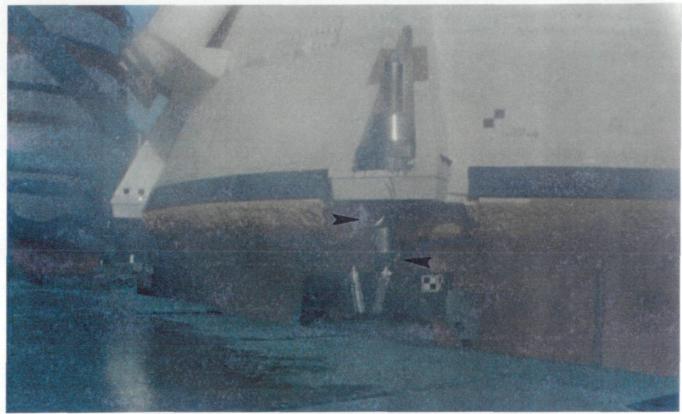
Photo 12: Holddown Post #2 Stud Hang-Up

A stud hang-up occurred on holddown post #2. As the vehicle gained altitude and the stud became visible above the HDP shoe, aluminum from the wall of the stud hole could be seen in the stud threads. Two semi-circular pieces of aluminum fell from the top area of the stud to the HDP shoe. Drag from the stud hang-up and the rising vehicle lifted the holddown post shoe approximately 2 inches before the stud cleared the SRB aft skirt foot.

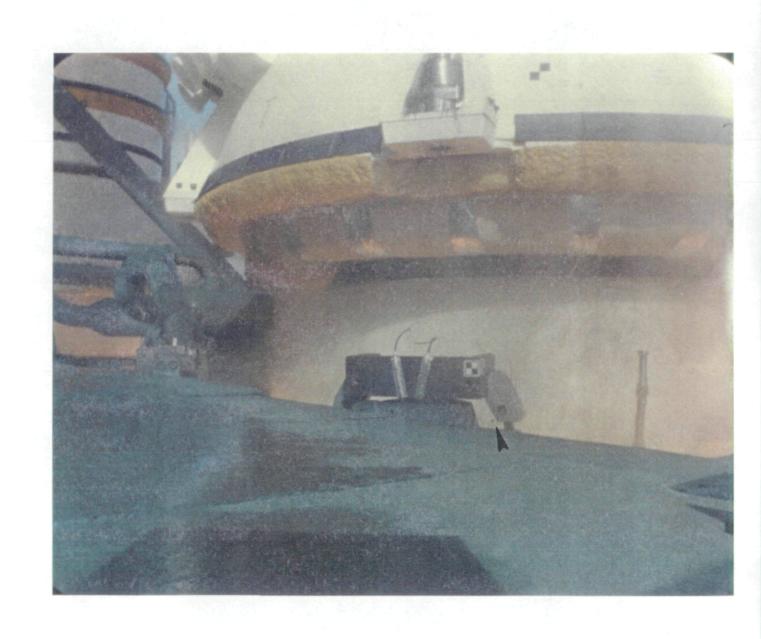
Photo 13: Ordnance Debris Fell from Stud Hole

One ordnance fragment fell from the Debris Containment System (DCS) after the stud cleared the stud hole
29

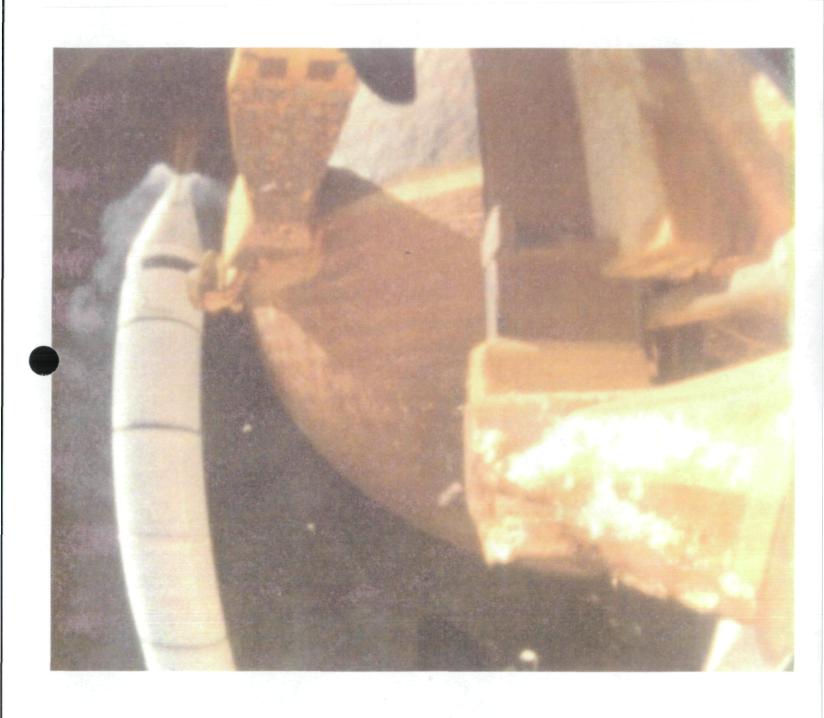
Photo 14: SRB Separation from External Tank

SRB separation from the External Tank was nominal. Foam was missing or eroded from the horizontal (clamshell) section of the cable tray and the aft surface of the -Y vertical strut - a common occurrence.

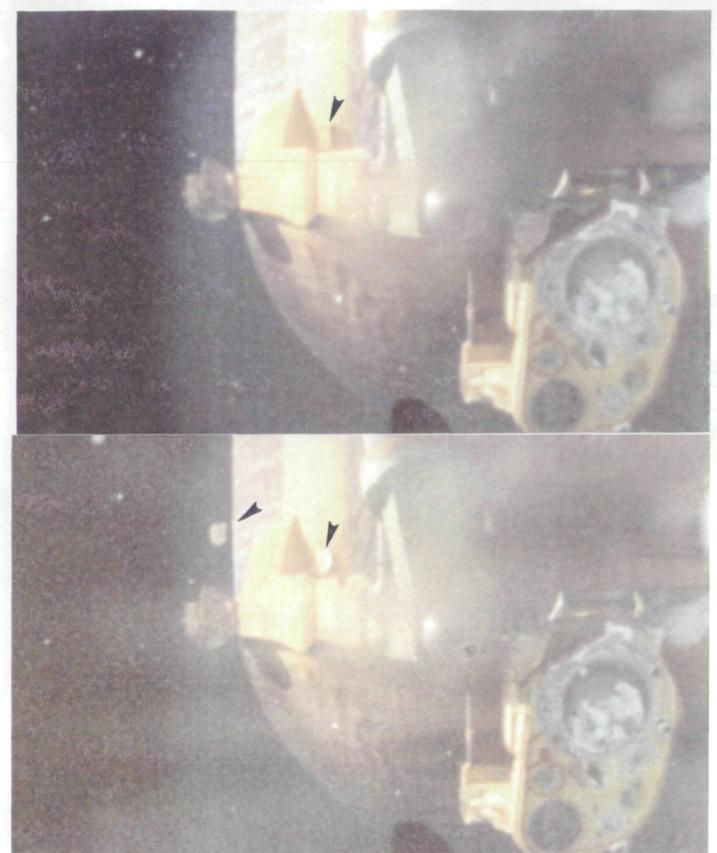
Photo 15: Vertical Strut/Cable Tray Attach Point Closeout

An 8-inch by 6-inch by 1-inch TPS closeout over the -Y longeron-to-vertical strut/cable tray attach point popped off the External Tank and moved in the -Y direction shortly after ET separation. A large void, but no substrate or primer, was visible afterwards. A cryopumped void in the closeout, along with possible cracks in the TPS closeout induced by flexing of the strut during separation, is believed to be the cause of this event.

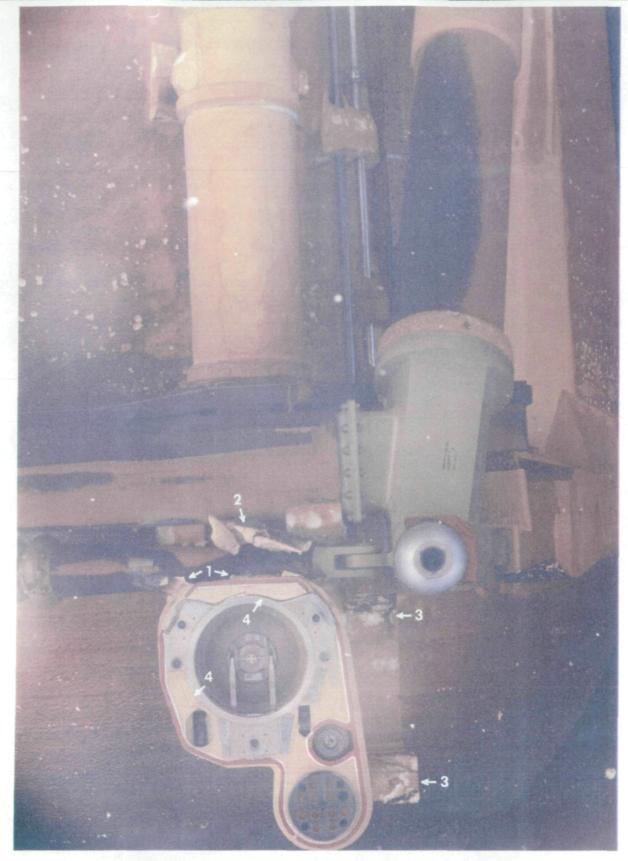
Photo 16: ET/ORB LO2 Umbilical

The LO2 ET/ORB umbilical sustained TPS damage at the top and inboard forward corner (1). Pieces of loose foam from these damaged areas were wedged against the aft side of the crossbeam (2). Numerous divots and eroded areas were visible on the horizontal and vertical sections of the cable tray (3). Lightning contact strips across the forward part of the umbilical and at the 8 o'clock position were missing (4).

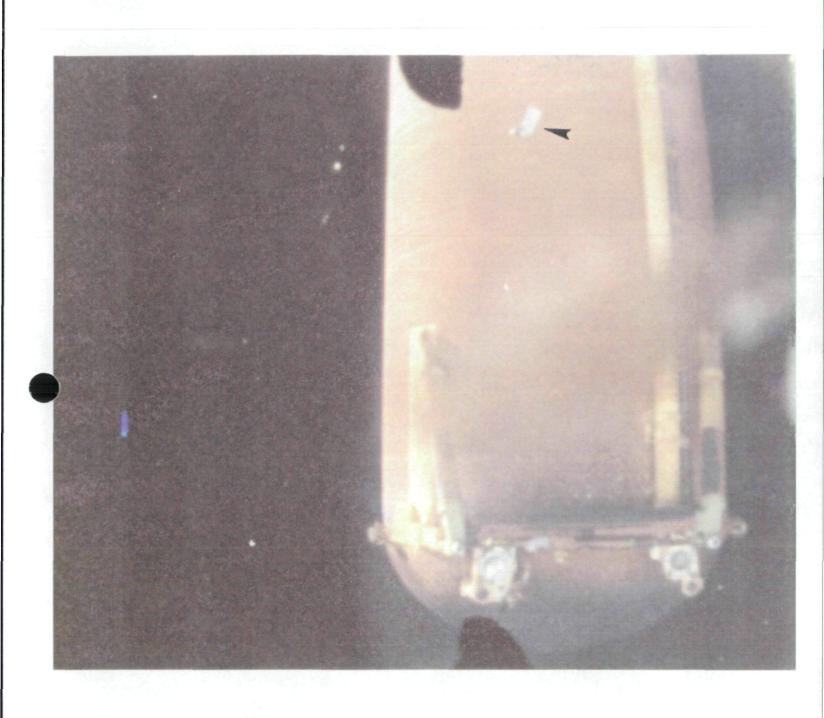
Photo 17: Missing Lightning Contact Strip

A thin, metallic-foil object, believed to be the small lightning contact strip from the LO2 ET/ORB umbilical 8 o'clock position, drifted across the camera field of view after ET separation.

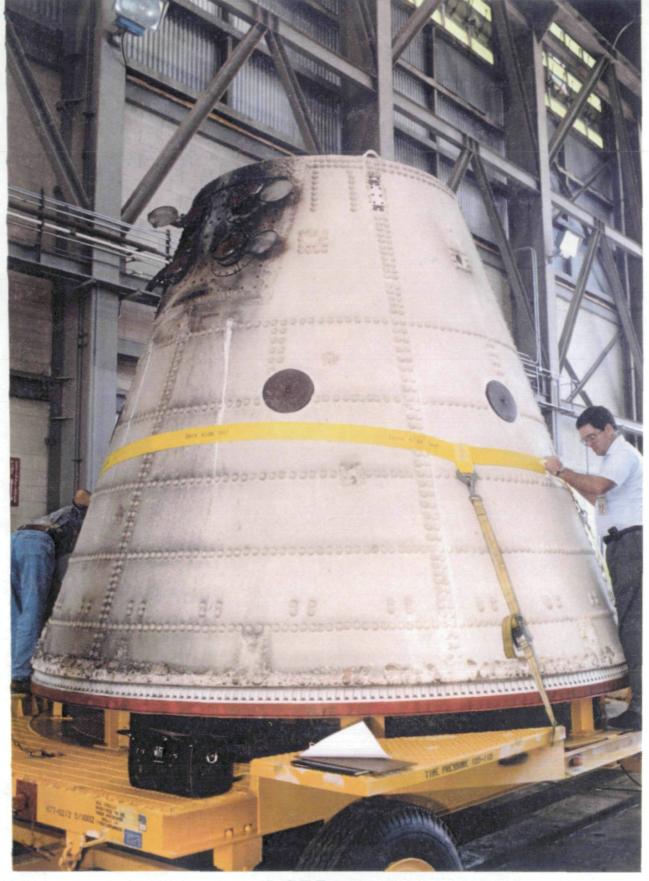
Photo 19: RH Frustum

The RH frustum was missing no TPS. The number of debonds (67) over fasteners was greater than average. The BSM aero heat shield covers had locked in the fully opened position though the upper left cover attach ring had been bent by parachute riser entanglement.

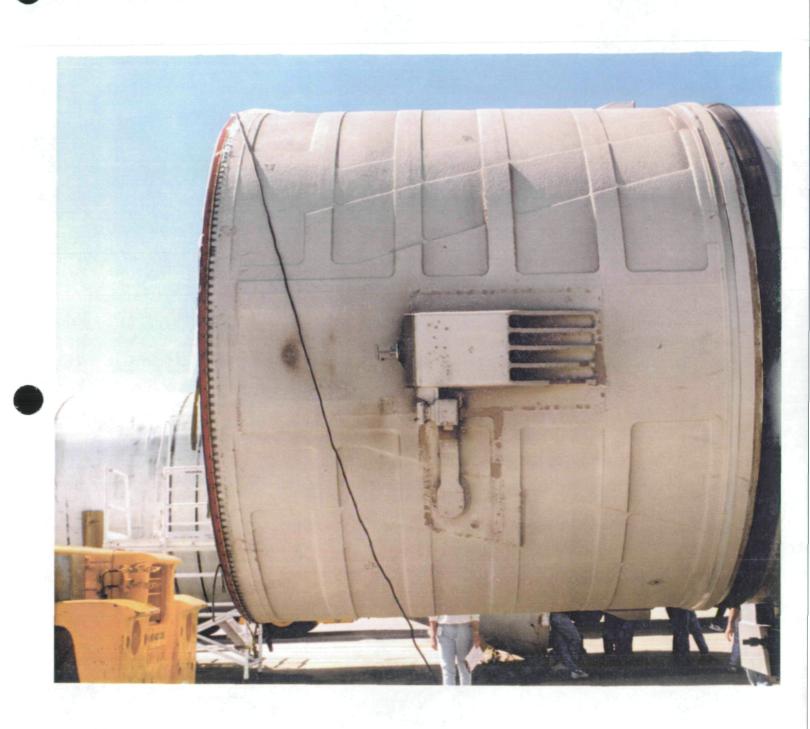
Photo 20: RH Forward Skirt

The RH forward skirt exhibited no debonds or missing TPS. Both RSS antennae covers/phenolic base plates were intact. Hypalon paint was blistered/missing over the areas where BTA closeouts had been applied.

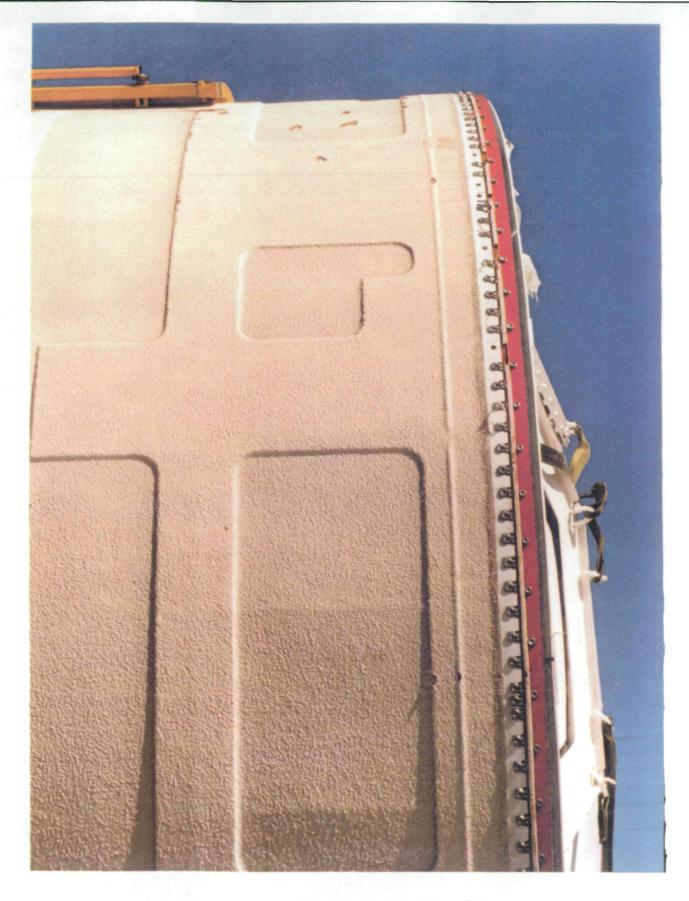
Photo 21: Severance Ring Pins and Retainer Clips

Numerous pins and retainer clips were missing from the frustum severance ring. Strands of nylon fiber caught on adjacent clips indicated the damage was caused by the parachute risers after splashdown.

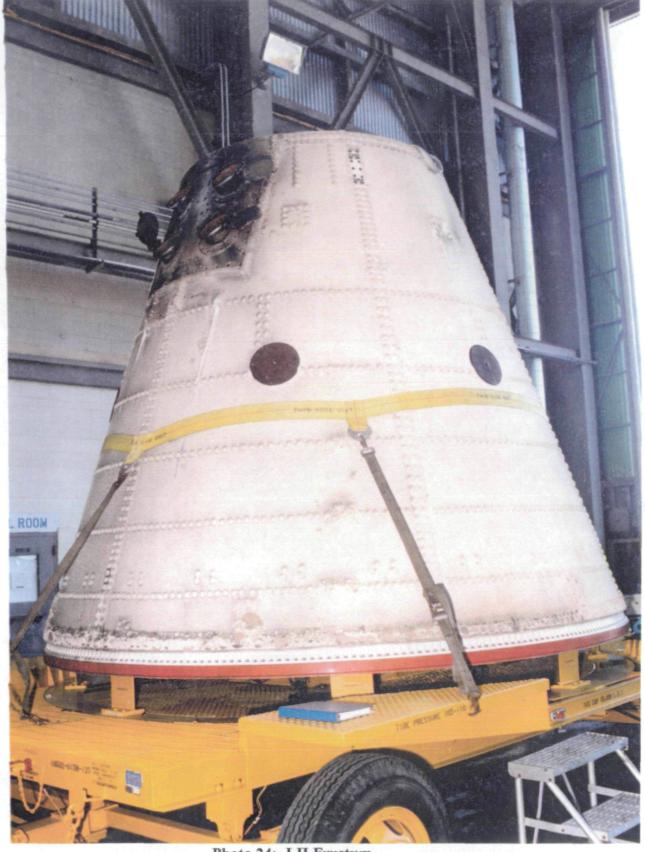
Photo 24: LH Frustum

The LH frustum was missing no TPS. The number of MSA-2 debonds over fasteners (54) and over acreage (2) was greater than average. Hypalon paint was blistered/missing along the XB-395 ring frame where BTA closeouts had been applied. However, most of the exposed BTA substrate was not sooted.

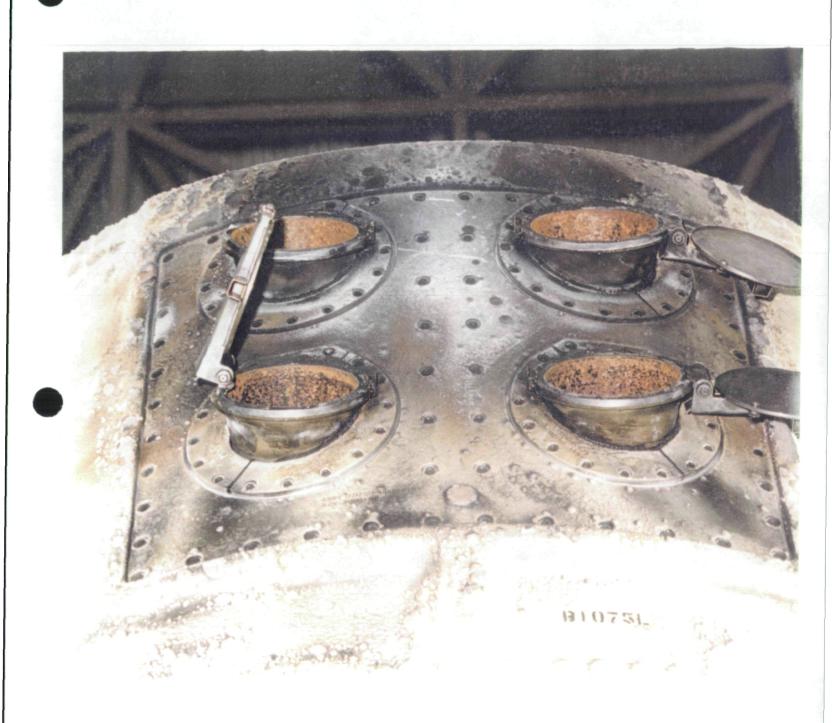
Photo 25: BSM Aero Heat Shield Covers

The BSM aero heat shield covers had locked in the fully opened position though the lower left cover attach ring had been bent. The upper left cover was missing. The damage to the BSM covers/attach rings was caused by parachute riser entanglement after splashdown.

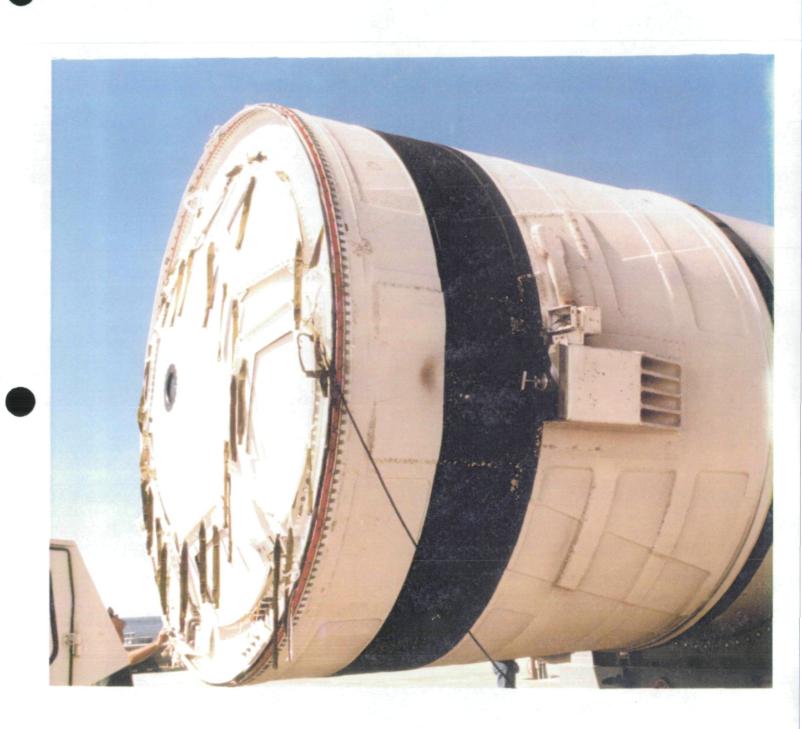
Photo 26: LH Forward Skirt

The LH forward skirt exhibited no debonds or missing TPS. Both RSS antennae covers/phenolic base plates were intact. Hypalon paint was blistered/missing over the areas where BTA closeouts had been applied.

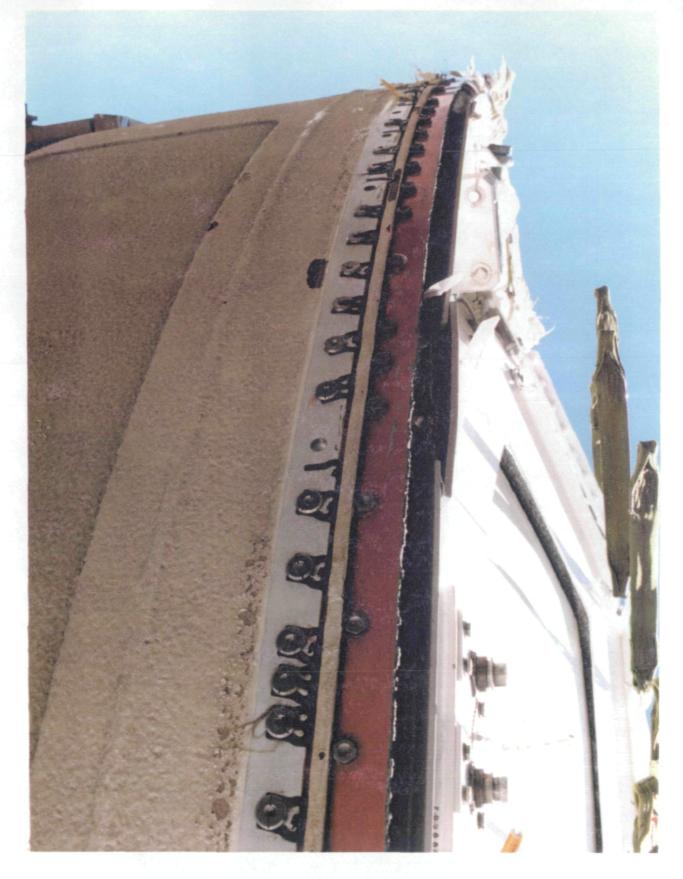
Photo 27: Severance Ring Pins and Retainer Clips

Some of the pins and retainer clips were missing from the frustum severance ring. Strands of nylon fiber caught on adjacent clips indicated the damage was caused by the parachute risers after splashdown.

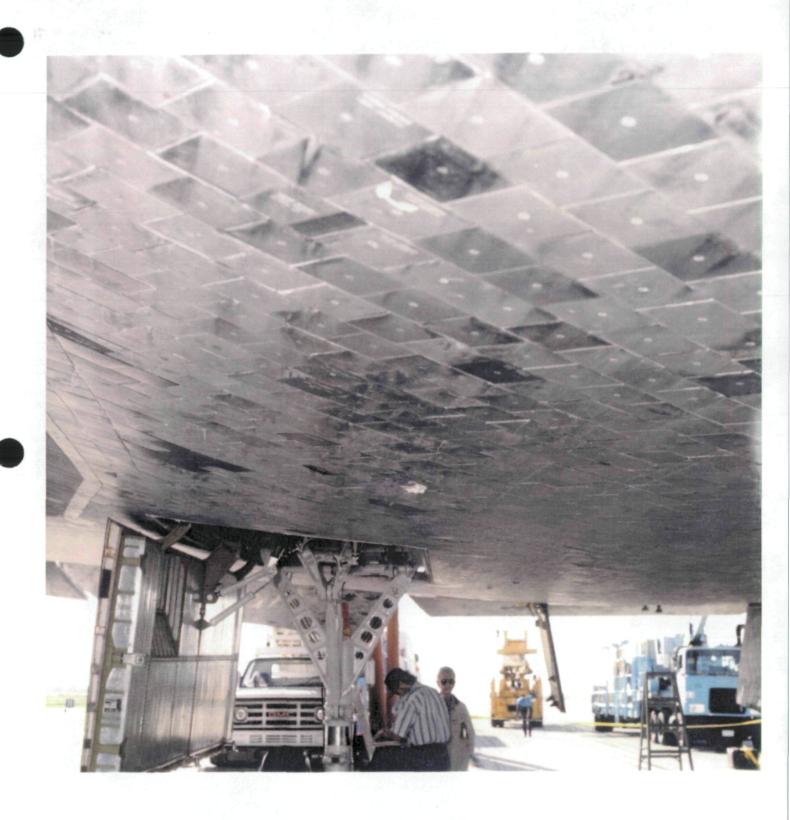
Photo 31: Lower Surface Tile Damage

The Orbiter lower surface sustained a total of 102 hits, of which 17 had a major dimension of 1-inch or larger. The largest lower surface tile damage site occurred approximately 10 feet forward of the RH MLG wheel well.

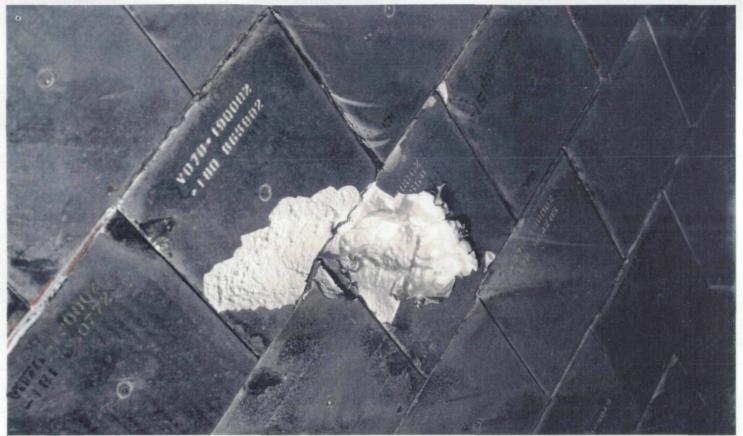
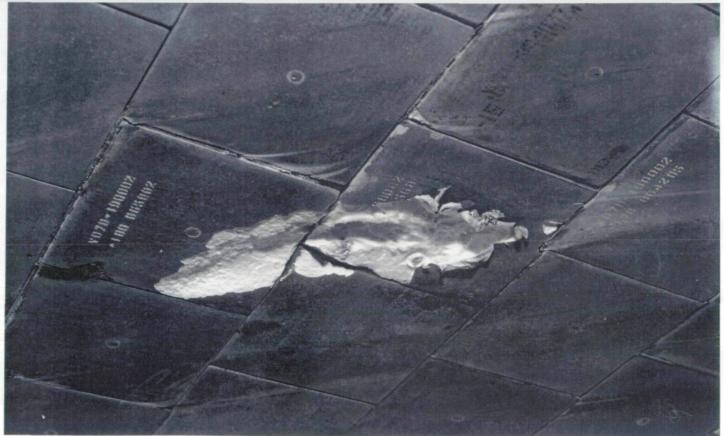
Photo 32: Lower Surface Tile Damage

Two views showing a large tile damage site on the lower surface. The damage site, which measured 11.0 inches long by 3.8 inches wide by 0.8 inch maximum depth, showed significant signs of re-entry heating including interior glazing, slumping at the tile edge, and melting of the surface coating material.

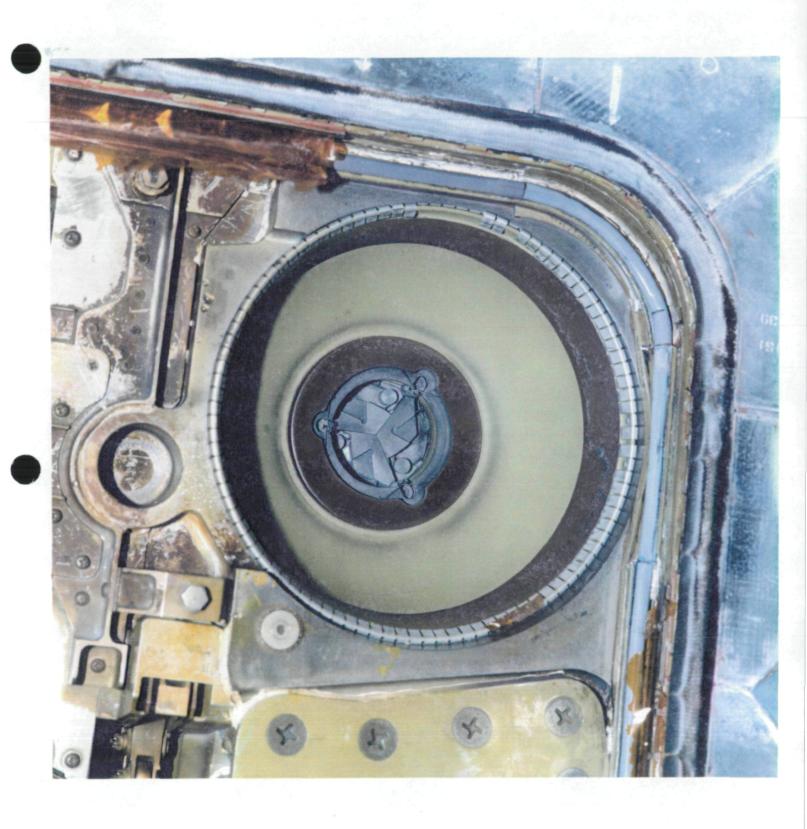
Photo 35: ET/ORB Fitting Lining Clips

ET/Orbiter separation devices EO-2 and EO-3 functioned normally. Numerous damaged clips on the "salad bowl" liners were noted: EO-2: two bent, two missing; EO-3: two bent, six missing.

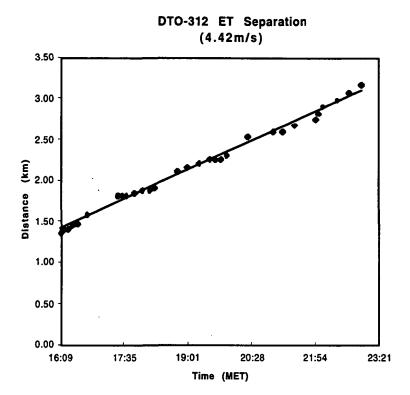
Figure 2.4.1 (A) ET Separation Velocity

The external tank was calculated to be a distance of 1.37 kilometers away from the Orbiter on the first image (taken 16 minutes after liftoff). The tank separation velocity was calculated to be 4.42m/s. The roll rate of the external tank was calculated to be 0.15 deg/sec. The tumble rate was calculated to be 1.91 deg/sec.

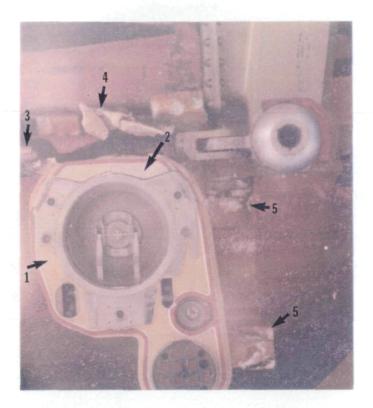
Figure 2.4.2 (A) LO2 Umbilical Events

TPS damage was noted at the top inboard forward corner of the LO2 umbilical (3). A piece of light colored material (possibly foam) was seen just forward of the LO2 umbilical just aft of the crossbeam (4). Numerous areas of TPS erosion were visible on the horizontal and vertical sections of the LO2 cable tray (5).

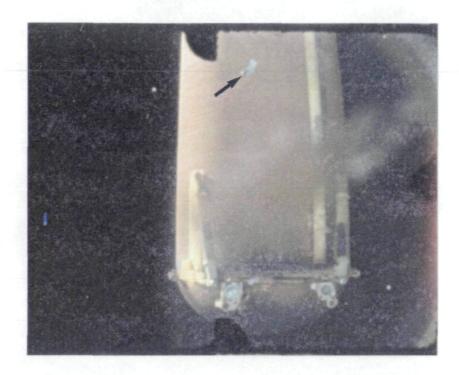
Figure 2.4.2 (C) Metallic Appearing Debris

A metallic appearing debris object is visible on the 16mm film (10mm lens frame 8303) approximately 14 seconds after ET separation. This debris is believed to be a missing lightning contact strip from the LO2 umbilical.
