NASA Technical Memorandum 104627

Degradation of FEP Thermal Control Materials Returned from the Hubble Space Telescope

Thomas M. Zuby, Kim K. de Groh, and Daniela C. Smith

DECEMBER 1995

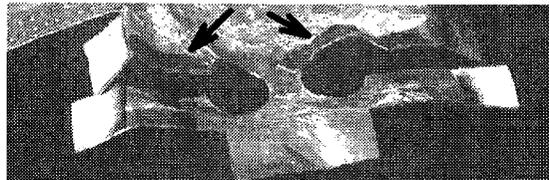
Both magnetometer MLI sections show a very dark discoloration in the areas of highest solar fluence. These dark areas appear in proximity to an underlying acrylic transfer film adhesive layer. The transfer adhesive is applied in 1.3 cm widths along the edges of the FEP layer. This is the approximate width of the darkened zone. The combination of thermal effects and UV induced degradation are thought to have caused this browning. Figure 6 shows the darkened areas for one of the two magnetometer MLI assemblies.

Figure 6: Solar induced browning of a magnetometer MLI. Acrylic tape is used in this area to fasten the top FEP layer to the second layer in this MLI assembly.

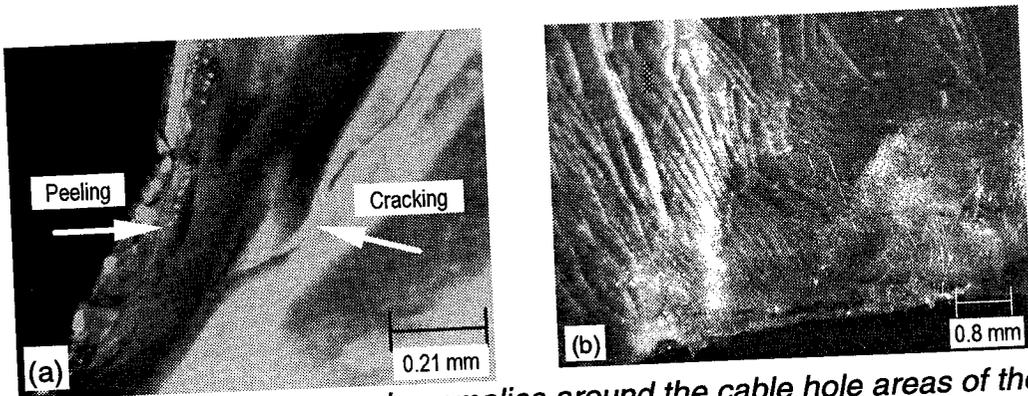
In addition to discoloration, areas of separation or peeling of the FEP film from the acrylic adhesive, and cracks in the FEP are apparent. The peeling and cracking are more pronounced on the surfaces of the magnetometer MLI with highest solar fluence. Figure 7 shows the peeling and cracking phenomena noticed in the cable areas of the FEP layer of the magnetometer MLI.

Figure 7: Photographs of observed anomalies around the cable hole areas of the magnetometer MLI. (a) Area of magnetometer MLI showing peeling and cracking of the FEP layer. (b) Area of the MLI surface showing severe cracking.

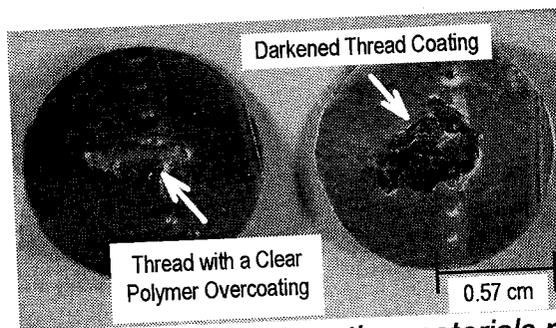
The overall appearance of this blanket assembly looked good except for the apparent browning of a silicone polymer used as a thread coating (see Fig. 8), and visible through-thickness cracks (see Fig. 9). A slight milky appearance was also present. These anomalies were noted in areas of high solar exposure. Modeling of the SA-I drive arm MLI to calculate solar exposure has not yet been performed. The cracks were noted at KSC during the de-integration of the hardware, before contact or any other handling was performed on the blanket assembly.

Figure 8: Comparison of the polymer thread coating materials removed from the SA-I MLI. The coating on the left is relatively undarkened, and the thread and MLI features are still visible. The coating on the right has darkened significantly. The thread is faintly visible through the coating. The sample on the left received a lower solar fluence than the sample on the right.

The darkened silicone thread protective material pictured on the right in Figure 8 was found to contain SiO_x and a small amount of fluorine. Adjacent to the polymer overcoat, the oxidized FEP substrate and trace amounts of silicon were found. The thread area itself contained only SiO_x and silicone.

In comparison, the sample with the clear thread coating (see Fig. 8) was analyzed. Adjacent to the coating, carbon, fluorine and a small amount of oxygen were noted. The clear coating was found to contain only silicon, carbon, and oxygen. No fluorine was detected. The oxygen content measured in the undarkened sample was considerably lower than that of the darkened sample.

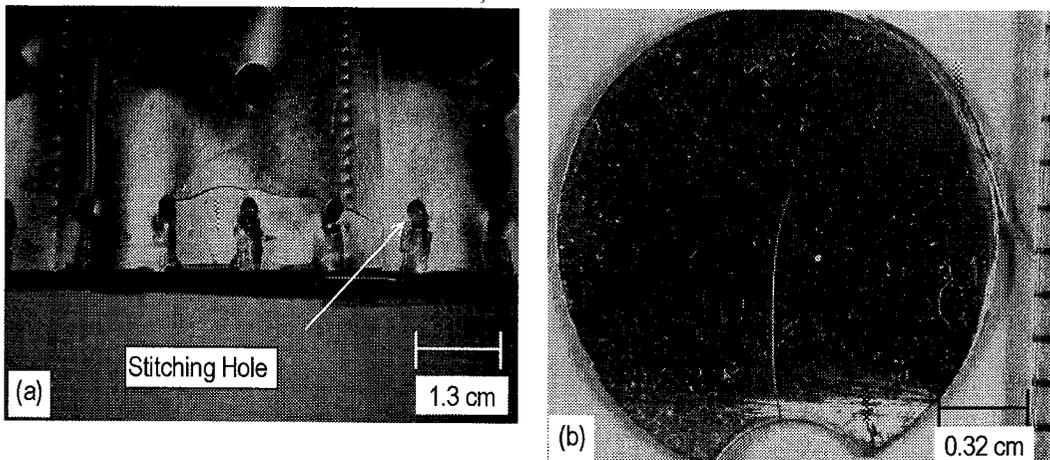
Figure 9: Areas of through-thickness cracking on the SA-I MLI. (a) Cracks are pictured near the edge of the blanket assembly. This is the area where the two mating sides were sewn together. (b) A cracked area sampled near one of the vent holes.

Two vent hole areas showing through thickness cracks (similar to the crack of Figure 9b) were examined to see if chemical changes in the FEP material may have induced the cracking. The results vary between the two samples. For one sample, the analysis directly on the cracked area showed fragmented carbon-fluorine bonds, and less oxygen than an area adjacent to the cracked area. The second sample showed equivalent chemistry between cracked and uncracked areas.

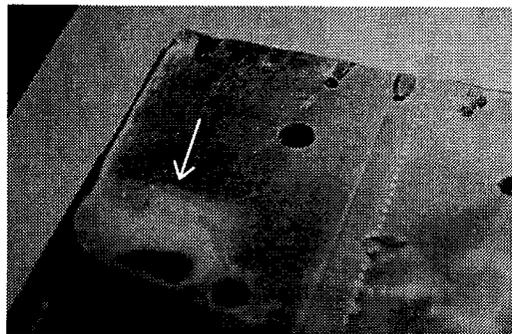
Figure 10: The largest localized area of contamination in the SA-I drive arm MLI is shown in this photograph.

Analysis of the large area of discoloration in Figure 10 showed the major constituent of the residue to be hydrocarbon based materials. This is the only area where hydrocarbons are predominant in the residue. Away from the center of the contaminated area, the FEP substrate, and small amounts of silicon and oxygen are present.

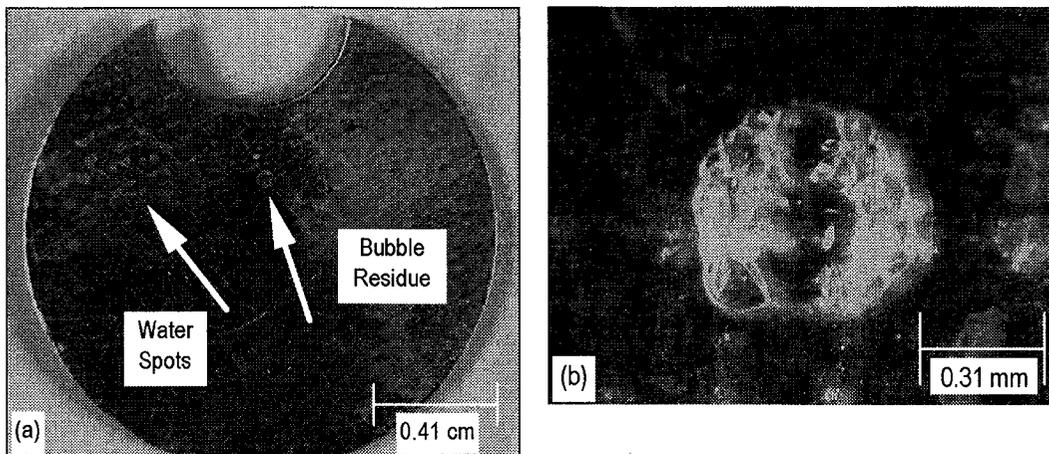
Figure 11: Indication of a pre-flight wiping operation is shown in these photographs. (a) Liquid droplet trails are evident in this picture leaving behind what is being termed “water spots”. In proximity to the water spots, a bubble residue was located. (b) Enlargement of the bubble residue.

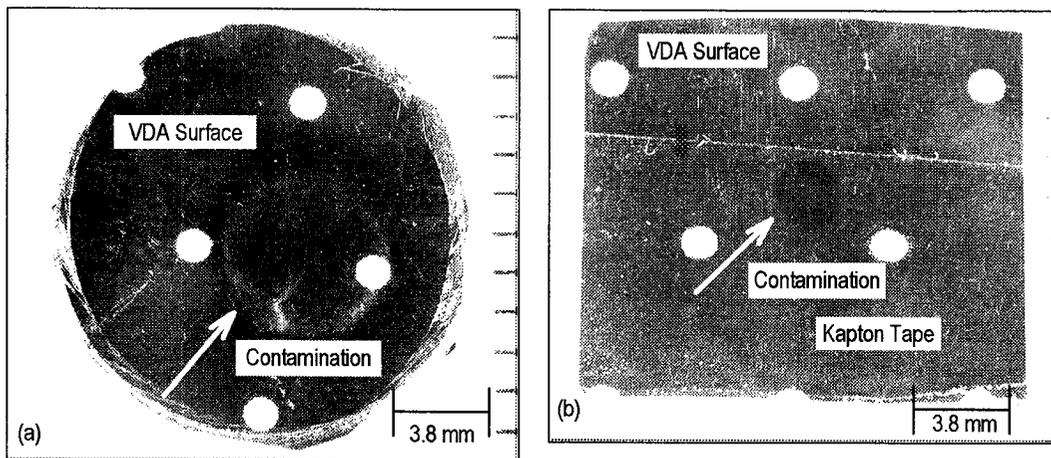
The second layer of the SA-I drive arm MLI assembly was also sectioned and analyzed in two areas (see Figures 12a-b). The sample in Figure 12a was taken from an area exposed to the space environment below a vent hole in the top FEP layer. The sample in Figure 12b was taken below a stitching hole in the MLI assembly. The results from the XPS analysis show the presence of fluorine, silicone, and SiO_x on the VDA and Kapton surfaces.

Figure 12: Second layer contamination from the SA-I MLI. The second layer is a Kapton substrate with both sides coated with VDA. The contaminants are predominantly fluorine, silicone and SiO_x . (a) This section was removed from underneath a vent hole in the FEP layer. (b) This sample was removed below a stitching hole (see Fig. 9a). The area of contamination is located on a piece of Kapton tape that has been applied to the VDA surface.

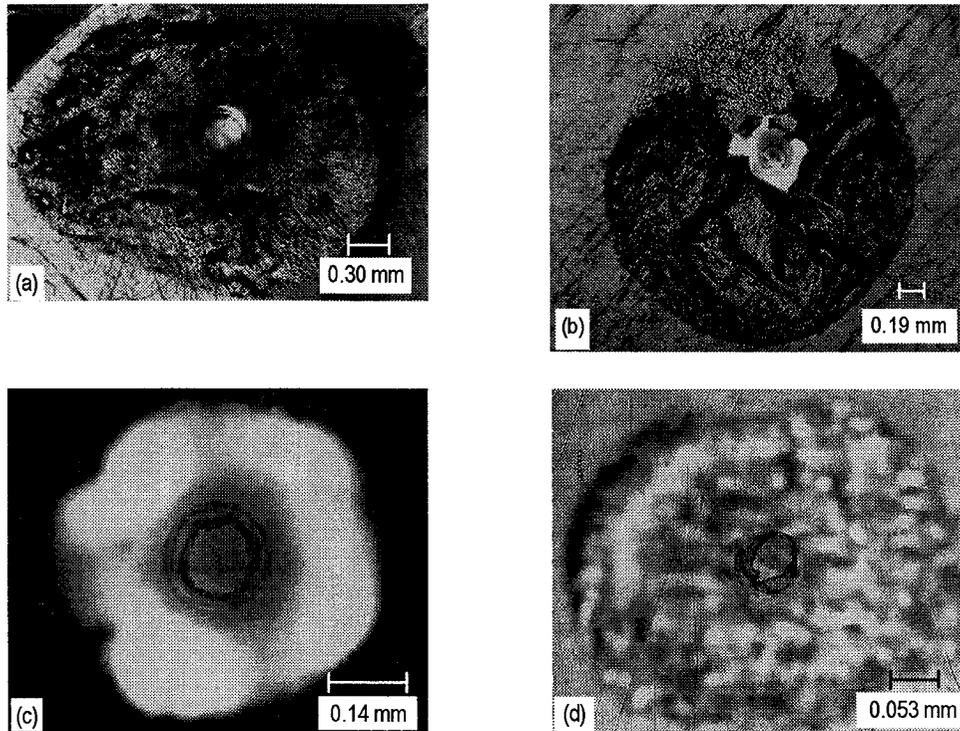
Six MMD impact holes were found on the SA-I MLI. Examination was performed with optical microscopy up to 200x magnification. The largest “shock ring”, or impact affected area was found on the solar facing surfaces of the MLI. Other samples were taken from material that was wrapped around the circular drive arm, and pointed away from the sun. It has not yet been determined if the shock ring size can be correlated to the embrittlement of the FEP material, or if is just a function of particle size. Figure 13 shows 4 of the 6 observed impact sites for the SA-I drive arm FEP layer. For the areas of high

solar exposure, the shock ring is over 7 times the diameter of the impact hole. For the areas of lower solar exposure, the shock ring is roughly 4.5 times the diameter of the impact hole.

Figure 13: MMD impact sites from the FEP layer of the SA-I MLI. Samples (a) and (b) were removed from an area of the MLI that was predominantly solar facing. Sample (c) and (d) were removed from areas of lower solar fluence.

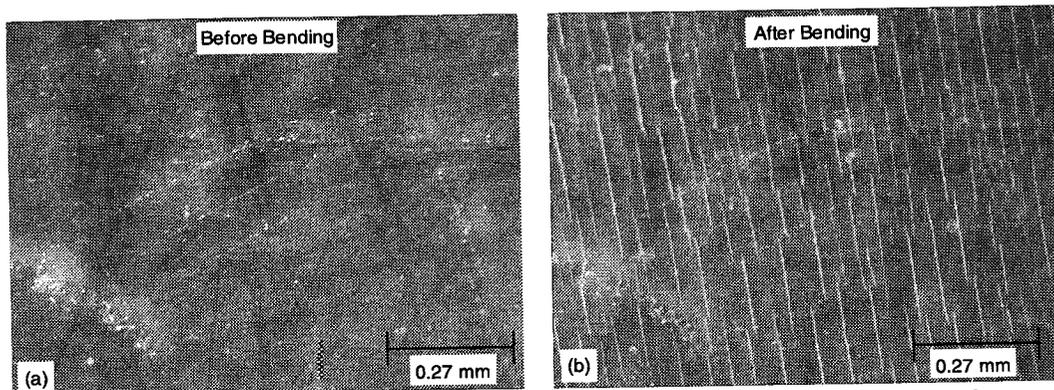
A two step bending process was another method used to evaluate the extent of embrittlement of the SA-I MLI FEP material. Small sections, roughly 2 cm on each side, were cut from the FEP layer. The samples were subjected to folding, or bending around an 0.83 mm diameter mandrel. In one direction, across the middle of the samples, bending was performed to cause compression on the space exposed surface of the FEP layer. Perpendicular to the compressive fold line, the FEP was bent so that the space exposed surface was subject to tensile stress. Each fold direction was subject to 25 cycles. The results indicate that compressive folding had no observed effect on the materials. Tensile folding induced cracking in the material for the samples with high solar exposure (see Fig. 15). No cracking was observed for the samples with the lower solar exposures.

Figure 15: SA-I MLI FEP layer subjected to the tensile bending. This sample received the highest solar exposure. (a) Sample prior to bending. (b) Sample after the tensile bending.

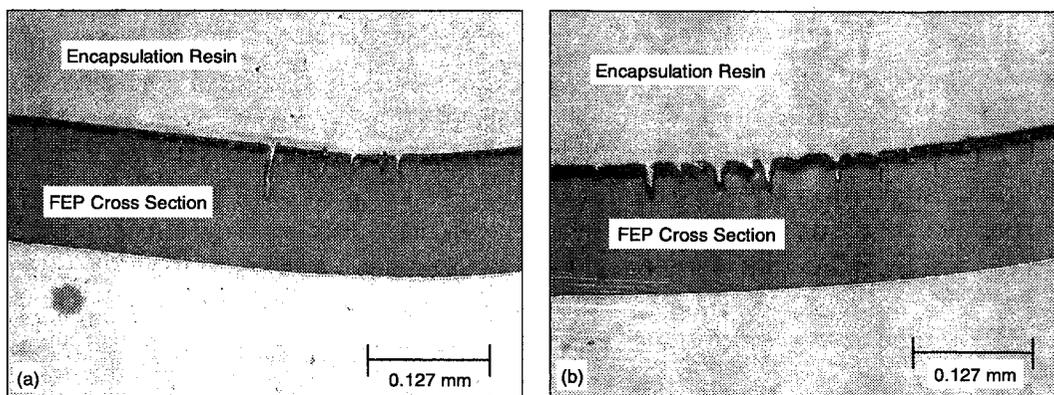
Figure 16: Cross sectional micrograph of the magnetometer FEP. Both thicknesses are measured to be 0.113 mm. (a) Sample removed from 11,339 ESH area of MLI, adjacent to the 16,670 ESH area. (b) Sample removed from the 16,670 ESH surface of the MLI.

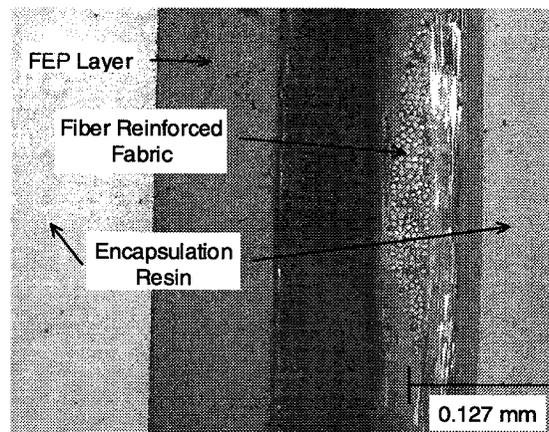
Figure 17: Cross section of the SA-I MLI FEP layer from an area of high solar exposure.
