# **Debris/Ice/TPS Assessment and Integrated Photographic Analysis of Shuttle Mission STS-74**

*Gregory N. Katnik, Barry C. Bowen, Jill D. Lin,  
Vehicle Engineering/Mechanical System Division/ET-SRB Branch,  
Kennedy Space Center, Florida*

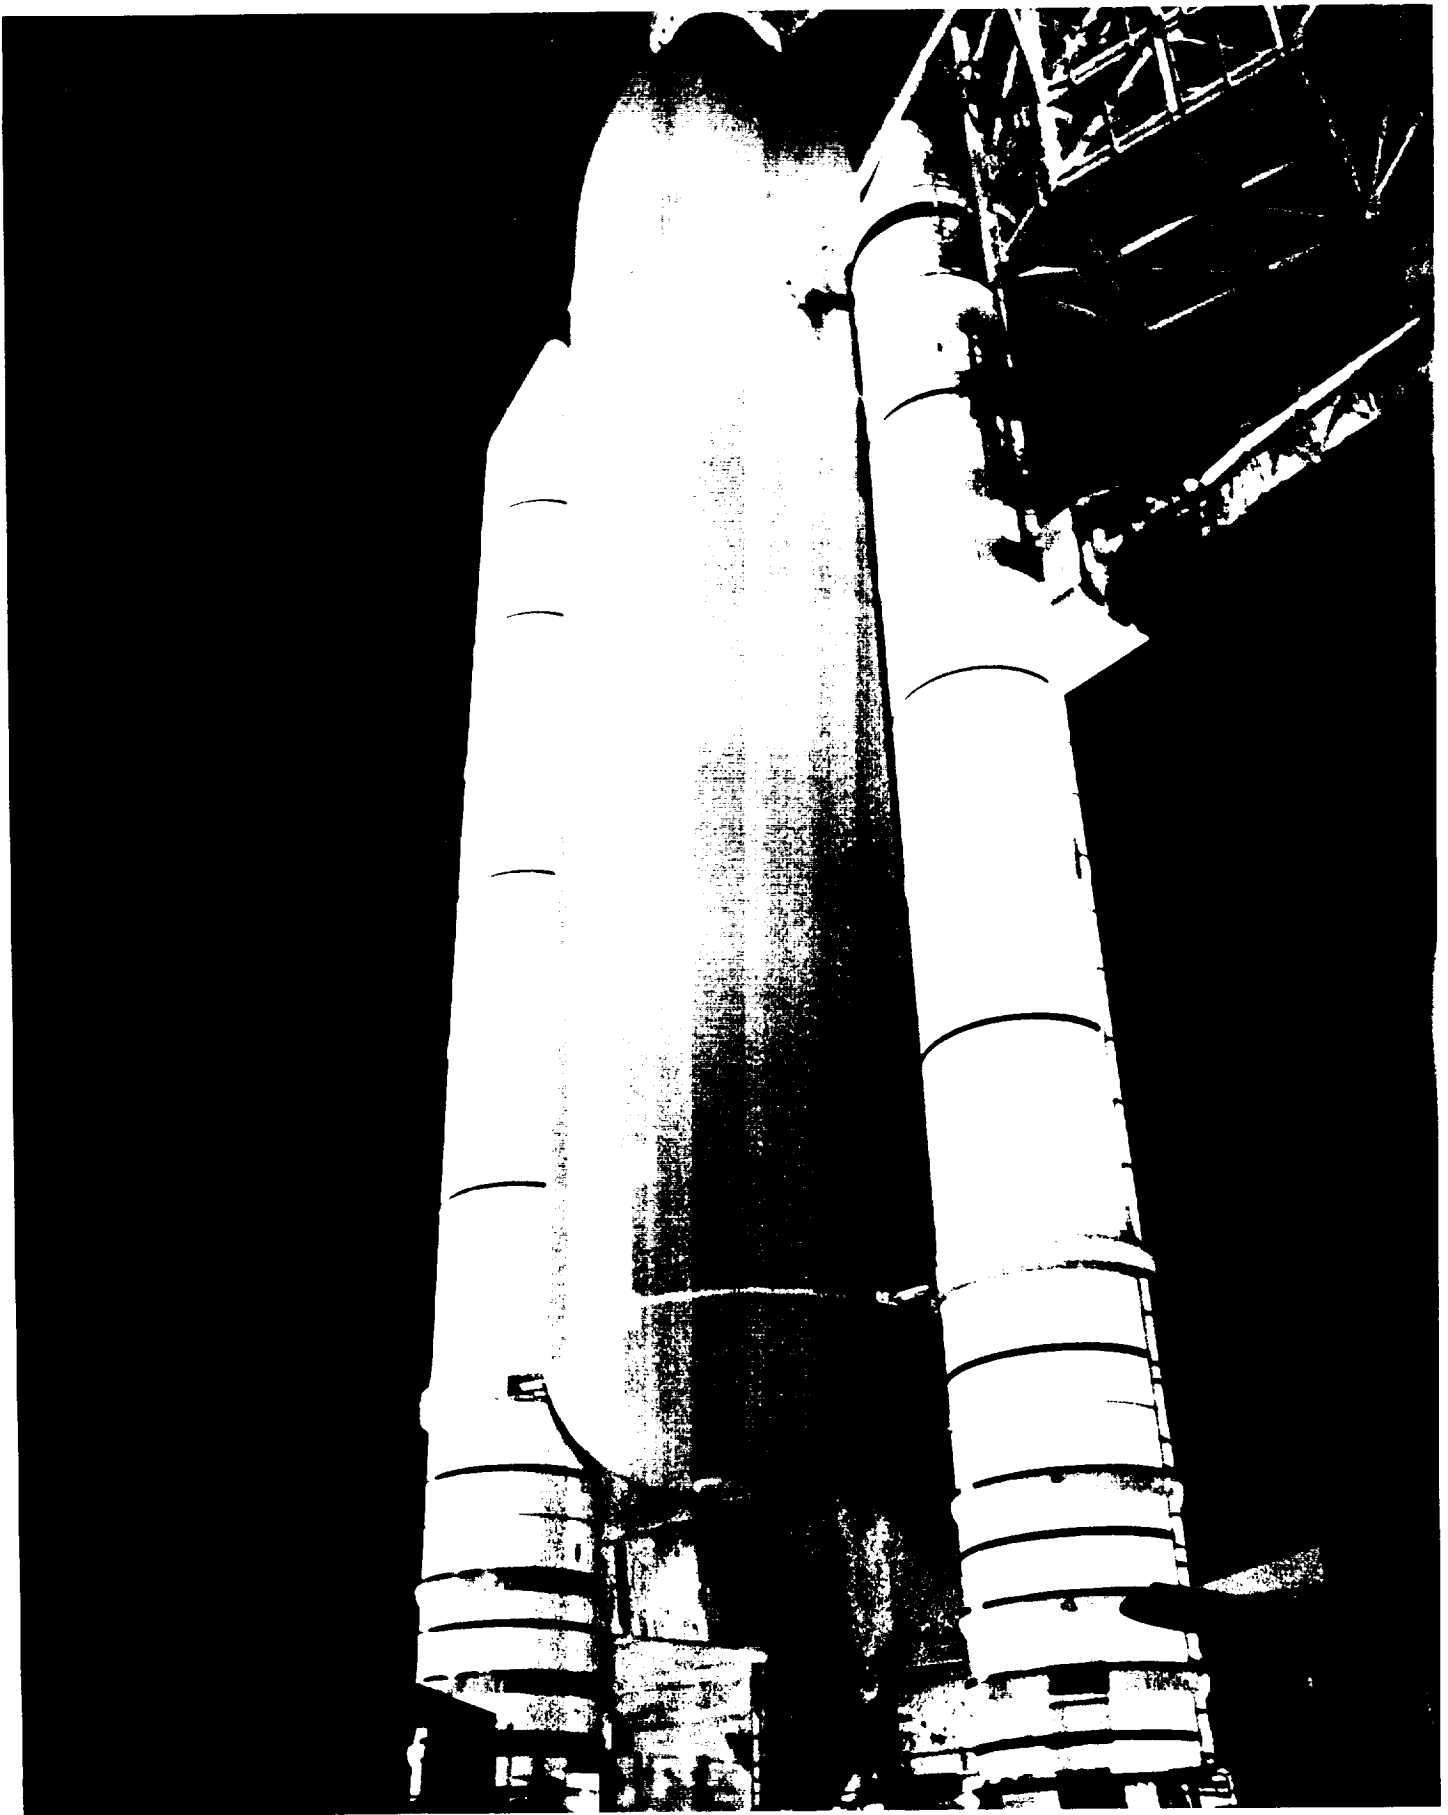
**Photo 2 : Cryoloaded External Tank**  
No acreage ice/frost conditions or TPS anomalies

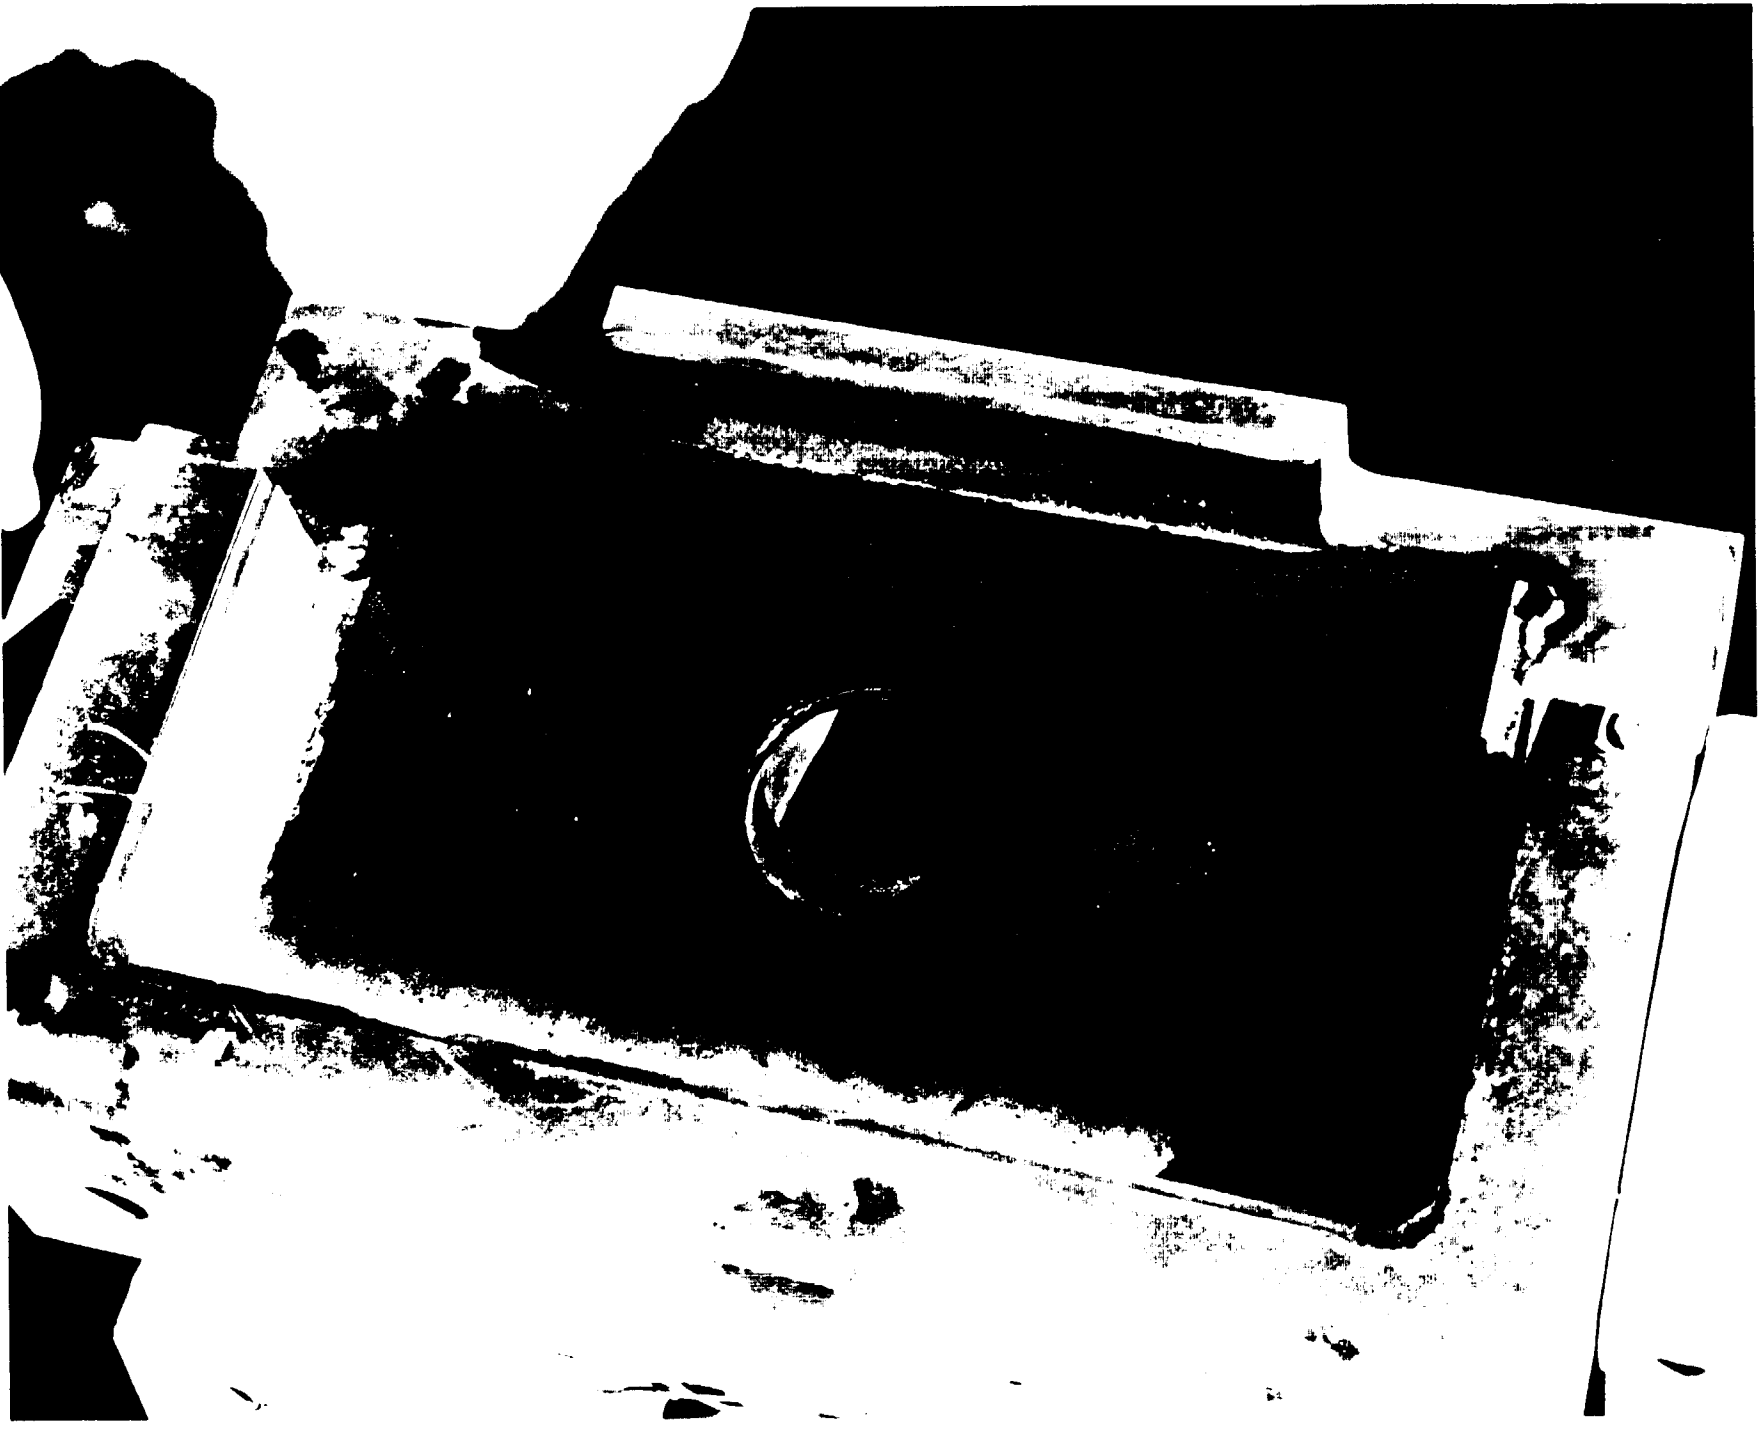
**Photo 4 : SRB Hold Down Post Shim**

Although the aft skirt shoe shim material was intact, the new material, which is somewhat darker than the material used prior to BI-074, exhibited a bubbled appearance after launch.

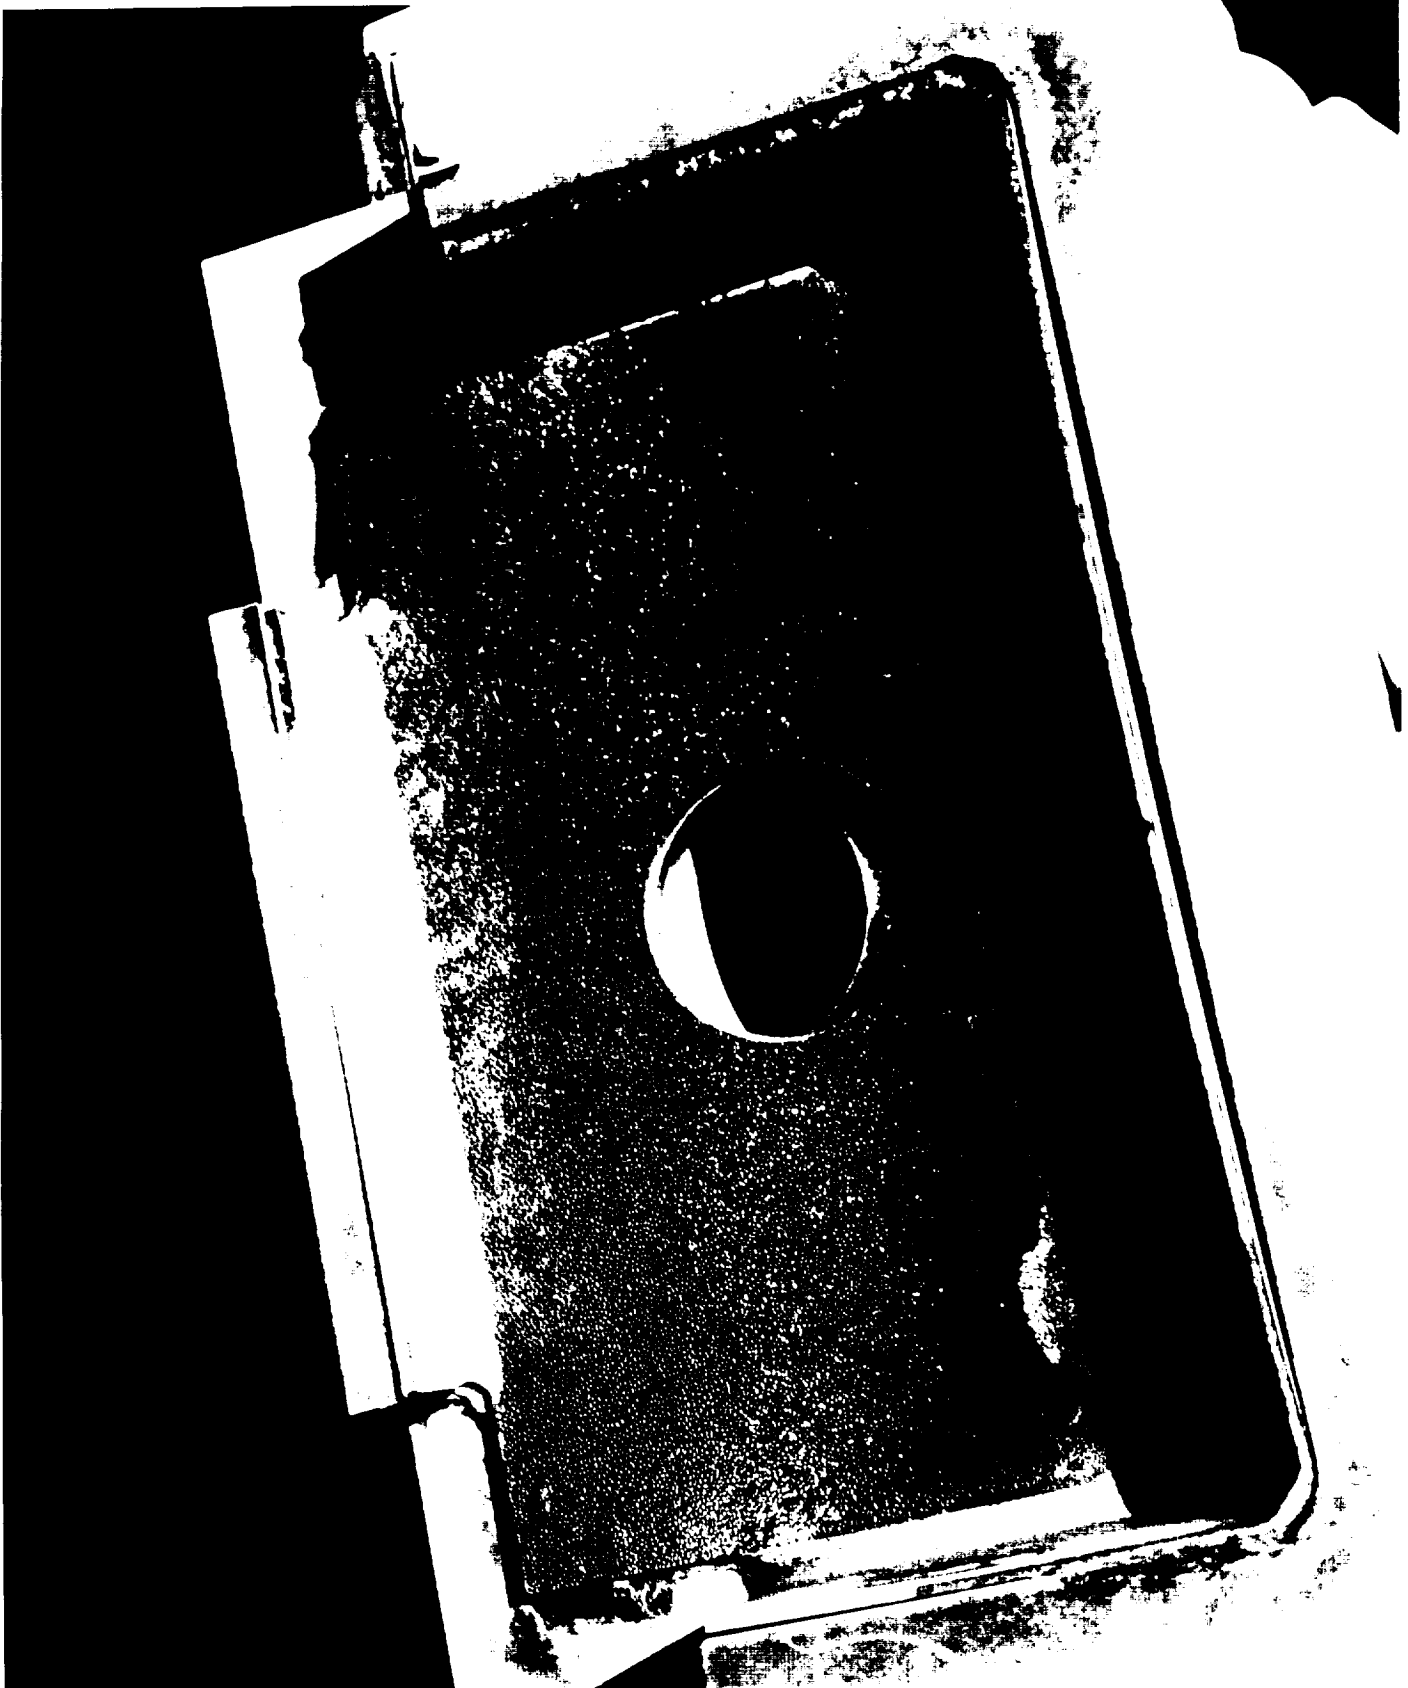
**Photo 5 : SRB Hold Down Post Shim**

Although the aft skirt shoe shim material was intact, the new material, which is somewhat darker than the material used prior to BI-074, exhibited a bubbled appearance after launch. The aft skirt shoe shim is slightly debonded.

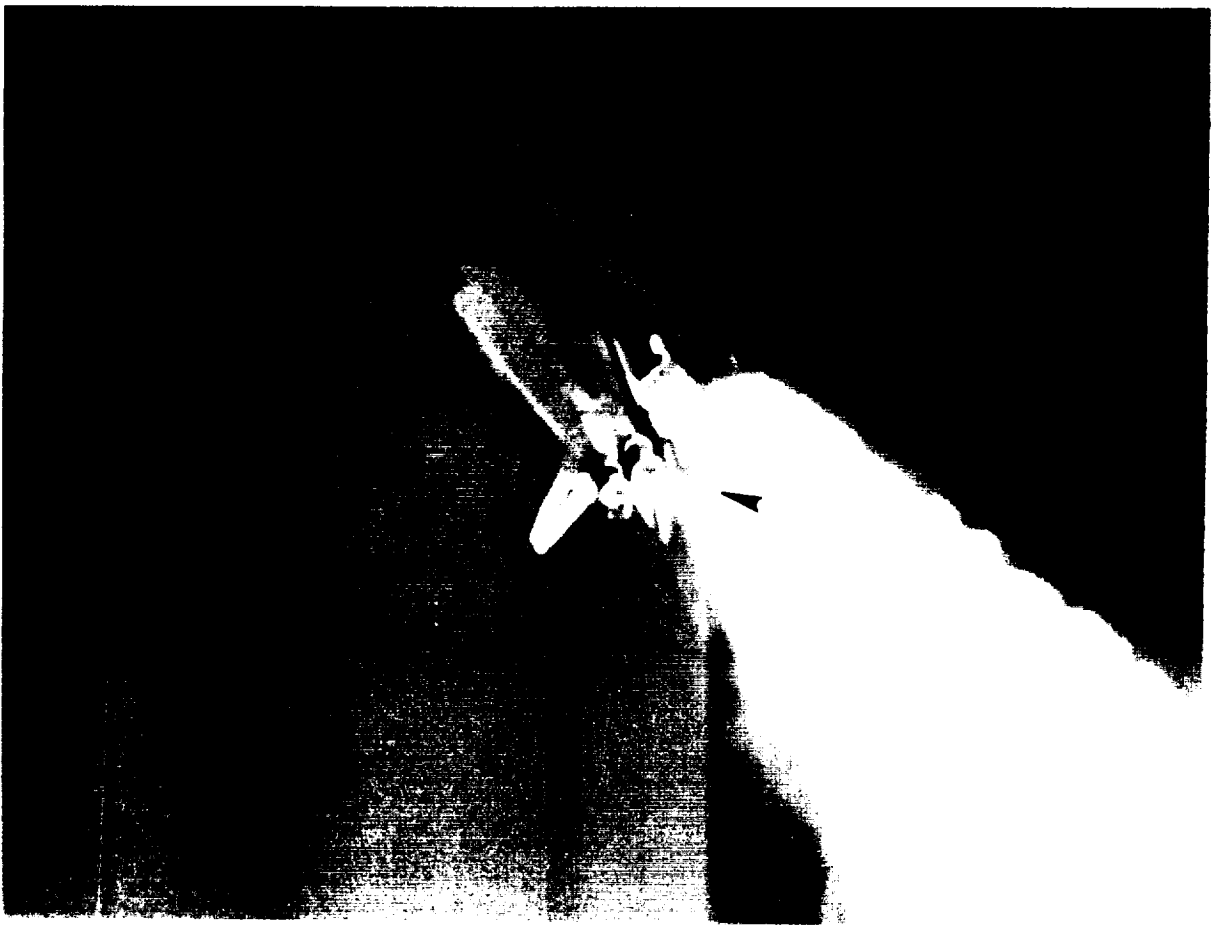
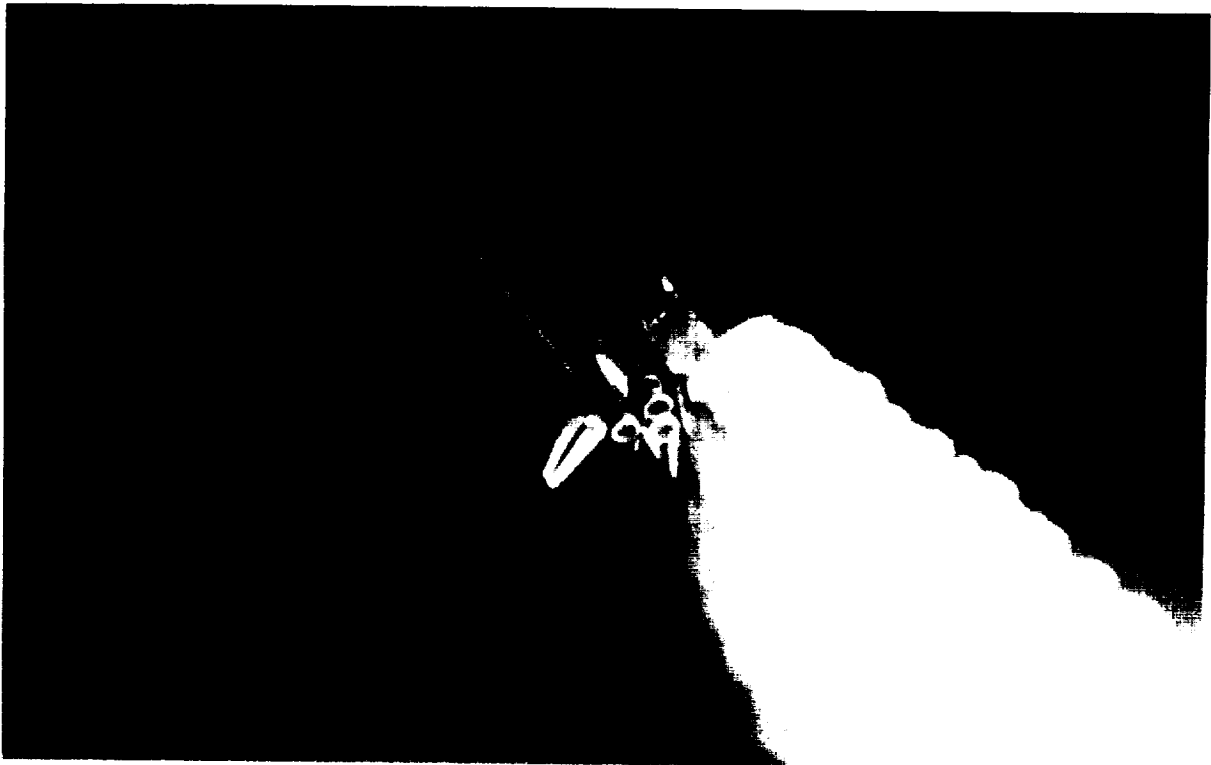
A flare in the SSME #2/#3 plume was caused by the vaporization of a light-colored object, which first appeared from an area aft of the vehicle and behind the RH SRB plume (E-223, frame 4365).

**Photo 6 : Flare in SSME Plume**

**Photo 7 : Flare in SSME Plume**

A flare in the SSME #2/#3 plume was caused by the vaporization of a light-colored object, which first appeared from an area aft of the vehicle and behind the RH SRB plume.

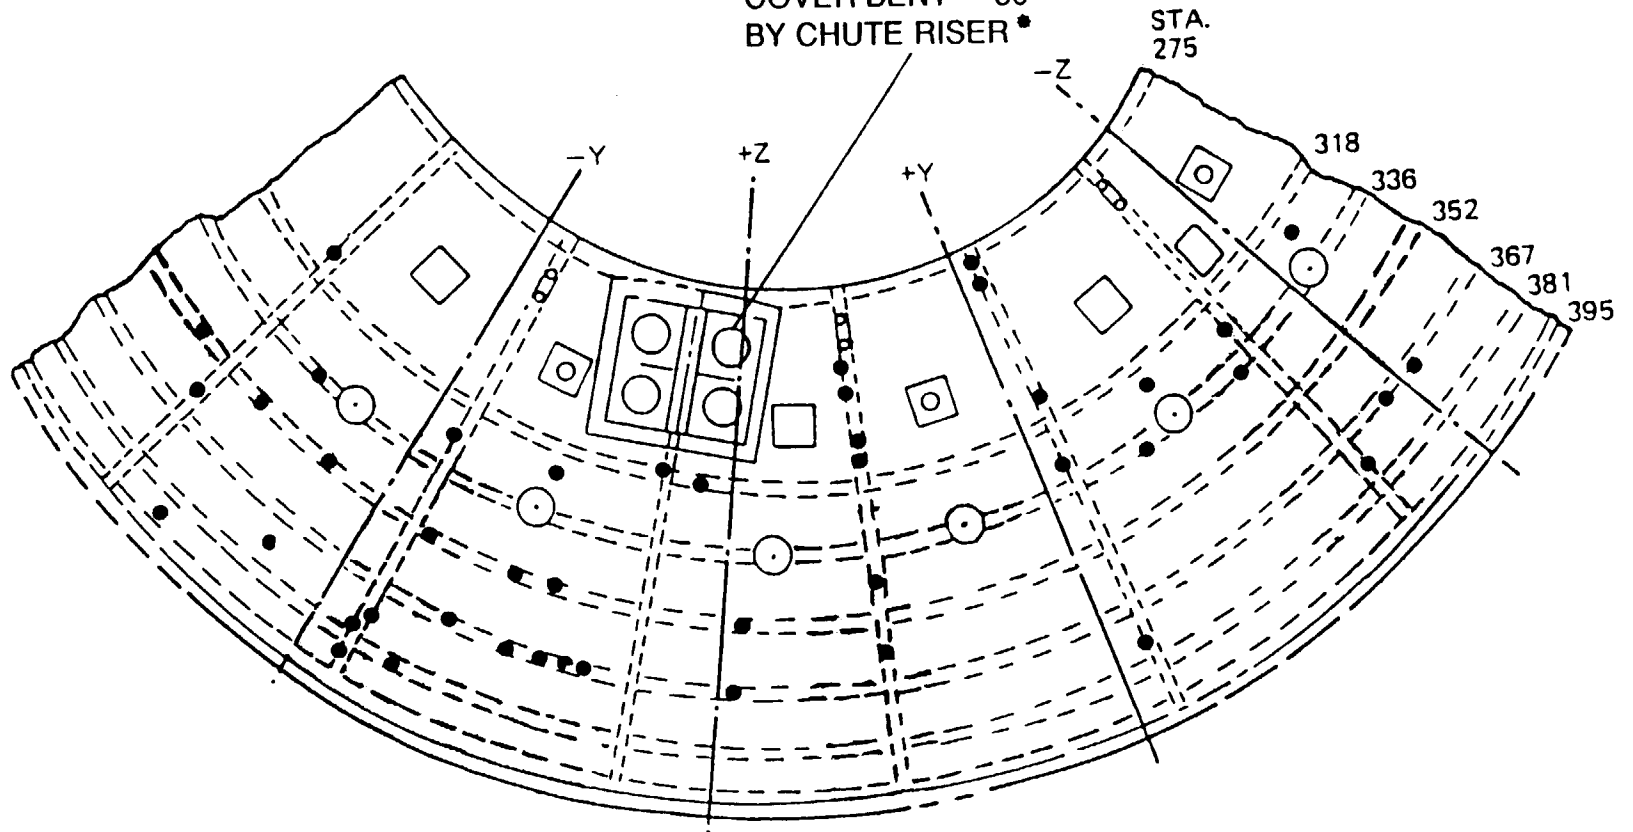
Figure 1 : RH Frustum

COVER BENT ~ 30°  
BY CHUTE RISER •

MISSING TPS  
NONE

DEBONDS  
● 45

• NYLON FIBERS CAUGHT  
ON DOOR LATCH

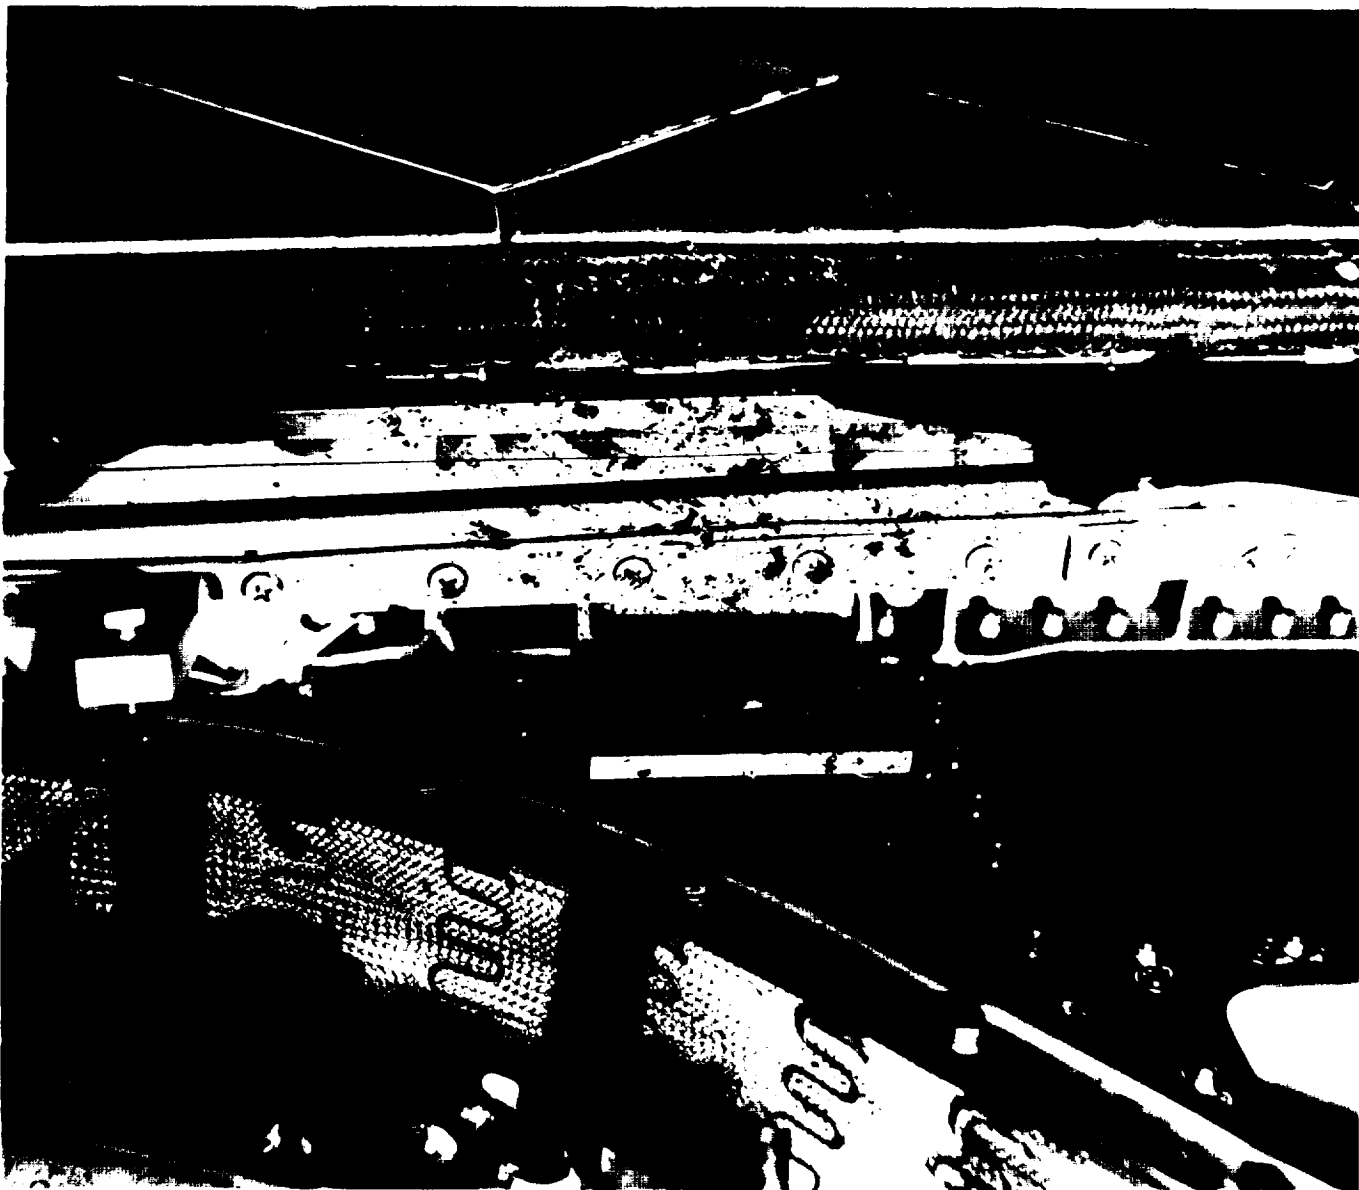
**Photo 22: Debris and Exhaust Residue**

Exhaust residue, small TPS particles, and debris had accumulated on the LH2 ET/ORB umbilical plate during ascent

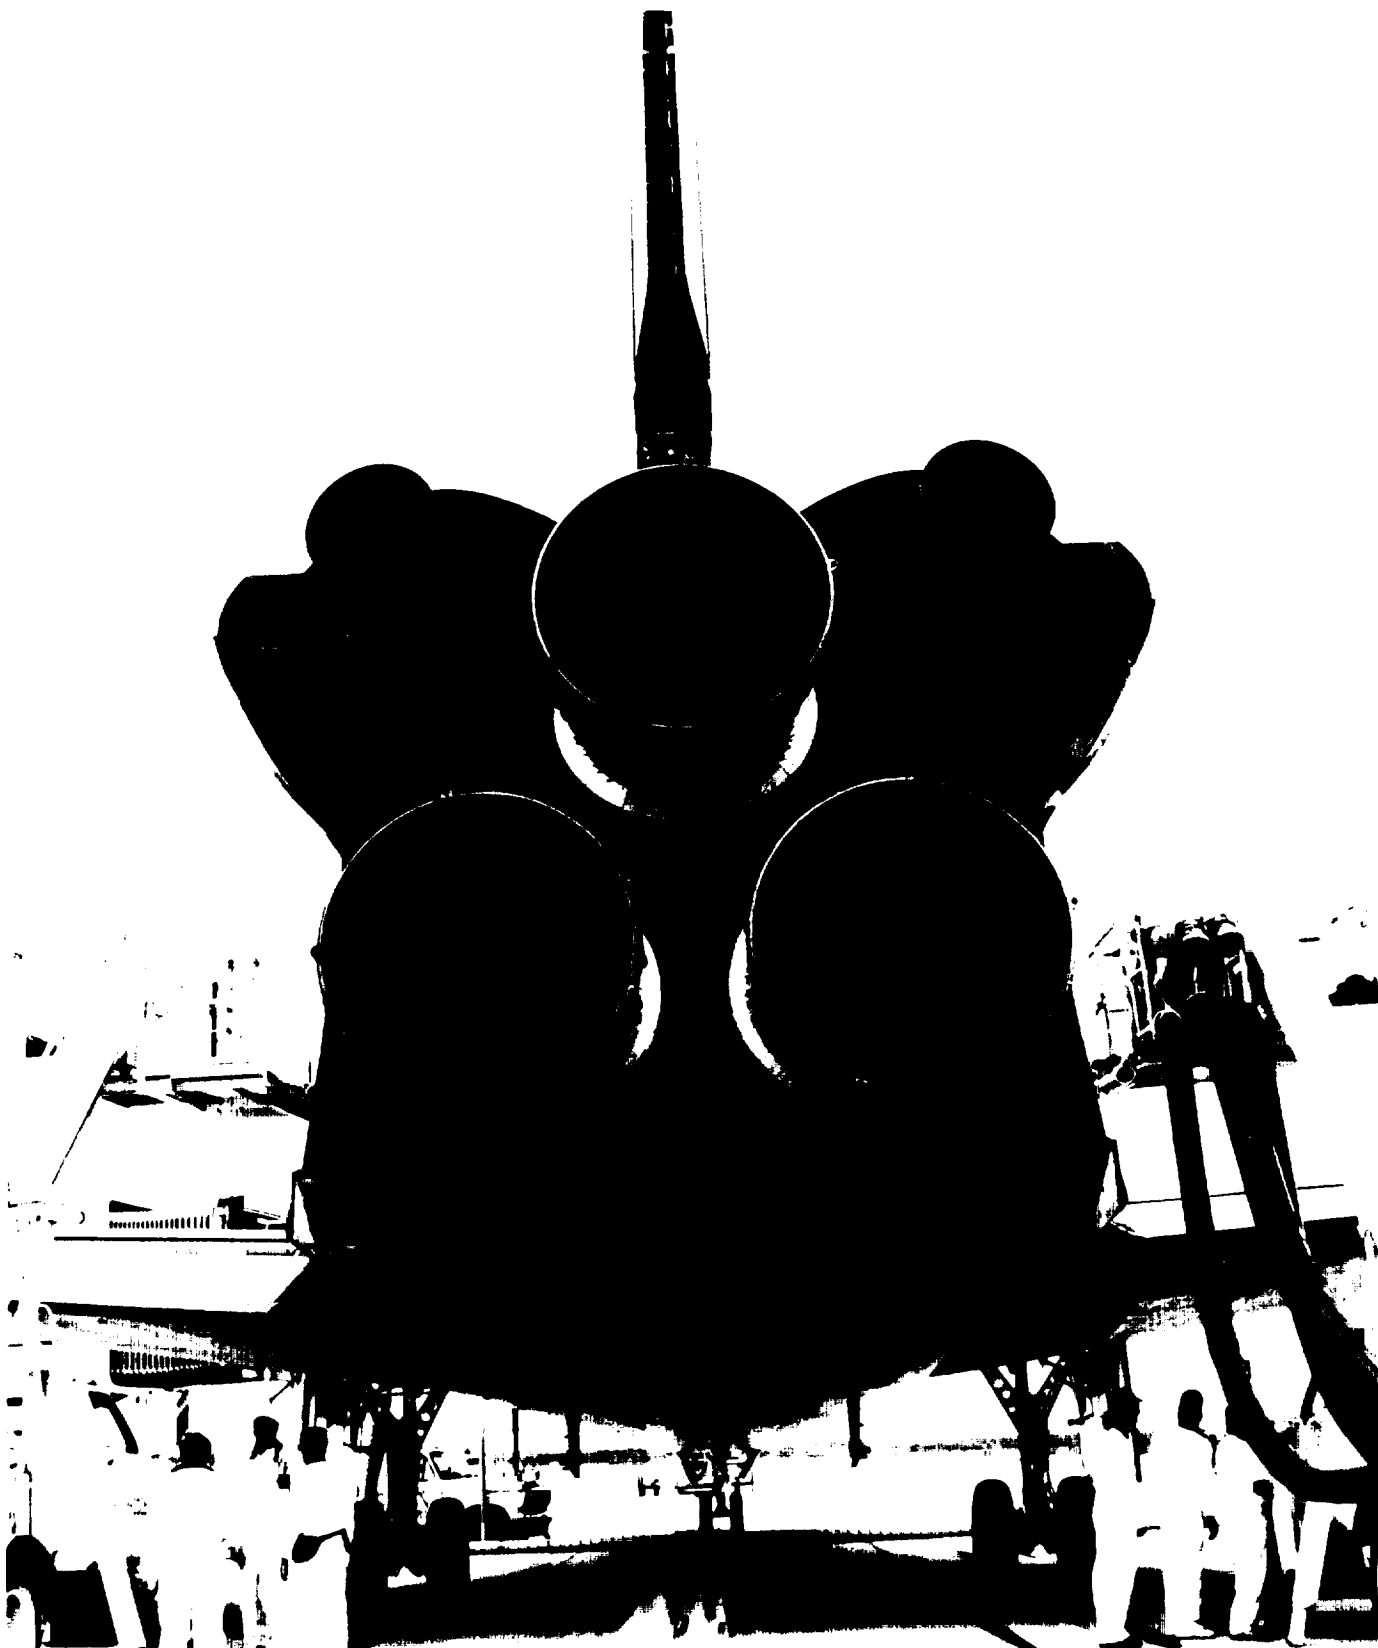
**Photo 23: Base Heat Shield**

Base heat shield tiles and SSME Dome Mounted Heat Shield closeout blankets were in good condition

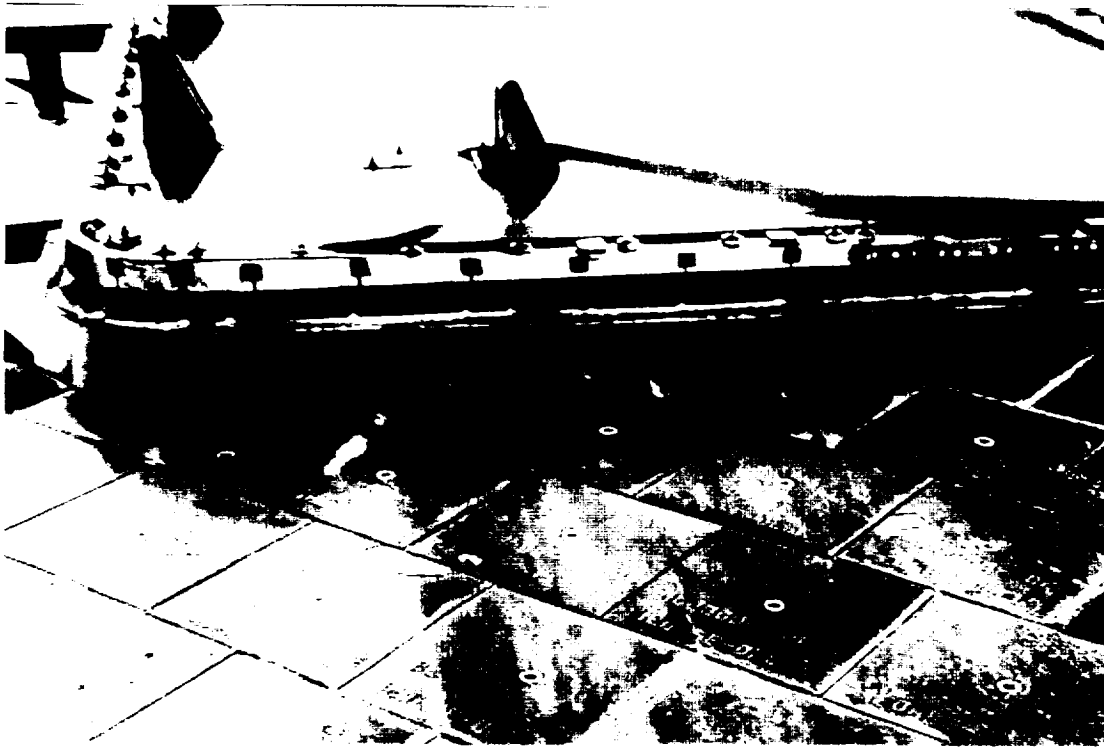
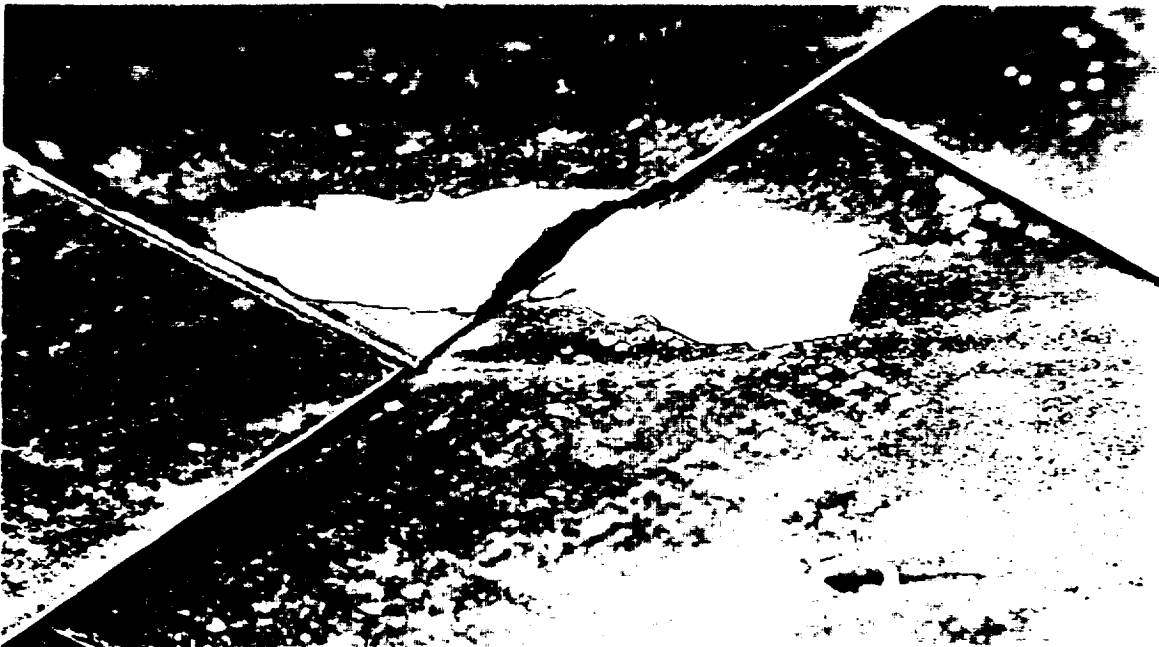
**Photo 25: Lower Surface Tile Damage**

**Photo 26: Lower Surface Tile Damage (Largest Damage Site)**

Although the total number of lower surface tile damage sites (78) was less than average, the number of damage sites 1-inch or larger (17) was slightly above average. The largest lower surface tile damage site occurred near the Orbiter centerline just forward of the ET/ORB umbilicals. The damage site measured 3.5-inches long by 1.5-inches wide by 0.25-inch deep.
