# **Debris/Ice/TPS Assessment and Integrated Photographic Analysis of Shuttle Mission STS-75**

*Vehicle Engineering/Mechanical System Division/ET-SRB Branch,  
Kennedy Space Center, Florida*

**22 February 1996**

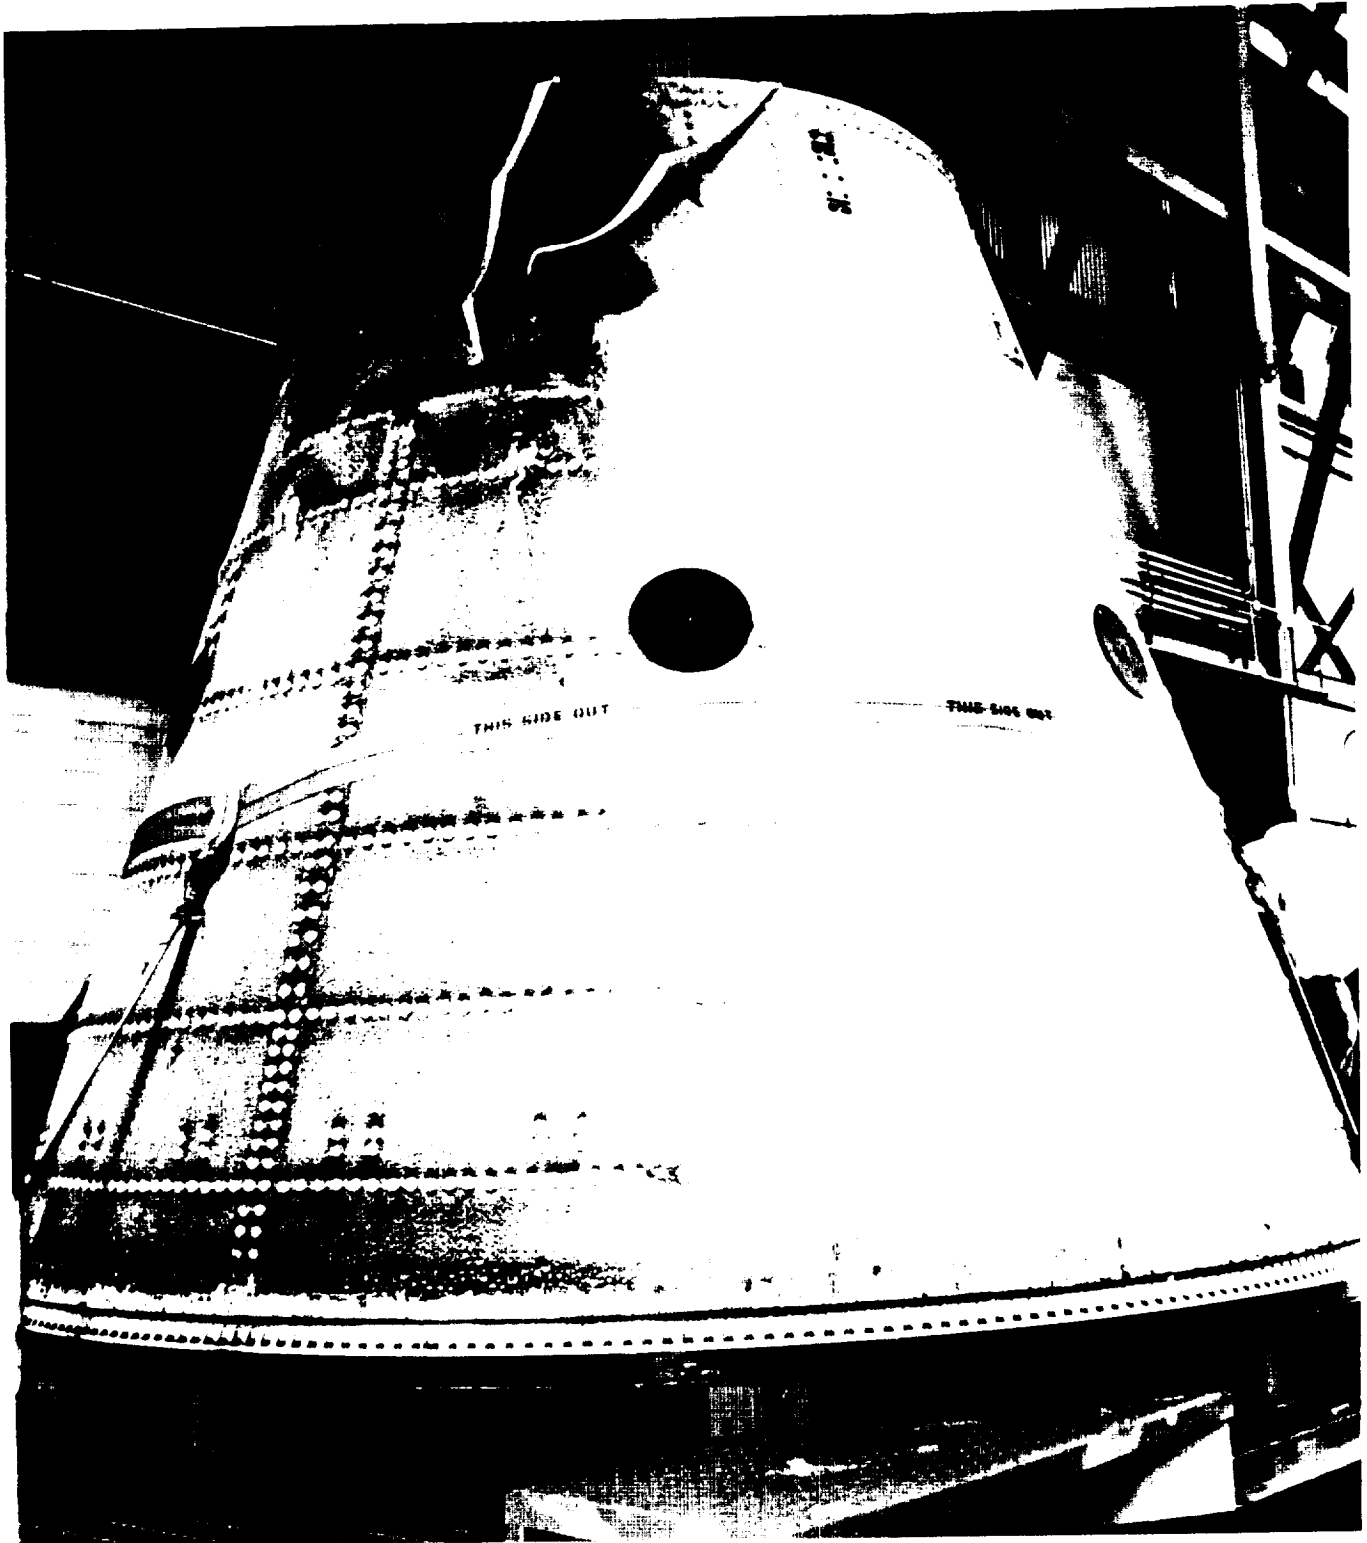
**Photo 14: RH Frustum**

The RH frustum was missing no TPS. The number of debonds over fasteners (16) and over acreage (2) was less than average. Hypalon paint was blistered/missing along the XB-395 ring frame where BTA closeouts had been applied. However, most of the exposed BTA substrate was not sooted. The BSM aero heat shield covers had locked in the fully opened position.

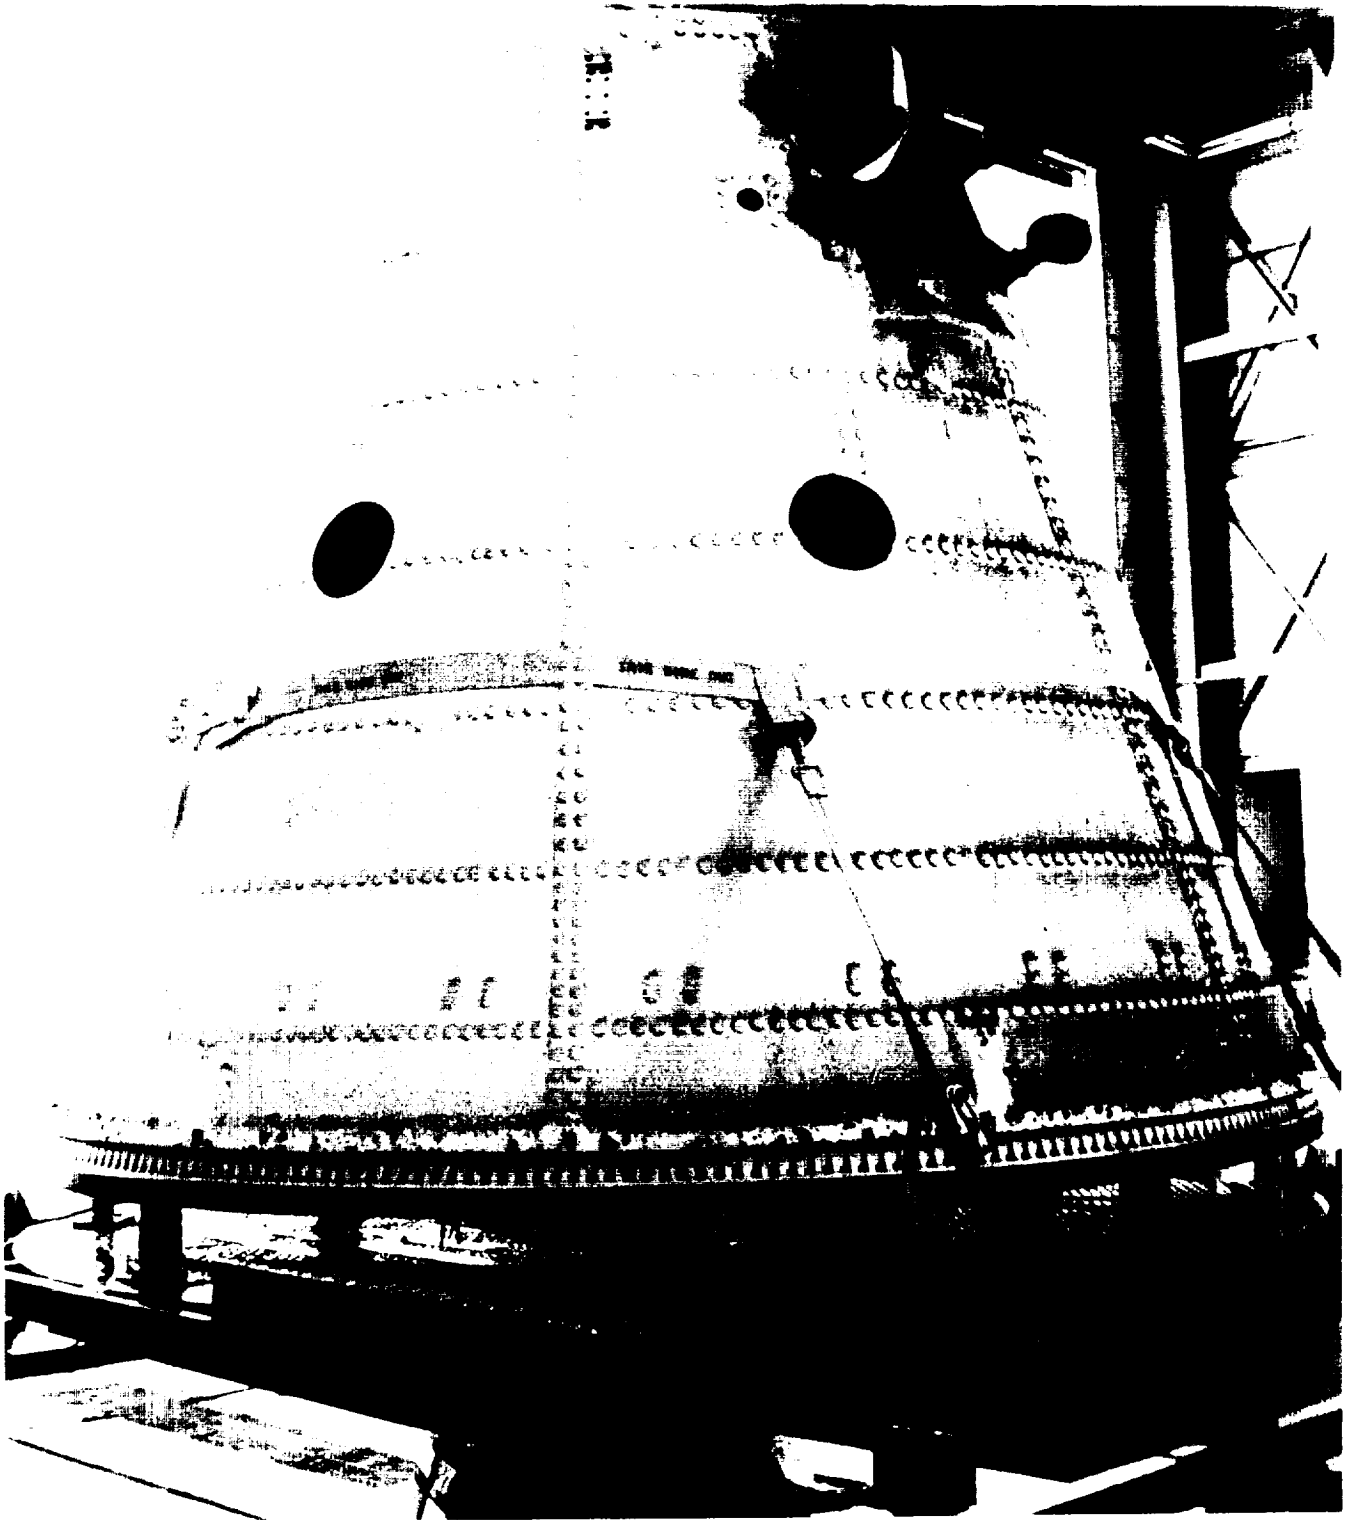
**Photo 17: LH Frustum**

The LH frustum was missing no TPS. The number of MSA-2 debonds over fasteners (20) was less than average. The BSM aero heat shield covers had locked in the fully opened position though the two right cover attach rings had been bent by parachute riser entanglement after splashdown.

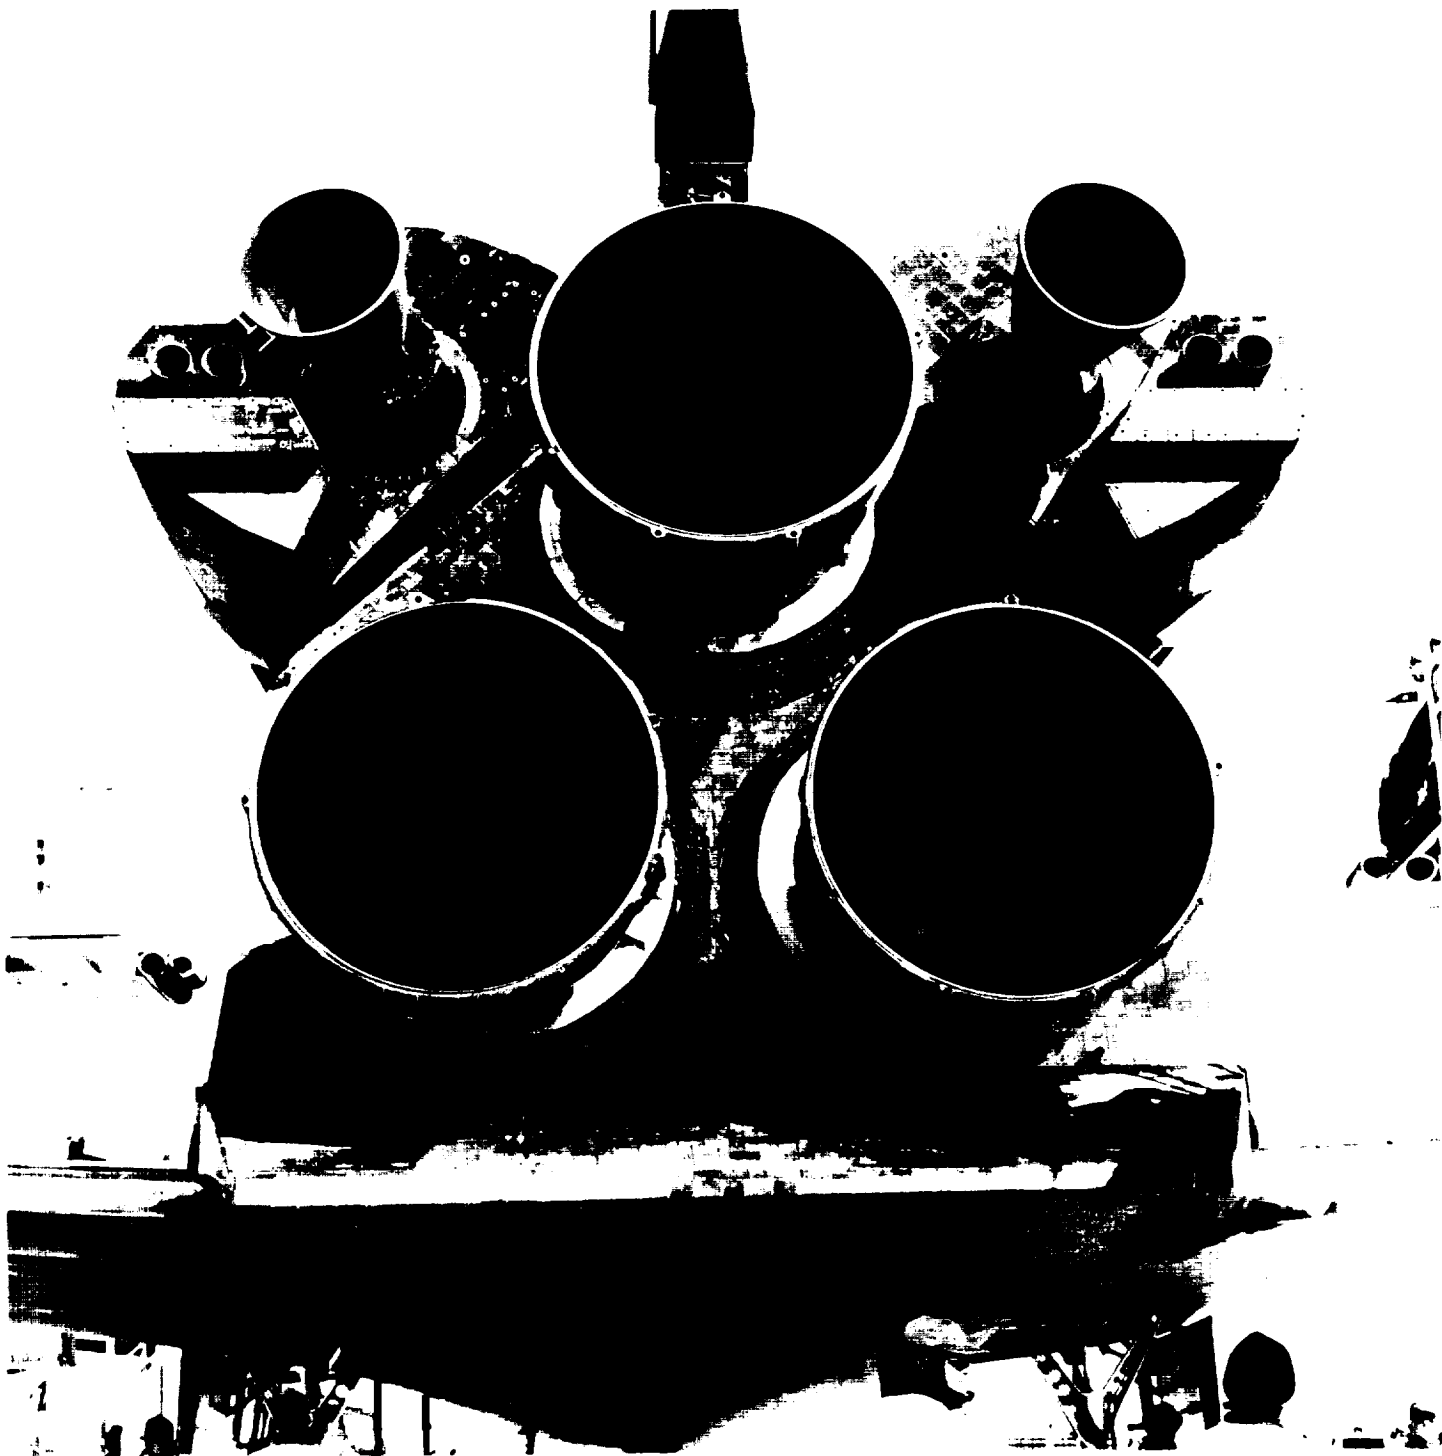
**Photo 23: Base Heat Shield/SSME's**

The SSME #1 and #2 Dome Mounted Heat Shield (DMHS) closeout blankets were unstitched or torn at the 6-7:00 o'clock and 3-5:00 o'clock locations, respectively. The SSME #3 DMHS was in excellent condition with no damaged material. Tiles on the vertical stabilizer "stinger" and around the drag chute door were intact and undamaged.

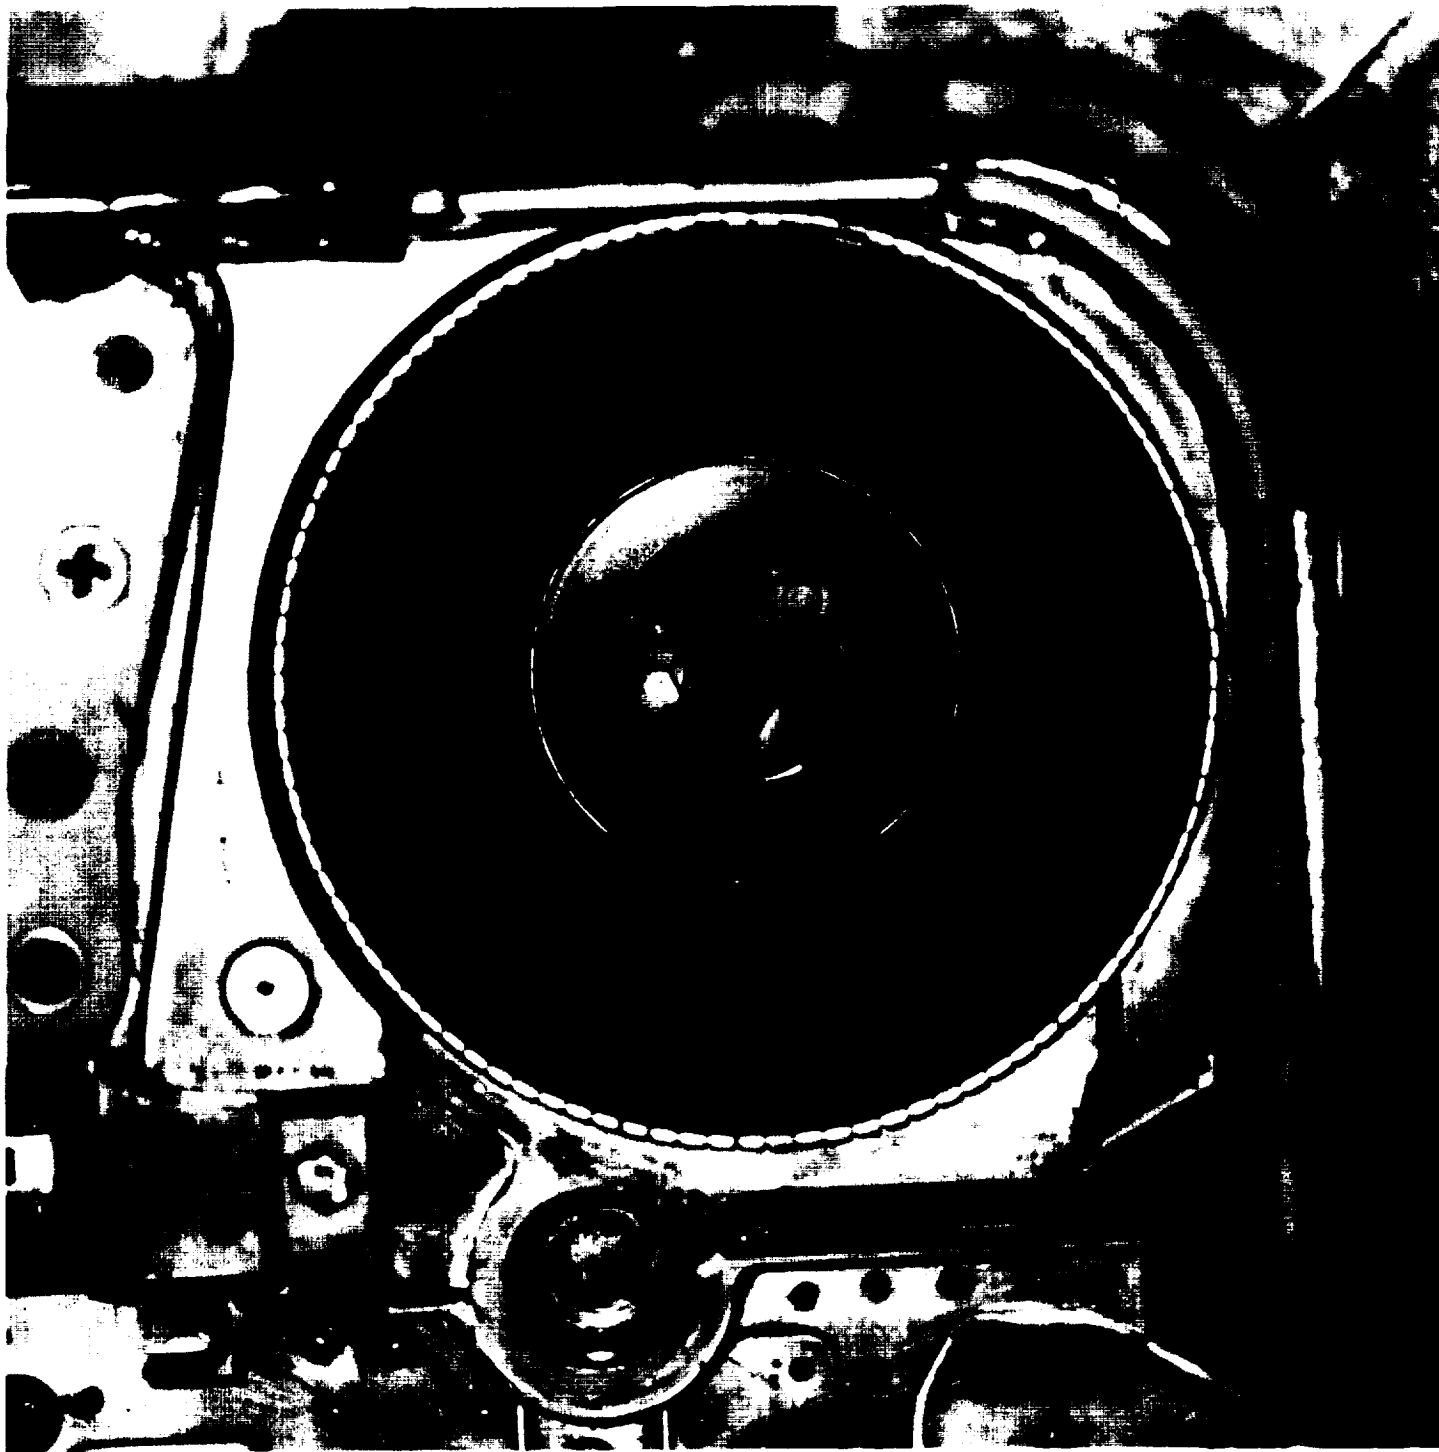
**Photo 26: EO-2 Debris Container Iris**

ET/Orbiter separation devices EO-1 and EO-3 functioned normally. The EO-2 debris container iris was obstructed and had not closed fully. No ordnance fragments were found on the runway beneath the umbilical cavities.

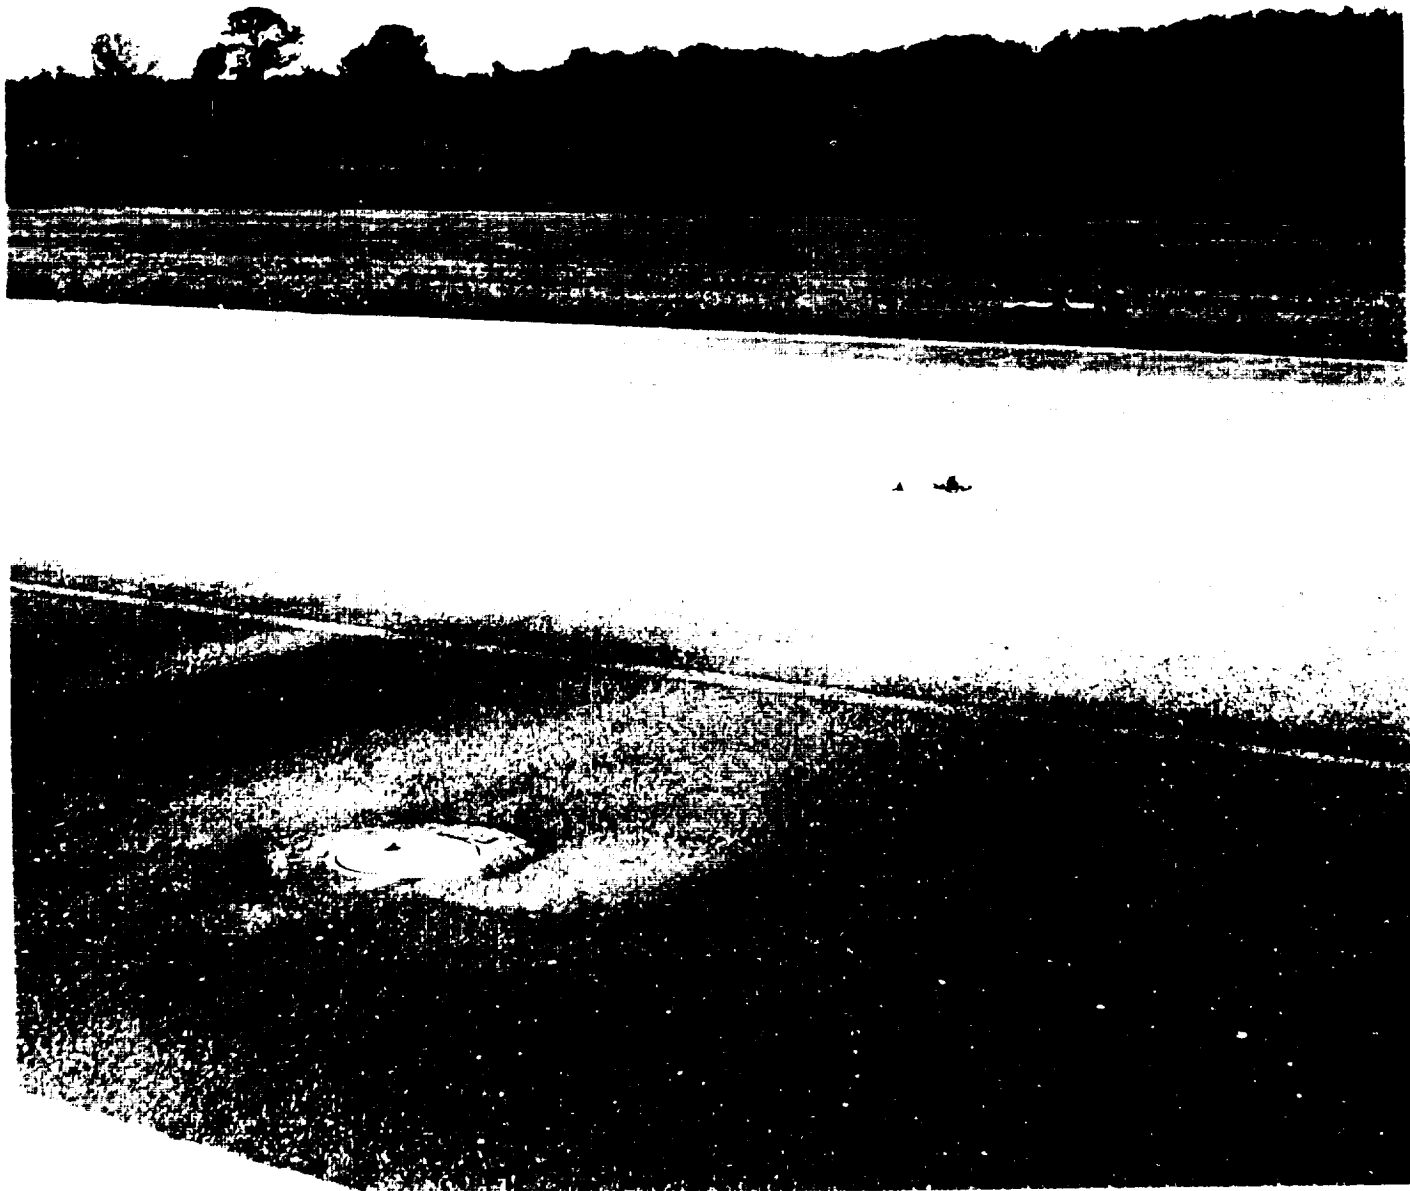
**Photo 31: Runway Light Damage**

All drag chute hardware was recovered and appeared to have functioned normally. The drag chute door had skidded along the runway and impacted a runway perimeter light. The major pieces of the light stanchion and lens were recovered.
