Mechanical Properties Degradation of Teflon® FEP Returned From the Hubble Space Telescope

Joyce A. Dever and Kim K. de Groh
Lewis Research Center, Cleveland, Ohio

Prepared for the
36th Aerospace Sciences Meeting & Exhibit
sponsored by the American Institute of Aeronautics and Astronautics
Reno, Nevada, January 12-15, 1998

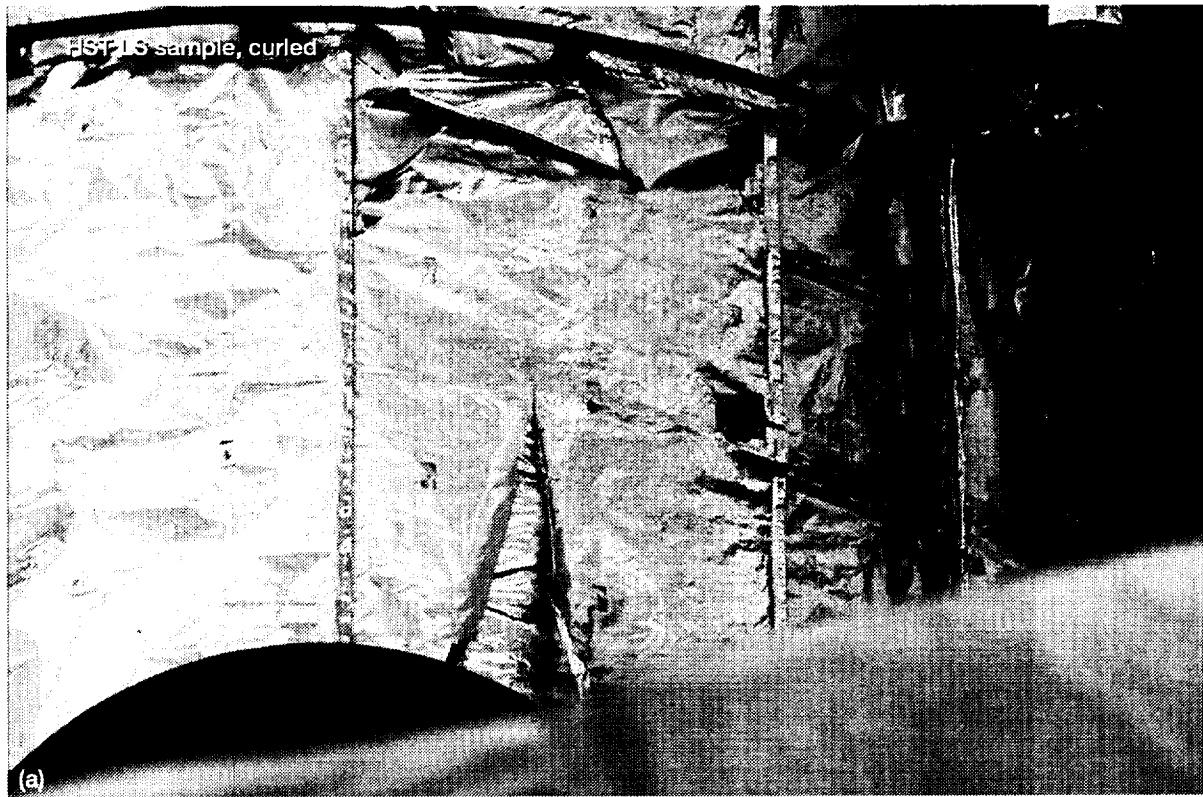
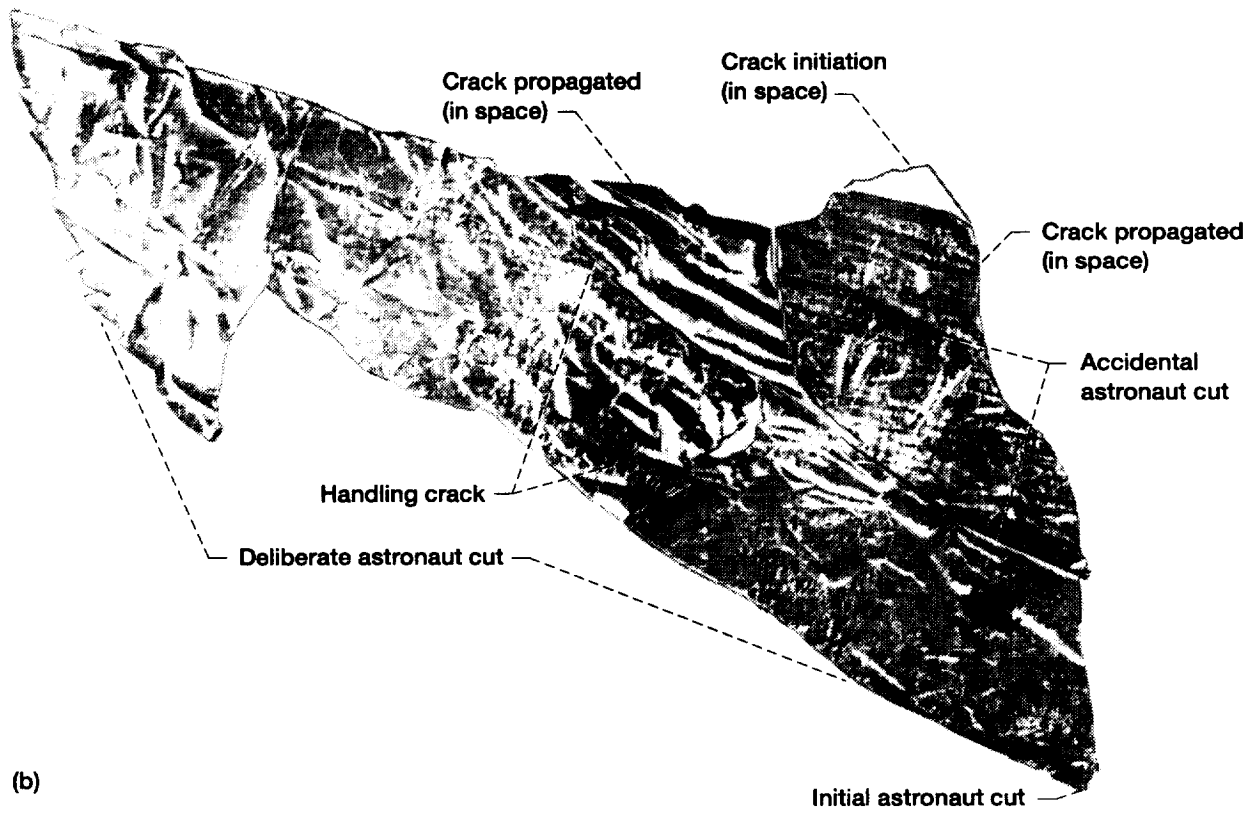
The two largest cracks in the HST LS MLI had 127 μm (0.005 in.) FEP/VDA MLI blanket patches installed over them during the SM2 mission. A small sample of the cracked MLI was trimmed off of the LS by astronauts during patch installation and was brought back to Earth for analysis. The cracked material (Fig. 2(a)) had curled, with the space-exposed FEP surface facing the inside of the roll, to a diameter of 1.5 cm (as measured after retrieval), indicating a volume shrinkage gradient. As evidence of its embrittlement, this specimen broke into several pieces as a result of handling during its return to Earth. Figure 2(a) shows the specimen on the HST LS prior to removal. Figure 2(b) shows the specimen reassembled following its return to Earth. Figure 2(b) identifies pre-launch and astronaut scissor cuts, crack initiation sites (where the blanket was cut to fit around a handrail stanchion), cracks that propagated in space, and subsequent handling cracks.

Figure 2.—HST SM2 Light Shield sample. (a) In place on the HST Light Shield prior to removal. (b) Photographs of pieces reassembled to show original configuration.

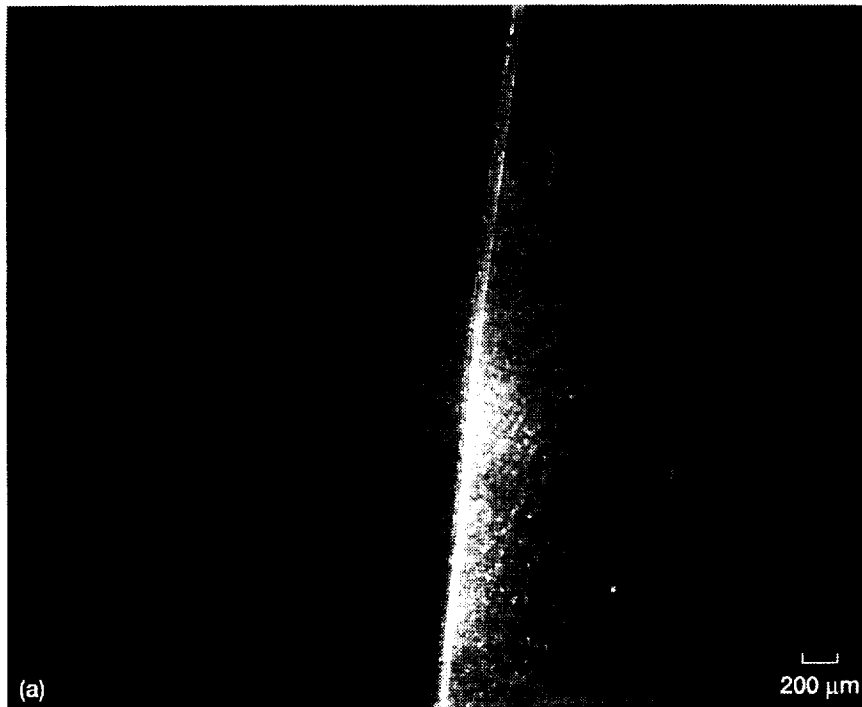
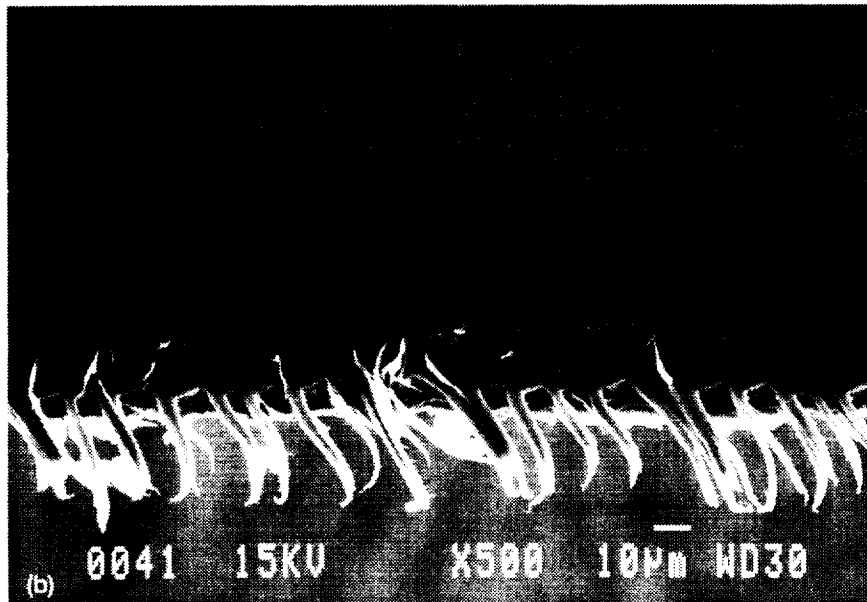
Each SM2 LS sample showed sudden formation of a single straight full-width crack due to bending around just one or two mandrels where there had been no previous sign of cracking. In each case, the crack formed was quite deep, leaving only a small amount of material holding the two halves of the bend-tested sample together. The SM2 LS fracture behavior is similar to that of brittle glass or ceramic materials where crack initiation is the critical stage of the fracture process. Once the crack is initiated, catastrophic fracture is inevitable, because energy absorbing processes such as plastic deformation, which would prevent crack propagation in ductile materials, do not occur. A single crack initiation site is typically observed. As shown in Table 2, cracking occurred at approximately 2 to 2.5 percent strain for SM2 LS samples. Figure 3(a) shows a photomicrograph of one of the cracks formed by bend testing the SM2 LS material. One SM2 LS bend-tested sample broke into two pieces due to handling. A scanning electron photomicrograph of the fracture surface of this sample, Figure 3(b), shows there are two distinct regions. The crack surface formed during bend-testing is the fibrous region, which accounts for approximately 80 percent of the fracture surface. The lower 20 percent of the fracture surface has long fibers of material extending from the fracture surface. These long fibers are probably the last remaining material which once held the bend-tested cracked sample together. Although it is likely that the degree of embrittlement in the SM2 LS material is a function of depth, these two distinct regions cannot be simply classified as embrittled and non-embrittled regions. The bending fracture mechanism is complicated by the fact that stress/strain will decrease after the crack is generated at the surface and continues to decrease as the crack propagates through the thickness of the specimen. Therefore, it is unlikely that the depth of the crack formed during bend testing is directly related to the depth of

Figure 3.—Crack in HST SM2 LS sample induced by bend-testing. (a) Photomicrograph of cracked surface. (b) Scanning electron photomicrograph of cross section of crack surface.

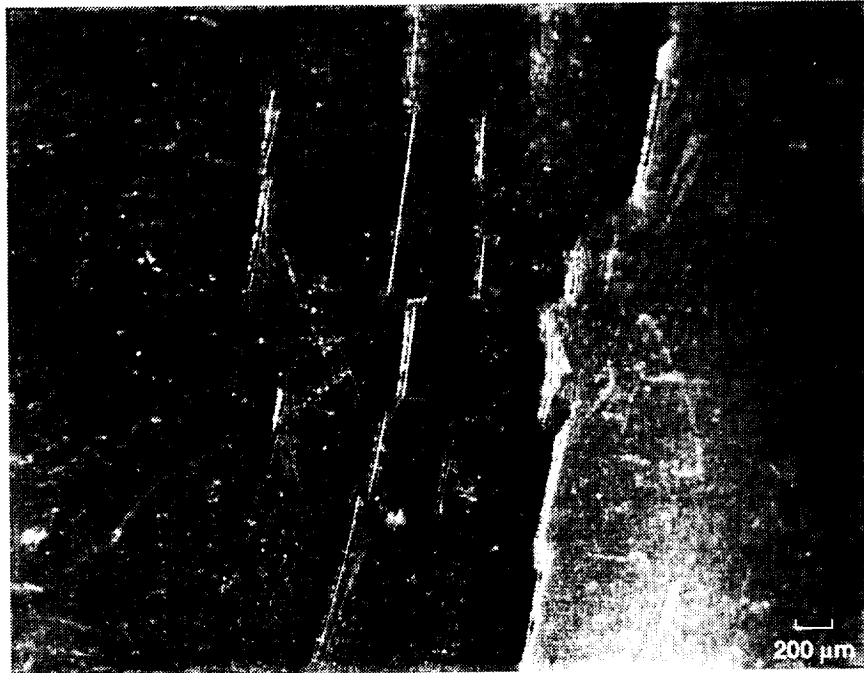
Results of bend testing of the SM1 MSS-A and MSS-D materials are also shown in Table 2. For these samples, hairline cracks due to handling already existed in the as-retrieved material. The data in Table 2 show the mandrel size and strain at which worsening of these existing cracks first occurred. Slight increases in length and width of existing cracks occurred as the material was bent around successively smaller mandrels. Although it was not measured, it is possible that depth of cracks also increased to some extent. However, bend-testing of these samples to the smallest mandrel did not result in deep catastrophic cracking as occurred with the SM2 LS material. Cracks formed in the SM1 MSS materials were much shallower than those formed in the SM2 LS material as evidenced by the structural integrity of the SM1 MSS bend-tested samples. Figure 4 shows an example of the jagged crack pattern as occurred in sample MSS-D.

Figure 4.—Photomicrograph of crack in HST SM1 MSS sample induced by bend-testing.

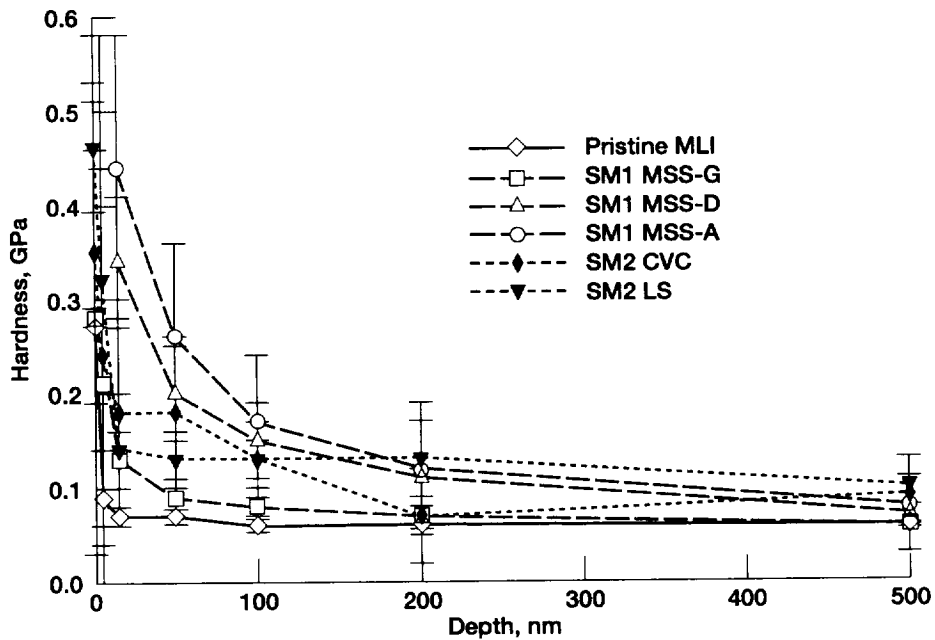
Table 4 and Fig. 5 show the results of the surface micro-hardness measurements. The legend of Fig. 5 shows sample labels in increasing order of solar exposure. The estimated exposure environment for each sample is described in Table 1. Evaluation and comparison of hardness among SM1 samples has been previously reported by de Groh et al.³ In general, the HST-exposed materials are harder at the surface, and hardness decreases with increasing depth into the material. According to the data in Table 4 and Fig. 5, at 500 nm depth all samples have similar hardness.

500 nm. Also based on the bend test and tensile test data, it was anticipated that the surface hardness would be greater for the SM2 LS material than for the SM2 CVC and SM1 MSS materials. However, this is not the case. At depths from the surface to 100nm, the SM1 materials generally show increasing hardness with increasing solar exposure; however, the SM2 LS material, which received much greater solar exposure than the SM1 materials, had surface hardness values similar to the lowest solar exposure SM1 material. Also, the SM2 CVC material which was more degraded in tensile strength and elongation than the SM1 MSS material has a surface hardness similar to the lowest solar exposure SM1 MSS material. The reasons for these discrepancies are not completely understood, but they may be related to different space environmental exposure levels or different levels of surface contamination. Such differences could significantly influence results of a surface analysis method. It is also possible that the damage necessary to cause degradation in bulk mechanical properties does not produce increased hardness in the material. It is evident that this surface analytical method is not as sensitive as tensile testing to quantitatively evaluate the significant differences in bulk embrittlement of these materials.

Figure 5.—Hardness of retrieved HST materials as a function of depth into the surface.
