NASA/TM-1998-206932

Technical Assessment of the National Full Scale Aerodynamic Complex Fan Blades Repair

January 1998

National Aeronautics and
Space Administration

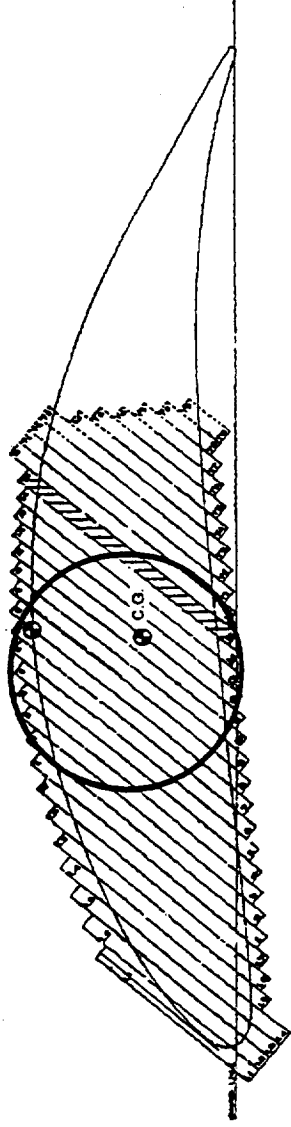
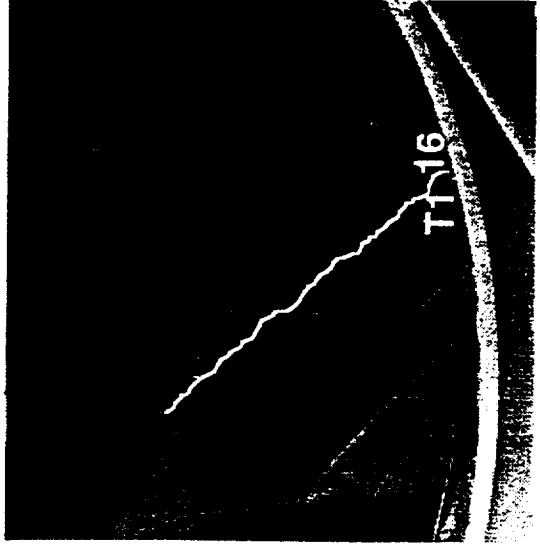
Figure 5. Physical evidence of cracking in root area of NFAC blade.

Recent cracking of the National Full Scale Aerodynamic Complex (NFAC) wooden fan blades has been attributed to higher mean loads and higher cyclic loads due to complex fan inflow disturbances. The blade configuration and material composition is shown in fig. 4. Hydulignum is a compressed material that is manufactured from birch veneers approximately 1/16 in. thick (ref.1). Hydulignum is a very dense material with tensile strengths up to 30 ksi in the grain direction. Sitka Spruce is a lighter wood with lower strength, but has long been the standard material used for wooden fan blades construction for NASA Wind Tunnels, see ref. 2. For the NFAC blades, the hydulignum laminates (pressed boards) indicated in fig. 5, are approximately 3/4 inch. thick. Physical evidence of cracking is illustrated in fig. 5. Based on diagnostic test data obtained in 1996, and utilizing full scale fatigue test data (ref. 1), all evidence and analyses indicate that the blade(s) cracked in the manner expected, and at about the operational hours expected. Because of fan inflow disturbances, the high. 1/Rev. blade dynamic loading is the main contributor to fatigue damage (i.e. cracking). Also, a 4/Rev. blade dynamic loading was found to be significant, and higher than expected. There is ample evidence that the close proximity of the first fundamental mode frequency to a strong 4/Rev. disturbance (see fig. 6 taken from ref. 3) has contributed to the higher than expected 4/Rev. cyclic loading.

- Cracking occurs in nearly identical locations in the root area
- Cracking typically confined to hydulignum laminates 15 and 16.
- Cracks remain within the laminate (as opposed to along the glue joint between laminates).

As a result of the fan blade cracking problem, repairs are being implemented for all of the fan blades in order to keep NFAC operating safely until a new replacement set can be designed and manufactured. The goal was to achieve the best repair possible. The present fan blade repair concept was formulated in 1996 and utilizes a carbon composite overwrap (glove) that is designed to transmit 30% of the mean (static) plus dynamic loads to the threaded metal cuff. The repair concept is illustrated in figure 7. The carbon fiber inner wrap (patch) illustrated in figure 7 is shown installed on the blade in the photo of figure 8. The metal cuffs are flange connected to blade retention shafts which are attached to the fan hub. Based on detailed structural analysis,

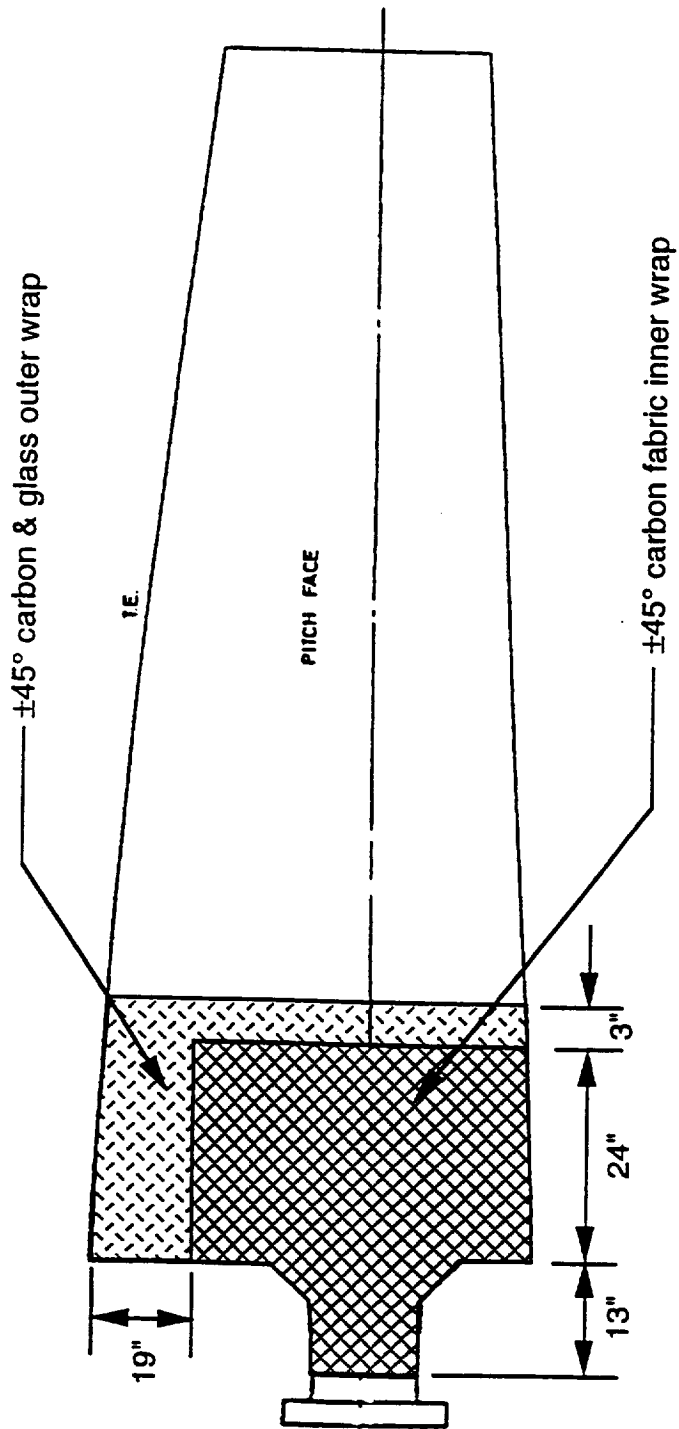
Figure 7. Fan blade assembly repair illustration.

An illustration of the repair design is given in figure 7. Photos of a repaired blade are provided as figures 8 and 9. The repair consists of a carbon composite patch that is tailored to transmit 30% of the peak loads (static + dynamic) to the exterior of the metal cuff. The patch is then overwrapped with carbon and fiberglass composite lay-ups around the blade root section and metal cuff. The loads are transmitted by shear through the bond between the blade and composite overwrap into the steel cuff. This unloads the blade by 30 percent in the highly stressed threaded root inside the metal cuff (fig. 4).

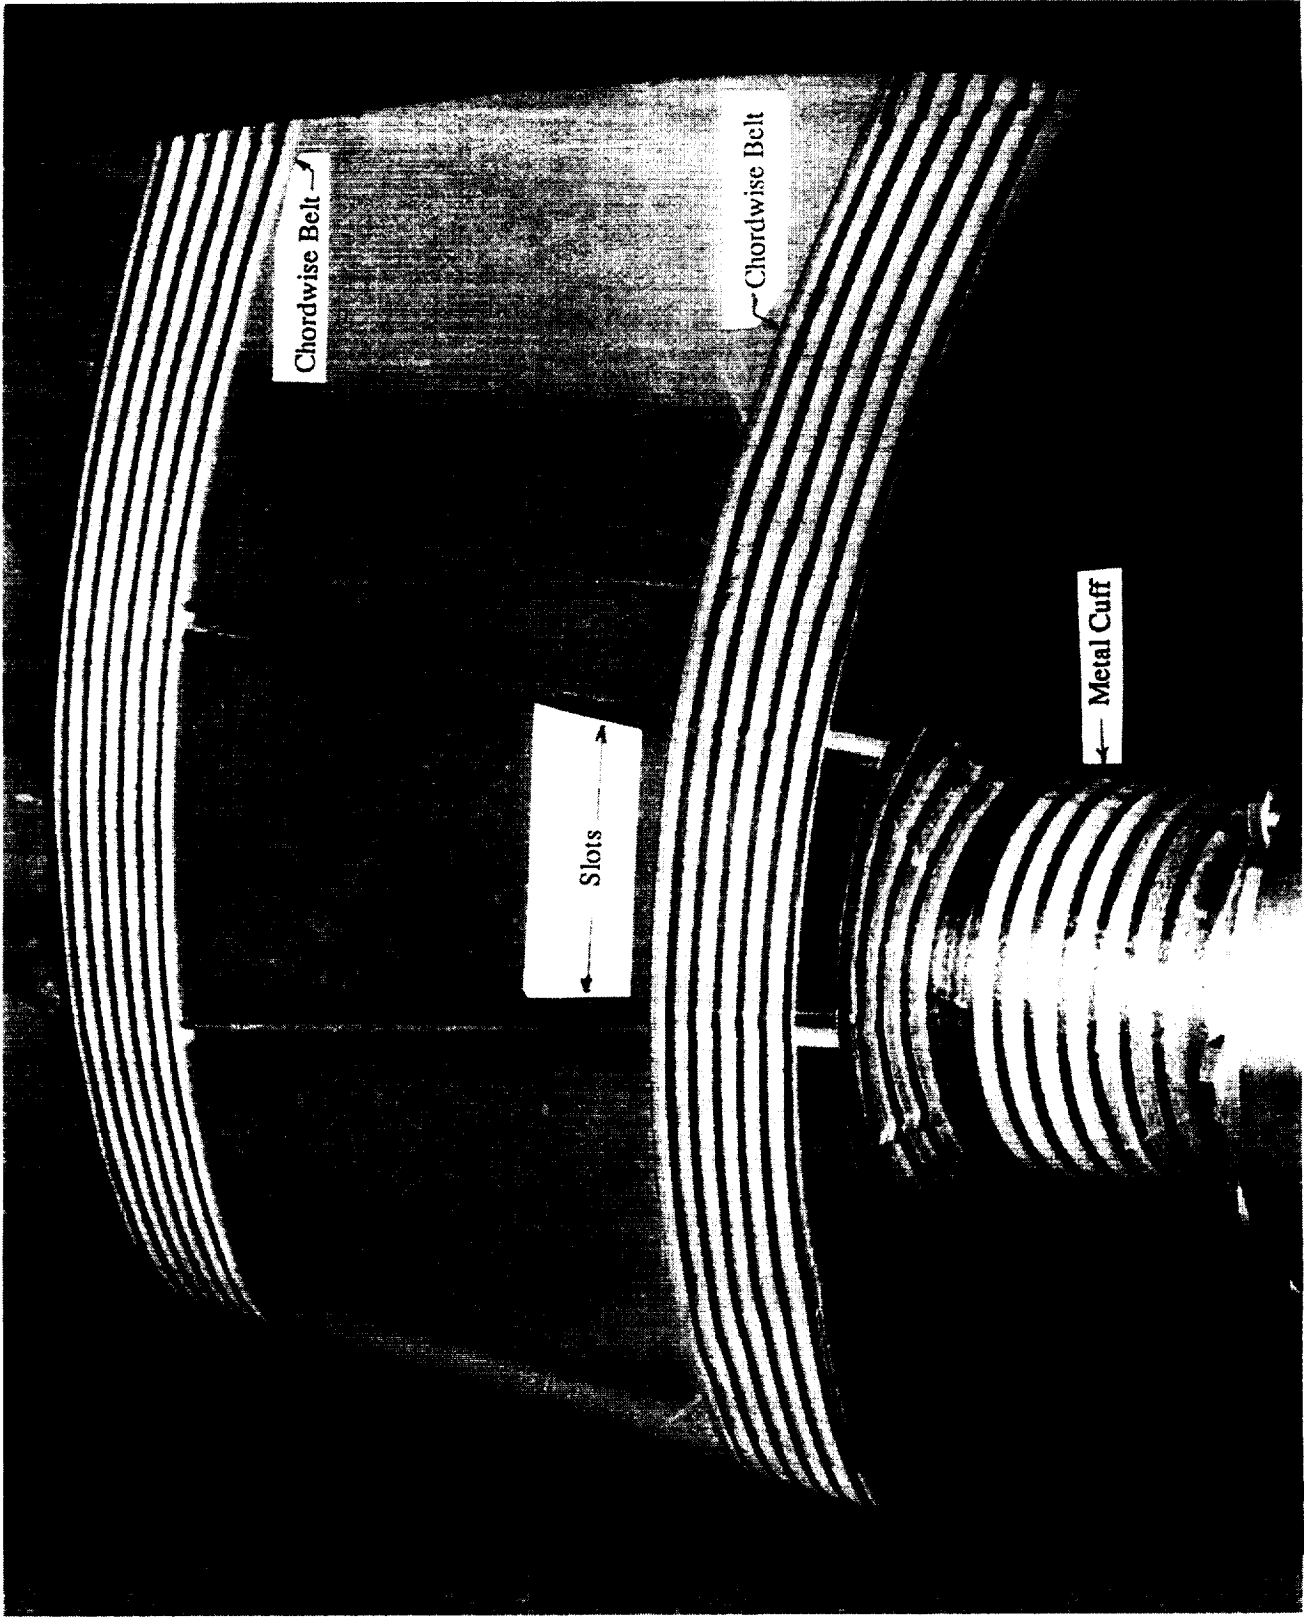
Figure 9. Photo of repaired blade upper surface illustrating overwrap of blade and metal cuff with chordwise.

Chordwise belts around the blade at the root and outboard edge of the lay up (see figures 9 and 10) were added to retard crack growth, provide transition and containment. A principal decision was the selection of an adhesive that would provide a strong bond between the composite material, the wooden blade and steel cuff. A Minnesota Mining and Manufacturing (3M) AF-126 film adhesive was selected for bonding the composite material to both the wood and steel. See the adhesive specification provided as Appendix A.

It should be noted that for the 3 prototype blades chordwise belt wraps, i.e. the root and outboard overwraps (see figures 9 and 10) were cured during the step 2 autoclave process. This is contrary to the review team recommendation that the chordwise belts be laid up after step 2 and cured at room temperature (or slightly elevated temperature) to avoid possible thermal constraint effects from the belts during the second step cure. The decision to do this by the Ames Project Team was based on poor quality lay-up results from the third step process using the testbed blade 120, and subsequent successful 2 step cure results on the three prototype blades.

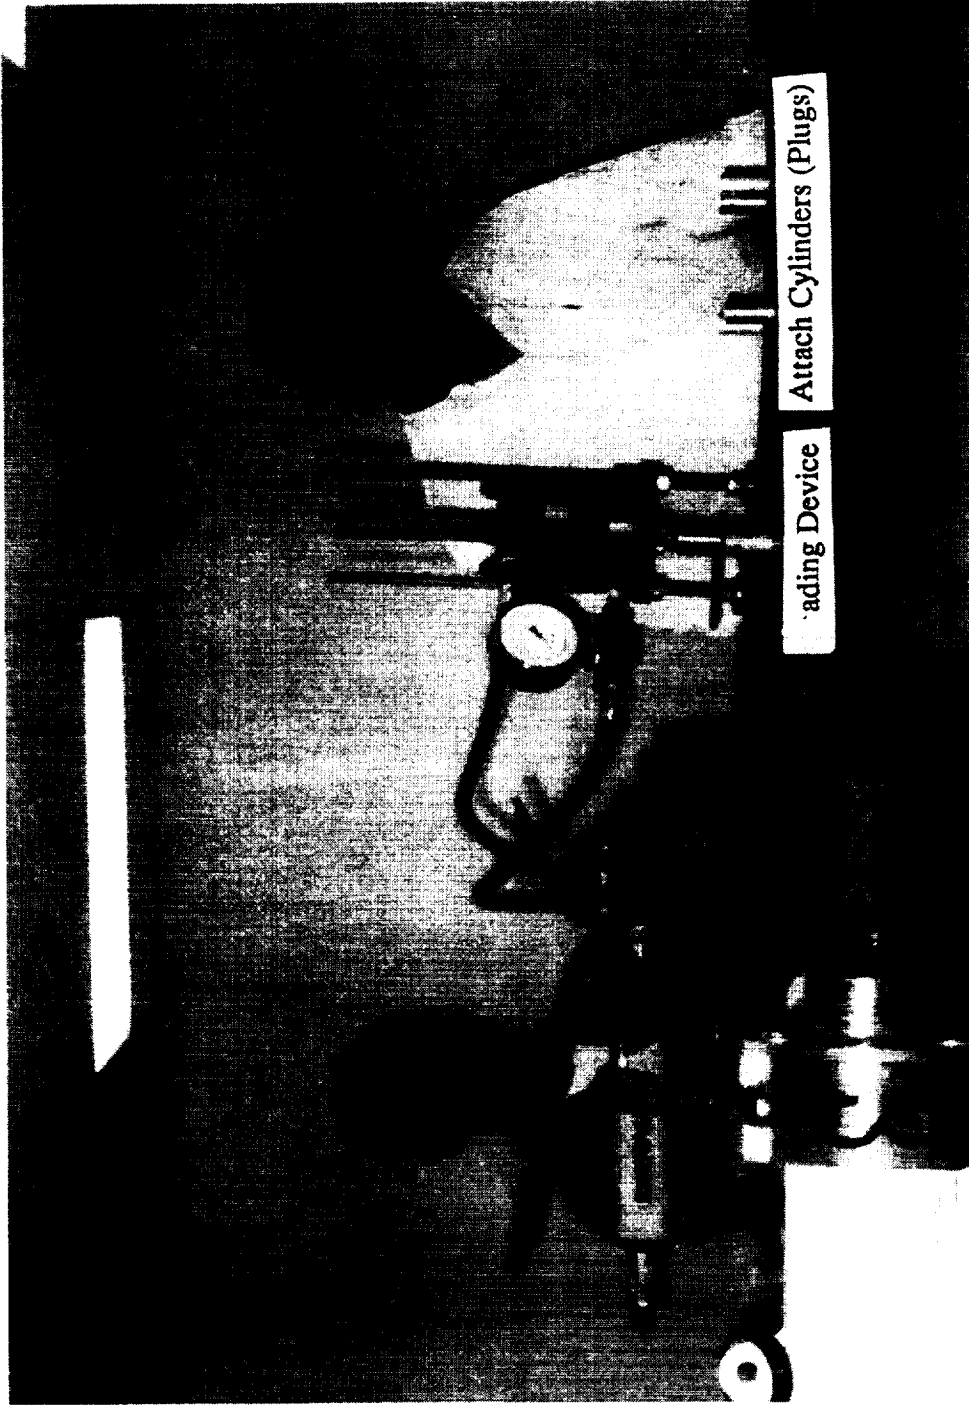
Figure 15. Photo of pull test rig installed on blade 120.

Three prototype blades were fabricated using the selected primer, comprised of resorcinol based Weldwood, with pin prick, 60 grit sanded surface and “fresh” adhesive. Pull tests (see fig. 15) were conducted on the adhesive layer at outboard stations on both surfaces of each of the three blades. These locations were selected so as to not compromise the integrity of the repair. The purpose of the pull tests on the 3 prototype blades was to verify that the bond strength values would be as good or better than those achieved on the full scale test bed (blade 120). Also the resorcinol-based Weldwood was used for this application so that bond strength verification was mandatory. Results of the prototype blade pull tests are provided in Table II. The Pull tests were conducted in the same manner as those conducted on the test bed blade No. 120. The flat tensile strengths results given in Table II are very good. Excluding the strength values in Table II, where the pull test was not normal to the blade surface, testing gave the following statistical strength values for the 3 prototype blades. The mean strength value is 1835 psi with a standard deviation of 297 psi or about 16% of the mean. Comparing the 3 prototype blades mean strength value with the mean strength value obtained for blade 120 in Table I for both the pin prick and UMF Weldwood with 60 grit finish gave a difference of about 8% based on blade 120 mean value. The prototype pull test results obtained after the first step cure were judged to be acceptable. The 3 prototype blade repairs were then laid up and cured in the autoclave (step 2).

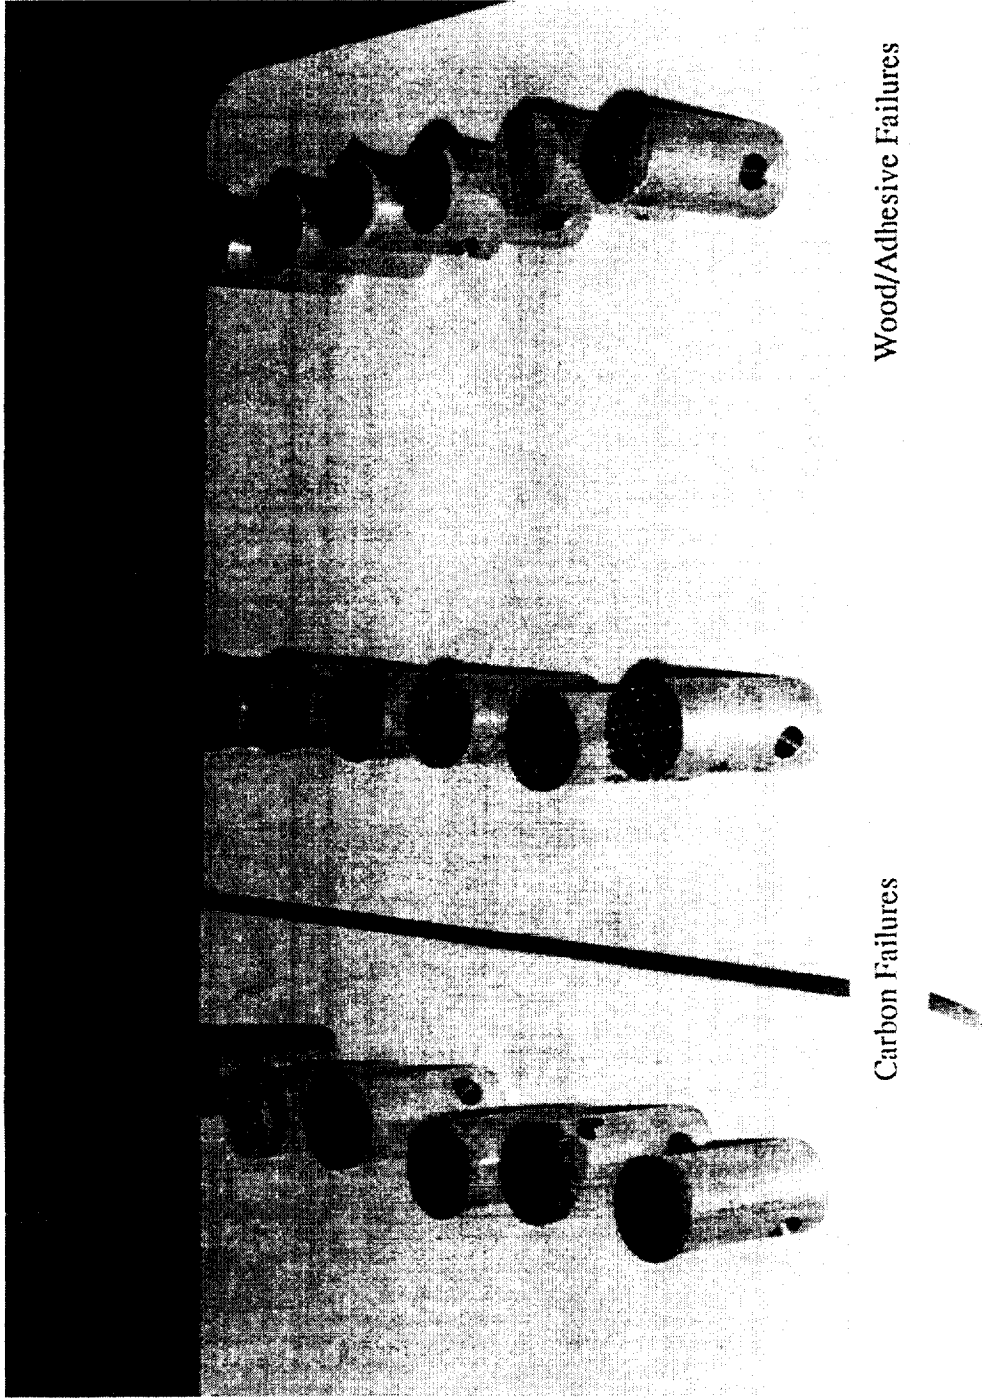
Figure 16. Photo illustrating pull test plugs from blade 120 test bed.

After the second step cure, pull tests were conducted on the composite overwrap (metal cylinders shown in first and second rows of figure 16) and the adhesive layer (third row of figure 16). These tests were witnessed by members of the technical review team in early July, 1997. Failures in the carbon laminate occurred as expected (see Table I). The adhesive layer bond strengths given in Table I, after step 2 were basically the same as those bond strengths obtained after the first step cure.

Upon review of the pull test results, it was found that the Weldwood primer used by the fabricator was not resorcinol based but was urea-melamine-formaldehyde (UMF) based and contained chlorine. Chlorine is harmful to wood when the bond line is exposed to heat or loads for a long period of time, and is also corrosive to metal. As a result, the use of this off-the-shelf product as a primer raised the question of durability. The decision was made to use a resorcinol based Weldwood as a primer, since this product is commonly used as an adhesive for wooden fan blades, and should have as good or better strength properties than the UMF based Weldwood. The optimum surface primer selected was to use a 60 grit finish with pin prick, plus resorcinol based Weldwood for the prototype and production blades.
