ENGINE OPERATING CONDITIONS THAT CAUSE THERMAL-
FATIGUE CRACKS IN TURBOJET-ENGINE BUCKETS

By James R. Johnston, John W. Weeton, and Robert A. Signorelli

Lewis Research Center
Cleveland, Ohio

MEMORANDUM 4-7-59E

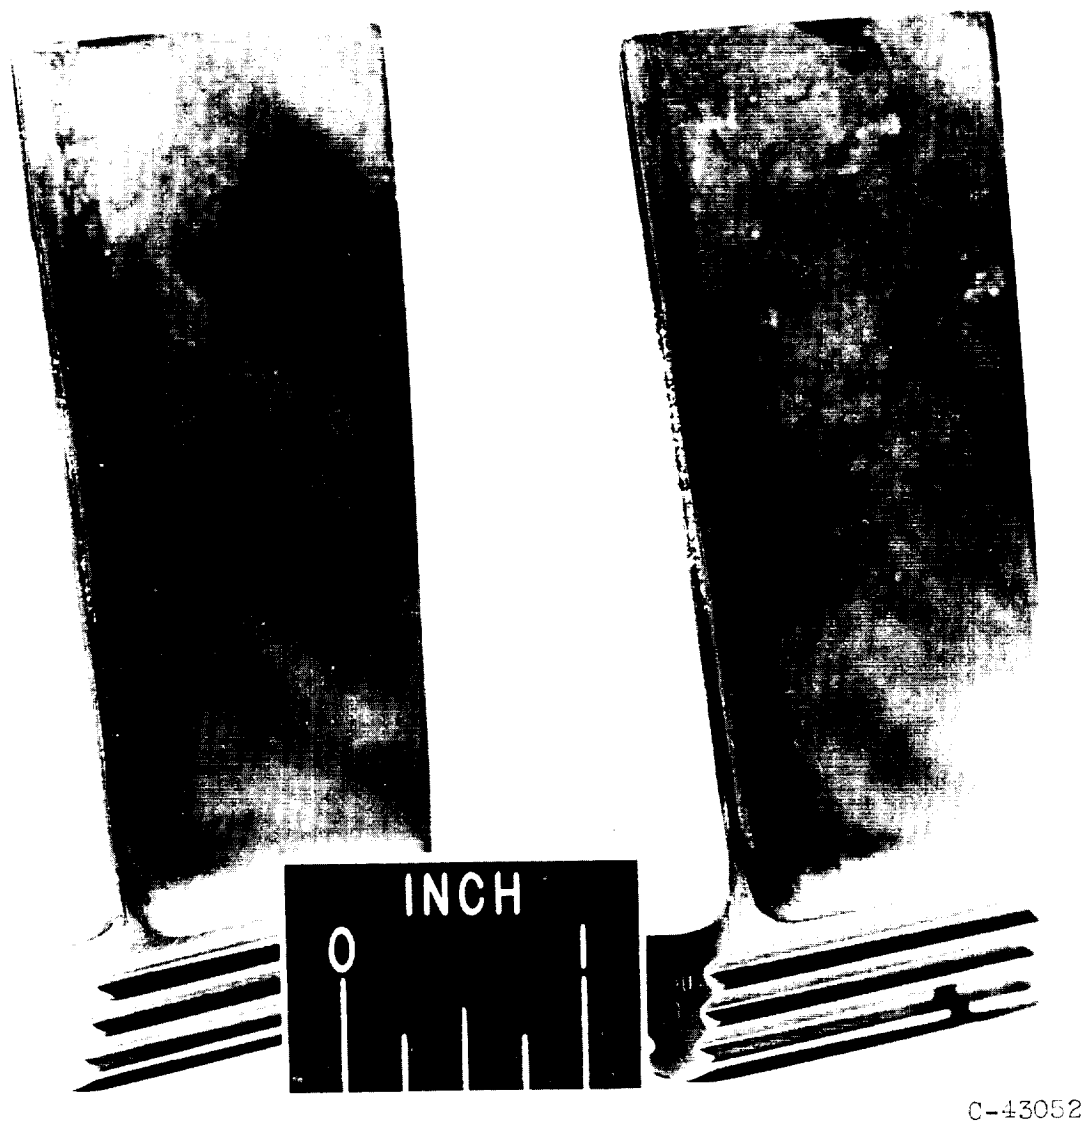
(a) Inspection, 115 starts.

During the normal-start - stop test, cracks were first observed in the M-252 buckets at 85 cycles and in the S-816 buckets at 295 cycles. At the end of the test (425 cycles), 84 percent of the M-252 buckets and about 9 percent of S-816 buckets were cracked. A series of photographs was taken (figs. 3(a), (b), and (c)) of a typical group of M-252 buckets to indicate the type of cracks observed and to show the extent of crack propagation. In general, the cracks in M-252 propagated gradually to an appreciable depth; the maximum depth of the deeper cracks was $1/8$ inch. The cracks in S-816 were less severe, usually about $1/32$ inch or less in depth. Many cracks propagated to their maximum depth relatively early in the test.

Figure 3. - Progression of cracks in M-252 buckets during start-stop test.

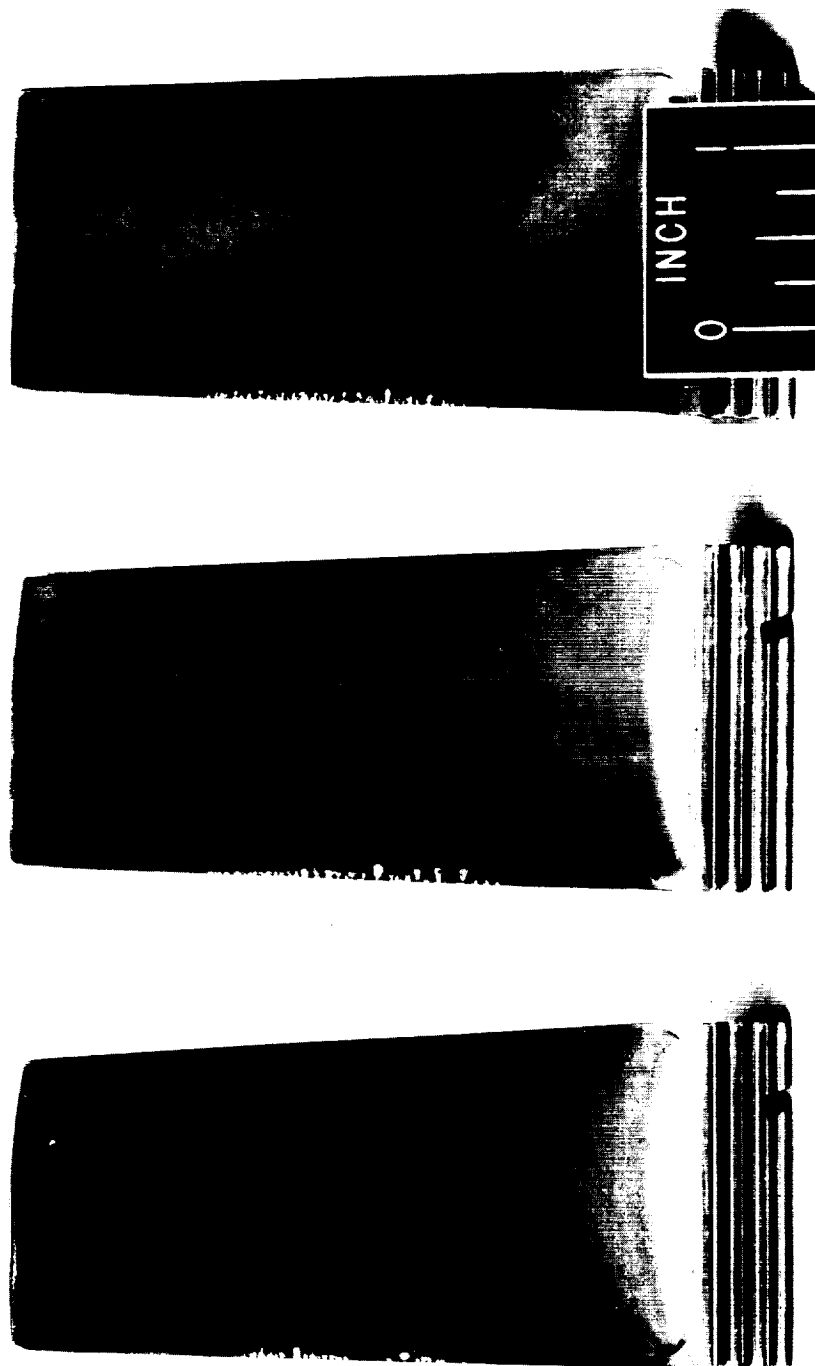
(b) Inspection, 205 starts.

Figure 3. - Continued. Progression of cracks in M-252 buckets during start-stop test.

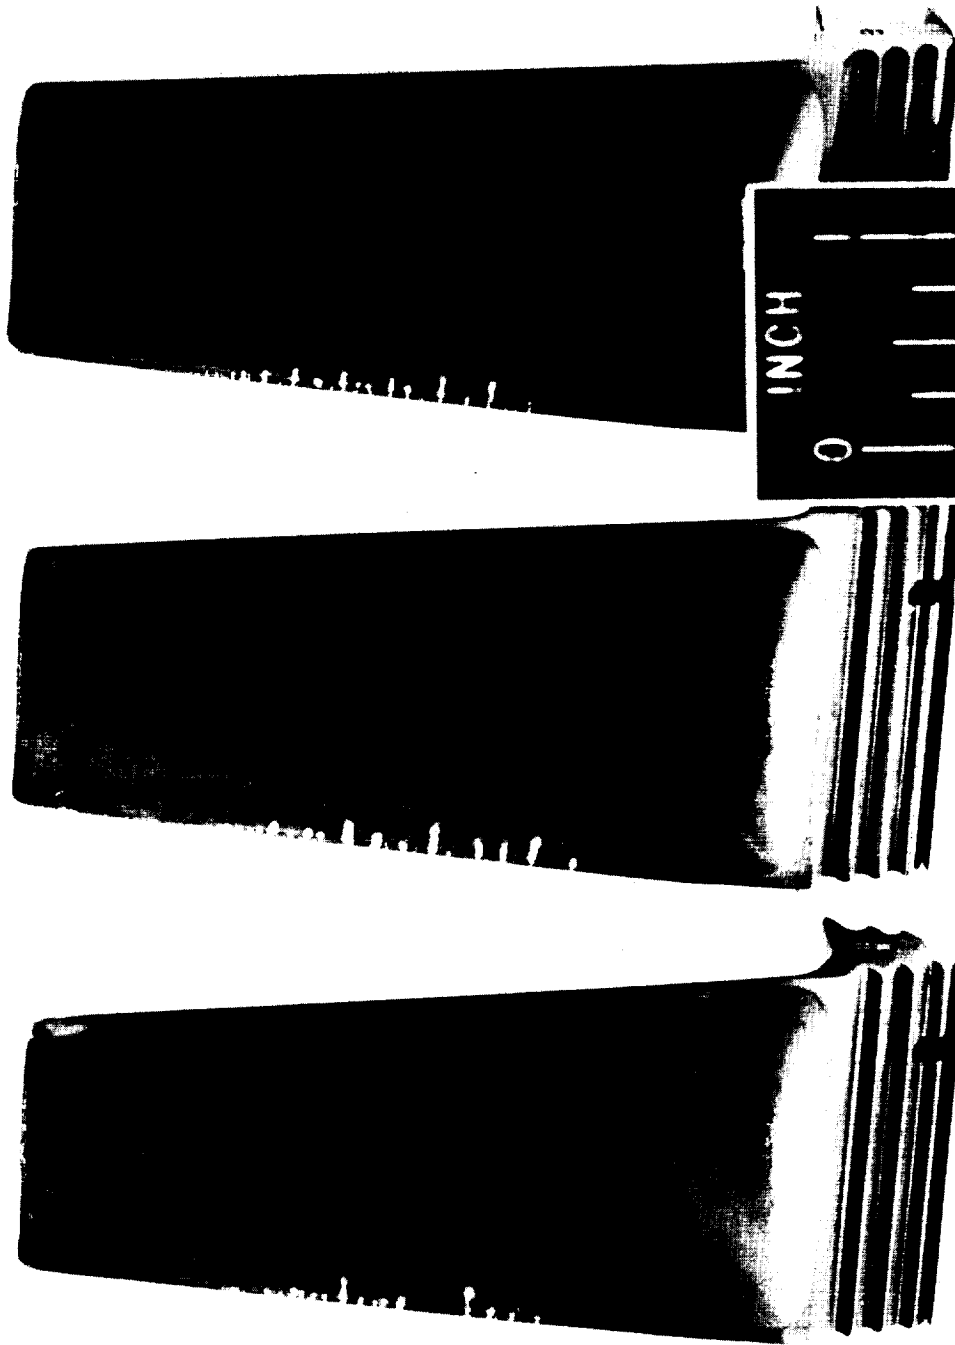
(c) Inspection, 425 starts.

Figure 3. - Concluded. Progression of cracks in M-252 buckets during start-stop test.

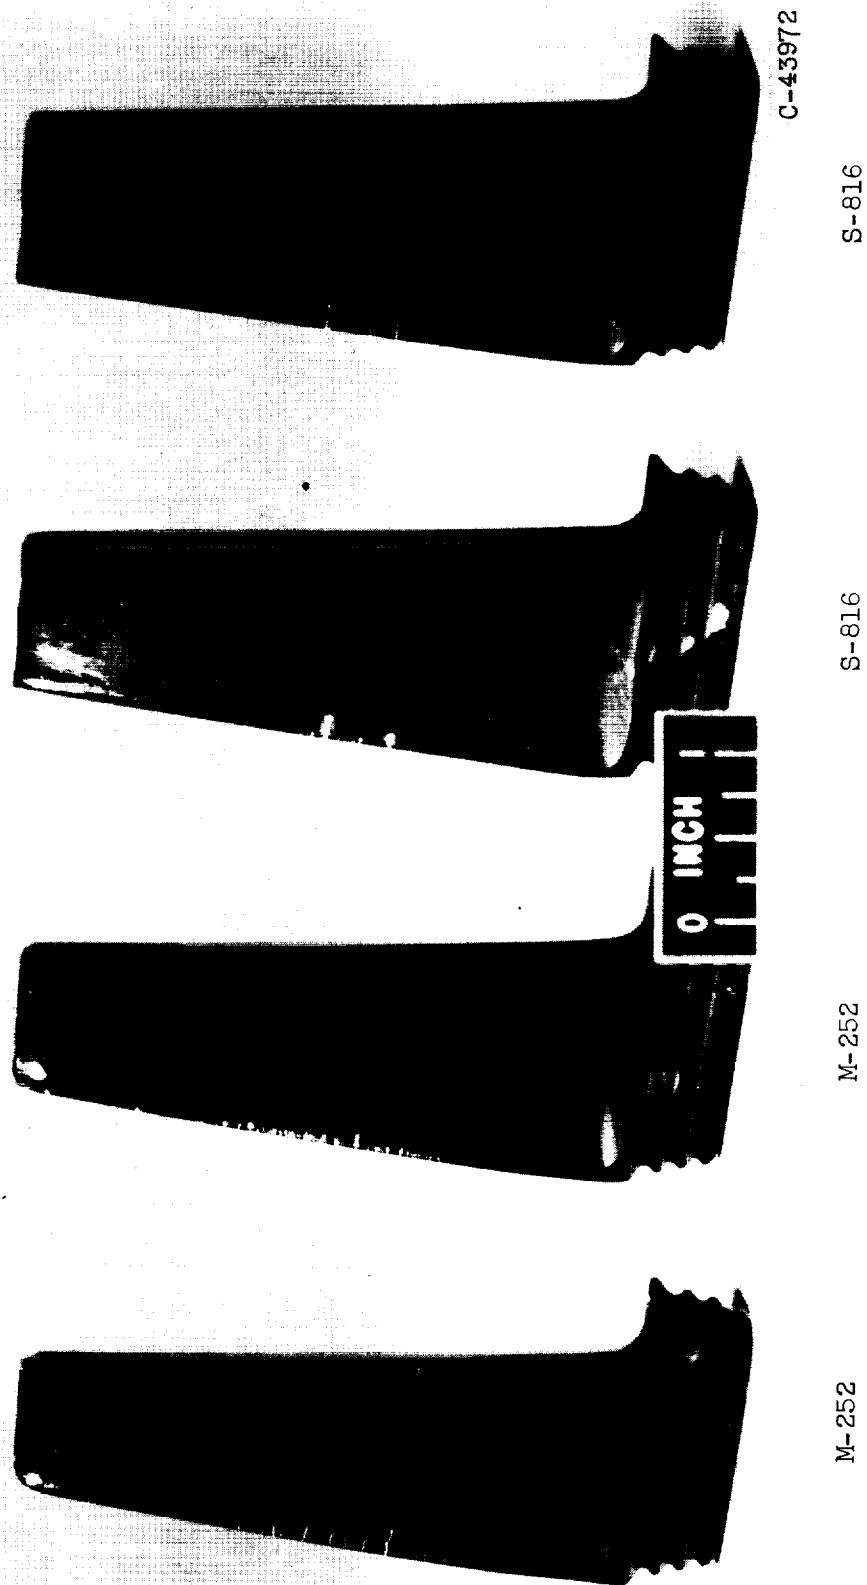
(a) Inspection, 100 starts, 25 hours.

During the start - rated-speed - stop test (in which 15 min of rated-speed operation were added to each start-stop cycle), cracks were first noted in the M-252 buckets at 40 cycles and in the S-816 buckets at 63 cycles. At the end of the test (200 cycles and 50 hr at rated speed), cracks were observed in 76 percent and 32 percent of the M-252 and the S-816 buckets, respectively. Figure 4 shows the leading-edge cracking in typical M-252 and S-816 buckets during this test. The maximum depth of crack propagation was $3/8$ inch in the M-252 and $1/2$ inch in the S-816 buckets. These deep cracks were not typical of all the buckets. The average maximum crack depth for all the cracked buckets in this test was about $3/32$ inch for M-252 and about $1/8$ inch in S-816. None of the cracks propagated to complete fracture.

Figure 4. - Progression of cracks in M-252 and S-816 buckets during start - rated-speed - stop test.

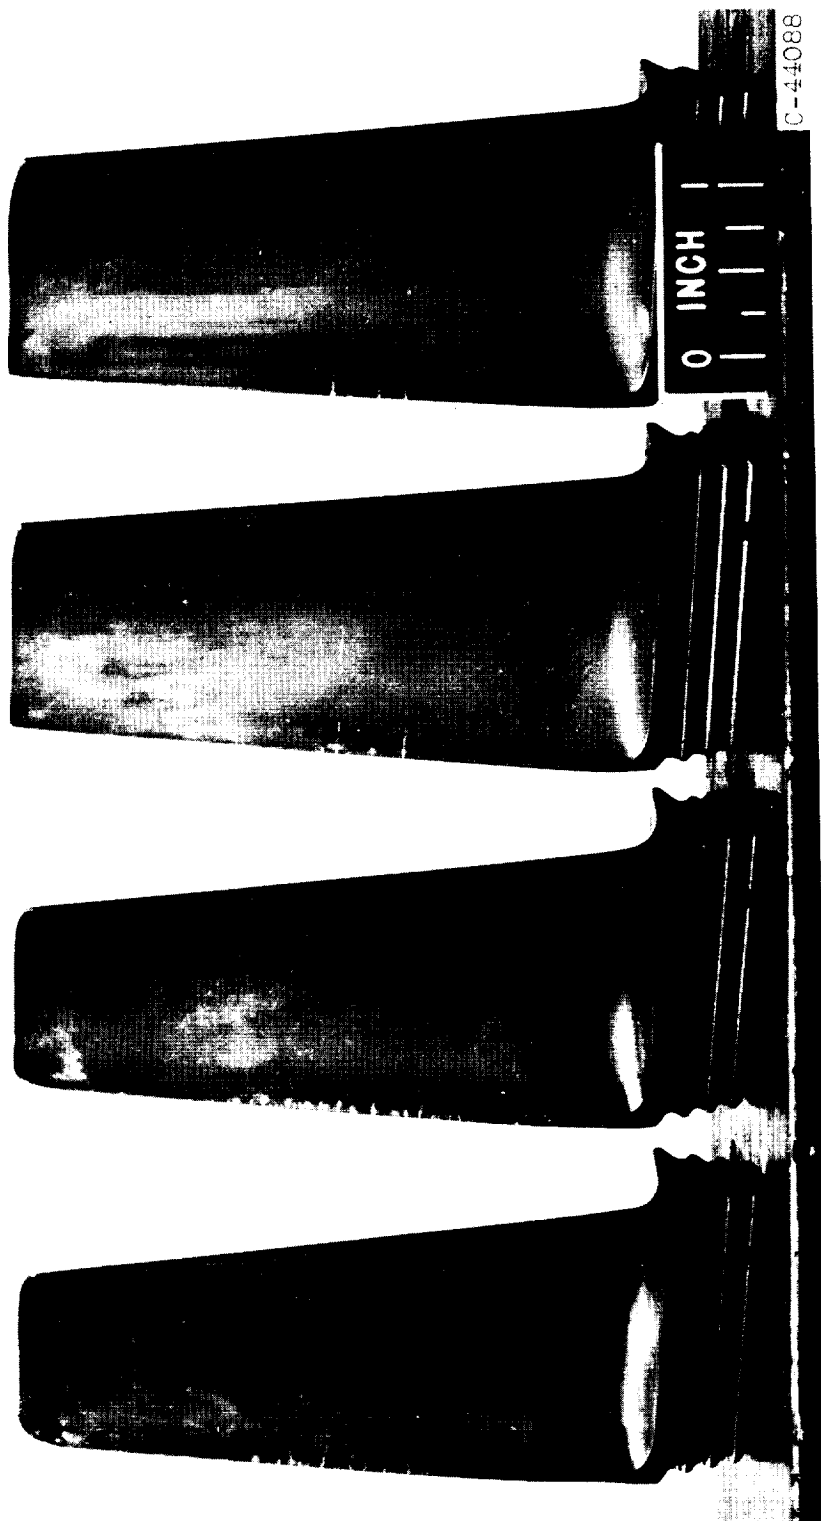
(b) Inspection, 200 starts, 50 hours.

Figure 4. - Concluded. Progression of cracks in M-252 and S-816 buckets during start - rated-speed - stop test.

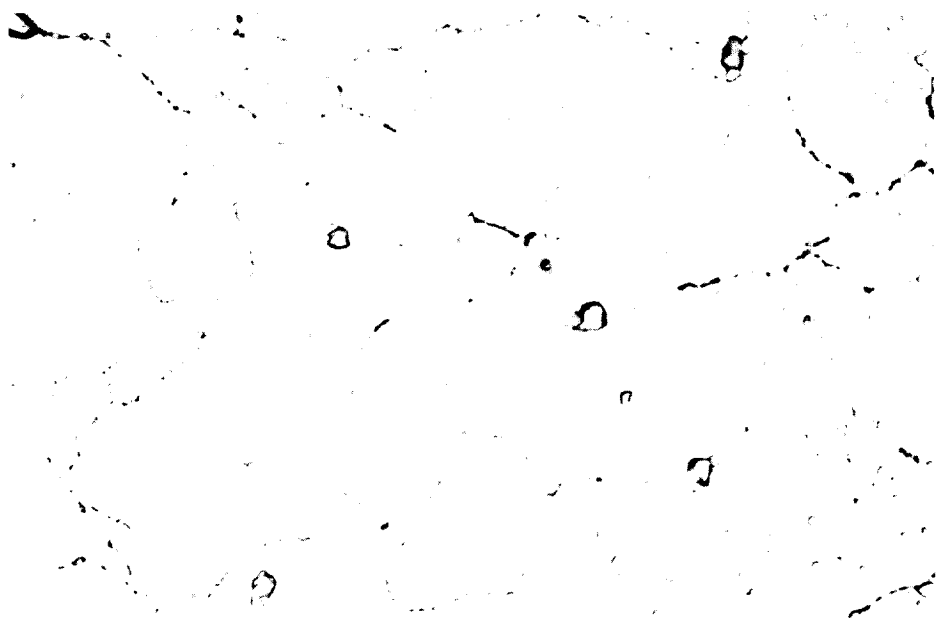
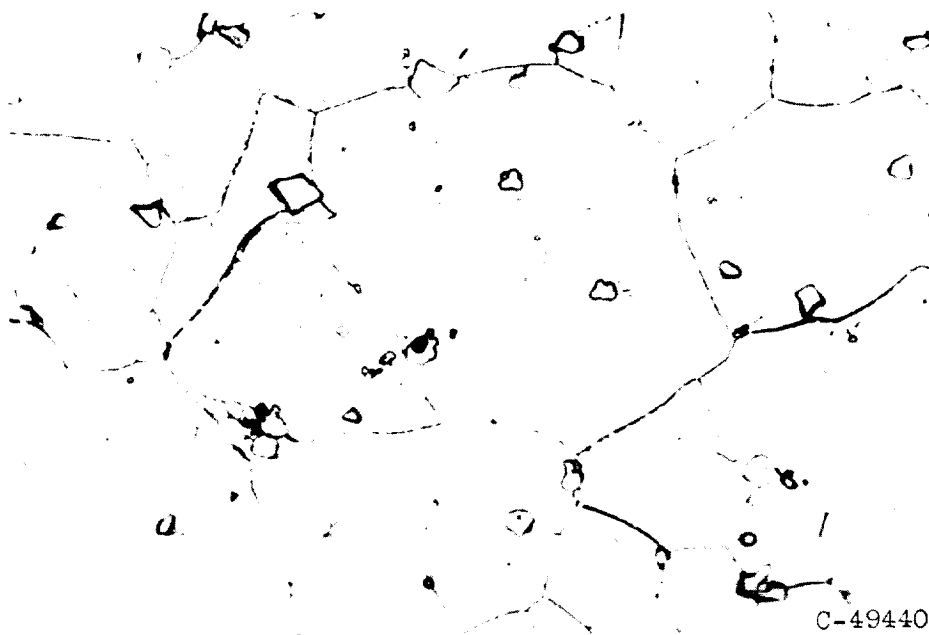
(a) Cycle: start, 5 minutes at idle, and stop.

run in the start-stop test (fig. 6(a)) exhibit agglomeration and spheroidization of grain boundary precipitates, but the hyphenation of grain boundaries is more pronounced in M-252. The S-816 bucket indicates a slight tendency to form precipitation along slip lines. Figure 6(b) shows the microstructure of cracked buckets after operation in the engine test in which 15 minutes of rated time were added to each start-stop cycle. In the case of M-252, the microstructure is not greatly different from that of the bucket from the start-stop test, but there appears to be slightly more matrix precipitation along residual grain boundaries. The microstructure of the S-816 bucket from the start - rated-speed - stop test contains definite evidence of overaging. In addition to the grain boundary hyphenation, there is considerable matrix precipitation, especially along slip lines.

Figure 6. - Microstructures of buckets after engine testing. X750.

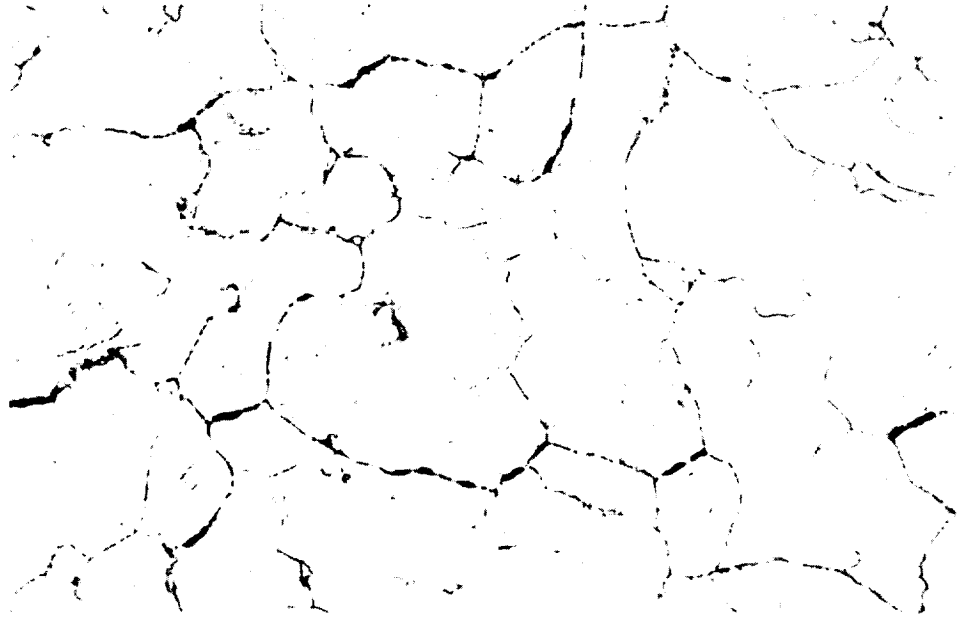
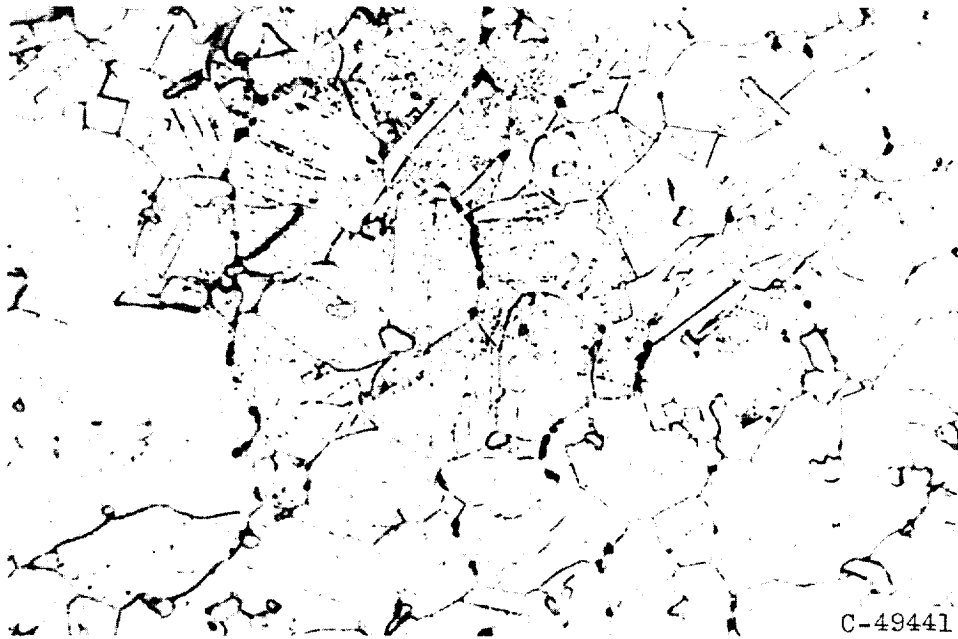
(b) Cycle: start, 15 minutes at rated speed, and stop.

Buckets of both M-252 and S-816 from the start - rated-speed - stop test contained clusters of voids along the grain boundaries in areas close to the leading edge. Some of these voids are apparent in the photomicrographs of figure 6(b). There was no significant evidence of voids in either alloy operated in the start-stop engine test.

The hypothesis of localized creep damage at the leading edge is supported by the appearance of voids in the grain boundaries (fig. 6(b)) of buckets run in the start - rated-speed - stop test. These voids are sometimes noted in rupture specimens (ref. 4) and are considered to be evidence of third-stage creep. Similar voids also have been noted in buckets which failed by a similar mechanism in other engine tests (ref. 5). Since the voids occur only in the areas close to the leading edge where the high thermal stresses are induced during starts, it seems reasonable to associate the creep damage with the stresses that arise as a result of engine starts.

There is some evidence that microstructural changes aside from creep damage may also have contributed to the earlier cracking of the buckets run in the start - rated-speed - stop test. As noted in the results, the photomicrographs in figure 6(b) indicate a more advanced state of aging than was evident in the buckets from the start-stop test (fig. 6(a)). In the case of S-816, the structure appears definitely overaged. The evidence of overaging is not apparent in the M-252 structure, but it is possible that there were submicroscopic effects in M-252 involving precipitation of intermetallic compounds. It is possible that overaging caused some embrittlement of the bucket materials (run in the start - rated-speed - stop test) and reduced their resistance to failure by thermal fatigue.

Figure 6. - Concluded. Microstructures of buckets after engine testing. X750.
