RESULTS OF A CYCLIC LOAD TEST OF AN RB-47E AIRPLANE

By Wilber B. Huston

Langley Research Center

MEMORANDUM 3-15-59L

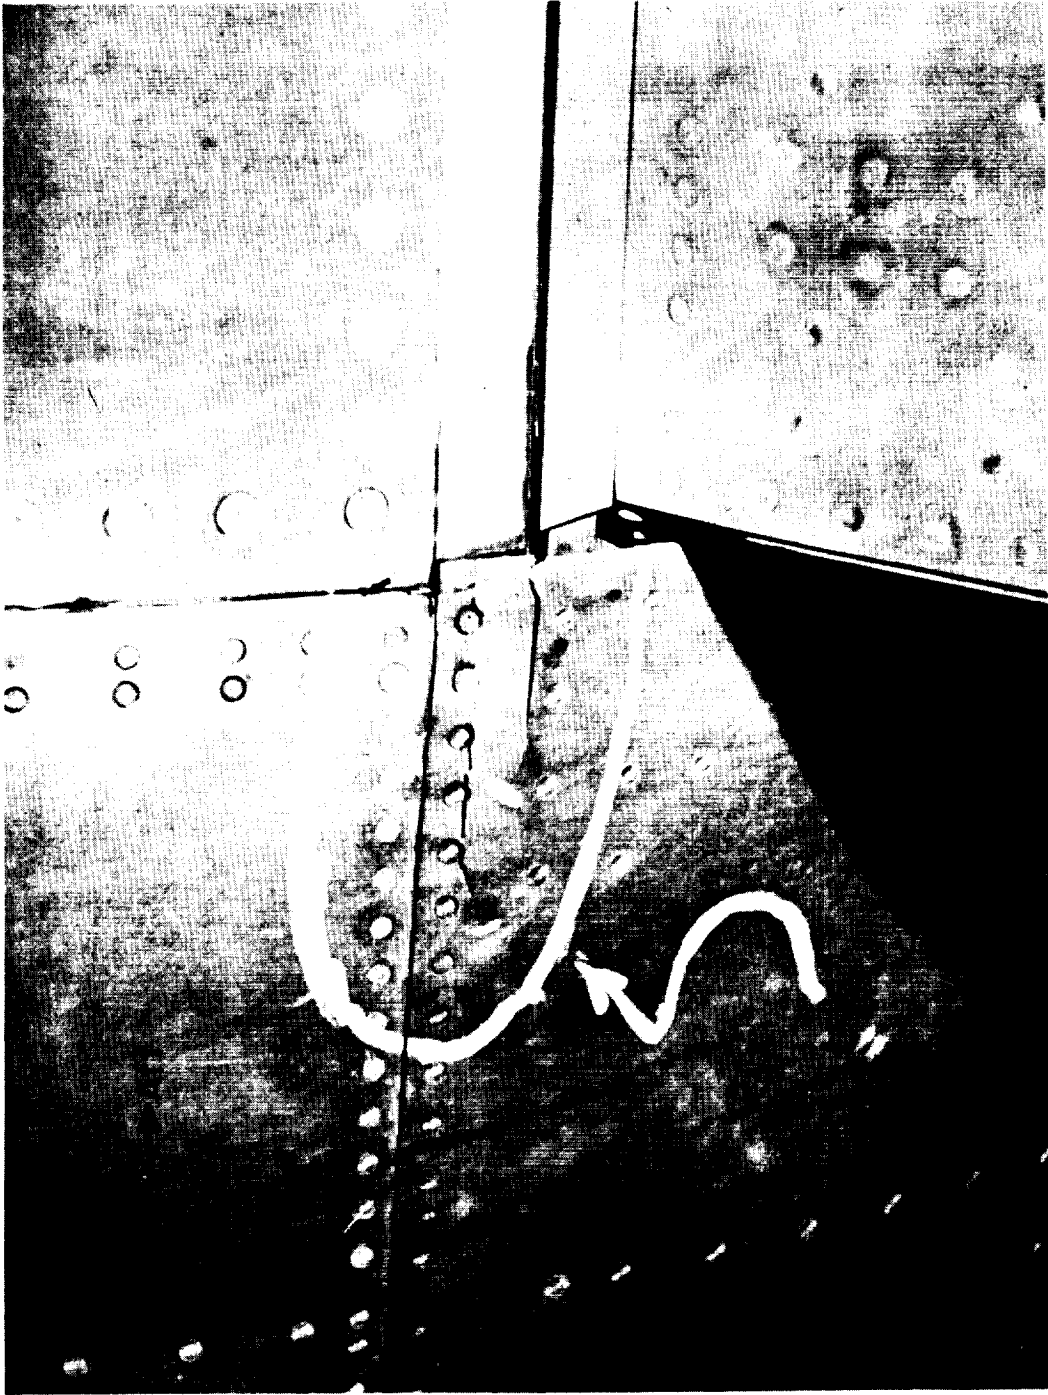
Inspection 7	7. Four 1/2-inch to 1-inch cracks occurred in bottom skin of fuselage at B.S. 425.	No repair was made.
Inspection 9	8. 1/2-inch crack was found in fillet of the left upper inboard shear tie at B.S. 442.5. See figure 14.	No repair was made.

L-59-178  
Figure 11.- Cracks in lower left fuselage skin forward of bomb bay door. Body station 425.

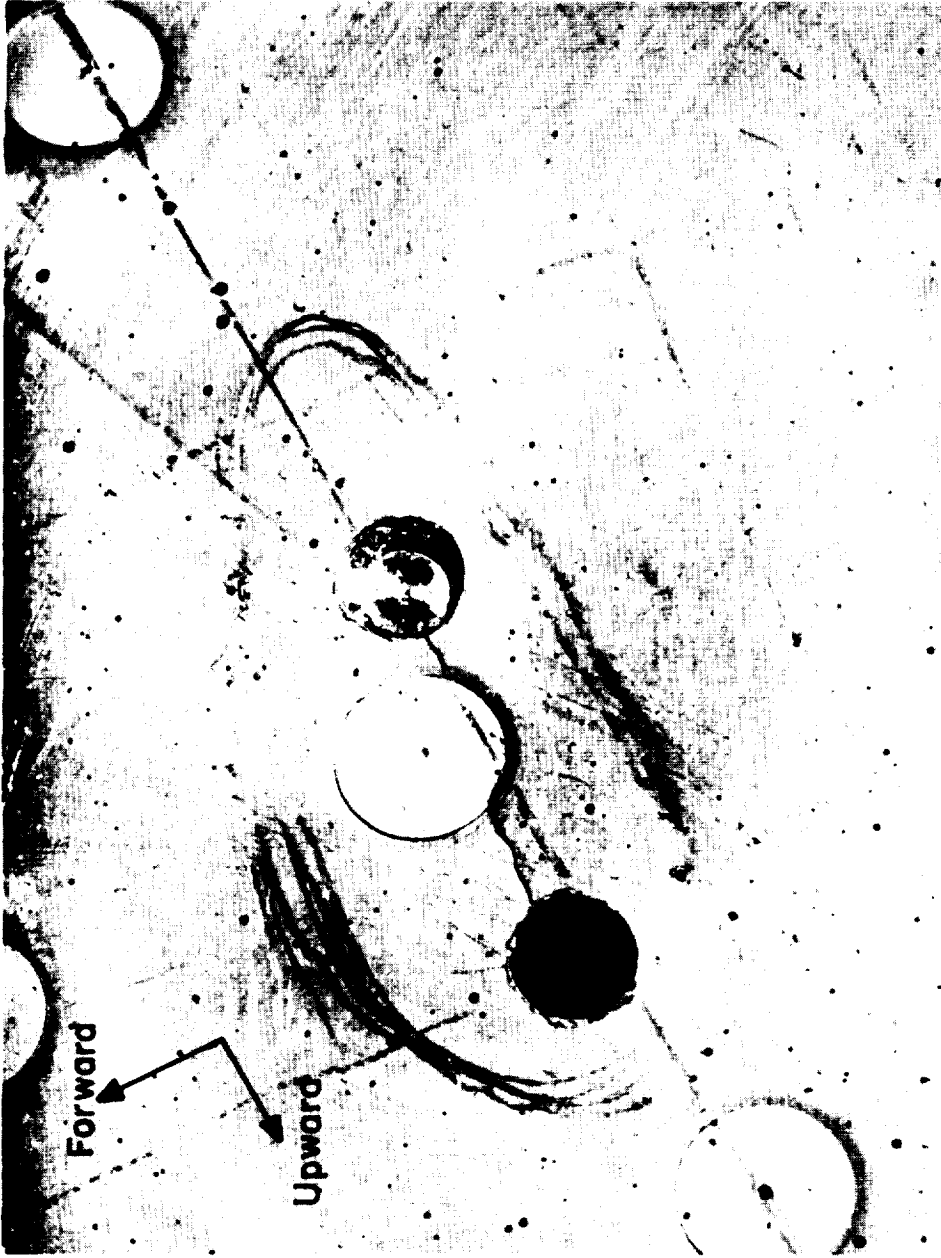
Crack 6 which occurred in the fuselage crown skin 10 inches aft of the upper-skin reinforcement plate was the first crack to be observed which may be considered to be associated with the reinforcements. It occurred during the 13th spectrum, 10 spectrums after the longeron modification. The crack which is illustrated in figure 13(a) occurred on the right side. The reinforcement plate shown in figure 13(b) was also installed on the left side at the same time to determine whether it might forestall development of a corresponding crack on the left side. When this doubler was removed at the end of the program, a crack was found in the skin beneath the doubler similar to the one shown in figure 13(a).

(a) Crack at spectrum 13, as stop-drilled. I-59-180

Figure 13.- Crack and repair in right fuselage crown skin at body station 601, 10 inches aft of reinforcing plate.

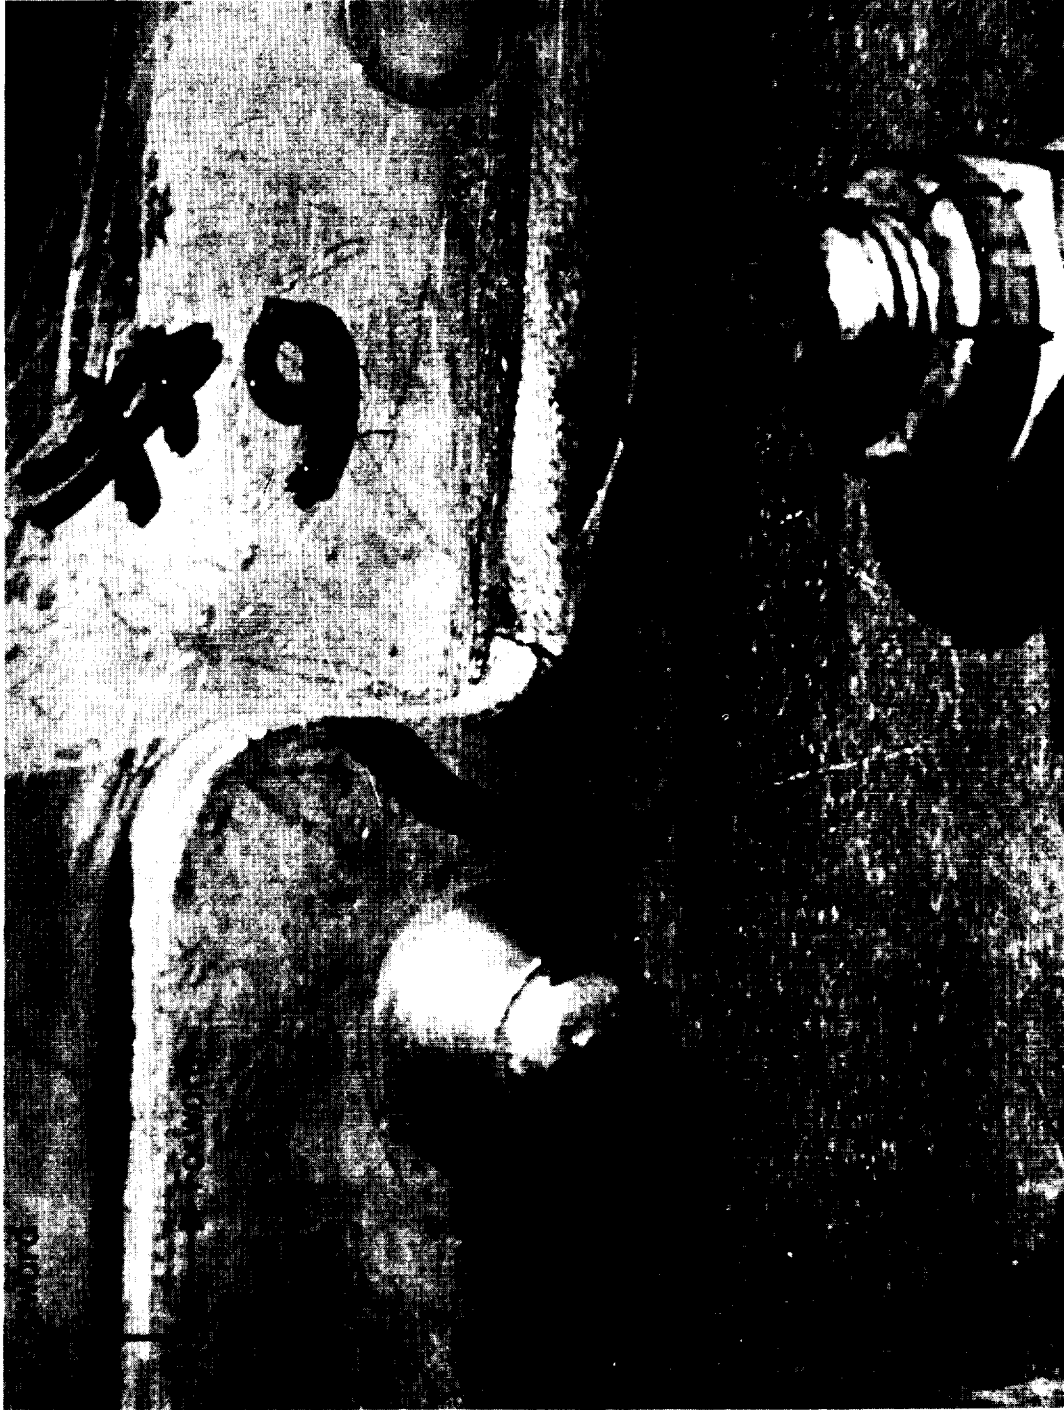
Cracks 8 and 9 which involved the upper inboard shear ties on both sides were not repaired. Crack 8 is illustrated in figure 14.

L-59-181  
Figure 14.- Crack in fillet of left inboard upper shear tie at body station 442.5.

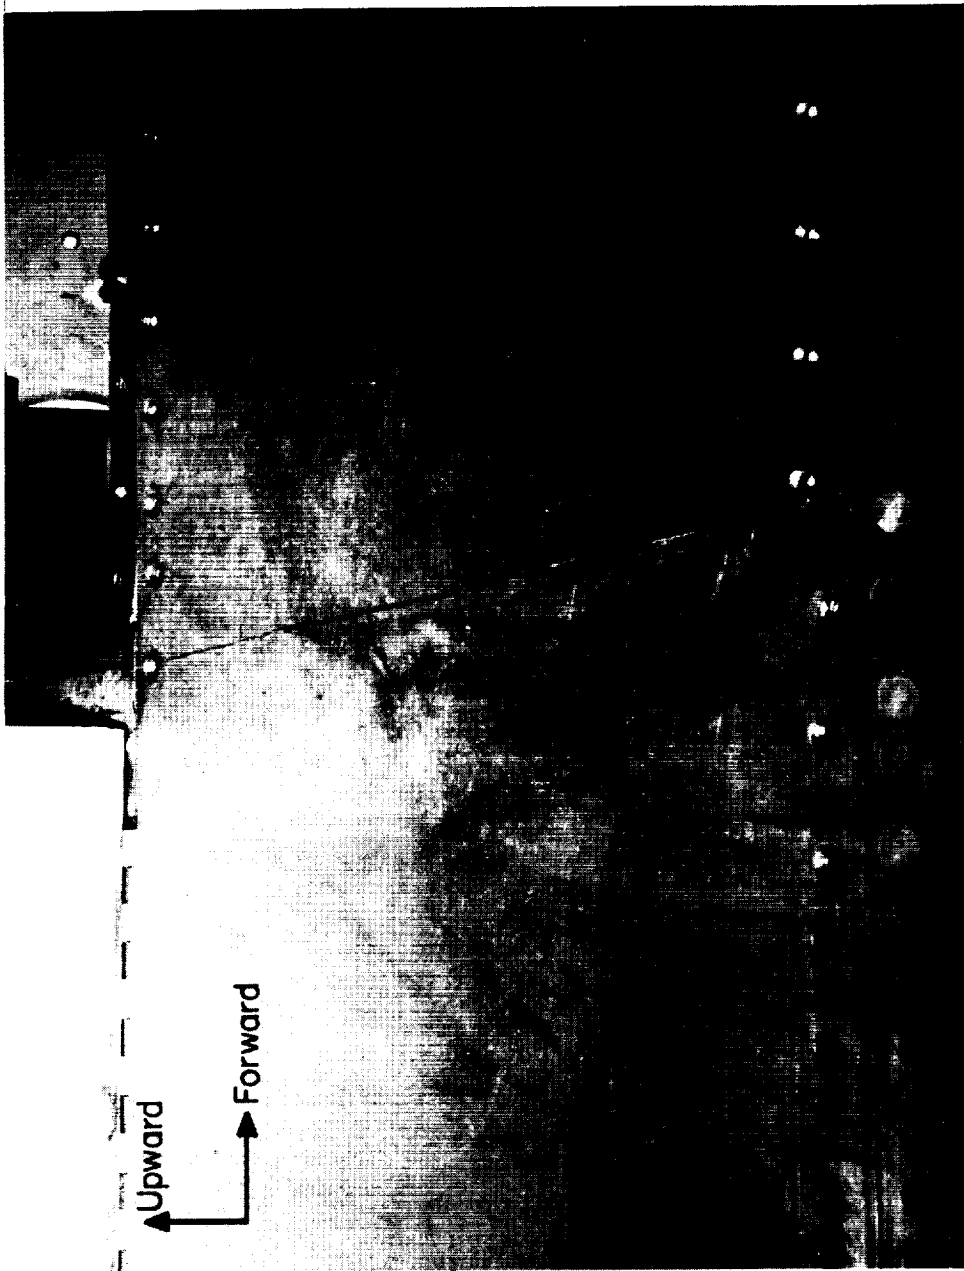
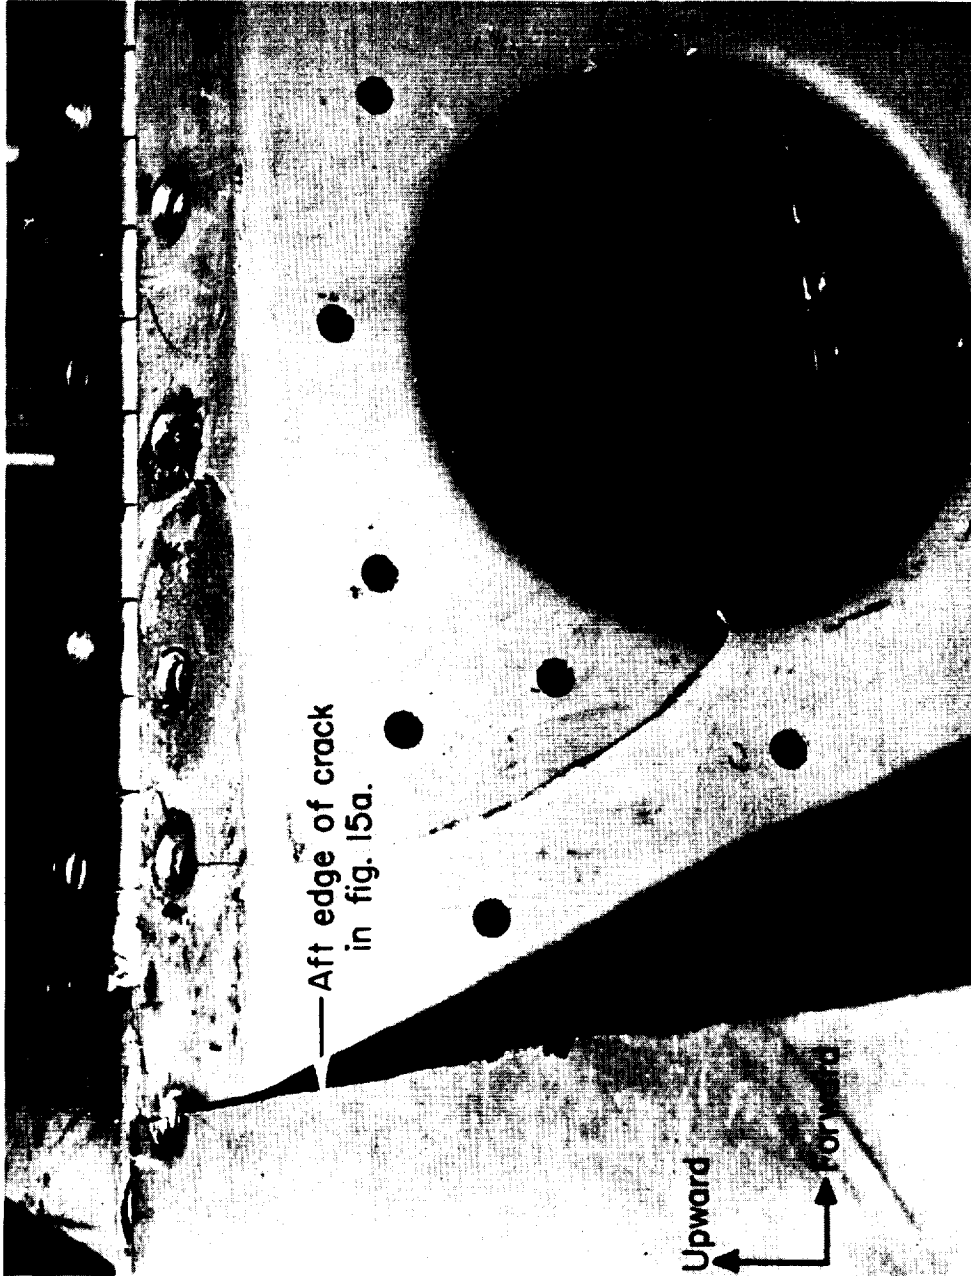
Crack 10 at B.S. 648 involved both the right fuselage crown skin and the adjacent stiffener that supports the walkway door hinge. Crack occurrence was marked by a loud report, which was observed by one of the test personnel who happened to be standing in the vicinity on the floor beside the fuselage. The cracks occurred during the high-gust portion of the 20th spectrum, 17 spectrums after the longeron modification. The cracks and repairs are illustrated in figure 15.

(a) Fuselage crown skin, 12 inches long. Crack did not extend beyond bottom rivet hole.

Figure 15.- Fuselage cracks at body station 648 on right side.

(b) Vertical stiffener in life-raft compartment. L-59-183

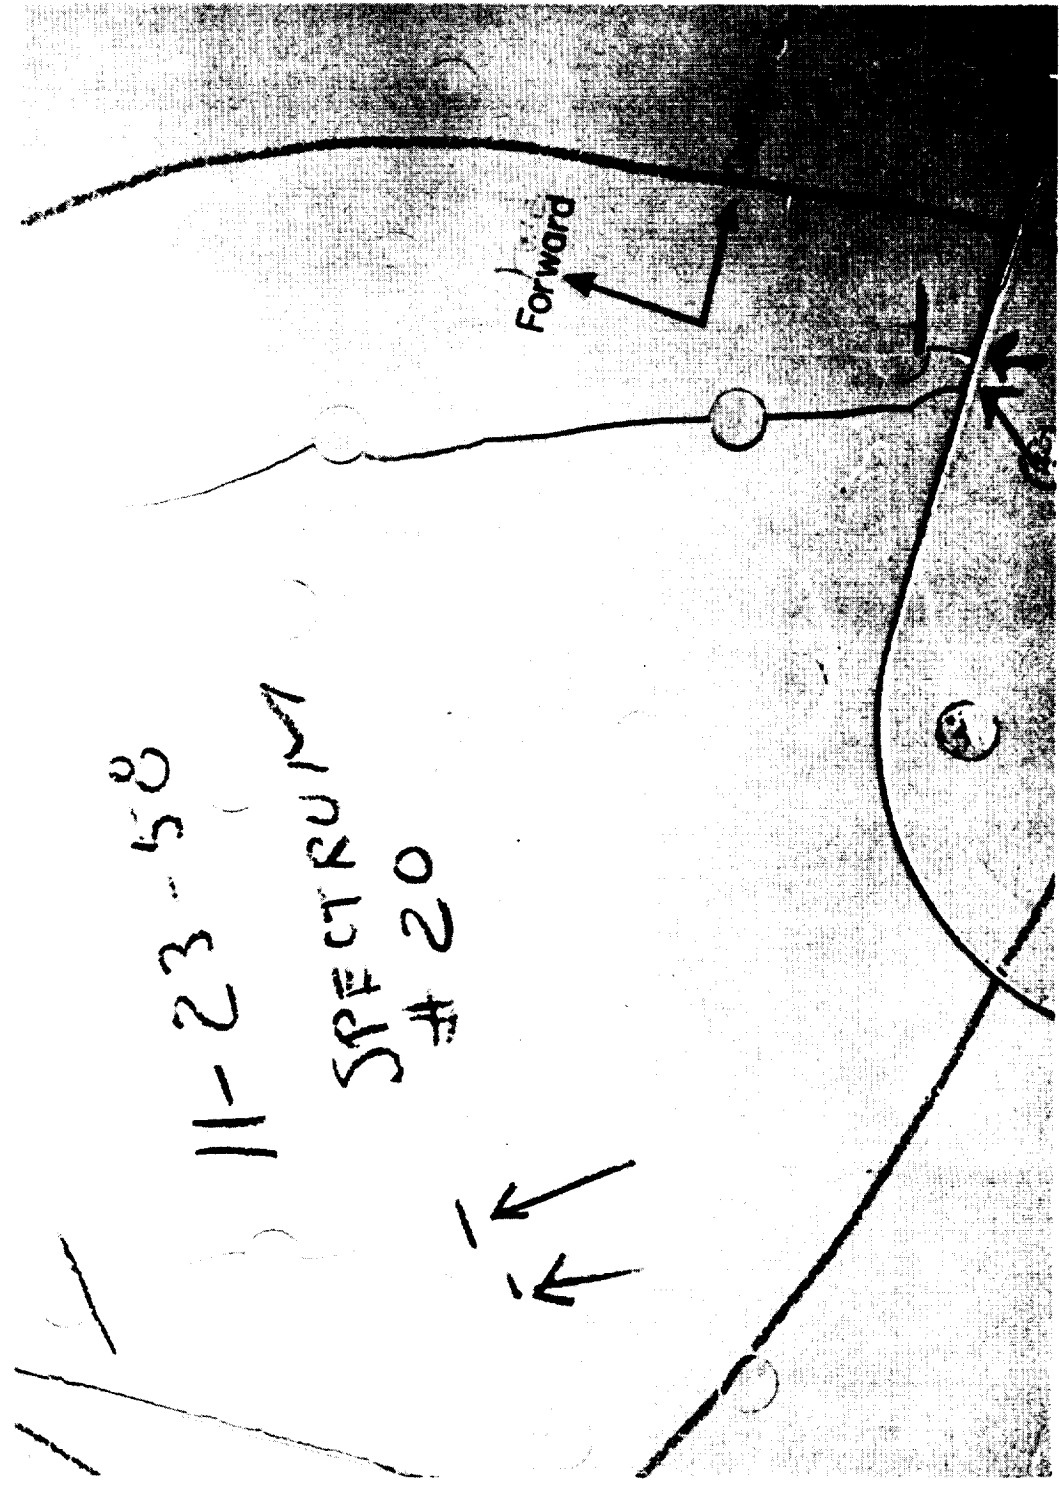
Item 11 in table 6 records 20 distinct cracks in the leading-edge skin, all located between wing stations 114 and 389. Typical examples are shown in figure 16. These cracks were first observed during cycling in spectrum 20; they varied in length between 1/2 inch and 6 inches at that time. Easily visible under load, they were nearly all virtually invisible when the wing was in the inspection position. At the end of the program, cracks, frequently multiple, could be found at 22 distinct stations. At eight stations the leading-edge attach angle was involved, and at three of these stations it was failed completely. Inspection of

the leading-edge skin during spectrum 17 did not reveal leading-edge cracks; thus, it is virtually sure that these cracks appeared subsequent to spectrum 17. Their occurrence during the present program indicates that the life of the magnesium leading-edge sections may be less than the augmented life of the wing splices and that close inspection of the wing leading edge would be warranted as airplane flight time increases.

11. Twenty 1/2-inch to 6-inch cracks were found in the magnesium skin of the leading edge between W.S. 114 and W.S. 389. Twelve cracks occurred in the left wing and eight occurred in the right wing. See figure 16.	The cracks were stop-drilled after reaching 0.75 inch in length.
Spectrum 23	12. 1 1/4-inch crack occurred in the fuselage skin at the edge of the filler neck opening on right side at B.S. 550. See figure 17(a).	The crack was stop-drilled as a temporary repair. A reinforcement plate was installed to the area during inspection 12. See figure 17(b).
Inspection 12	13. 0.1-inch and 0.2-inch cracks were found at the Jo-bolt holes in the fuselage skin reinforcing plate at left B.S. 560 and right B.S. 567, respectively. See figure 18.	No repair necessary. Additional cracks occurred in this same region during the remainder of the test.
Inspection 13	14. 1/4-inch crack found at rivet hole in left fuselage crown skin at B.S. 600.	No repair was made.

Figure 16.- Typical cracks in leading-edge skin. L-59-185

Cracks were found in the magnesium leading-edge skin after spectrum 20. These cracks indicate that the fatigue life of the leading-edge skin may be less than the augmented life of the wing splices, and that close inspection of the wing leading edge would be warranted as airplane flight time increases.

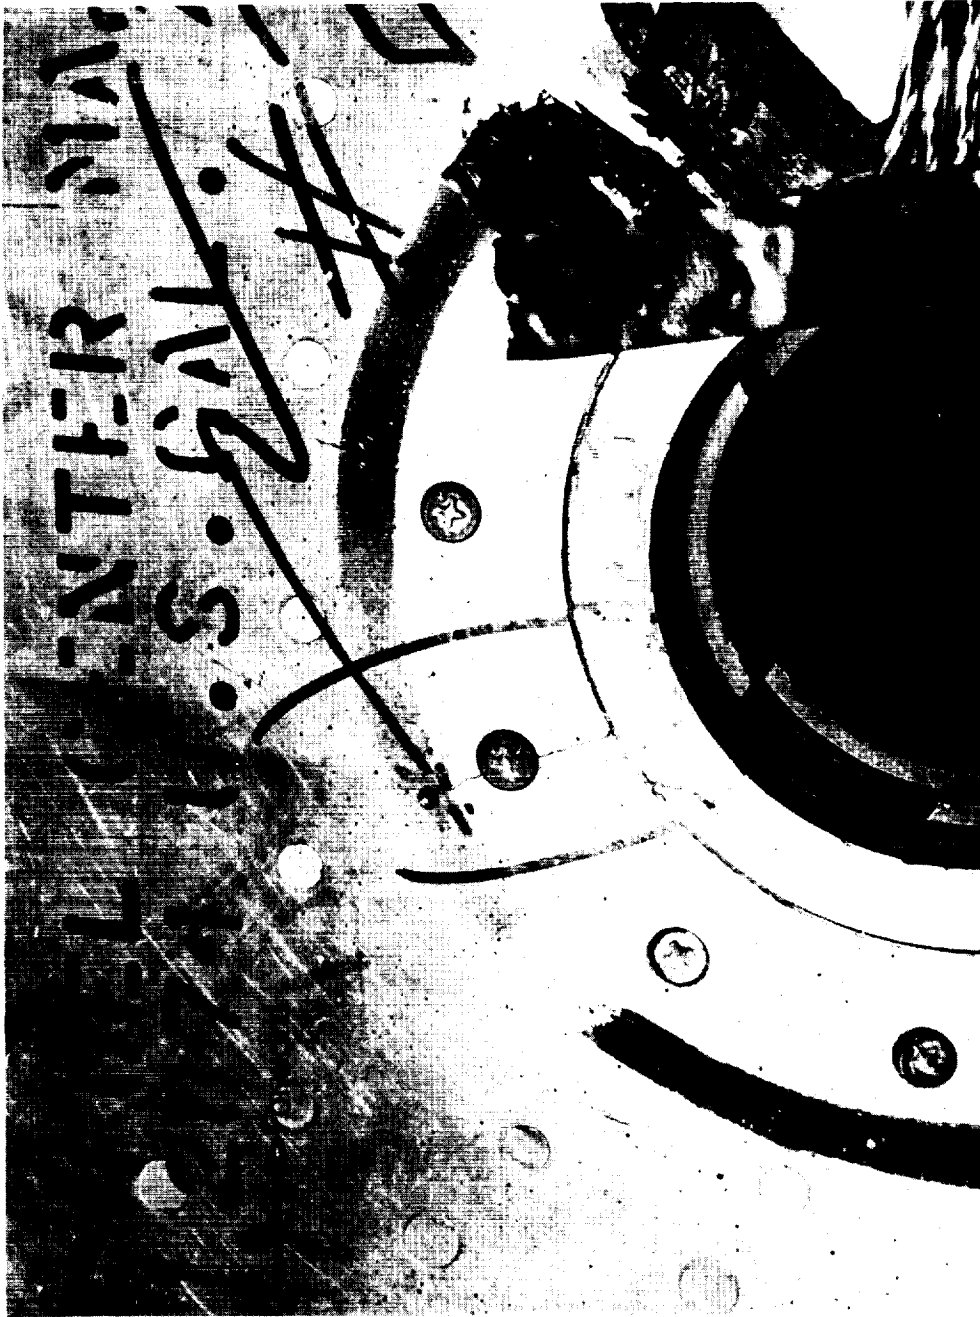
(a) Crack as stop-drilled, spectrum 23. L-59-186

Figure 17.- Crack at filler neck opening on right side at body station 550.

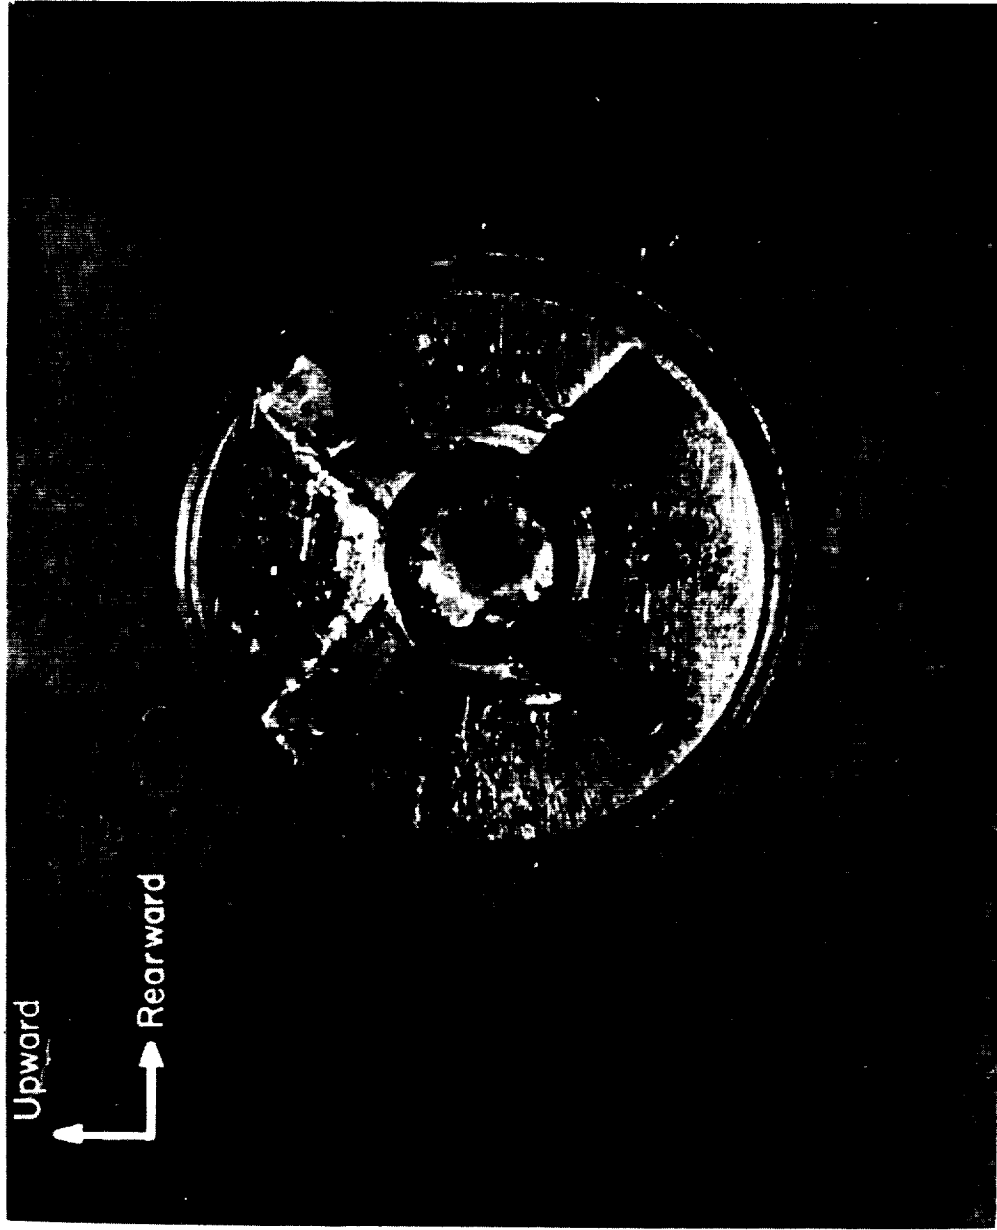
During inspection 12, following spectrum 24, small cracks (item 13) were found in the upper-crown-skin reinforcing plate. Barely visible to the unaided eye in the inspection position, they were discovered during the night by the chance observation of disturbances in the reflection pattern from an overhead light bulb.

L-59-187  
Figure 18.- Typical crack in lower leg of upper-fuselage crown-skin reinforcing plate, discovered during inspection L2 following spectrum 24.

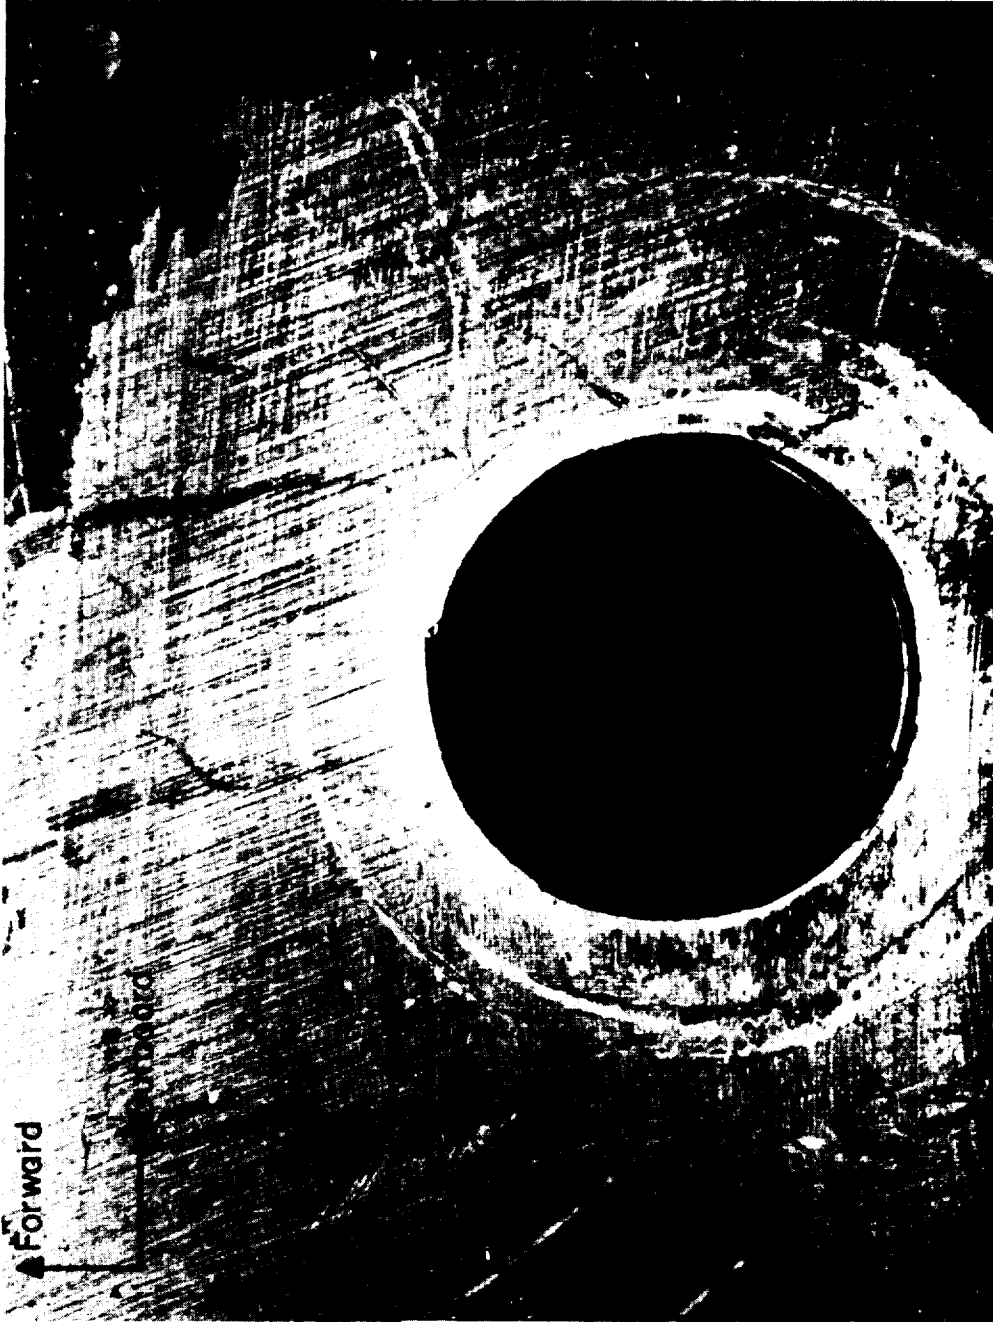
The first crack in a wing splice developed at the left B.L. 45 area in a rear outboard finger of the reinforcement. This crack area, item 15, is pictured in figure 19(a) and was found at spectrum 26. An additional crack, item 16, in this area was found at spectrum 28. No cracks were found in the wing splices at W.S. 354 during the program.

15. 1/4-inch crack found in the outboard finger of the reinforcing plate at bolt hole 406 at left B.L. 45. See figure 19(a).	The hole in the finger was enlarged to include the crack and hole left open. See figure 19(b).
Inspection 14	16. 1/4-inch crack was found in the outboard finger of the reinforcing plate at bolt hole 410 at left B.L. 45.	No repair was made.

(a) Crack as found during inspection 13, following spectrum 26. L-59-188

Figure 19.- Crack in outboard finger of splice at hole 406 at left buttock line 45.

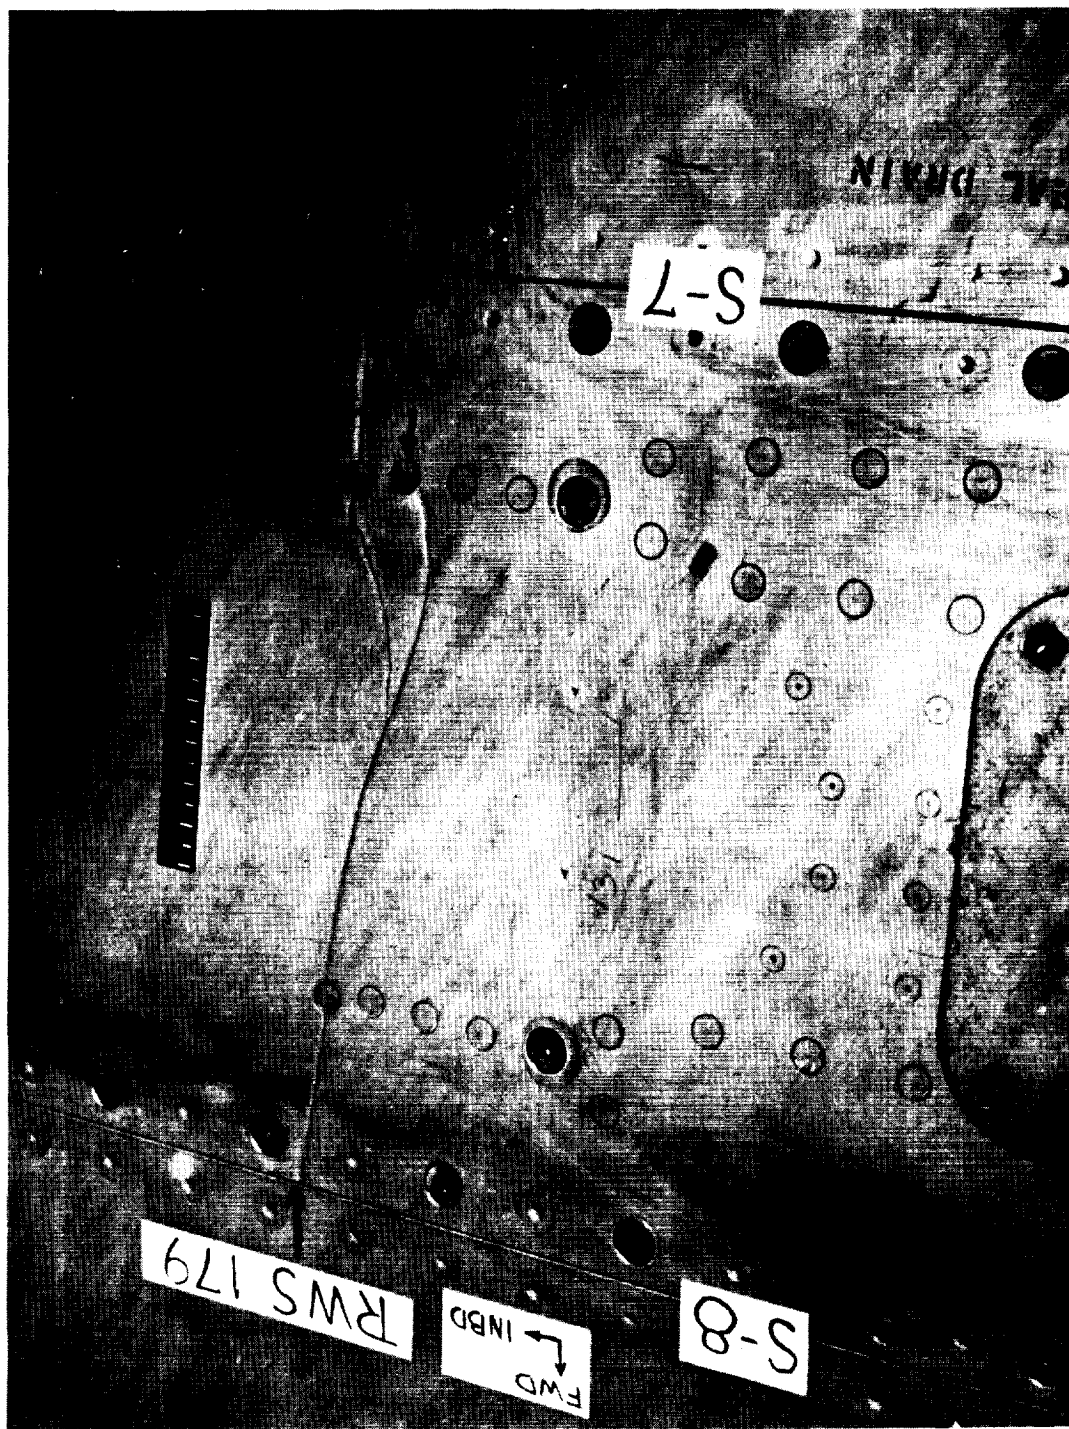
During the application of the 90 percent limit loading of spectrum 29, the right wing closeout panel failed. The failure was marked by a clearly audible report just as the applied load reached the load maximum. The wing was returned to the droop position by dropping the ram pressure to zero. Inspection of this crack area (item 19) showed that the whole of the lower closeout panel had failed at W.S. 179 between stiffeners 7 and 8 (see fig. 20), a distance of 21 inches, and that the inboard rivets at the ends of the fingers on the doubler of the hole for the water-injection-pump access door were involved. The crack is clearly evident in the droop position because of the marked necking-down of the material at the lower surface. Preliminary inspection of spars and stringers in the crack area has revealed no secondary failures associated with this crack.

Because of the magnitude of the crack at right W.S. 179, and because of the number of cracks which had developed in the fingers of the B.L. 45 splice, as well as in the fuselage crown-skin reinforcing plate, it was considered that further cyclic loading would not contribute to the objectives of the program. Cyclic loading was, therefore, terminated.

L-58-1060a  
Figure 20.- Crack in right wing closeout panel at wing station 179. Spectrum 29.

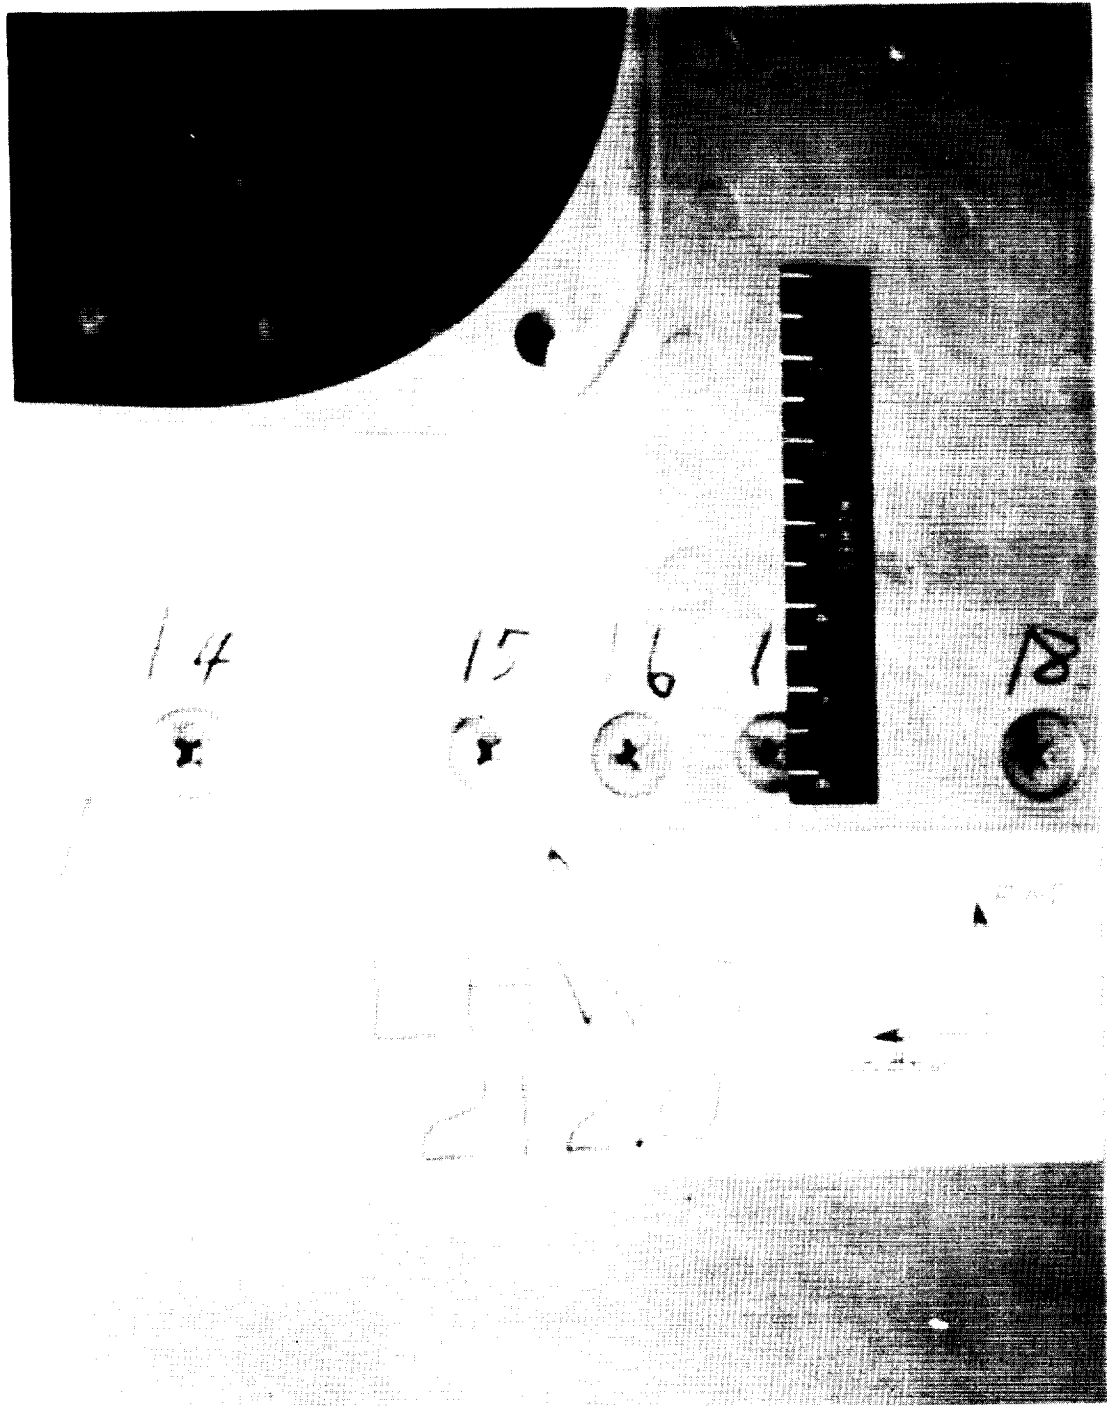
The B.L. 45 bolt hole inspection was repeated and two cracks, items 20 and 21, were found in the outboard aft fingers of the splice plate at B.L. 45 on the right side. These cracks were not present on the preceding inspection following spectrum 28. A crack (item 22) was also found in the closeout panel on the left side at the hole for the water-injection-pump-access door at W.S. 212. The crack, which is approximately 3.5 inches long, apparently originated in a tool mark in the radius of the cutout and propagated rearward to a bolt hole in stringer 7. (See fig. 21.)

21. 0.015-inch crack was found in the outboard finger of the reinforcing plate at bolt hole 407 at right B.L. 45.	
	22. 3.5-inch crack was found in the left wing closeout panel at W.S. 212. See figure 21.	This crack apparently originated in a tool mark in the radius of the cutout.

Figure 21.- Crack in left wing closeout panel at wing station 212, found during inspection 15.
