DEGRADATION OF HUBBLE SPACE TELESCOPE METALLIZED TEFLON® FEP THERMAL CONTROL MATERIALS

Patricia A. Hansen, Jacqueline A. Townsend
NASA/Goddard Space Flight Center
Greenbelt, Maryland 20771

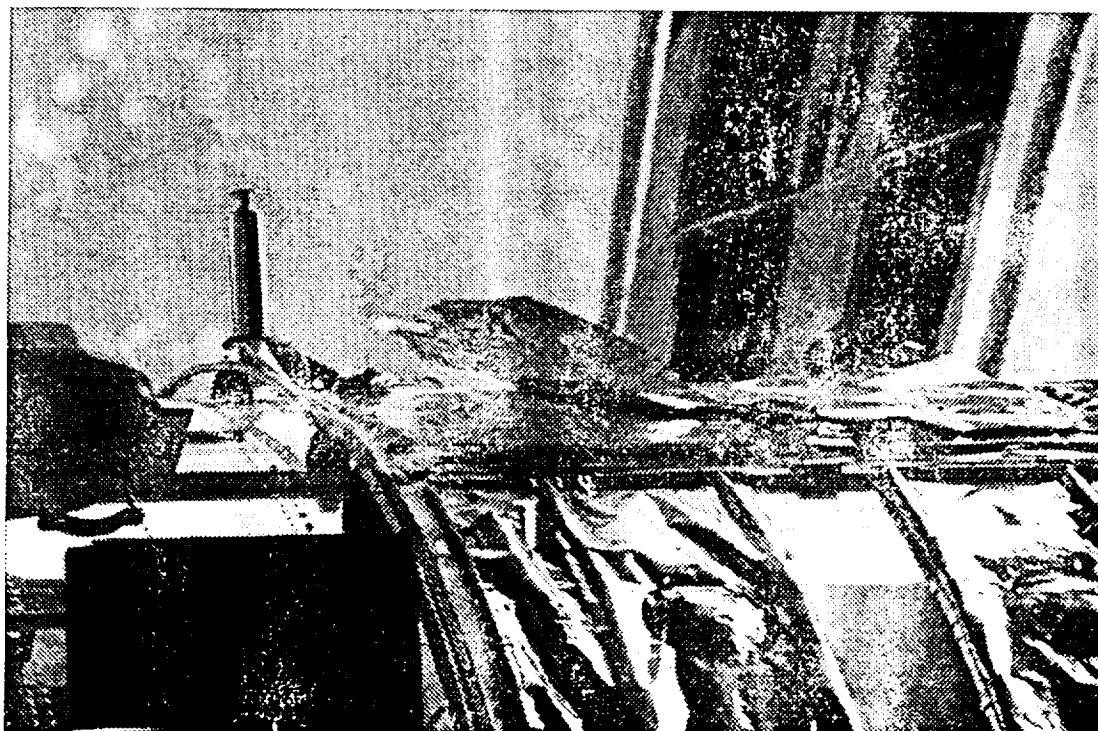
Figure 4: SSM Bay 8 MLI Crack

Prior to patching the corners of the SSM Bay 8 MLI, the astronauts performed two tests: a Velcro® cycling and Teflon® FEP bend test. The Velcro®, attaching the MLI blanket to the bay, was cycled to determine its integrity – was it still attached to the telescope substrate and did the hook still hold the pile securely? The astronauts reported that the Velcro® appeared to be securely fastened to the vehicle substrate and the hook seemed to hold the pile securely. The astronauts also bent a piece of the Teflon® FEP over on itself to determine if manipulating it during the patching process would cause significant damage. The astronauts reported that the Teflon® FEP did not crack.

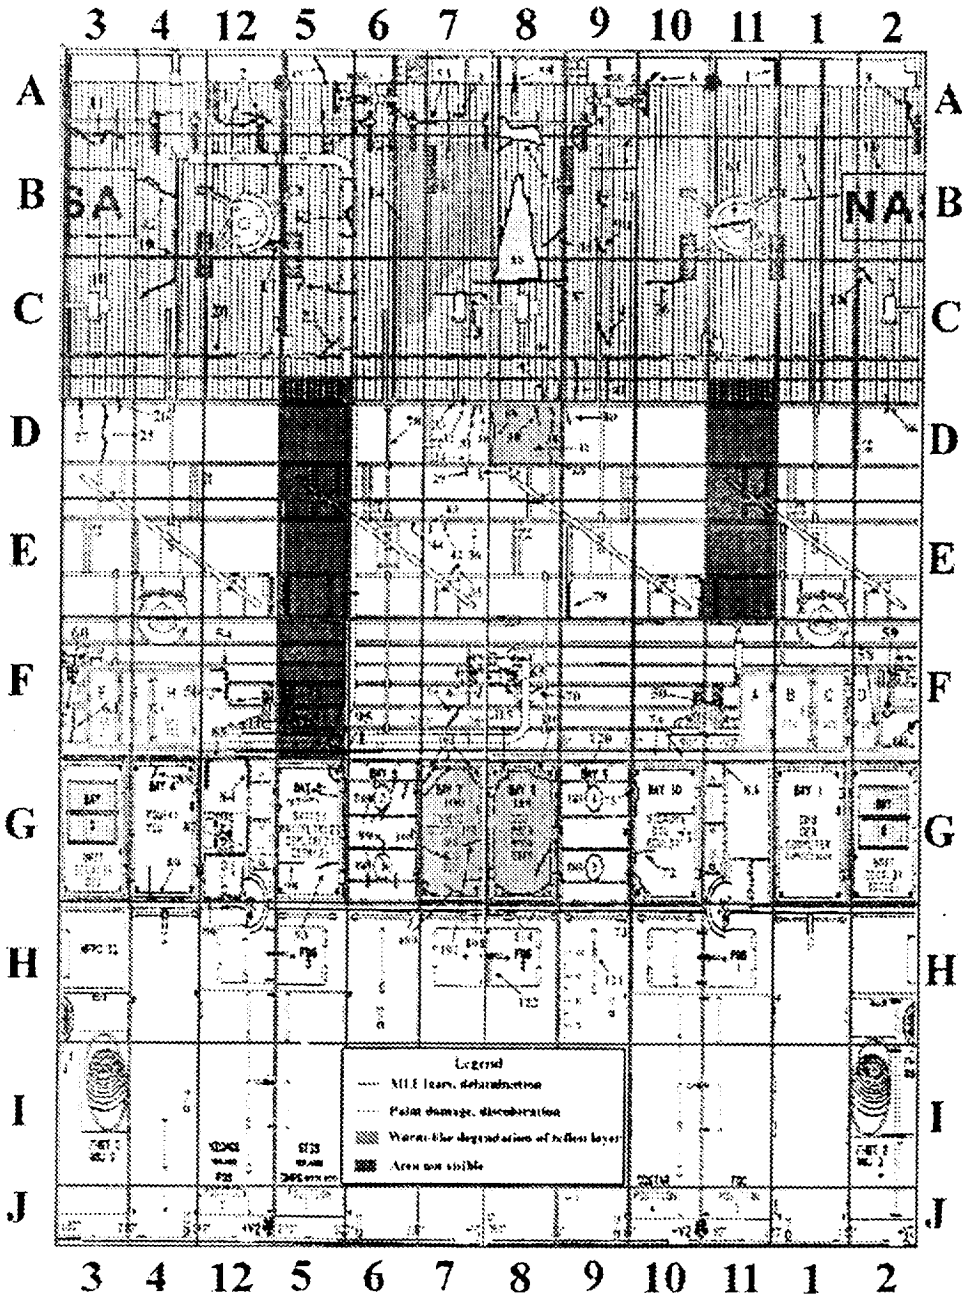
5.2 Damage Map Post mission analysis of the photographic documentation indicated that the MLI outer layer was cracked extensively on all MLI surfaces. The cracks were noticeably larger and more numerous on the sun side (+V3) of the telescope. The cracks in the FEP Teflon on the anti-sun side (-V3) of the telescope tended to start and end at stress

concentration points. Whereas, the cracks on the sun side (+V3) of the telescope start at stress concentration points and either end where two cracks meet or in the middle of an MLI blanket.

Figure 5 shows a map of the MLI damage, using SM2 photo documentation (Reference 3). This map depicts the damage and notes where the cracks have opened on the LS and SSM bays. The location of the features on the map is approximate and shown for illustration purposes only. The most important item to note is that the damage is seen all over the vehicle and is noticeably worse on the sun side (+V3).

Figure 5: HST Thermal Control Subsystem Degradation Map

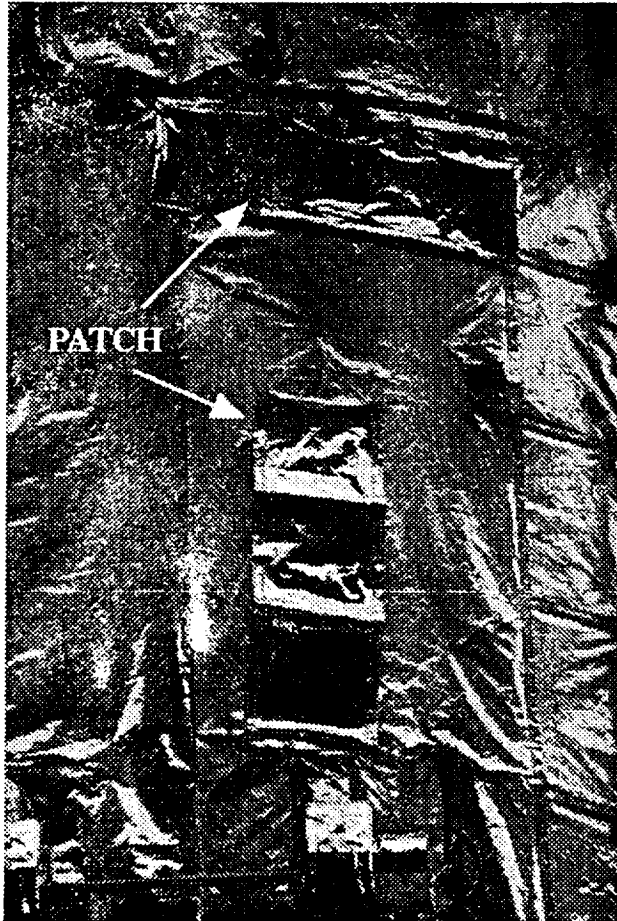
Figure 7: HST Light Shield MLI Cracks with Patches Installed

Although the damage to the MLI was visually dramatic, there was no measurable thermal effect due to the cracks and the exposure of the DAK to the telescope environment. However, during the SM2 mission, a program decision was made to reconfigure flown MLI patches to patch the worst of these damaged areas.
