NASA/TM—1999-208907

Plumbrook Hypersonic Tunnel Facility Graphite Furnace Degradation Mechanisms

Nathan S. Jacobson
Glenn Research Center, Cleveland, Ohio

March 1999

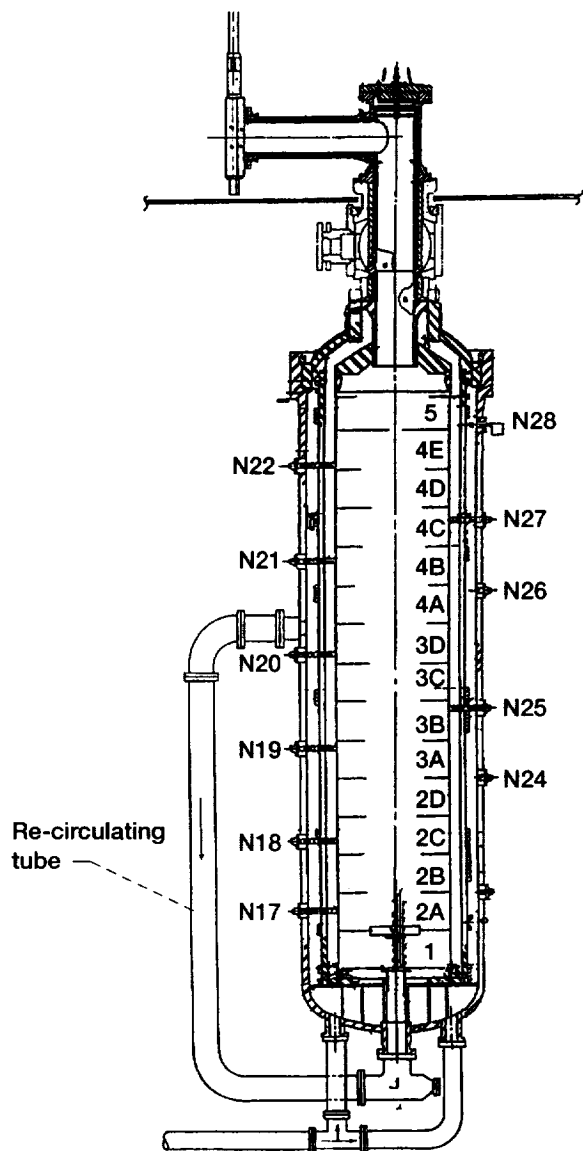
An estimated 5 to 10 percent of the felt was consumed or about 218 lbs. From the graphite blocks alone, about 3083 lbs was lost. This combines with the amount of consumed felt for a total of 3301 lbs (1.5×10^6 gm). Most of the consumption appears to be adjacent to and immediately above the large recirculating tube coming off the midpoint of the furnace, as shown in figure 1. Vertical gradients would make these the hotter blocks, since they are near the

As indicated, most of the consumption is adjacent to and immediately above the recirculating pipe at the mid-point of the furnace (fig. 1). Vertically, this is the hottest part of the furnace. Horizontally, there is probably a fairly constant temperature through the blocks. However, possible water leaks from either the induction coils and/or furnace ports would be closest to the outer edges of the graphite.

Figure 1.—Schematic of furnace, showing flow path of purge gas.

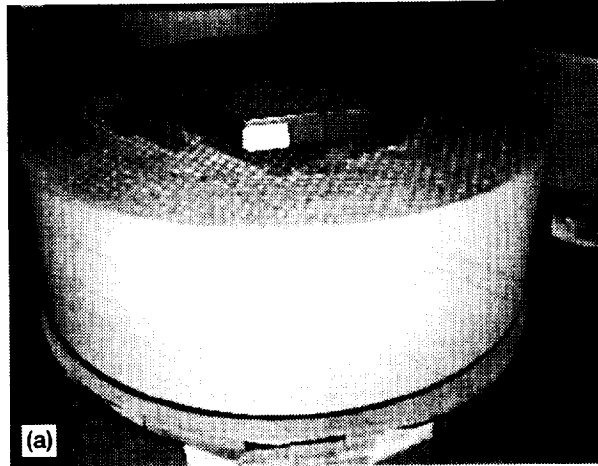
Block	Reduction in diameter, in.	Estimated weight lost, lbs
5	0	0
4E	0.44	296
4D	0.44	296
4C	0.75	507
4B	0.69	464
4A	0.88	590
3D	0.75	507
3C	0.38	254
3B	0.12	85
3A	0	0
2D	0	0
2C	0	0
2B	0	0
2A	0.06	42
1	0.06	42

Figure 2.—(a) Photograph of large graphite block. (b) Photograph of the felt, showing grooving.

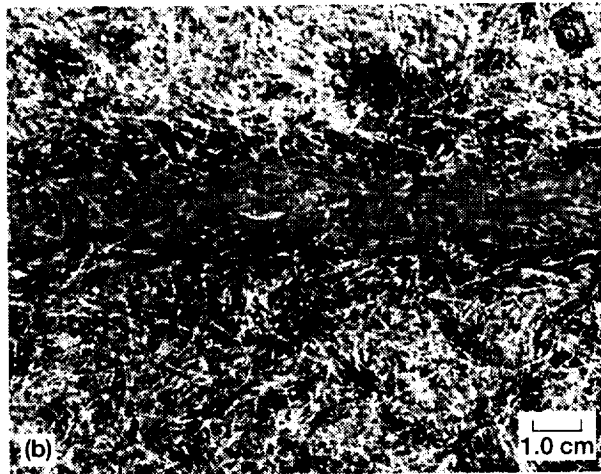
3. Attack was primarily in two modes: (I) Reduction in diameter of the upper graphite blocks (II) 'Furrowing' or deep groove formation and consumption of the felt. Figure 2(b) is a photo of one of these grooves. These would both be the last to 'see' an inrush of air.

Location	Condition of felt
Top Block 4E to Bottom Block 3D	Felt slumped, furrowed Inner 2 to 3 in hard with a 'burnt' appearance
Top Block 3C to Bottom Block 2D	Similar to above, but not as severe
Top Block 2C to Bottom Block 1	Felt in good condition

The reactive components of the purge gas should be eliminated or minimized as much as possible. The planned use of an inert purge gas, such as argon or helium, in place of nitrogen should certainly help. The inert gas should be gettered to remove residual oxygen and water vapor. Hot titanium chips are generally used for this purpose. If possible, it would be best to recirculate this gas. This way the product species in the gas stream would suppress further reaction and this would avoid leaking noxious gases into the atmosphere. However, total pressure must be carefully monitored in a recirculating scheme to avoid pressure rises if additional gaseous species are formed.

The 100 ppm of H_2O , which appears to arise from a leak in the housing or water cooled power lines, must also be reduced. The calculations indicate that even a reduction to 10 ppm would help substantially. Ideally the level should be below 10 ppm. This may be extremely difficult in a furnace this size. Thorough leak checking of all components should be a part of the reassembly procedure. Monitoring of water vapor throughout the system during purging and testing is essential. A measured level above 10 ppm is an indication of a likely problem.

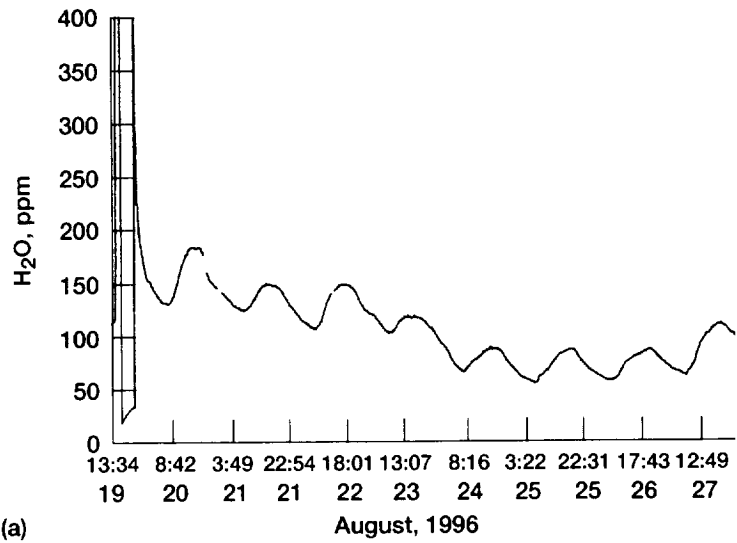
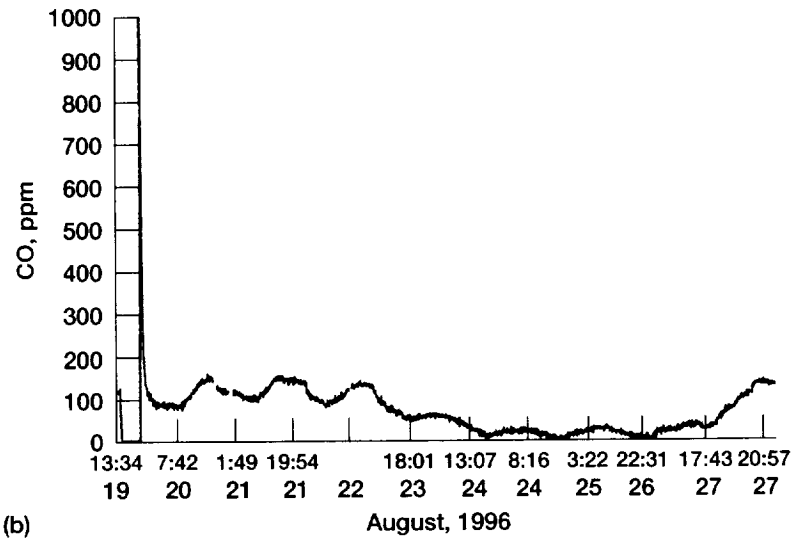
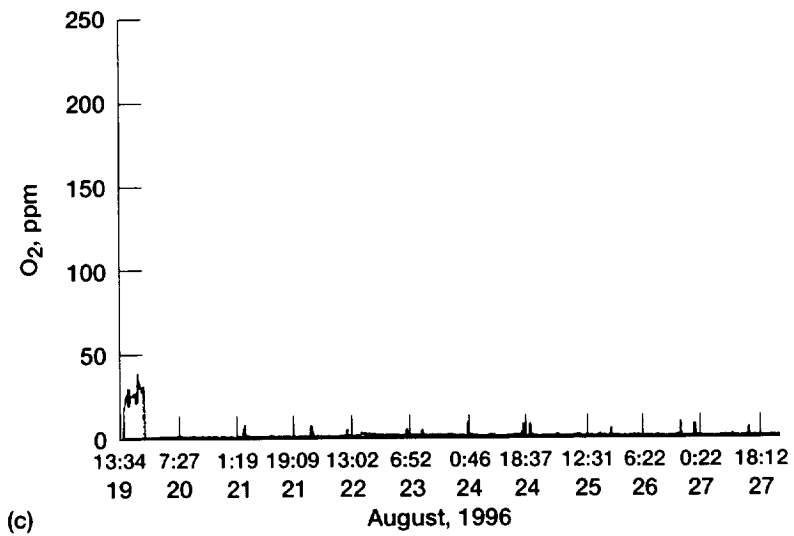
Figure 4 illustrates the output of several of the gas analyzers at position N28 on the furnace (see fig. 1). These data are very significant. Figure 4(a) indicates a substantial amount of water in the gas stream (>100 ppm). Variations in this amount of water track very closely with the amount of CO(g) (fig. 4(b)). This immediately suggests the oxidation of carbon by water vapor:

The measured oxygen content of the furnace was quite low (fig. 4(c)), as expected. It is also likely that there are variations in the amount of $\text{H}_2\text{O(g)}$ throughout this furnace.

Figure 4.—Gas analyzer (Position N28) output from prior runs, showing that increases in water vapor track with increases in CO(g). (a) H₂O. (b) CO. (c) O₂.
