ON-ORBIT TEFLON® FEP DEGRADATION

Jacqueline A. Townsend, Patricia A. Hansen
NASA/GSFC
Greenbelt, Maryland 20771
301-286-6685
jacqueline.a.townsend.1@gsfc.nasa.gov
patricia.a.hansen.2@gsfc.nasa.gov

ABSTRACT

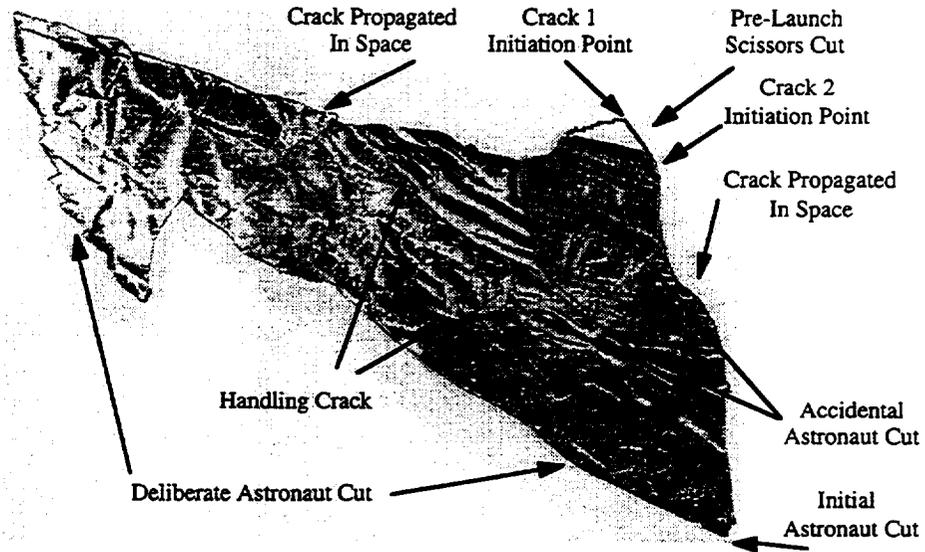
FIGURE 3: SM2 LS SPECIMEN POST-RETRIEVAL

The first task was to document the SM2 LS specimen and assemble the four pieces received into the single specimen that was cut in orbit. Both SEM and optical microscopy were used in this effort. Once the original configuration had been determined, the edges were identified as either a deliberate cut, a handling artifact, or an on-orbit fracture (Figure 3). From this information, the fracture initiation site became apparent.

SEM images of the initiation region showed clear differences between the scissors cut that occurred prior to launch or on orbit, the fractures that propagated while in orbit, and cracks from subsequent handling. The featureless nature of the orbital fracture is unique, and attempts to duplicate this smooth fracture with the SM2 specimen under bending or tensile stress resulted in fractures with more fibrous features. The inability to duplicate the featureless fracture indicated that the fractures propagated in orbit very slowly, in the presence of relatively low stress and under the influence of radiation and other environmental factors. This type of "slow crack growth" has never been studied in Teflon® FEP (3).

The image above was taken during post-retrieval analysis, when the SM2 LS specimen was uncurled and placed between glass plates. The edges of the specimen are identified as scissors cut, handling crack, or orbit crack. The top-right corner of the specimen contains the crack initiation sites.
