NASA/TM—1999-209399

Analyses of Contaminated Solar Array Handrail Samples Retrieved from Mir

Kim K. de Groh
Glenn Research Center, Cleveland, Ohio

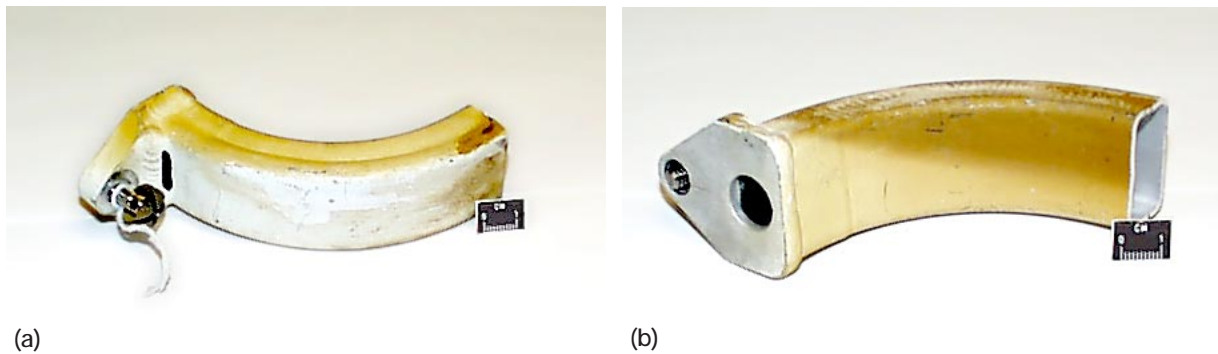
Figure 3. Curved rigid handrail sample. (a) Space-facing side of sample. (b) Array-facing side of sample.

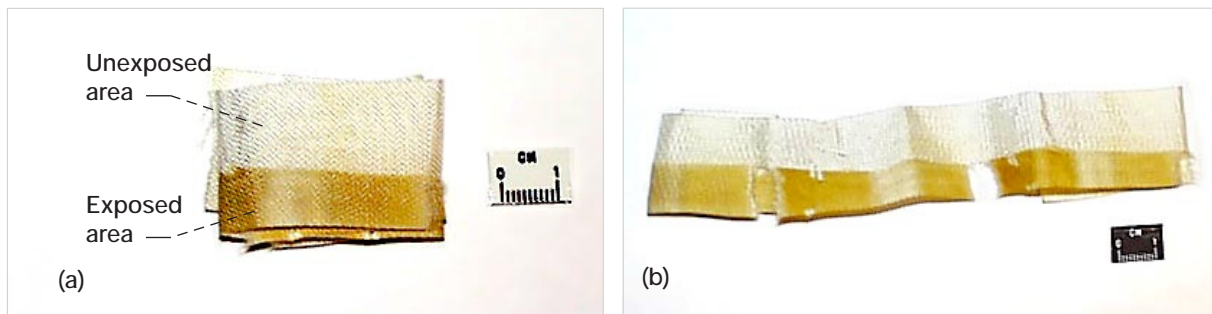
Figure 6. Flexible handhold over-wrap tape sample. (a) Sample as provided, folded onto itself. (b) Sample opened up.

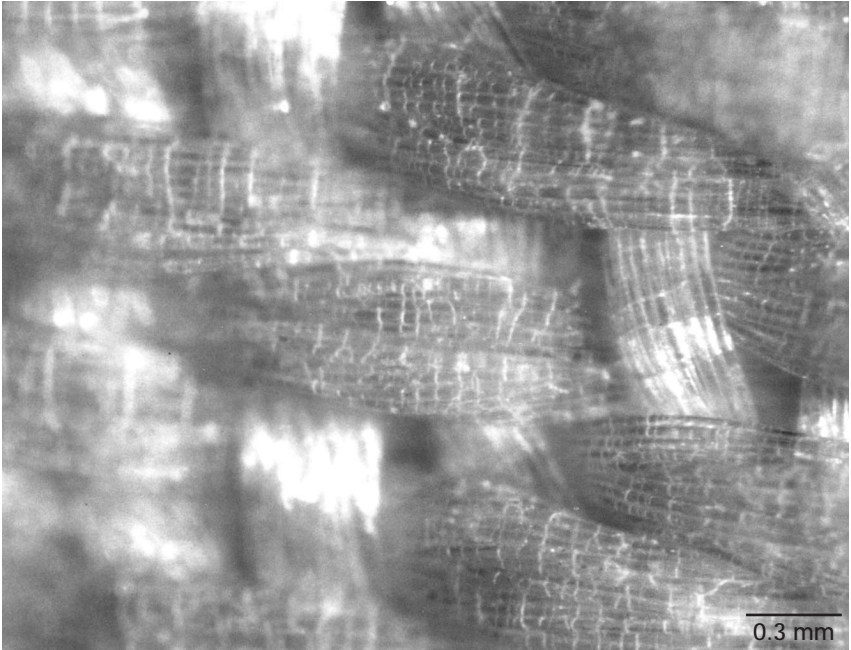
Flexible Handhold Over-Wrap Tape. Optical microscopy examination of the exposed, brown region of the handhold tape fabric revealed micro-crazing of a contamination layer, as shown in figure 11. This crazed layer is not present on the protected, unexposed region that has an off-white color (see fig. 12).

Figure 11. Micro-crazing of the brown contaminant layer on the exposed area of the flexible handhold over-wrap tape fabric.
