NASA/TM-1999-209839

An Experimental Investigation of Damaged Arresting Gear Tapes for the Langley Aircraft Landing Dynamics Facility

Angela J. Mason
Langley Research Center, Hampton, Virginia

December 1999

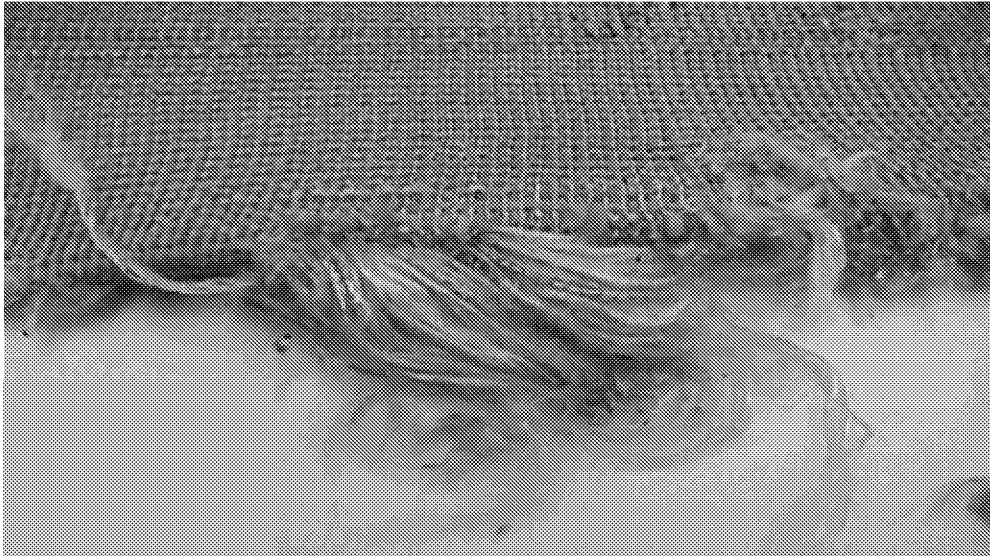
(a) Edge fray

A plot showing load displacement of a tape with edge fray damage, specimen 14, is in figure 13. This specimen failed at a maximum load of 40 206 lb. Popping sounds were also heard during this test. The specimen with edge fray damage failed at a much lower load than that of the specimen with transverse damage. Based on this observation, further tests should be performed because it is probable that the tapes with edge fray damage should be replaced sooner than the ones with transverse damage.

Figure 3. Types of damage.

One recommendation is if edge fray damage is detected and the damaged edges are trimmed, the trimmed edges should be treated with a polymer solution to help hold the fibers together to increase the tensile strength of the tape.

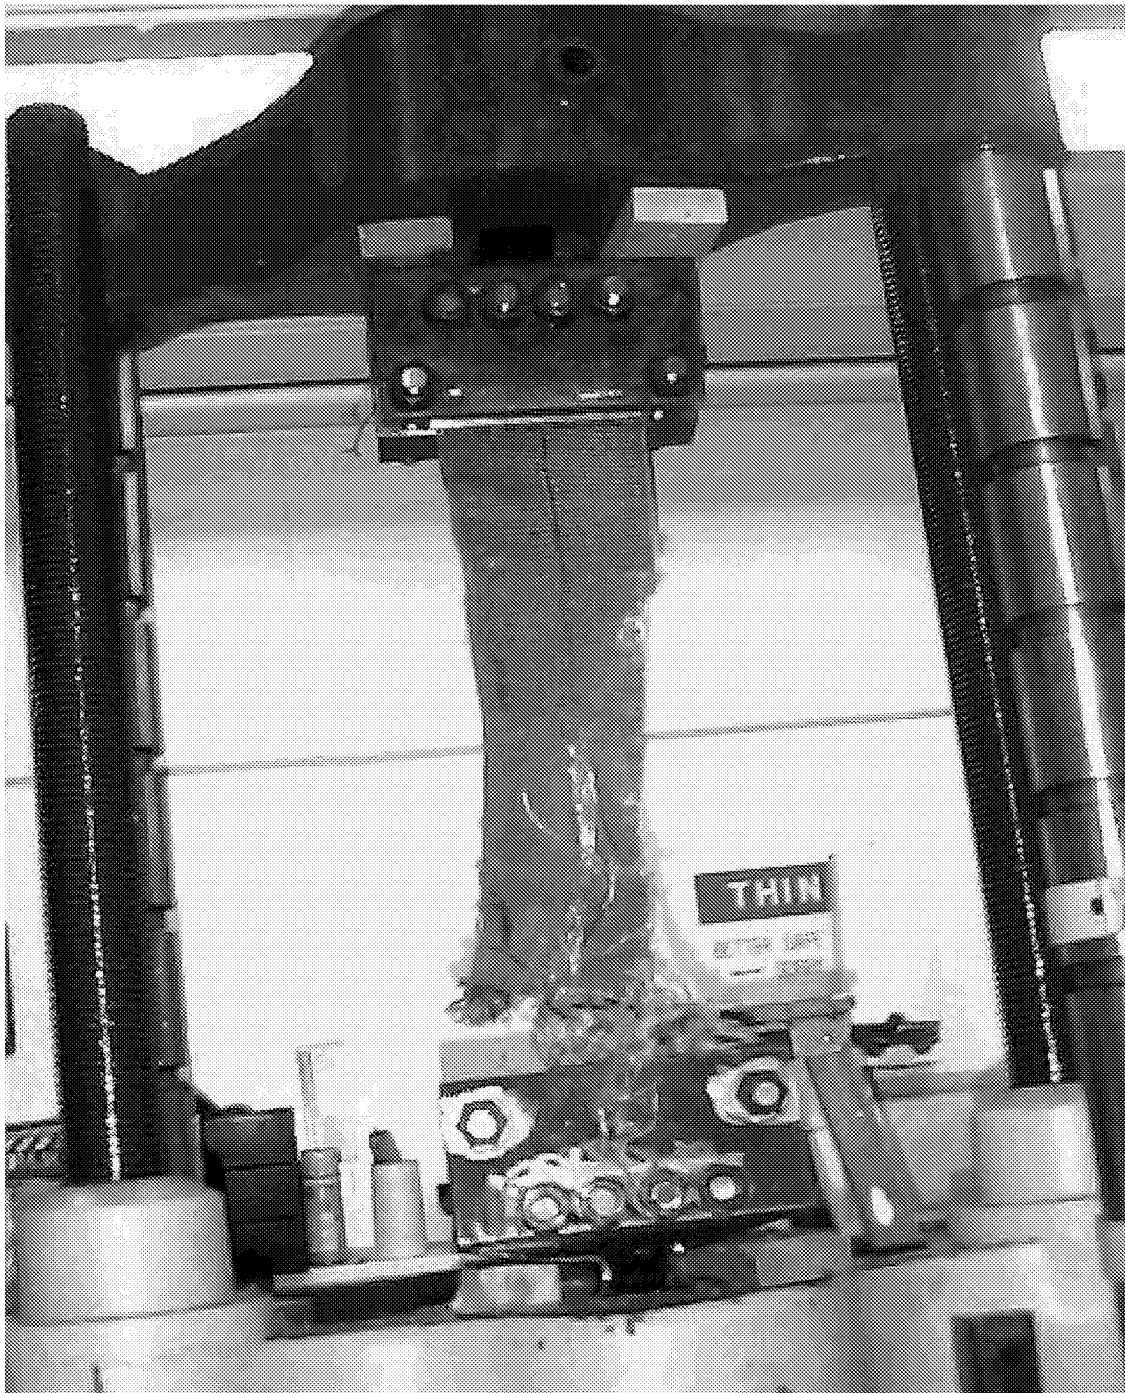
Figure 10. Arresting gear tape failure.

The testing machine was set to the maximum load capacity of 120 000 lb and a displacement transducer was mounted on the machine to measure deformation. A digital data acquisition system was used to collect data during each test. Loads were applied increasingly until failure occurred or the maximum travel length on the testing machine was reached. Most of the specimens failed at the grip fixture. A challenge was developing a fixture that did not cause the specimen to slip or fail at the fixture ends. The failure loads varied from 40 206 lb to 93 083 lb. Figure 10 displays a typical failed specimen.

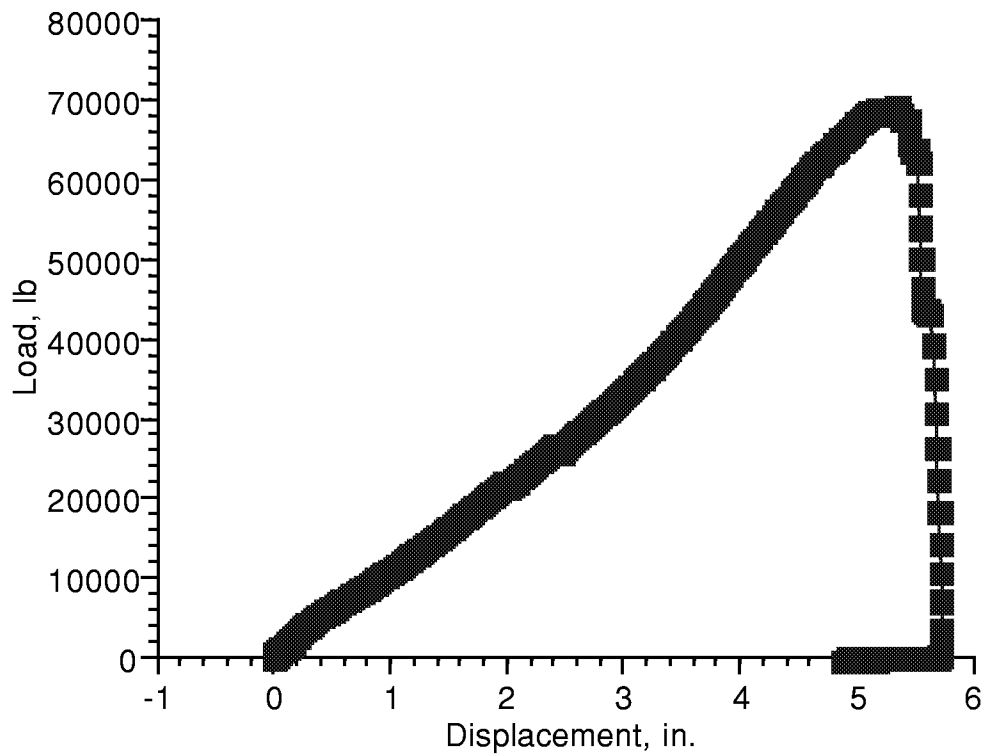
Specimens 12, 14, and 15, which exemplified tape failure, are now discussed. Figure 11 displays a load-displacement plot for specimen 12. The damage type for this specimen is transverse damage with minor edge fray. Specimen 12 failed at a maximum load of 69 048 lb. The minor discontinuity observed in the curve is possibly caused by internal fiber breakage of the specimen. Popping sounds were heard when the loads were approaching 20 000 lb.

Figure 11. Load-displacement plot for specimen 12 with transverse damage and minor edge fray damage.

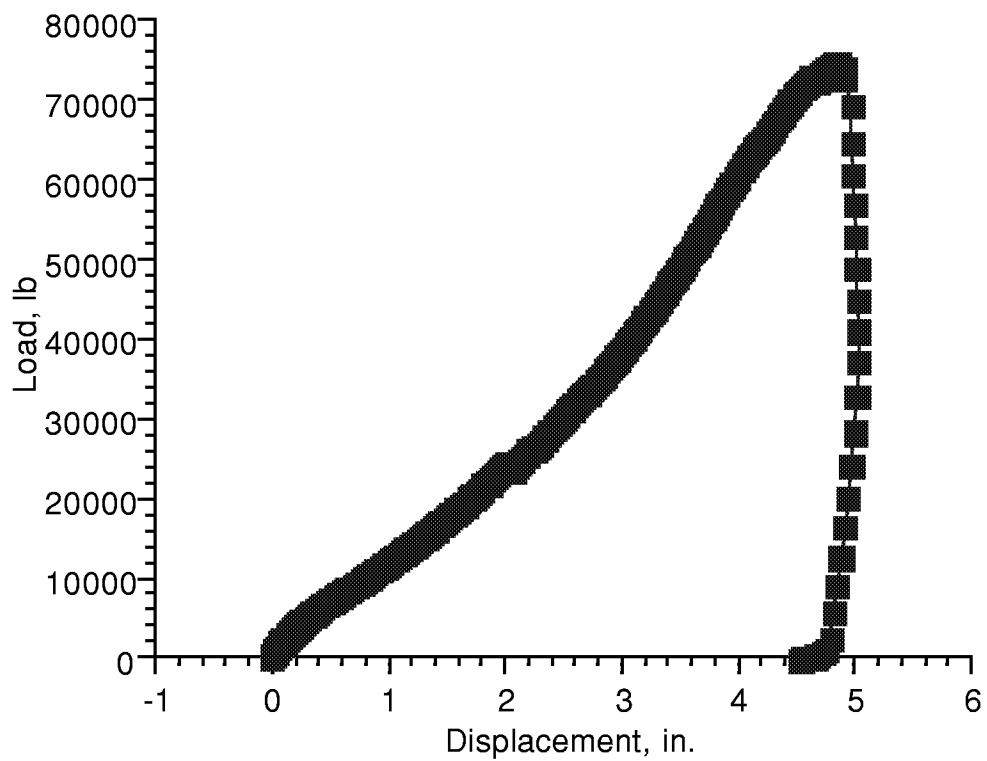
A load-displacement plot of specimen 15 is shown in figure 12. Specimen 15 exhibited transverse damage as well and failed at a maximum load of 74 634 lb. The curve in the figure shows some minor discontinuity approaching 25 000 lb. During the test, popping sounds were heard near these loads.

Figure 12. Load-displacement plot for specimen 15 with transverse damage.

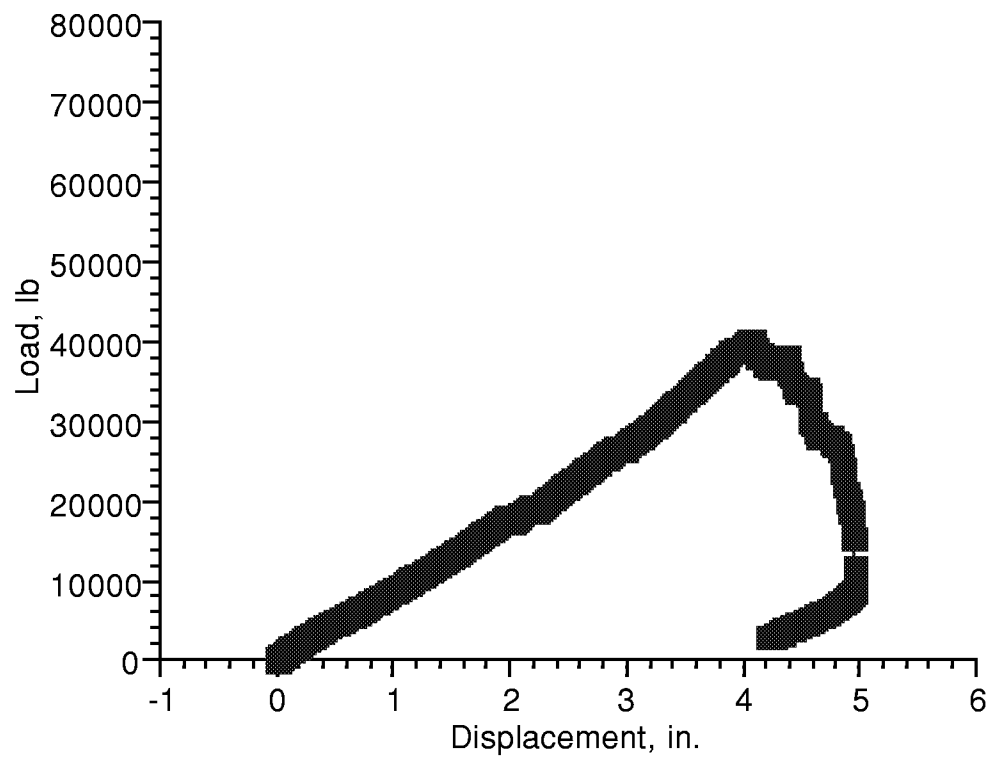
Figure 13. Load-displacement plot for specimen 14 with edge fray damage.

The specimens tested were characterized as exhibiting transverse damage and edge fray damage. The specimens with transverse damage failed at higher loads than the specimen with edge fray damage. This result suggests that if the arresting gear tape shows edge fray during the inspection procedure, consideration should be given to replacing the tape sooner than one with transverse damage. However, further tests should be conducted on specimens with both transverse damage and edge fray damage to acquire a larger data set before consideration is given to altering the inspection and replacement procedure.
