Hubble Space Telescope Thermal Blanket Repair Design And Implementation

ABSTRACT

Substantial damage to the outer layer of Hubble Space Telescope (HST) thermal blankets was observed during the February 1997 servicing mission. After six years in LEO, many areas of the aluminized Teflon® outer blanket layer had significant cracks, and some material was peeled away to expose inner layers to solar flux.

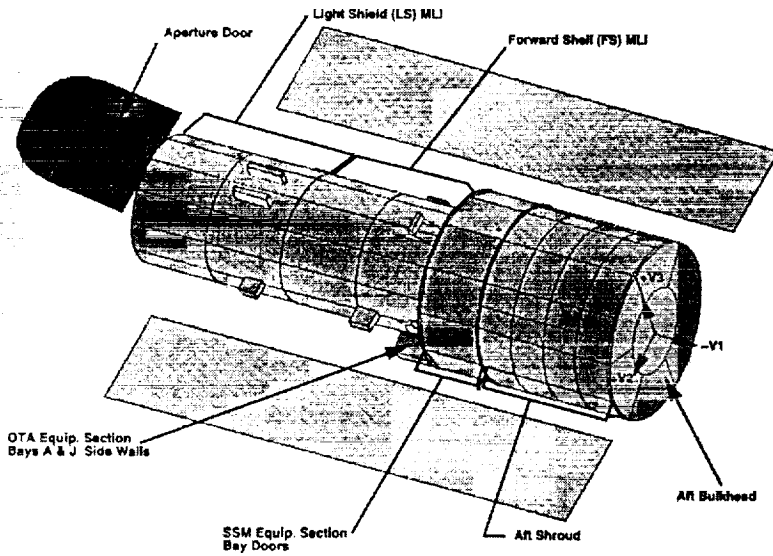
Figure 2 – HST layout

The areas most threatened by the MLI damage were the electronics bays on the sun side of the telescope, since some boxes in these bays had previously approached hot limits. The large tears and numerous small cracks on the sun side of the forward shell and light shield, along with the prospect of further degradation, led the FRB to recommend that these areas be repaired during the HST Third Servicing Mission (SM3). In both cases, the underlying MLI was not degraded, so installation of a new outer layer with proper material properties was determined to be adequate to restore the telescope thermal configuration.

Of the six bays on the sun side of HST (Bays 5 – 10 as shown in figure 2), four had flat doors (5, 7, 8, 10). The flat door NOBL material was bonded to a 1mm steel support frame conforming to the door bevel and shaped

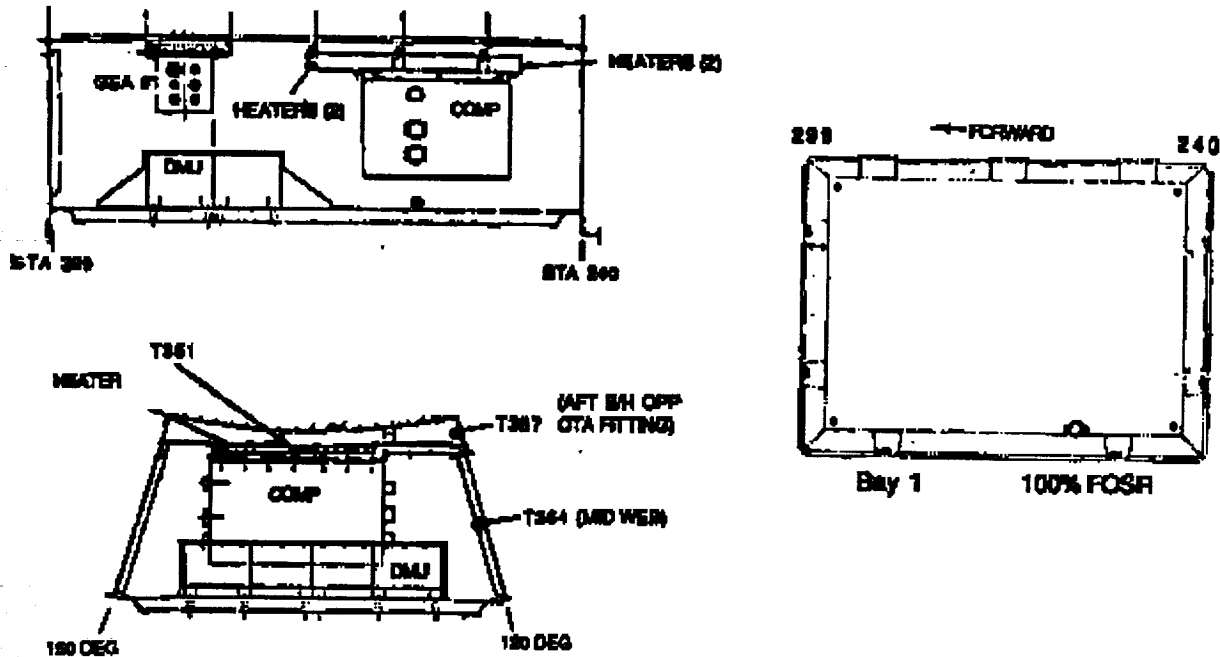
Figure 7 – Bay 1 Configuration

Bay 1 Thermal Study: This object of this study was to maintain Data Management Unit (DMU) temperature levels despite a large Bay 1 power reduction. The HST486 computer planned to be installed during SM3 dissipated about 30 watts, considerably less than the 119 watts dissipated by the old DF224/COP computer. Performance of the DMU was very sensitive to temperature, and the baseline temperature range provided optimum characteristics. To avoid increasing heater power consumption, it was decided to add an external MLI blanket or a shield in the form of a NOBL cover. Figure 7 presents the Bay 1 configuration with the DMU mounted on the internal door surface and the DF 224 computer mounted to structure off the tunnel. Figure 8 displays the DMU and HST486 computer temperatures and heater power requirements comparing the baseline thermal design with the DF 224/COP; an unchanged thermal configuration with a 35 watt HST486 computer; and a NOBL cover over 57% of the door with a 22 watt HST486 computer. The current DF 224/COP resulted in DMU temperatures between -2°C and 4°C with no heater power required. With the change to the HST486 computer at 35 watts, the DMU temperatures drop to -10°C to -7°C. The Bay 1 NOBL covering 57% of the door area with the HST486 at 22 watts results in DMU temperatures of -2°C to 3°C.

The Bay 1 NOBL design met its thermal design goal, maintaining DMU temperature level despite the 90-watt power reduction on the adjacent computer. The DMU temperature has averaged about -3°C, within its pre-mission range of -4° to +2°C.

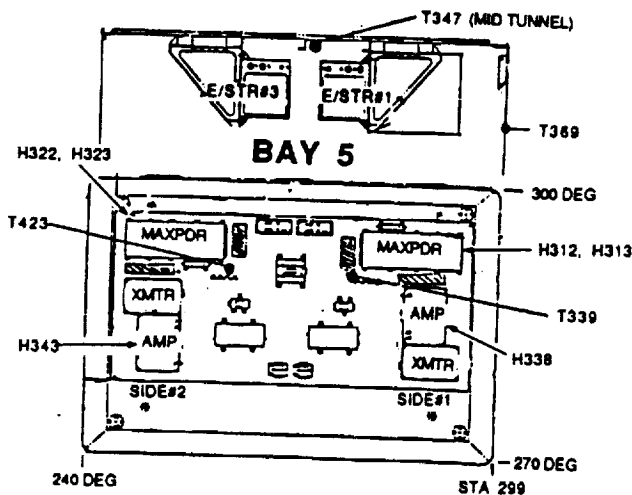
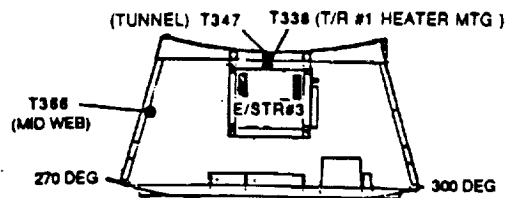
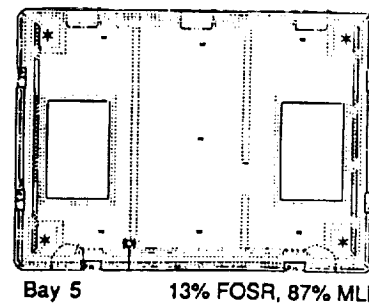
Figure 9 – SSM Bay 5 Configuration and Results

Bay 5 Thermal Study: The Bay 5 thermal study was conducted to help accommodate the higher transmitter duty cycles expected after SM3. Figure 9 presents the Bay 5 configuration with the transmitter components mounted on the internal door surface on an aluminum plate, two tape recorders mounted to structure off the tunnel, and the external bay door MLI pattern with 13% silver Teflon® radiators. Figure 9 also contains results from the MLI removal study performed with powers representative of one Solid State Recorder (SSR) and one tape recorder (ESTR). MLI removal before NOBL installation yielded a hot case temperature reduction of approximately 7°C for the transmitters, and about 5°C for SSR-1. The cold case heater power increase was 10 watts for the communications tray and 3 watts for ESTR-3. Bay 5 MLI removal was recommended to avoid reaching the transmitter temperature limits at end-of-life in hot conditions, with the expected increase in science data volume.

The effect of not repairing the outer layer of MLI is also shown on Figure 9 for four cases. With only the Bay 5 MLI outer layer of DAK, the transmitter temperatures increased to 16°C (a rise of 19°C) and the recorder temperature increased to 23°C. With a 30° roll, the recorder reached 40°C, close to its 43°C temperature limit. The condition with all +V3 bays DAK and a 30° roll

would result in the SSR-1 far exceeding its 43°C limit, reaching approximately 57°C.

COMPONENT	LIMITS	NOBL, NO MLI	ONE BAY DAK ONLY	ROLL, ONE BAY DAK	ROLL, ALL BAYS DAK
Transmitter	-18/60	-3	16	36	53
Tape Recorder	-12/43	12	23	40	<u>57</u>

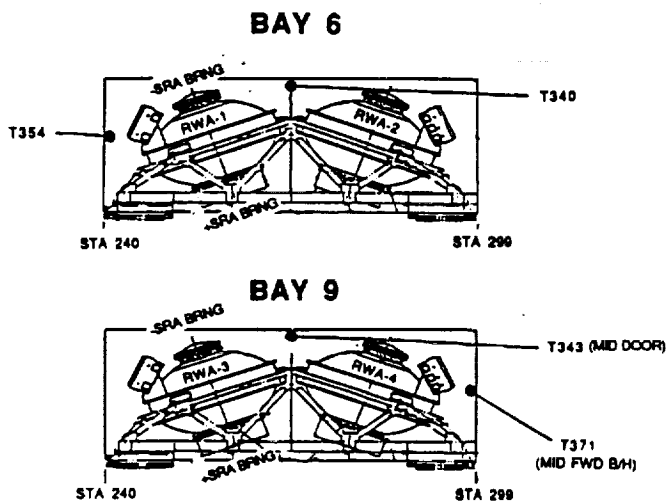
Figure 10 – SSM Bay 6 & 9 Configuration and Results

Bay 6 and 9 Thermal Study: Figure 10 presents the Bay 6 and 9 configuration with the two Reaction Wheel Assemblies (RWAs) in each bay. The Bay 6 door was 88% MLI covered, and the Bay 9 door had 81% MLI. (Bay 9 has a larger radiator because its adjacent bays are warmer.) RWA temperatures for the four cases studied are shown in Figure 10. The only limit exceedances occurred when all the +V3 bays are not repaired, and the MLI outer layer was DAK. With a 30° roll to the sun added on, the RWA temperatures got to 51°C (Bay 6) and 50°C (Bay 9), exceeding the 49°C limit. If +V3 NOBL installation were postponed, there could be roll constraints as the MLI DAK becomes exposed.

COMPONENT	LIMITS	NOBL, OVER MLI	ONE BAY DAK ONLY	ROLL, ONE BAY DAK	ROLL, ALL BAYS DAK
RWA (BAY 6)	-18/49	22	25	35	<u>51</u>
RWA (BAY 9)	-18/49	21	27	37	<u>50</u>

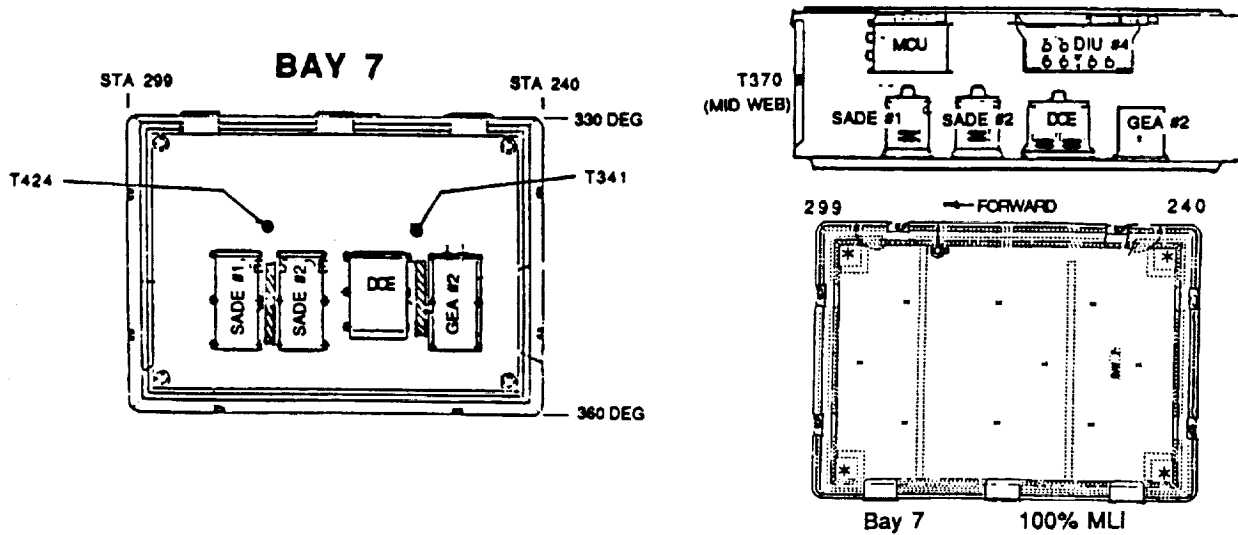
Figure 11 – SSM Bay 7 Configuration and Results

Bay 7 Thermal Study: Figure 11 presents the Bay 7 configuration with boxes mounted on the door internal surface and the tunnel structure. The Bay 7 door has always been completely covered with an MLI blanket. The impact of individual Bay 7 MLI with a DAK outer layer was large (about 20°C) since Bay 7 was directly in the sun. With the +V3 bays all DAK, three of the four boxes approached their 60°C limits. Adding a 30° roll would result in the GEA reaching its 60°C limit.

COMPONENT	LIMITS	NOBL, OVER MLI	ONE BAY DAK ONLY	+V3 BAYS DAK MLI
DIU	-40/60	21	37	50
GEA	-29/60	22	45	57
DCE	-34/60	22	45	56
SADE	-34/60	22	44	56

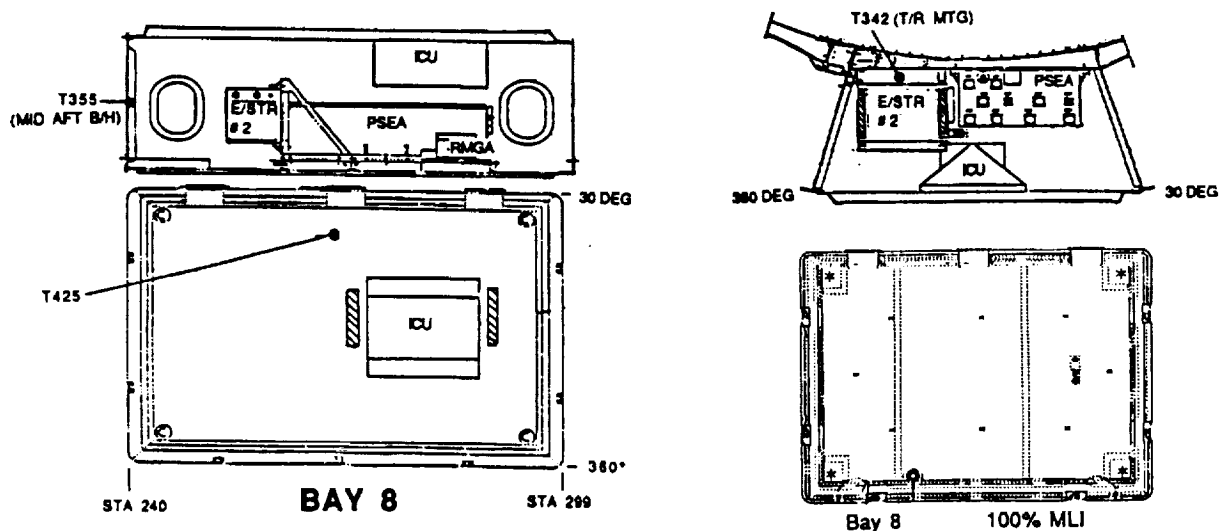
Figure 12 – SSM Bay 8 Configuration and Results

Bay 8 Thermal Study: The object of this study was to increase the bay heat rejection. The ESTR2 tape recorder has approached temperature during high solar flux and high duty cycle periods. Figure 12 shows the Bay 8 configuration with its boxes mounted on the door internal surface and the tunnel structure, and the Bay 8 door with 100% MLI blanket. Figure 12 also presents the Bay 8 thermal analysis results comparing the baseline MLI with aluminized Teflon® (α/ϵ ratio of 0.22/0.78) and the NOBL cover (α/ϵ of 0.13/0.67) for the hot cases at EOL. The addition of the NOBL cover with the lower α/ϵ ratio reduced the Bay 8 maximum temperatures by about 4°C. Removing the MLI from the door only reduced the maximum temperatures by 1°C to 2°C since the bay door outer surface has a low emittance. The cold case heater power increased to 28 watts with MLI removal. For these reasons, Bay 8 MLI blanket removal was not planned.

The impact to Bay 8 of not repairing the MLI outer layer is also presented on Figure 12. With the Bay 8 door MLI DAK outer layer, the Tape Recorder temperature increased to 35°C. With all the +V3 bays (5 to 10) door MLI outer layer of DAK, the recorder (50°C) exceeded its 43°C limit, and the PSEA (60°C) exceeded its 54°C limit.

COMPONENT	LIMITS	NOBL, OVER MLI	AL TEFLON OVER MLI	ONE BAY DAK ONLY	+V3 BAYS DAK MLI
Tape Recorder	-12/43	24	28	35	<u>50</u>
PSEA	-12/54	36	40	46	<u>60</u>
ICU	-30/60	18	22	33	48

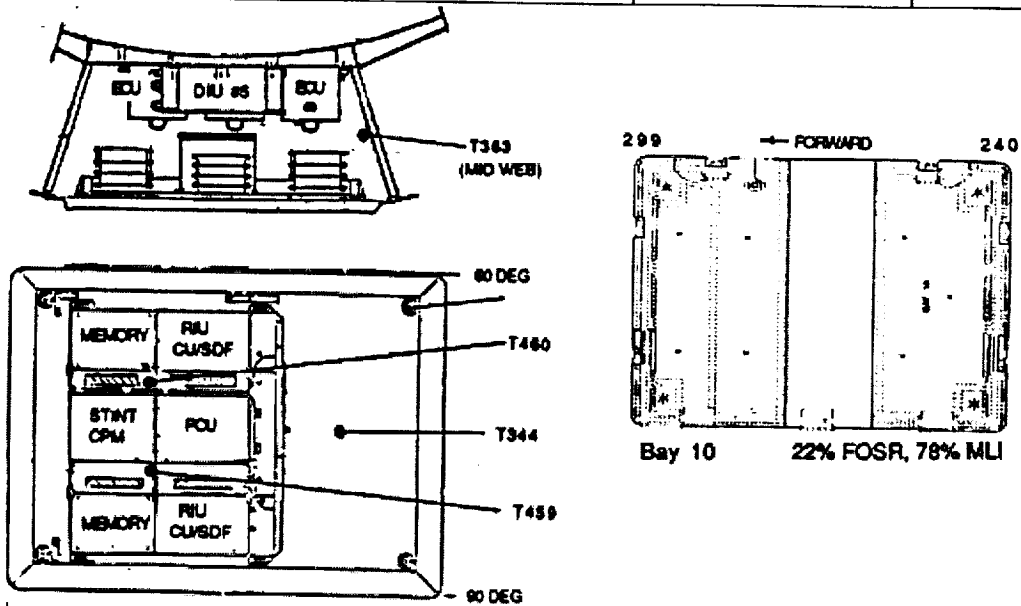
Figure 13 – SSM Bay 10 Configuration and Results

Bay 10 Thermal Study: The object of this study was to increase the bay heat rejection. During high tasking periods for the Scientific Instrument Command and Data Handling system (SI C&DH), high box temperatures have occurred, so science mission schedules were

reviewed for potential problems. If the ACS (Advanced Camera for Surveys) were to be added as planned during a future servicing mission, there would be higher SI C&DH duty cycles, thus hotter conditions. Figure 13 shows the Bay 10 configuration with the SI C&DH tray mounted on the door internal surface and four boxes mounted to the tunnel structure. The Bay 10 door with two MLI blankets and 22% door area silver Teflon® radiator is also shown. As presented in Figure 13, with the Bay 10 door MLI outer layer of DAK, the SI C&DH component temperatures increased to 27°C for the memory units and to 41°C for the SDF with current power levels. With a 30° roll with individual Bay 10 MLI outer layer of DAK, the temperature of the Memory Units increases beyond its 41°C limit to 45°C. With the higher SI C&DH duty cycles forecast, further increases in Memory Unit and SDF temperatures would be expected. With the NOBL cover installed and both MLI blankets removed, maximum temperatures were reduced by 5°C, and no heater power was required in the cold case. Since NOBL installed over the MLI produced no benefit, MLI removal followed by NOBL installation was recommended.

COMPONENT	LIMITS	NOBL, NO MLI	ONE BAY DAK ONLY	ROLL, ONE BAY DAK
Mem. Units	-10/41	16	27	45
SDF	-10/70	32	41	59
ECU	-24/60	20	28	44
