AIAA 2000-3898

**Development Status of the NASA MC-1 (Fastrac) Engine**

# Development Status of the NASA MC-1 (Fastrac) Engine

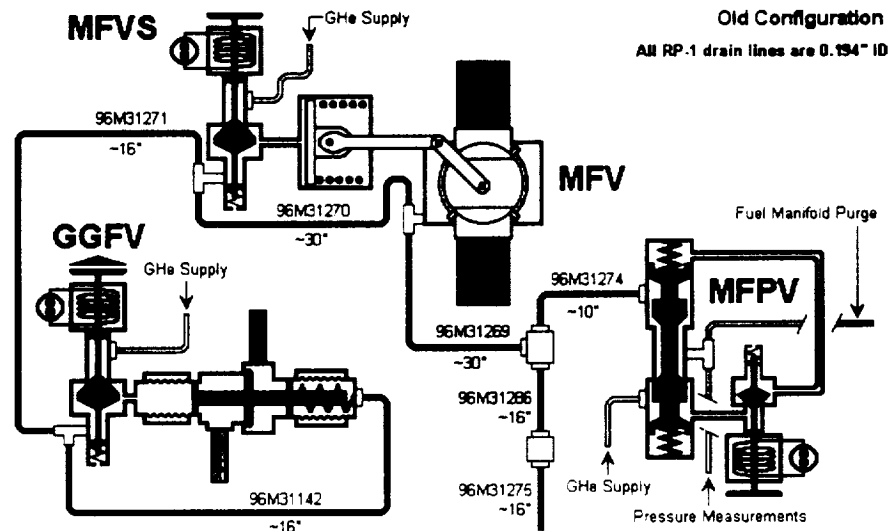
Figure 3: Old Vent Line Configuration

**MFV Cycling Anomaly** - During Firing Readiness Test (FRT) operations prior to test H0-4R, it was noted that the MFV cycled open without being commanded by the Propulsion System Controller (PSC). Testing was discontinued until it could be determined 1) if the MFV had actually cycled; 2) how it had cycled without being commanded; 3) how to prevent this event from reoccurring in the future. This caused significant concern due to the possibility that the root cause might allow other valves (esp. MOV) to cycle without being commanded. It was verified that the MFV did cycle without any command being issued by the controller. It was fortunate that the event occurred during the FRT, when no propellants were in the system. A fault tree was developed and investigated, pointing to the possibility that the MFV pneumatic piston may have been actuated by pressure from the MFPV vent port through the RP-1 drain lines and entering the pneumatic piston through the MFVS vent port. Because the drain lines are not

instrumented, verification of this failure mode was not possible. Part of the investigation involved a series of FRTs to cause the event to occur again, but it did not.

On the possibility of the existence of a "sneak circuit" between the vents of the MFPV and MFVS, the drain lines were separated to eliminate it. Lines 96M31270 and 96M31142 were separated from the 96M31274 MFPV drain line, shown below in Figures 3 and 4. To date, this anomaly has not recurred.

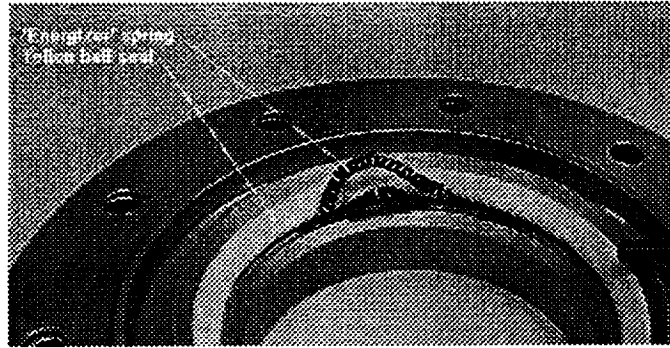
Figure 5: MFV Ball Seal Energizer Spring Extrusion

**MFV Seal Failure** - Immediately following shutdown on test H1-5b, some post-burning was noted in the main chamber for several seconds. The RP-1 afterburn stopped when the RP-1 facility preclude closed as part of the normal facility shutdown. Review of the test data showed that during shutdown the MFV left the OPEN switch but did not arrive at the CLOSED switch. This allowed fuel to enter the chamber after shutdown. The MFV was removed and inspected, which revealed the ball seal energizer springs extending into the flowpath (Figure 5), preventing the MFV from closing completely at shutdown. In addition, the ball had been scratched by the springs when it tried to close.

The MFV was shipped to the vendor for inspection and investigation. A serious concern with respect to this incident was that the MOV used a similar design and ball seal, and if it too failed, would cause a much more catastrophic event. Review of the seal design and water-flow tests revealed that the seal material was too flexible at ambient temperatures to maintain effective capture of the energizer springs. The heritage of the valve was adapted from an MOV design used on the RL10 engine and had been qualified for use under cryogenic temperatures when the material used in the seal is significantly stiffer. Because the GHe spin start pressure had been increased during the course of development testing to ensure adequate startup power to the turbopump, the pressure produced by the fuel pump at start had also increased, causing a high  $\Delta p$  across the valve when it initially opened. The reduced stiffness of the seal material degraded the ability of the seal to retain the energizer springs, which were extruded under the high  $\Delta p$  loading at start. As a corrective action, the ball seal design was modified to use a different material which had better stiffness at ambient temperatures.

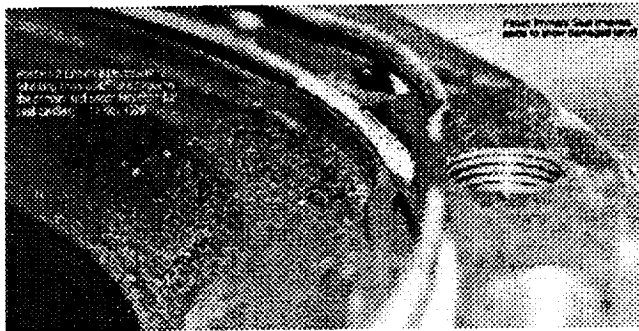
Figure 7: Damage to Chamber/MINJ Interface

**H4-3 Pop Anomaly** - During hotfire testing to simulate the thermal environment at X-34 vehicle launch (i.e., "Cold Box"), the main chamber and injector of an MC-1 engine was damaged (Figure 7). This was revealed during post-test hardware inspections and engine data review, although the engine itself had operated for the full planned duration. A subsequent investigation suggested that the most probable cause of the event was the presence of residual fuel in the main chamber during engine start (Figure 8), which collected in the acoustic cavity following the previous test and detonated when LOX was introduced into the main chamber during the start sequence. It was also determined that this was not a flight issue, as the nozzle will be replaced after each flight, eliminating the risk associated with residual RP-1 accumulation in the acoustic cavity. Recurrence control included the establishment of requirements to inspect and remove residual fuel from the main chamber prior to hotfire testing.
