Development Status of the NASA MC-1 (Fastrac) Engine

AIAA-2000-3989

Development Test Summary

Lessons Learned During Testing

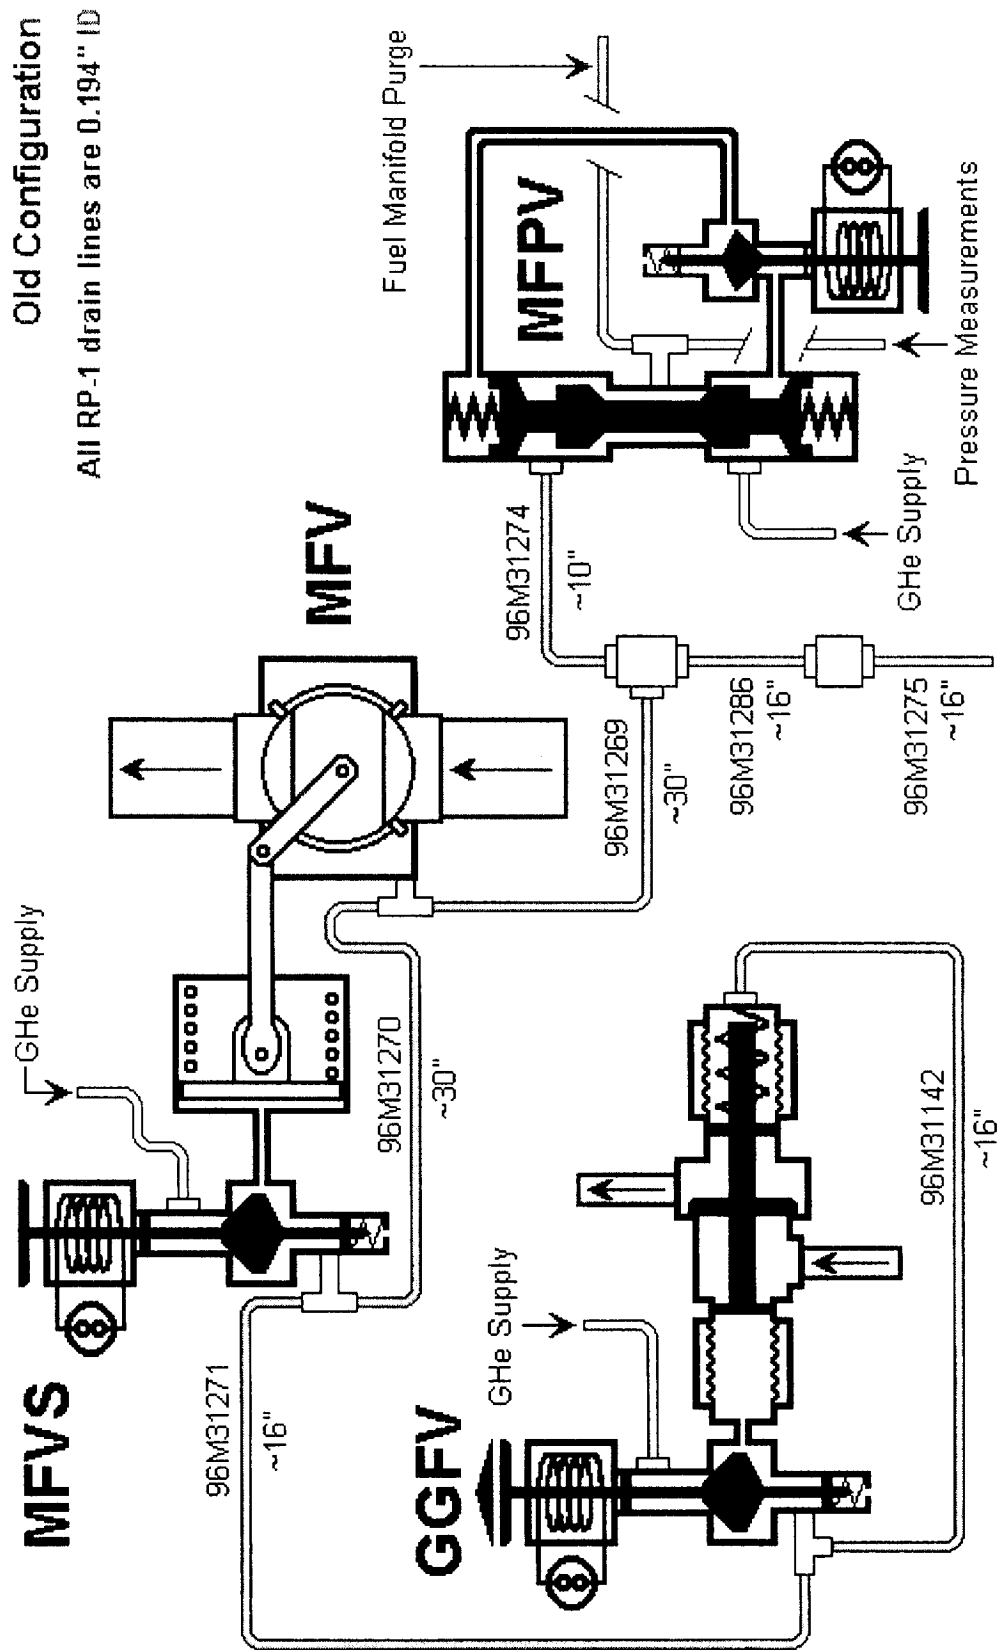
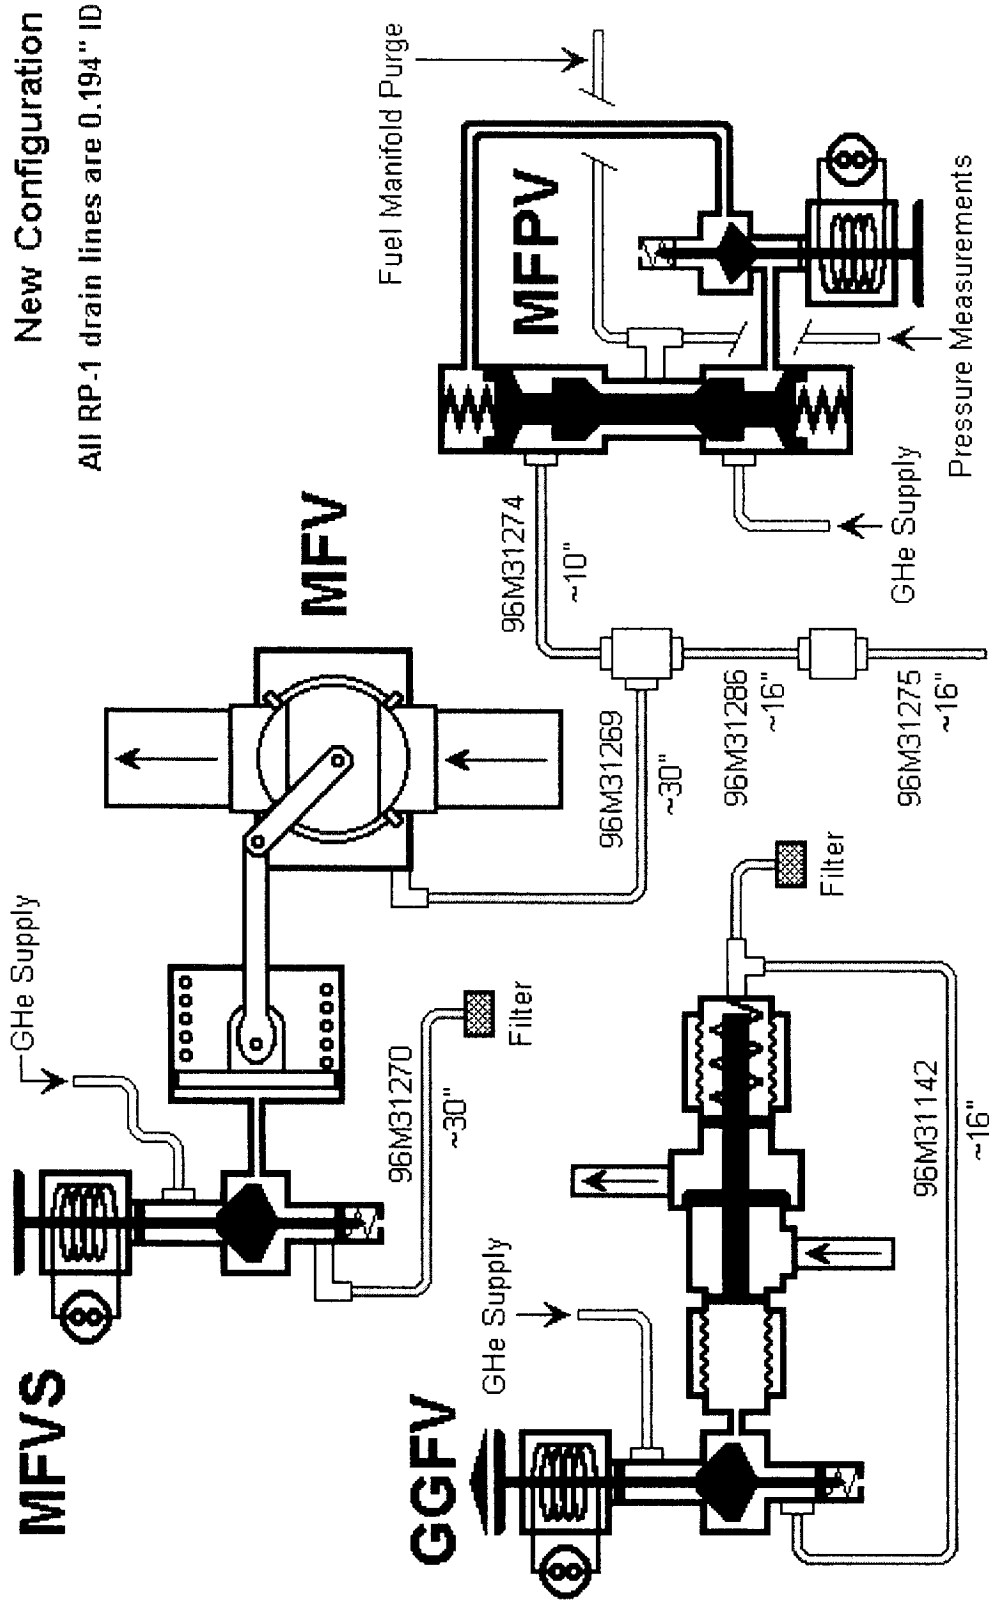
- MFV Cycling Anomaly (FRT Pre-H0-4R)
- Slow OBV Closure Performance
- MFV Seal Failure (Test H1-5b)
- GGFV Seal Failure (Test H3-1a)
- Start Sequence Modifications
- H4-3 Pop Anomaly

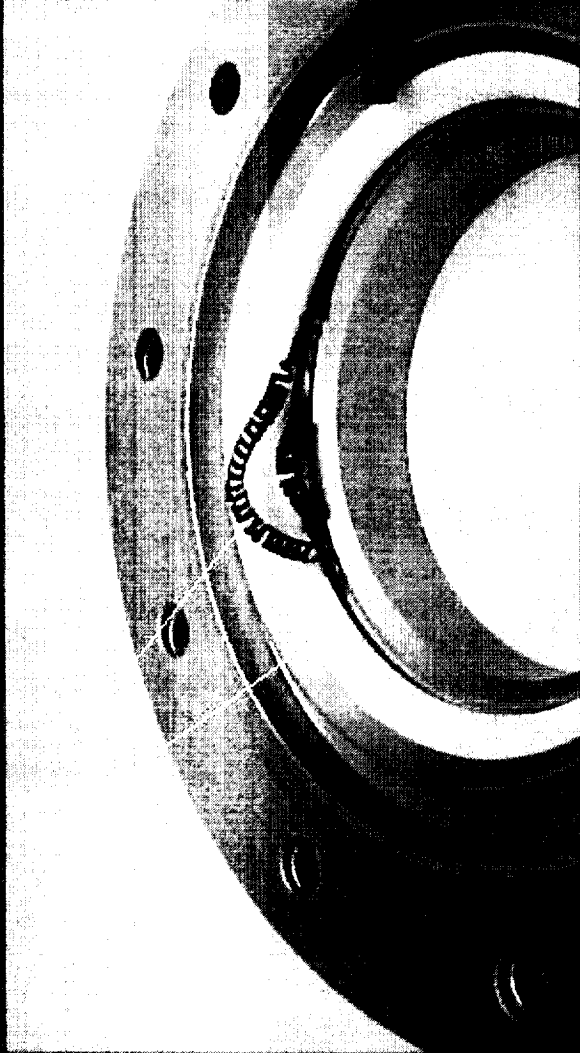
MFV Seal Failure

Scratches on MFV ball caused
by extruded ball seal and spring

MFV Inspection H1 5b
Allied Signal 6 Mar 1999
