STRUCTURAL RESPONSE AND FAILURE OF A FULL-SCALE STITCHED GRAPHITE-EPOXY WING

Dawn C. Jegley and Harold G. Bush
NASA Langley Research Center
Hampton, VA

Presented at the AIAA/ASME/ASCE/AHS 42nd Structures,
Structural Dynamics and Materials Conference

AIAA Paper No. 2001-1334-CP
Seattle, WA

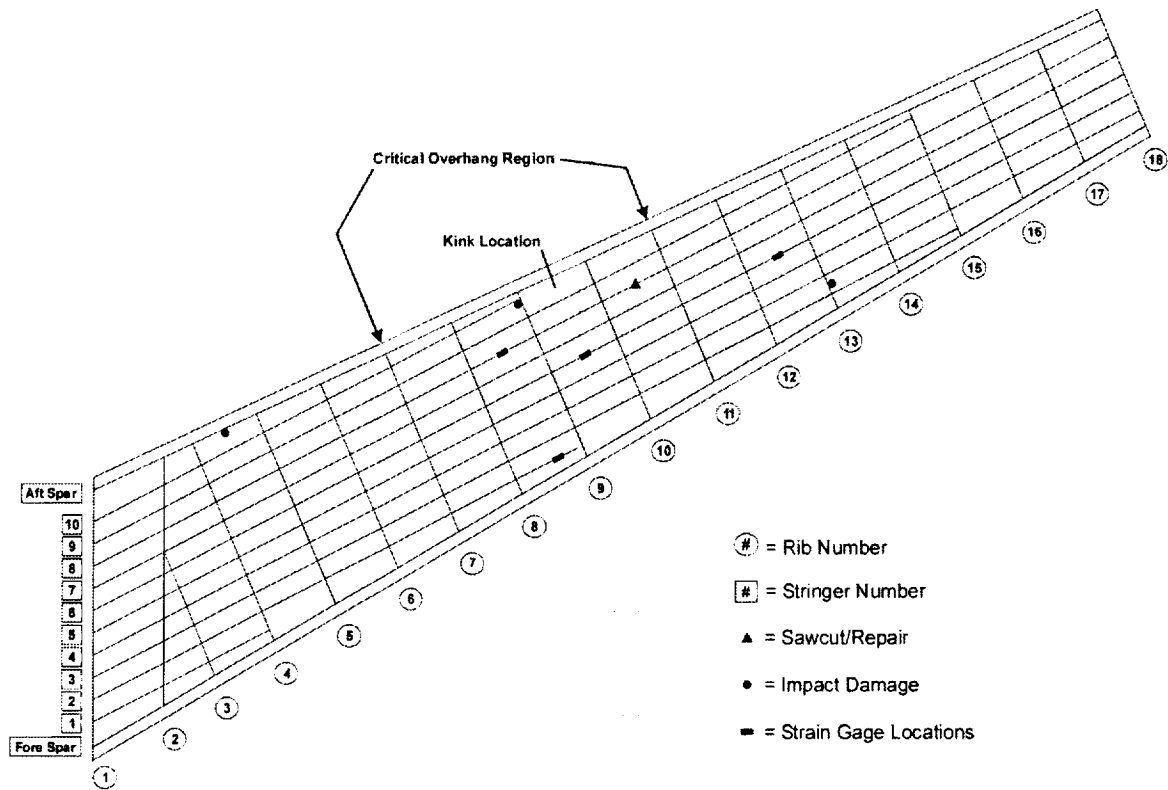
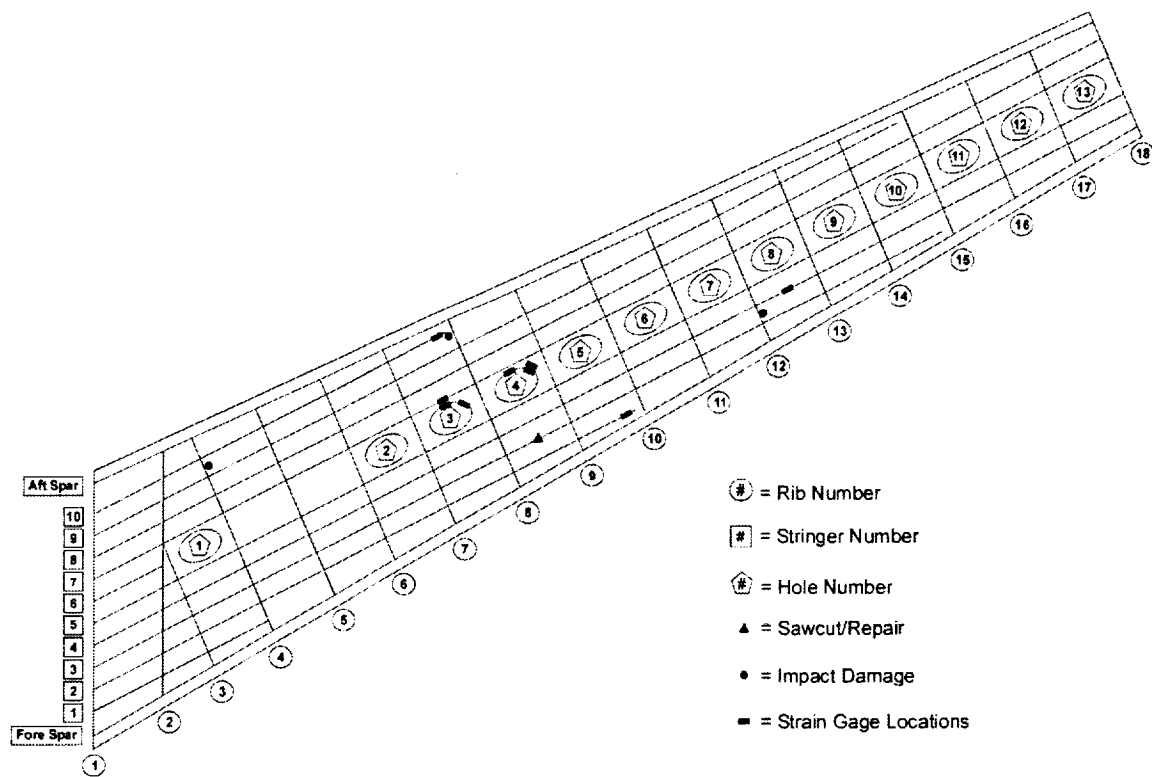
Fig. 2. Upper and lower panel configuration and strain gage locations.

An air-propelled steel projectile was used to inflict three impacts with an energy level of 83-84 ft-lbs to the lower cover panel. The locations of these damage sites are shown in figure 2b. A steel sphere with a 0.5-inch diameter was accelerated to a speed of approximately 545 ft/sec, resulting in clearly visible damage with dent depths up to 0.135 inches.

The wing was subjected to discrete source damage in the form of seven-inch-long sawcuts to the upper and lower cover panels, as shown in figure 2. Each sawcut ran through two stringer bays and cut through a stringer. Metal patch repairs were used to restore the wing to full load-carrying capability. The

damaged region was removed prior to implementing the repair. The repairs consisted of a metal plate which conformed to the wing surface on the outer surface of the cover panels and internally spliced stringers. All parts of the repair were attached to the wing with mechanical fasteners.

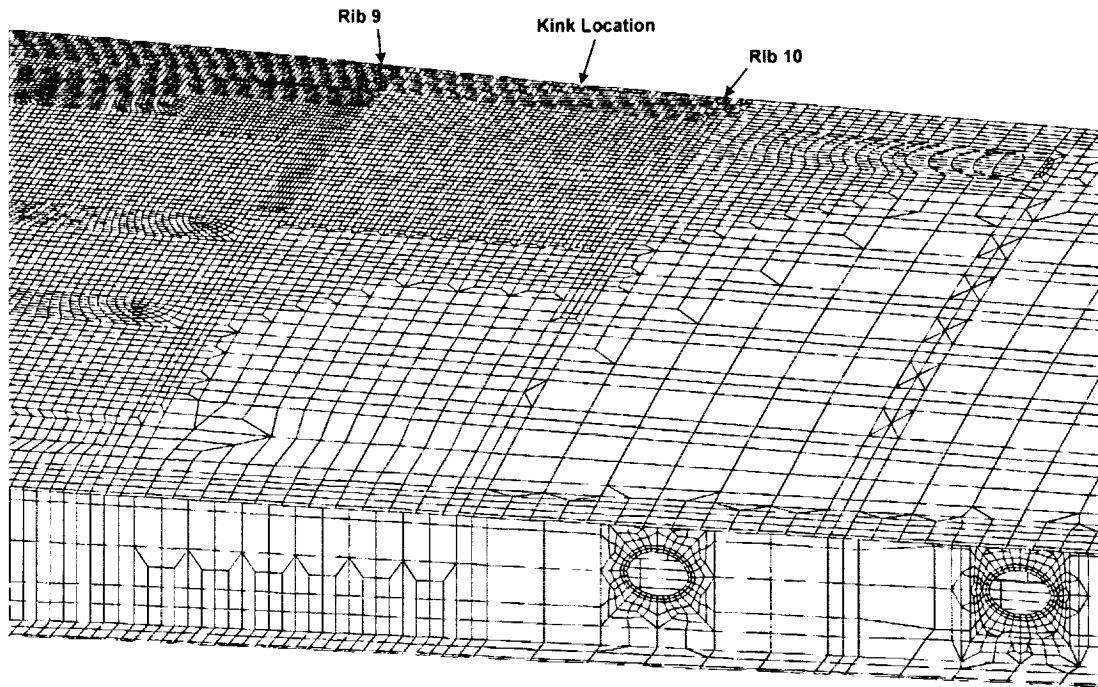
Fig. 16. Finite element model of kink region.

An overhang of the cover panels with a width of approximately four inches behind the rear spar left an unsupported edge along the length of the test article. This region is shown in figure 2a as the "critical overhang region." A small initial geometric imperfection in the form of a kink in the upper cover panel was present in the as manufactured structure.

This kink is centered half way between ribs 9 and 10 and has a maximum depth of 0.1 inches. The kink was initially considered minor enough that it would not influence the cover panel structural behavior. However, since the kink is in close proximity to a stringer runout and is in the region of the upper cover panel that displays nonlinear behavior, the kink influenced the behavior of the overhang region. Therefore, the kink was included in the post-test finite element model. This local refinement is shown in figure 16. The kink is a geometric imperfection in the skin.

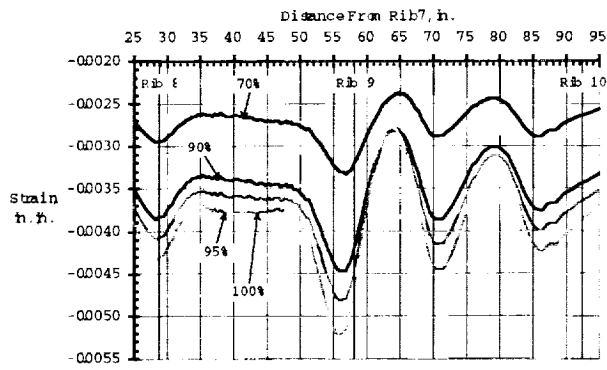
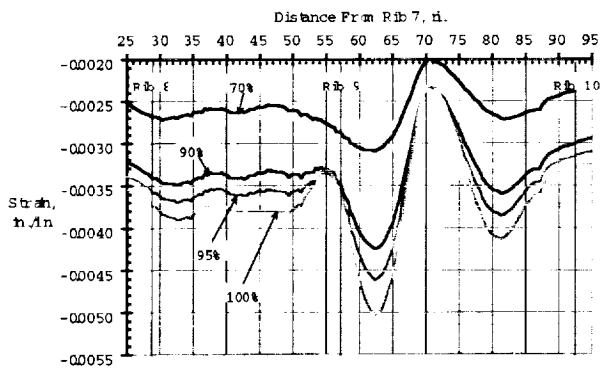
Fig. 17. Strains in the upper cover overhang region aft edge at several values of percent DUL.

Calculated strains along the rear overhang of the upper cover for the outer and inner skin surfaces for load levels of 70%, 90% and 95% and 100% DUL are shown in figure 17. Reversal of strain occurs in several places along the exterior cover surface. Strain reversal for the outer skin surface occurs 6-8 inches outboard of rib 9. Strain reversal for the inner skin surface occurs from 1-4 inches inboard of rib 9 and 13-15 inches outboard of rib 9. There were very few strain gages in this region, and hence experimental results are not presented.

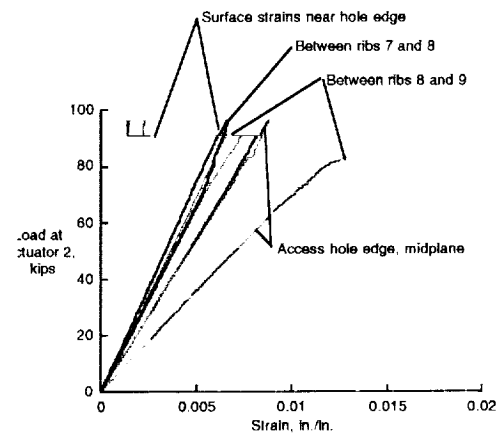
Fig. 18. Measured strain results at the edge of critical access holes.

Strain gages at the edges of the lower cover panel access holes indicate high strains at these locations. Measured strains at the outboard, rear corner of access holes 3 and 4, between ribs 7 and 8 and ribs 8 and 9, respectively, are presented in figure 18. The strain gage locations are shown in figure 2b. Nonlinearity in the load-strain behavior can be seen at these access holes. The most significant nonlinearity is at the outboard corner of access hole 4. The largest measured strain is at this location and is approximately 0.0096 in./in. at DLL. Final failure of the cover panel ran through this location. Since analytical results to date do not adequately capture the failure, comparisons of these strains for the access hole edges are not done with experimental results.
