NASA/TM—2002-211509

RQL Sector Rig Testing of SiC/SiC Combustor Liners

Michael J. Verrilli and Lisa C. Martin
Glenn Research Center, Cleveland, Ohio

Combustor liners, manufactured from silicon carbide fiber-reinforced silicon carbide, (SiC/SiC), were tested for 260 hrs using a simulated gas turbine engine cycle. This report documents the results of the last 56 hours of testing. Damage occurred in one of the six different components that make up the combustor liner set, the rich zone liner. Cracks in the rich zone liner initiated at the leading edge due to stresses resulting from the component attachment configuration. Thin film thermocouples and fiber optic pyrometers were used to measure the rich zone liner's temperature and these results are reported.

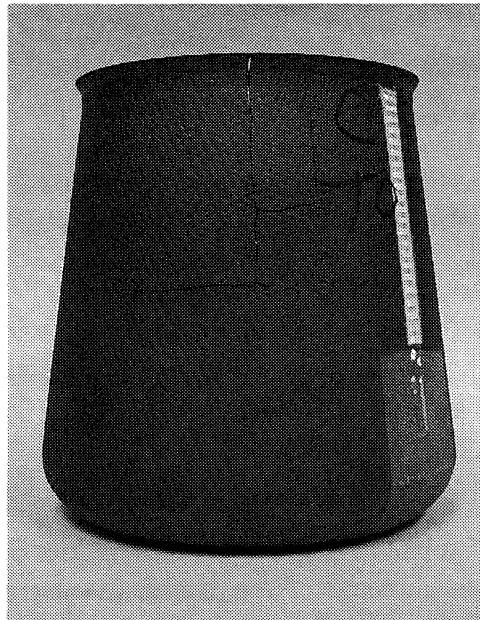
Cracking was found after the first test run of 7.5 hours in the CR side RZL (555-07-009). The crack initiated at the leading edge, grew about 2-3/4 in. along the flow direction, and bifurcated, turning 90° (i.e., in a circumferential direction). Another 90° crack branch existed about 1-3/4 in. from the leading edge (Figure 7). Propagation of these circumferential cracks was observed after the second test run of 8 hours.

Figure 7 – Post test picture of cracking in rich zone liner 555-07-009. Note the thin film thermocouple and wire leads.

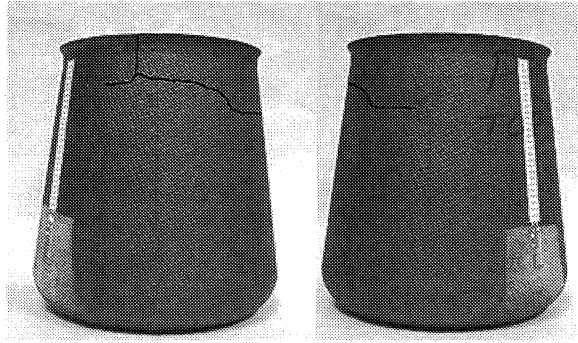
After the second test run, cracking that initiated at the leading edge was detected in the PL side RZL (555-07-010) as well. The crack was about 3/4 in. long, in a direction parallel to the flow direction, and it bifurcated. The circumferential portion of this crack spanned over 90° of the RZLs circumference, Figure 8. Relative displacement of the crack faces perpendicular to the flow direction was imaged with the boroscope. To avoid further damage and potential RZL failure during subsequent testing, both RZLs were removed and replaced with new ones. The replacement PL-side RZL (253-07-210) developed a leading edge crack after the third test run. Boroscope inspection after the fourth run imaged a second leading edge crack, 180° apart from the initial crack. The second crack initiated on a fiber cloth splice that was visible on the inner diameter of the RZL (Figure 9). Continued propagation of these two cracks was

Figure 8 – Post test pictures of rich zone liner 555-07-110, a) initiation site of crack at leading edge and branching in a circumferential direction, b) rotated view the can, showing the location of the crack tip.

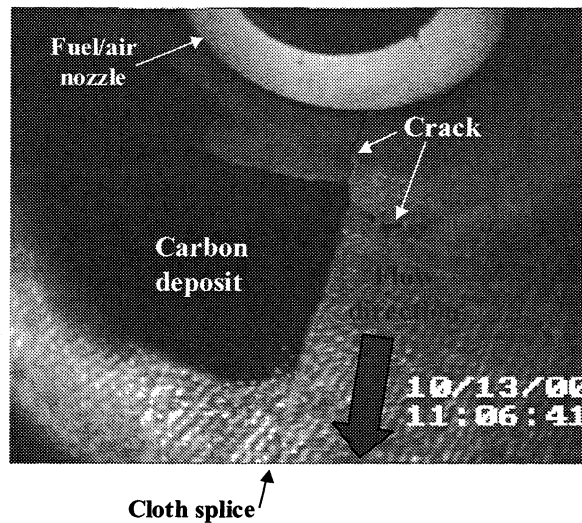
Figure 9 – Boroscope image of the ID of rich zone liner 253-07-210 showing crack initiation and growth from the leading edge on a ply splice.

observed after the fifth run. Both cracks were about 2 in. long, with a 90° branch. These branches were along circumferential directions. Also, a leading edge crack was now visible in the replacement CR-side RZL.

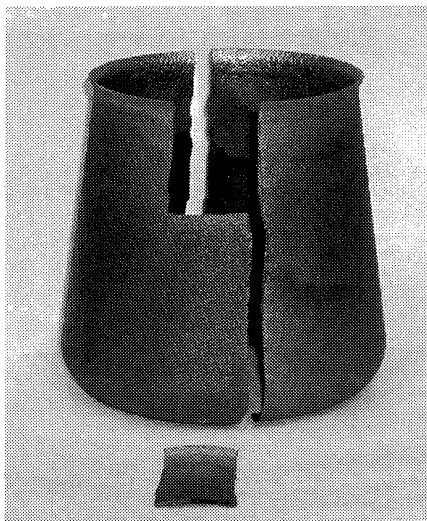
Inspection after the sixth run revealed that failure of the PL-side RZL occurred. An independent 2 in. long by 1-3/4 in. wide section was created when a new leading edge crack linked with an existing crack that had turned in a circumferential direction (Figure 10). Testing was suspended due to this damage. Note that the extensive cracking caused the RZL to split into two halves upon removal from the sector rig.

Figure 10 – Post-test view of PL-side RZL (253-07-210) showing damage that occurred after 40.5 hours of testing.

ranked lower than the six tested in 1999. In particular, the last PL-side RZL (253-07-210) that failed (Figure 10) had the lowest rank of the ten.

Two rich zone liners failed during initial testing of the sector rig. A significant force interaction occurred between the rich zone liners and the spring holding them in place at the leading edge, resulting in the failure (ref. 1). After the spring was redesigned to be more compliant, catastrophic failure did not reoccur. In the present study, crack initiation at the leading edge was observed for all RZLs. It appears that the modified spring attachment method needs additional alteration to reduce the axial and hoop loading on the cans and thus eliminate cracking.

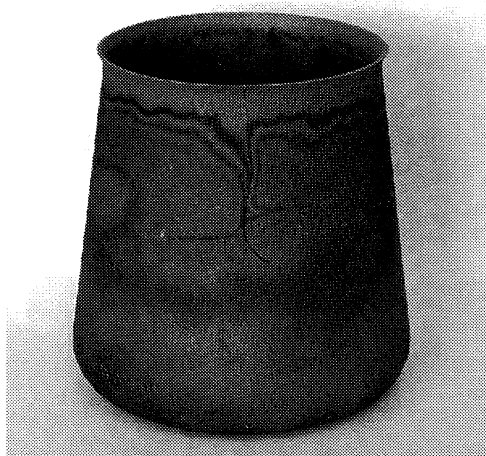
Figure 11 – Post-test image of CR-side RZL (555-07-005). Note the oxidation and crack originating from the leading edge.

A post-test image of the replacement CR-side RZL is shown in Figure 11. Similar to the PL-side RZL, a 2 in. leading edge crack that turned 90° exists.

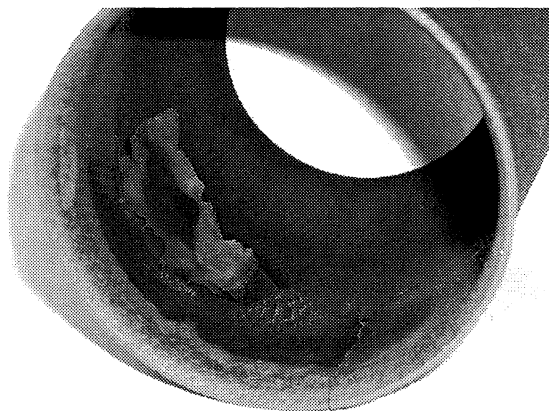
Carbon deposits are present in every tested RZL (Figure 12). Boroscope inspections revealed that carbon deposits form during the initial test exposure and grow with continued testing. Once formed, these carbon deposits typically remained on the ID of a RZL unless they grow significantly in a direction normal to the flow. In these cases, the forces of the flowing gas stream fracture the carbon deposits. Evidence indicating the results of carbon deposit growth and fracture was the large quantities of carbon nuggets that accumulated in the cooling water used downstream of the combustor.

Figure 12 – Carbon deposits and cracking in CR-side RZL (555-07-005) after 40.5 hours of testing.

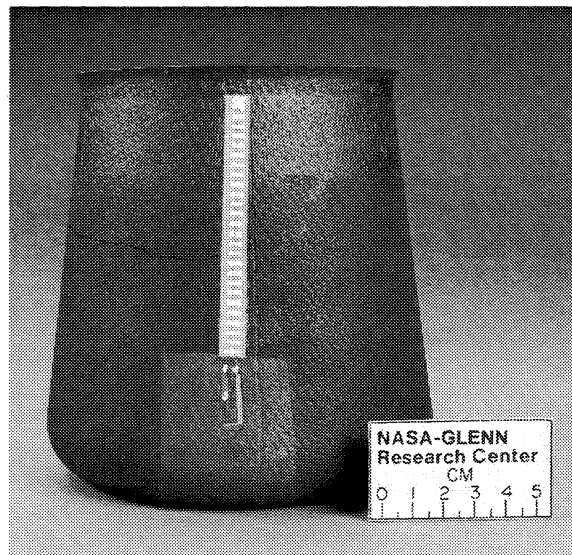
Figure 16 – Condition of a thin film thermocouple on a rich zone liner after combustion exposure.

Post-test analysis of the thermocouples revealed that the thin film thermocouples were intact and electrically continuous. There appeared to be very little physical damage to the films (Figure 16). However, the welds that held the platinum-13% rhodium wires to the films failed. The aluminum oxide insulation films were intact for all but one of the thermocouples. The fourth thermocouple had some flaking in the aluminum oxide film, resulting in lowered

electrical resistance in the film. Despite cracking in the rich zone liners, the leadwires that extended the length of the hardware were still intact and continuous. Because the wires that extended beyond the edge of the RZLs were damaged during removal from the test rig, these wires could not be evaluated.

The post-test analysis of the sensors indicated that the thin films and leadwires survived the test conditions, however the welds between the wires and thin films did not. The wires did not maintain full and intimate contact with the films. This may have contributed to the erratic data that occurred during the temperature increase after the combustor was lit. In particular, the platinum-13% rhodium wires failed to remain in contact with the films. This may have been due to oxidation of the rhodium in both the wire and the exposed film. During sensor fabrication, the film was not completely covered by the protective aluminum oxide overcoat to allow attachment of the leadwires. The degradation in the output signals during high temperature exposure may have been caused by a change in the composition of the exposed films and fine wires. Analysis of the thermocouple data indicates that the connections between the wires and films failed prior to the initiation of the actual sector testing, during the initial period during which the hardware was exposed to high temperature, high flow air. The

While the thin films proved to be physically durable during this testing, the failure of the wires and the degradation in the signal output demonstrates that the thin film-to-leadwire connections need to be improved for durability and the thin films need to be more fully protected from the harsh test environment.
