NASA/CR-2002-211774

Design and Test of an Improved Crashworthiness Small Composite Airframe

James E. Terry
Terry Engineering, Andover, Kansas

August 2002

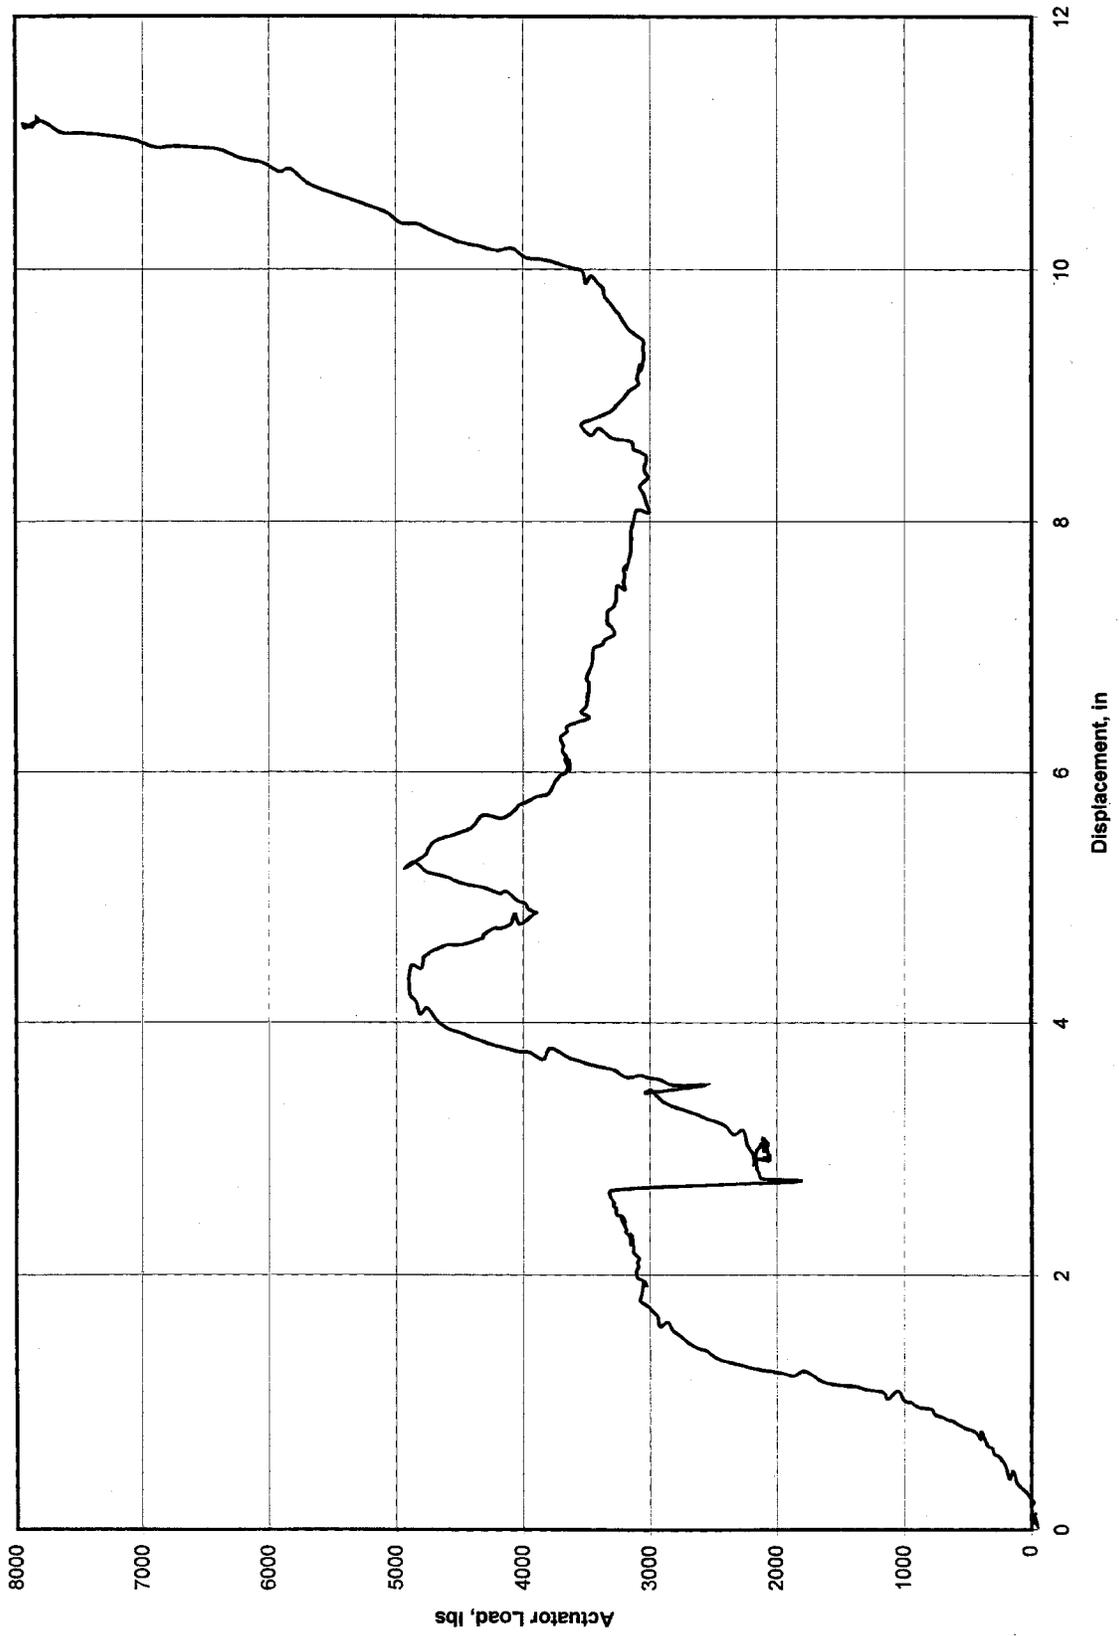
Figure 10, Half Scale Mount 3 Test Data

Tube sizes were further reduced for mount 3 and it showed a progressive failure pattern but with less load than desired (Figure 10).

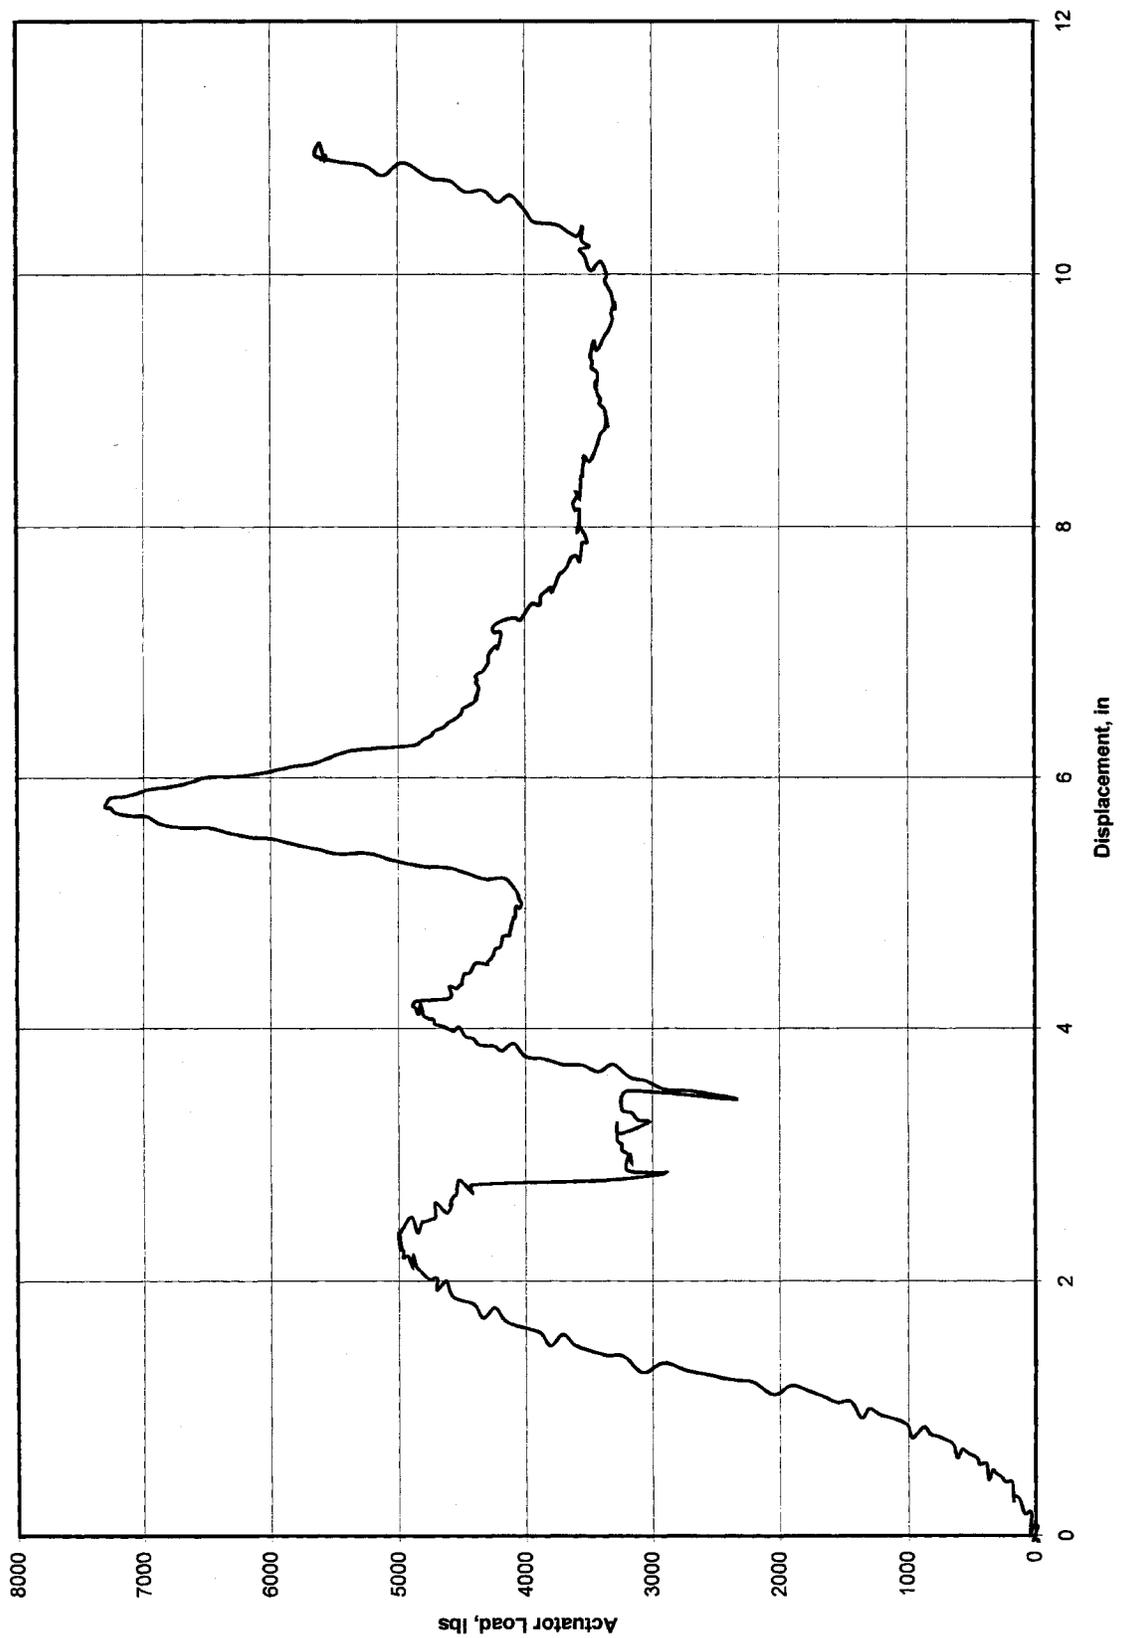
Figure 11, Half Scale Mount 4 Test Data

Several tube sizes were increased for mount 4 and a similar failure pattern at somewhat higher load was obtained (Figure 11). Both mounts 3 and 4 had failures of the lower rail which was thought to be a potential problem in soft soil. The fracture left a forward facing tube which could penetrate the cowling and on into the soil.

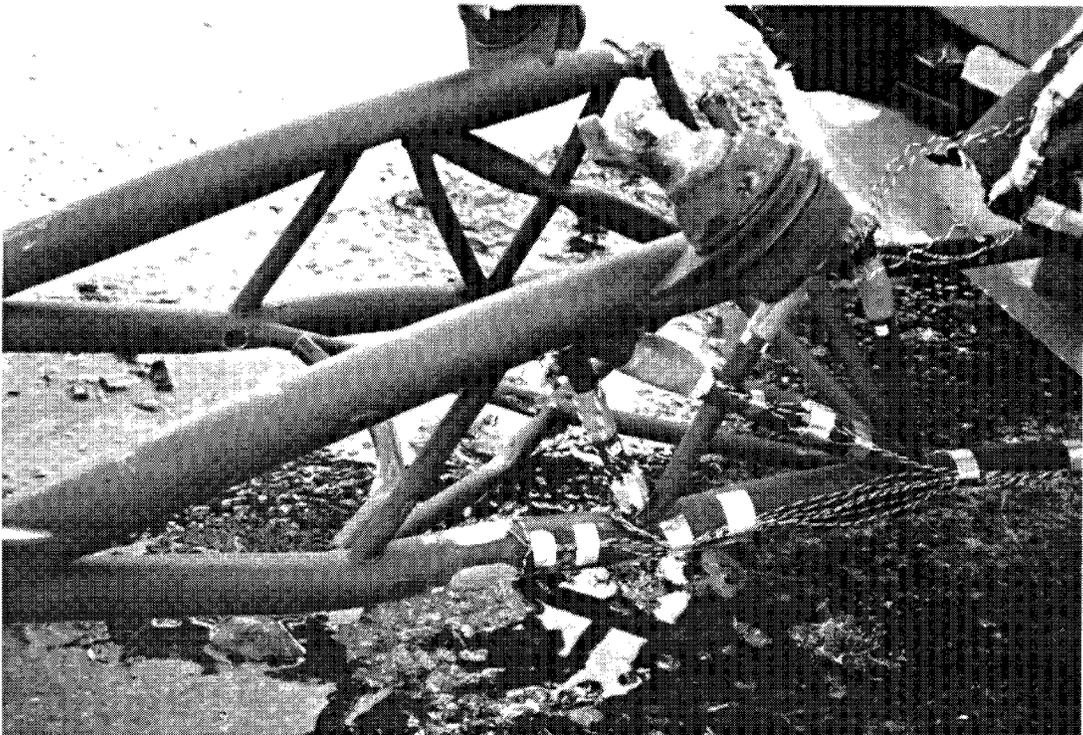
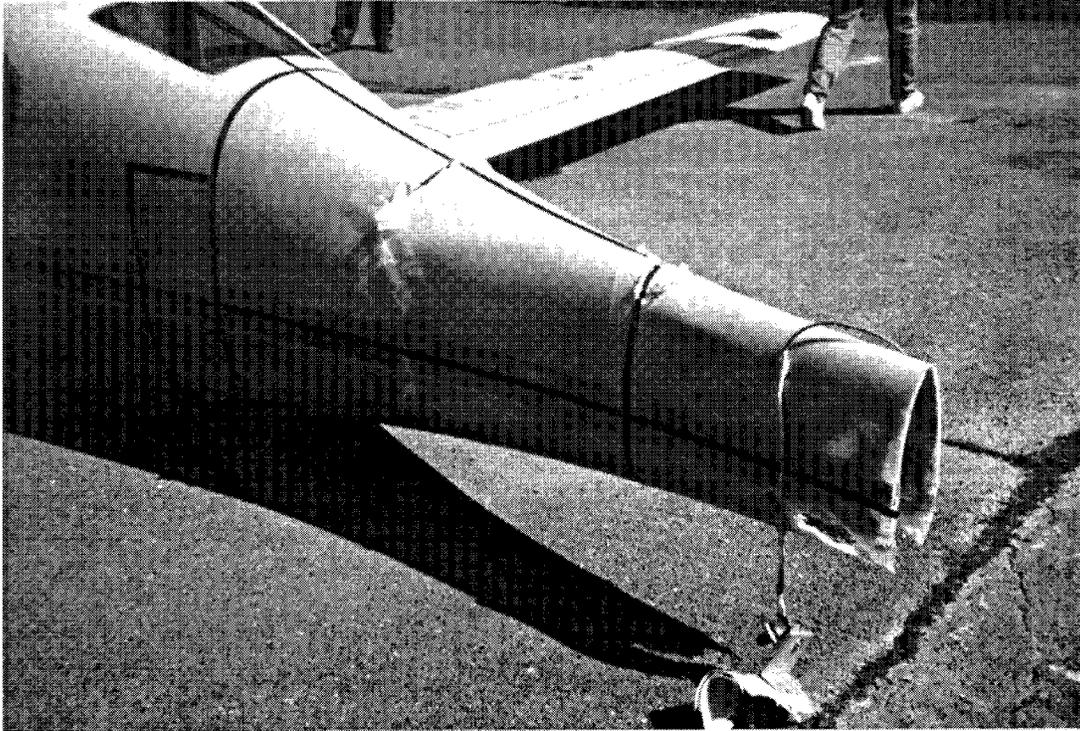
Figure 24, Post Crash Damage for Test 1

The first full scale test onto a hard surface showed that the dynamic strength of the engine mount was much higher than the quasi-static tests had indicated leading to high acceleration loads. A new engine mount and cowling design based on the half scale soft soil test performed well in the second full scale test onto soft soil. However, the dummies hit the instrument panel due to seat and shoulder harness inertia reel failures. Harness loads were well above allowable limits while airframe accelerations were within the survivable range.

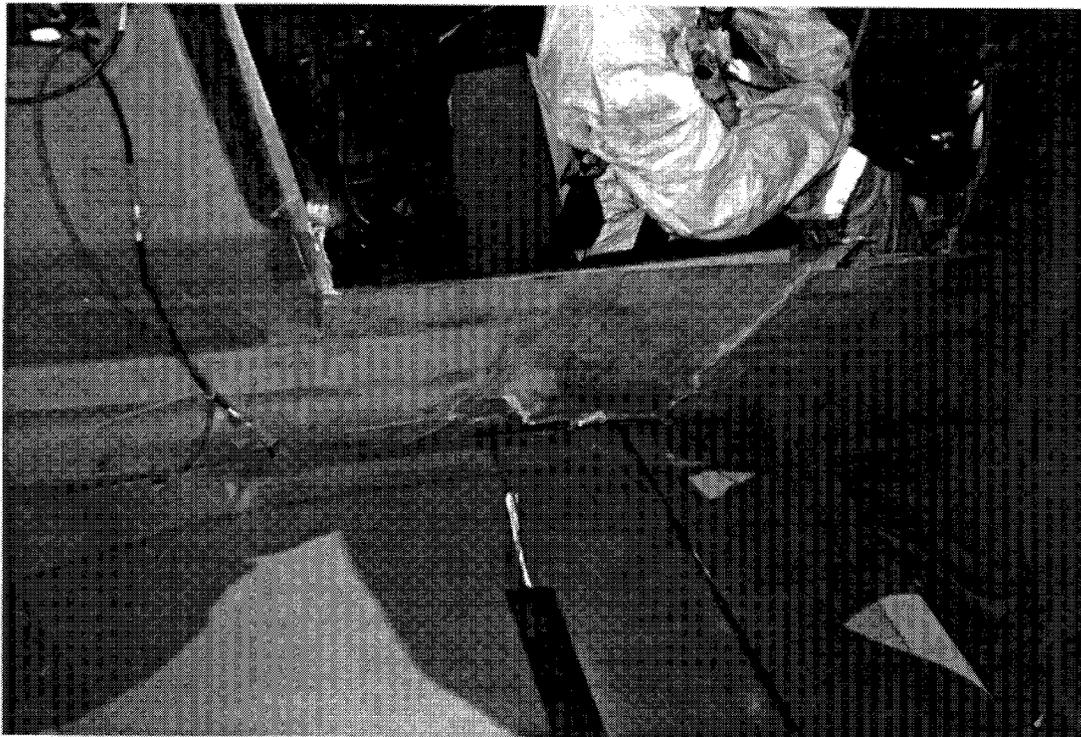
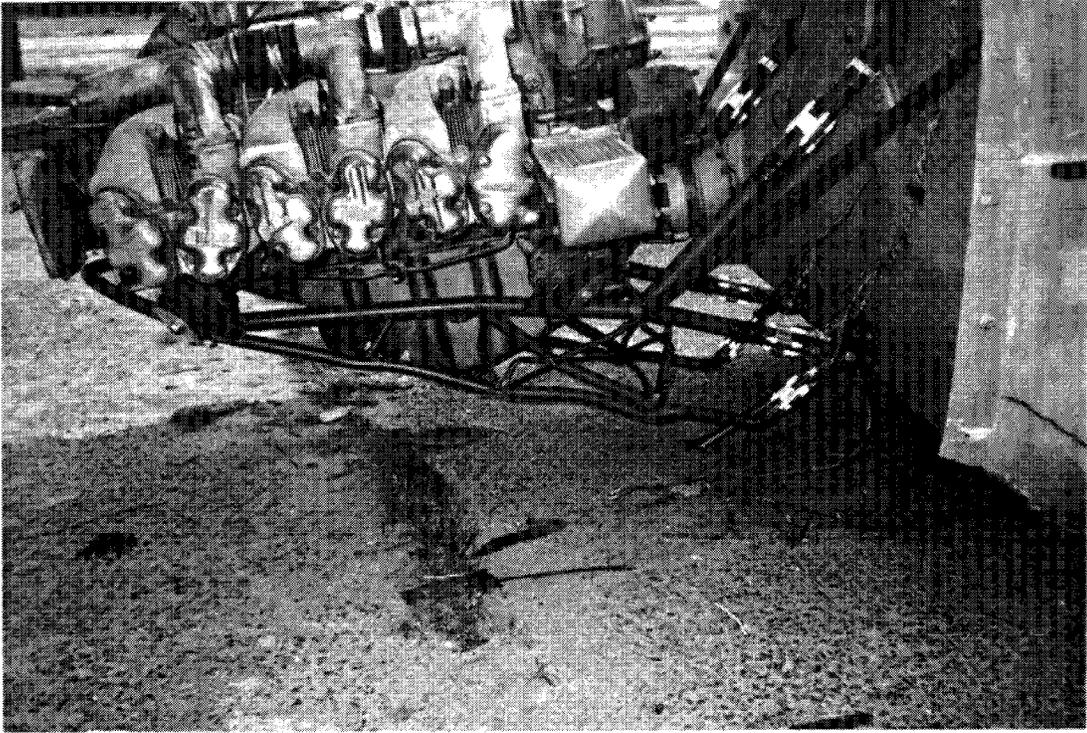
Figure 60, Post Crash Damage for Test 4

The windshield shattered at about 30 milliseconds after impact followed shortly by failure of the forward roll bar and side beams under the doors just aft of the forward edge of the door as shown in Figure 60(a-b). Both doors also came loose early. This allowed the forward fuselage to rotate upward approximately 12 degrees (Figure 59) and the engine mount did not deform as much as predicted (Figures 60(c-d)). Analysis had indicated the engine mount would collapse completely as shown in Figure 53 but the analysis did not allow for the forward fuselage failure, loss of the doors, or for the physical size of the engine and its oil pan. This engine has a cast aluminum oil pan and the front portion was shattered by the impact as shown in Figure 60(e). Forward mount brackets (portion attached to the engine) were broken but the aft brackets were intact. The mount did deform more than in test 1 and the deformation was more like that from the quasi-static tests.

There was no loss of cabin space and the deformation of the forward cabin was not enough to cause major damage to the legs of the front seat occupants. There was some fracturing of the slanted firewall segment on both sides as shown in Figures 60(f-g) but no penetration. There was no loss of structural integrity of the firewall at the braces near the floor but there was damage to the firewall beside the braces both above and below the cross tube as shown in Figure 60(h). Bond line failures along the upper engine mount support beam and some failure of the side shear panel can be seen in Figure 60(i). Bond lines also failed on both sides of the "Z" beam above the rear energy absorber as shown in Figure 60(j). There were a number of other areas of failures of bond lines and fracturing of fibers in transition locations.

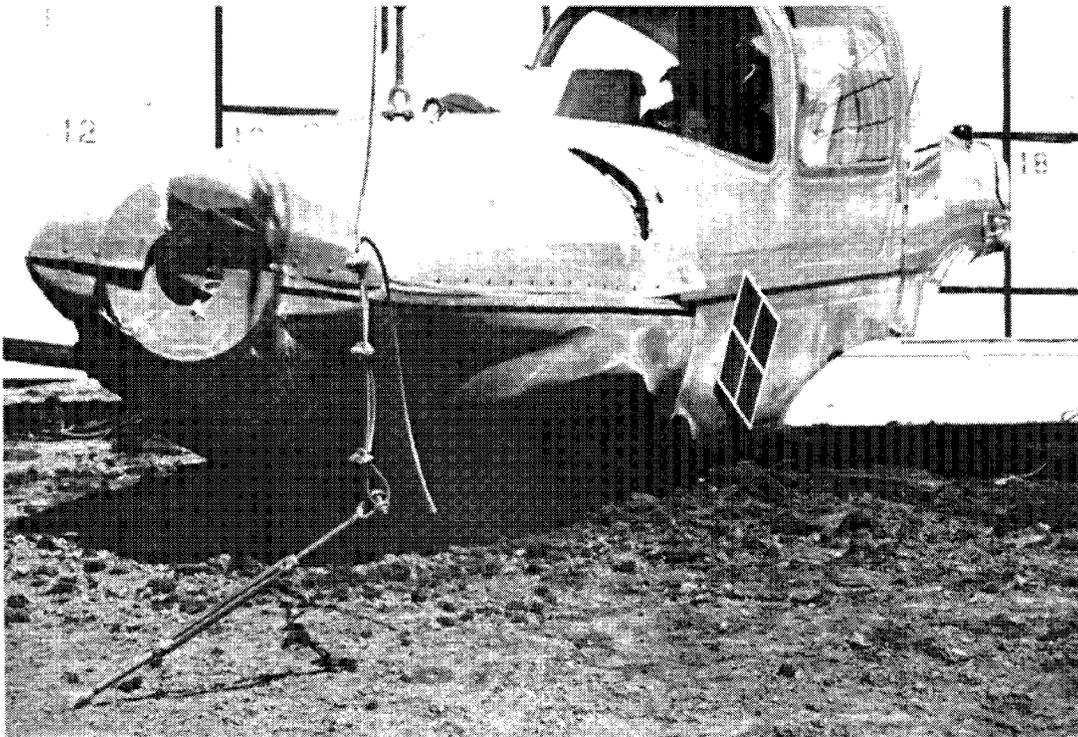
Figure 101, Post Crash Damage for Test 2

One of the wing rear spar attachment bolts had failed in test 2. While having parts separate from the airplane removes kinetic energy, it also increases the probability of breaking fuel lines and changes the loading on the energy absorbers. It is not known if this is favorable or not at this time since attempts to stop and restart the analysis with changes had not been successful. Rear spar attach fitting strength and the bolt size were increased for airplanes 3 and 4.

Test 2 was survivable except that both dummies were thrown forward into the instrument panel, the pilot because of a seat failure and the copilot because of a shoulder harness failure. An air bag was added for the pilot and airframe mounted load limiting shoulder harnesses were installed for both occupants for test 3. These will be described more fully below.
