Battery Reinitialization of the Photovoltaic Module of the International Space Station

Gyan Hajela and Fred Cohen
The Boeing Company, Canoga Park, California

Penni Dalton
Glenn Research Center, Cleveland, Ohio

Prepared for the
37th Intersociety Energy Conversion Engineering Conference
sponsored by the Institute of Electrical and Electronics Engineers,
Electron Devices Society
Washington, DC, July 28–August 2, 2002

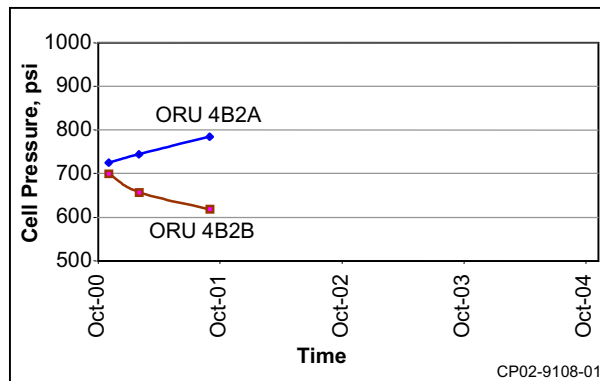
FIGURE 1. BATTERY 4B2 ORU PRESSURES

the battery 4B2. Battery 4B2 is showing a larger than expected pressure difference and the pressure difference is rising with time, Figure 1. However, the remaining parameters of this battery remain well within the ranges specified above—intercell temperature gradient $\sim 1.5^{\circ}\text{C}$, intercell voltage gradient $\sim 0.03\text{ V}$, ORU voltage difference $\sim 0.5\text{ V}$.

The 4B2 Battery is comprised of two ORUs that have cycle history differences or ages. This age difference was caused by 2 years of on-ground IEA testing. When the power channels were populated, the battery ORUs were matched to another containing cells of the same vintage (activation dates) but battery 4B2 contains two ORUs that have different ground test histories. We continue to monitor this battery very closely.

To resolve this performance anomaly, it was proposed to perform a controlled discharge of both batteries to a state of full discharge and then to charge them back up. This procedure would bring both ORUs to the same state before charging. This reinitialization is expected to reduce ORU pressure differential.

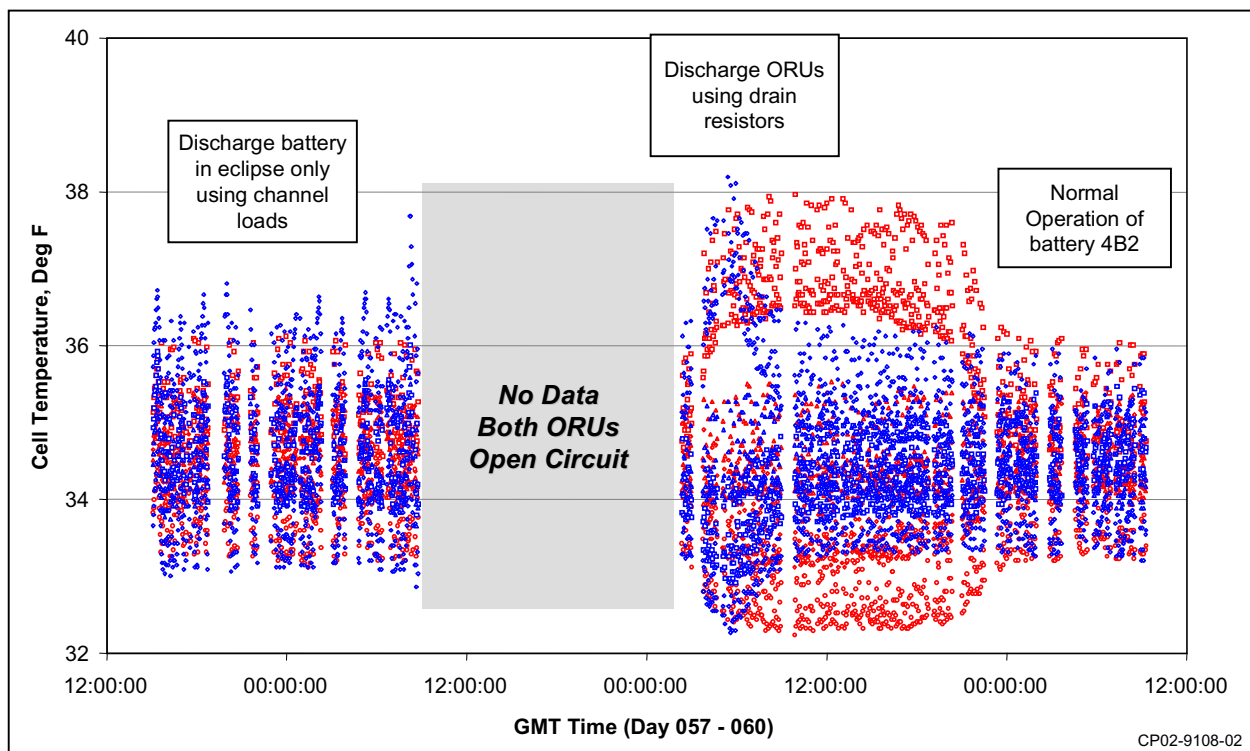
FIGURE 2. MONITORED BATTERY CELL TEMPERATURES

- Figure 2 shows the battery cell temperature during this step. All cells remain well within the allowable temperature limits of 32 to 50°F, and the temperature difference between cells remained within a design-to range of 5.4°F.

- Figure 2 shows that all cells remained well within the allowable temperature limits of 32 to 50°F. Note that the temperature difference between cells remained within a design-to range of 5.4°F.

- Figure 2 shows that all cells remained well within the allowable temperature ranges.
 - Figure 3 shows that it was cell #04 of ORU 4B2A that dropped first. Due to loss of communications with the ISS, the data showing drop to 0.1 V were lost.

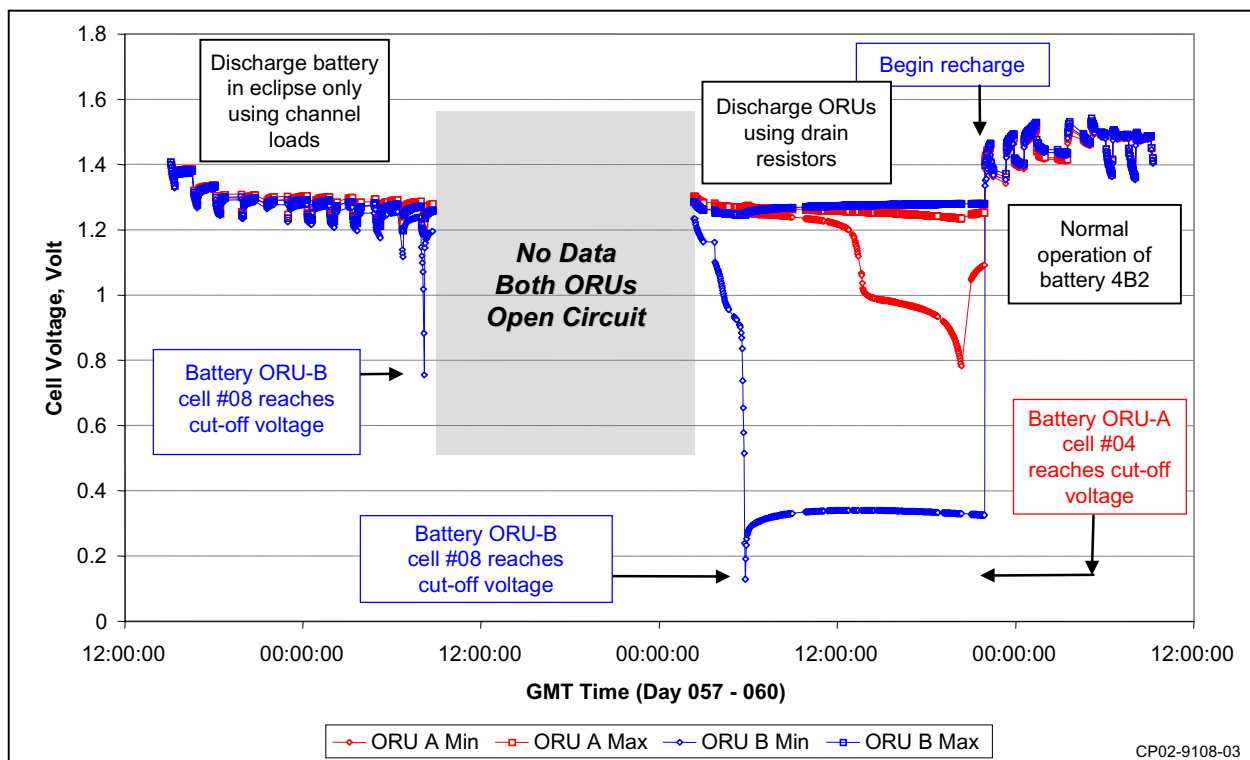
FIGURE 3. BATTERY CELL VOLTAGES, MIN AND MAX

- Figure 3 shows cell voltages. It shows that the cell #08 of ORU 4B2B reached the cutoff voltage first.
 - Figure 4 shows ORU voltages and the battery voltage (sum of the voltages of the two ORUs connected in series). It shows that the battery voltage remained well above the cutoff value of 76 V.

- Figure 3 shows that it was again the cell #08, of ORU 4B2B, which reached the cutoff voltage of 0.1 V first.
 - Note that cells in the ORU 4B2A has still not reached the first cutoff level, cell voltage below 0.7 V. This clearly shows the inequality of stored capacity between the two ORUs.

- Also note that the ORU 4B2B, cell #08 voltage rose to about 1.2 V when it was disconnected from the load (after dropping to below 0.7 V). Similar trend was demonstrated after this cell reached the second cutoff voltage of 0.1 V while on the drain resistor. The voltage rose again, to about 0.3 V, as soon as the drain resistor was disengaged.

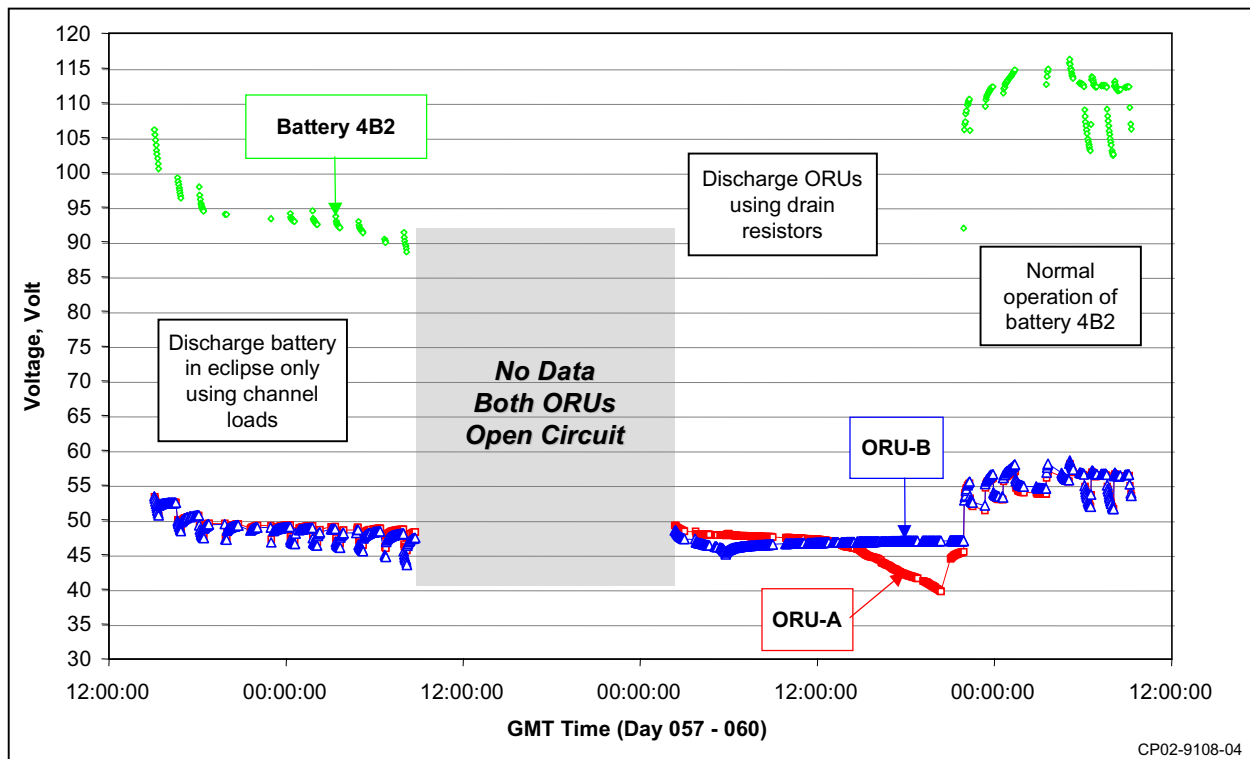
FIGURE 4. 4B2 VOLTAGES VS. TIME

- Figure 4 shows that the battery voltage remained well above the cutoff value of 76 V.
 - Figure 5 shows that cells of ORU 4B2A and 4B2B remained tightly grouped together, as before. Average pressure of ORU 4B2A and 4B2B remained apart by about the same value during this step, that is, no change in the ORU pressure differential.

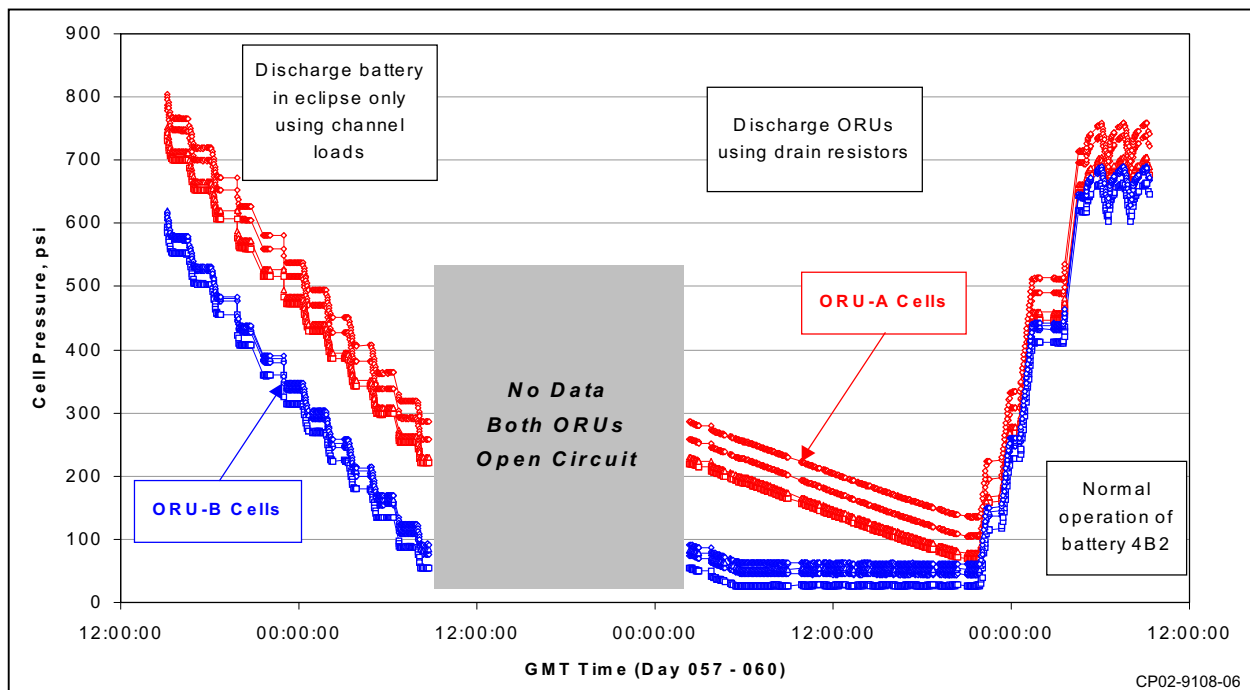
FIGURE 5. MONITORED CELL PRESSURES

- Figure 5 shows cell pressures. It can be seen that cells of ORU 4B2A and 4B2B remained tightly grouped together. Cell pressures dropped steadily during the eclipse periods and stayed unchanged during the insolation periods (charge inhibited). Average pressure of ORU 4B2A and 4B2B remained apart by about the same value during the discharge.

- Figure 5 shows that cells of ORU 4B2A and 4B2B remained tightly grouped together, as before. Pressure of cells in ORU 4B2A dropped during this step while pressure of cells in ORU 4B2B stayed the same. ORU pressure differential, at the time when ORU 4B2A reached the cell cutoff voltage, was reduced to 50 psi.

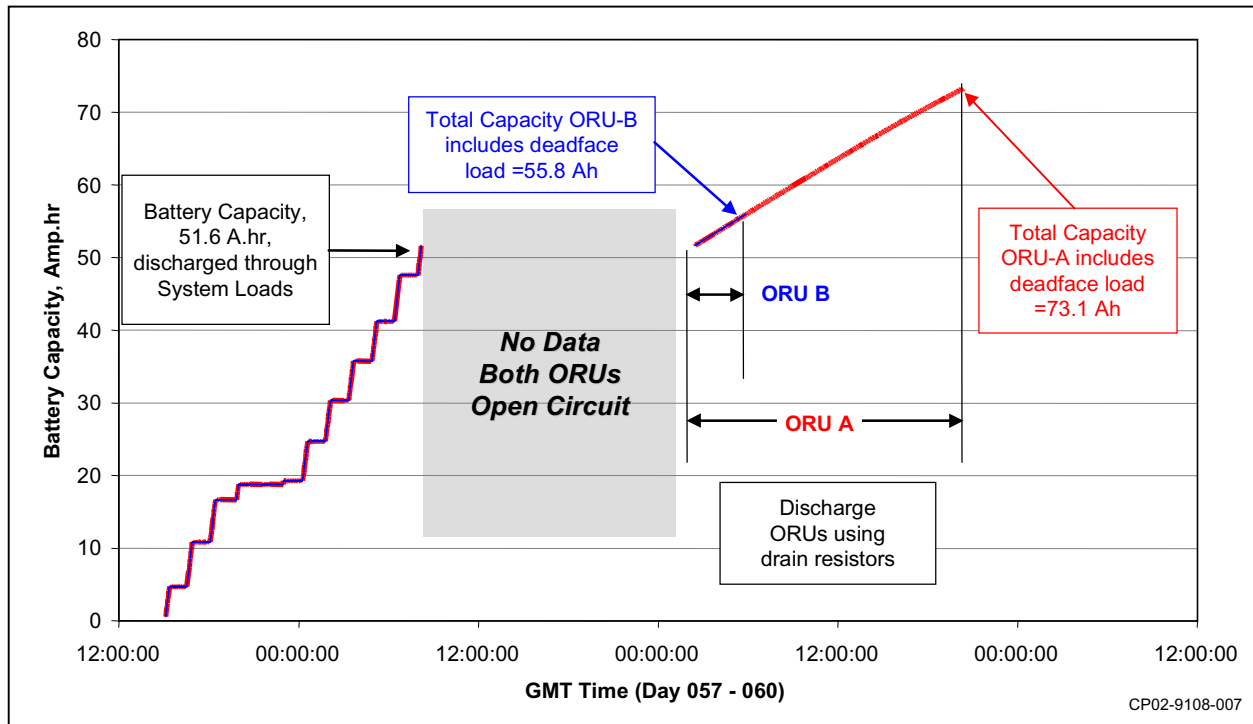
FIGURE 6. CALCULATED CAPACITY

- Figure 6 shows the battery capacity. It shows that the battery capacity was 51.6 A.hr at this rate of discharge (~17 A.). Note that the batteries need to discharge 50 A.hr to satisfy all discharge power requirements (continuous and contingency) and, thus, it is shown that the batteries continued to meet or exceed all power performance requirements even before reinitialization.
