RESTORING REDUNDANCY TO THE MAP PROPULSION SYSTEM

James R. O'Donnell, Jr.*, Gary T. Davis*, David K. Ward*
NASA Goddard Space Flight Center, Greenbelt, Maryland 20771, USA

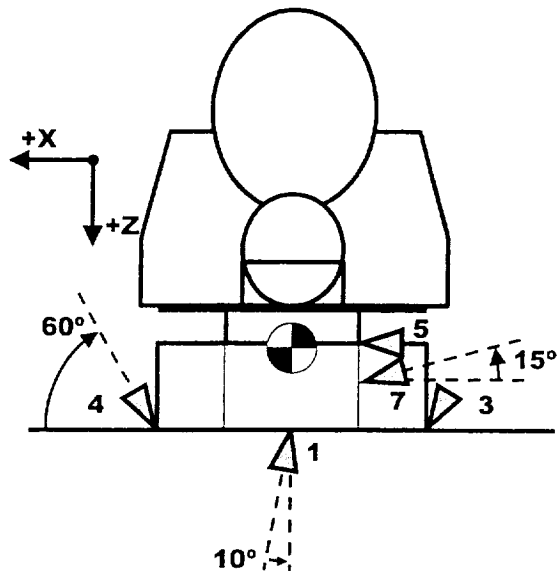
Figure 5: Thruster Layout with Thruster 1/2 Cant

With the 10° cant added to thrusters 1 and 2, MAP's propulsion system had backups for any single thruster

failure. Table 4 shows the primary and backup thrusters and beginning of life torques for each direction. The torque authority for each backup mode represented from 18% to 97% that of the primary, all viable and stable modes.

The final question was how the actual thrust redirection would be accomplished. Plume deflection shields had been considered as the simplest method for thrust redirection, but it was considered the least deterministic method with regard to final thrust direction. Bending the thruster nozzles themselves was also considered, but it was considered a significant risk to the reliability and performance of the thrusters. Instead, bending the tubing upstream of the thruster was selected as the preferred method for redirecting the thrust. Figure 5 shows the final thruster flight configuration.

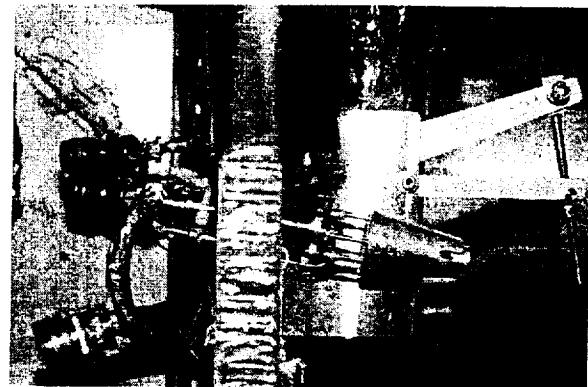
Figure 9: Thruster and Bend Tool After Bending

The new thruster brackets which incorporated a 10° thruster orientation were installed via a clamshell arrangement and the fasteners were installed and torqued. The thruster orientations were re-verified with the alignment mirrors. No additional adjustments were needed. Figure 8 and Figure 9 show thruster photographs before and after the bend (the pictures were taken from slightly different angles, but the bend is clearly shown.)

In the second phase, the bending tool was assembled in-place around the tube and thruster. Before the tube was bent, a measurement of the initial thruster orientation was taken to act as a starting reference. All orientation measurements were performed using optical theodolites, a reference cube attached to the spacecraft and, a flat mirror attached to the exit plane of the thruster nozzle. The bending tool was actuated by hand to execute the bend, which was measured frequently until the desired angle was reached.

The bend was performed in a similar manner to a common hand tube bender, although the 1 inch bend radius and sliding block of the bend tool supported the tube walls and precluded kinks. The tube bender mechanism consists of eight pieces which are bolted together. Some of the pieces are symmetrical so the tool can be assembled to perform bends in either direction. The tool was bolted to the thruster bracket mounting holes and then assembled in-place around the unbent tubes. A threaded rod allowed the tool operator to turn a nut to give a large mechanical advantage in forcing the sliding block about the radius.

The flight bends were performed while mirrors were installed on the thruster nozzles. Optical theodolites were used to measure the orientation of the nozzles before the bend and at several points during the bend until the desired angular change was met. Since the tool was reversible to accommodate thruster 1 or 2, four engineers were asked to verify that the thruster was going to be bent in the correct direction before the bending commenced. Thruster 1 was bent in four steps; the desired angular change from its starting orientation was $9.074 \pm 0.5^\circ$ and its actual change was 9.605°

(slightly out of the desired tolerance, but acceptable). Thruster 2 was bent in 5 steps; the desired angular change was $10.0 \pm 0.5^\circ$ and its actual change was 9.557° .
