RM A7D28 *Douglas**C-74/1*~~LANGLEY SUB-LIBRARY~~**NACA****RESEARCH MEMORANDUM**

AERODYNAMIC CHARACTERISTICS OF A PORTION OF THE

HORIZONTAL TAIL FROM A DOUGLAS C-74 AIRPLANE

WITH FABRIC-COVERED ELEVATORS

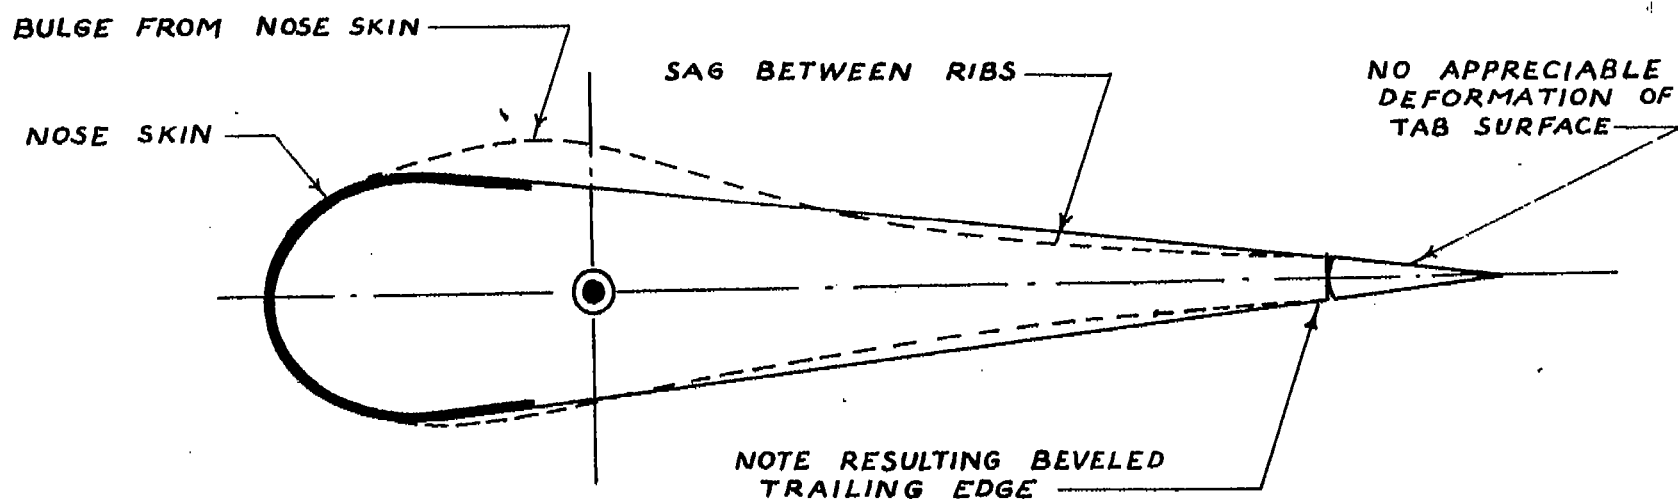
The first of these was one in which the elevator fabric, at the start of the testing, was attached to the ribs by small screws and drawn over the metal nose skin but attached to it only by doping. Early in the course of the tests the fabric pulled loose from the nose skin and a bulge developed which, upon increasing in size, began tearing the fabric from its fastenings to the fore parts of the ribs. The bulging and detachment from the ribs rapidly extended from about 5 to 40 percent of the elevator chord and, in extreme cases, bulging up to an estimated 4 inches in height occurred over about one-half of the test span. Fabric sag varying in

magnitude up to an estimated 1.5 inches in depth occurred between the ribs at the aft portion of the elevator over the complete test span. Typical bulging and sag of the elevator fabric for this condition is shown in figure 4. This first elevator condition will henceforth be referred to as the "original condition, fabric detached."

FIGURE 4. - TYPE OF SURFACE DEFORMATION FOR THE DOUGLAS C-74 ELEVATOR DURING TESTS IN THE AMES 16-FOOT HIGH-SPEED WIND TUNNEL FABRIC DETACHED CONDITION.  $\alpha = 0^\circ$   $\delta_e = +2^\circ$   $M = 0.55$

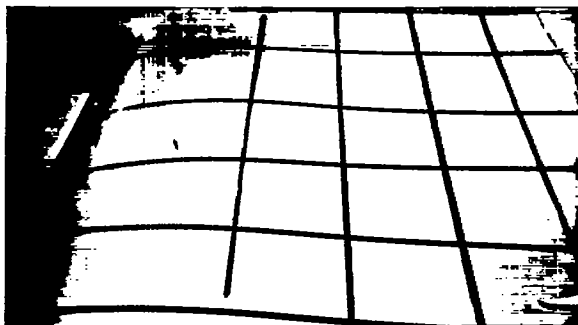
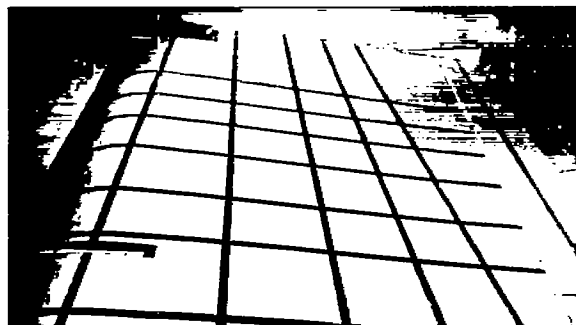
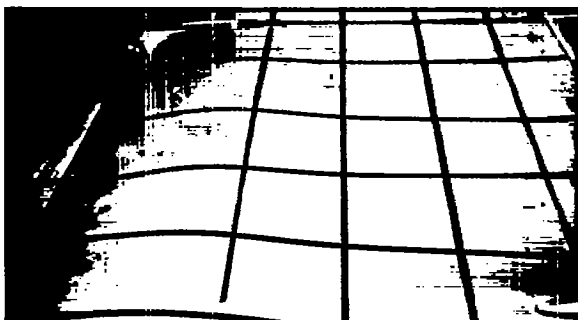
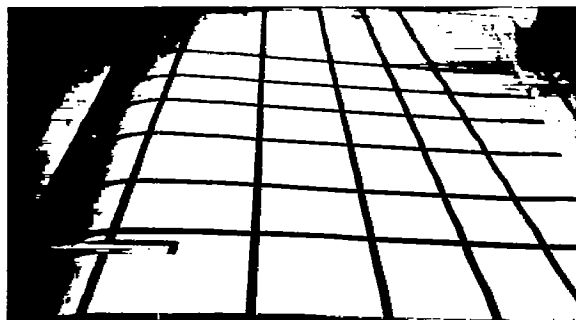
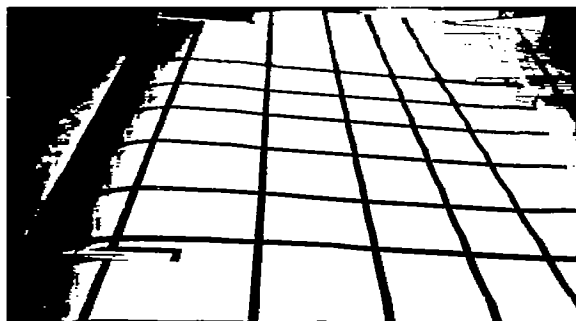
The fourth elevator condition was identical with the first, prior to testing, in representing the part directly off the airplane. However, the fabric on this elevator did not tear loose from the ribs and the bulging and sag were considerably less than that prevailing during tests of the first condition. (See fig. 5.) This fourth condition will be referred to as the "original condition." Control-tab characteristics were measured during this fourth set of tests.

(a) Fabric loose.

(b) Original condition.

Figure 5.- Photographs showing differences in bulging for the upper surfaces of two similar elevators tested in the Ames 16-foot high-speed wind tunnel.

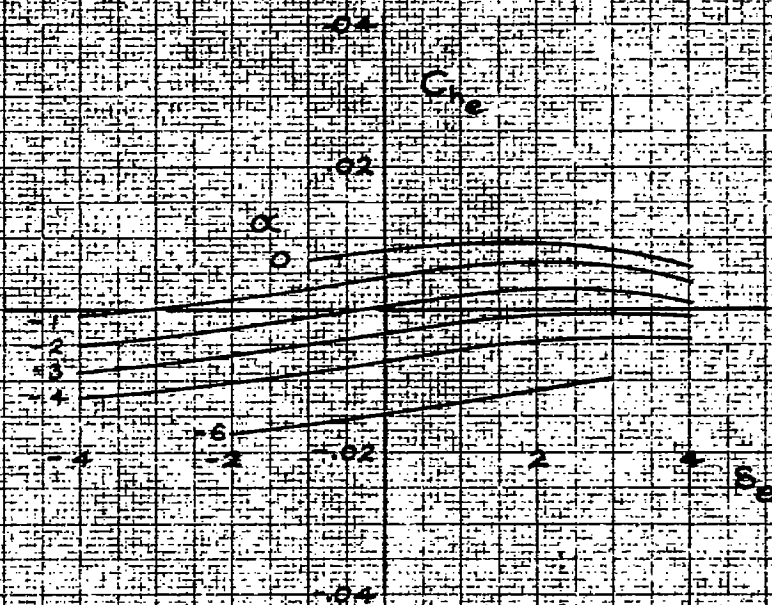
The variation of hinge-moment coefficient with elevator angle is presented in figures 6 to 9 for all the conditions tested. The positive variation for the fabric-detached (fig. 6) and the fabric-fastened conditions (fig. 7) is apparent. A negative slope is shown when the fabric was fastened with decreased rib spacing (fig. 8) and for the original condition (fig. 9), the predominant feature being a less negative slope with increase of Mach number. In some cases the tunnel-wall corrections were of such magnitude as to convert a negative slope into a positive one. Therefore, the absolute values of the coefficients, in each case, are subject to question.

FIGURE 6.— VARIATION OF ELEVATOR HINGE-MOMENT COEFFICIENT WITH ELEVATOR ANGLE FOR A SECTION OF THE HORIZONTAL TAIL FROM A DOUGLASS C-74 AIRPLANE. ORIGINAL CONDITION — FABRIC DETACHED.  $M=0.2$

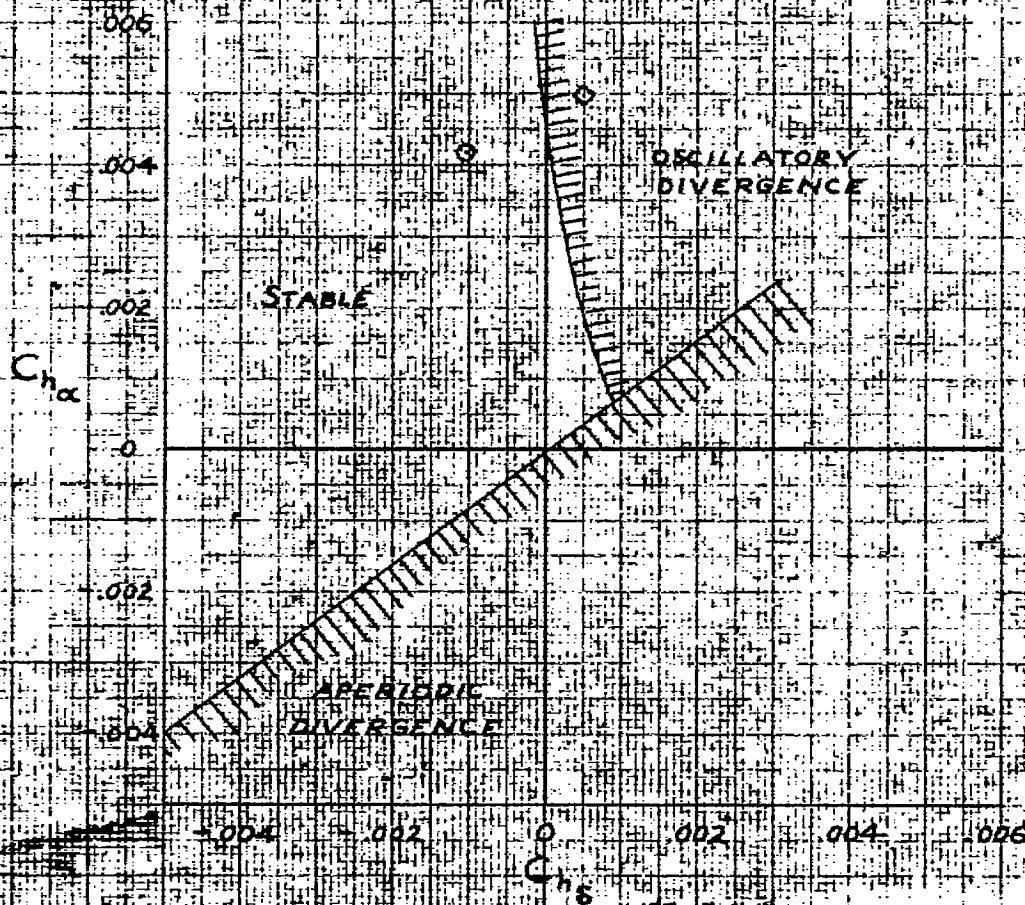
It is shown on figure 22 that either stable or unstable dynamic pitching-moment conditions of the airplane are possible, dependent on the extent to which elevator surface deformation occurs. Unfortunately, it is impossible to reach any definite conclusion from this curve due to the uncertainty of the absolute values of the data. It is evident, however, that for greater dynamic longitudinal stability more negative values of  $C_{H\delta}$  are required. The effect of bulge and sag, in general, was to cause more positive  $C_{H\delta}$  values. The bulging of the fabric over the nose of the elevator changed the nose balance shape to one of greater bluntness. A more blunt nose shape can produce more positive  $C_{H\delta}$  values (reference 1), which would be especially detrimental with a closely balanced elevator of this type. Adverse effects are also attributed, in part, to the beveled trailing-edge section resulting from sag of the fabric between ribs at the aft portion of the elevator. The beveled edge in this case was composed of the trim and control tabs whose surfaces did not deform appreciably under load. Results of flight tests of elevator sections have shown more positive  $C_{H\delta}$  values resulting from beveled trailing edges (reference 4). Wind-tunnel data for beveled trailing-edge elevators having overhanging balance and a blunt nose have shown overbalance at high Mach numbers (reference 5). Elimination of the overbalance, in that case, resulted upon changing to straight-sided elevators. The results obtained from tests of the C-74 elevator show that the only fabric condition in which  $C_{H\delta}$  remained negative with increase in Mach number was that where the surface deformation was held to a minimum by fabric fastening and decreased rib spacing. Fabric fastening and decreased rib spacing may not be the safest solution, however, as upon aging and deterioration of the fabric, it is possible that bulging and sagging may occur with accompanying

FIGURE 22. C-74 AIRPLANE ELEVATOR-FREE LONGITUDINAL STABILITY BOUNDARIES AT CONSTANT SPEED.

adverse effects. This consideration suggests the use of metal-covered elevators.
